TRI-TECH PINNACLE

Roof Condition Report - Sansar Apartments - 1140 Hillside Avenue, Victoria, BC

Inspection Date:

11/9/2022

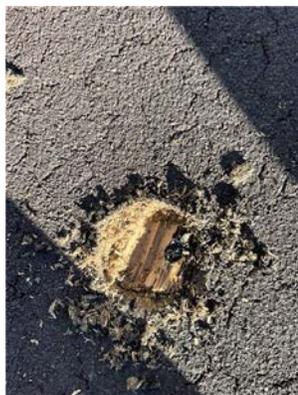
Core Sample

The core cut was taken to verify the roof condition and composition in this particular location on the roof. The roofing assembly is:

- 2 Ply Modified Bitumen Roofing Membrane
- Wood Deck

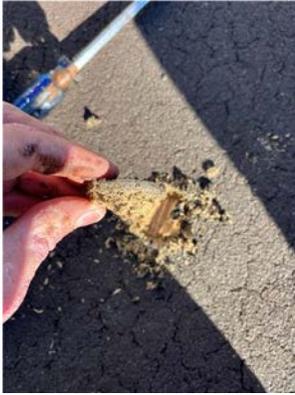
Core Sample 1

Another view of the roofing assembly

- 2 Ply Modified Bitumen Roofing Membrane
- Wood Deck

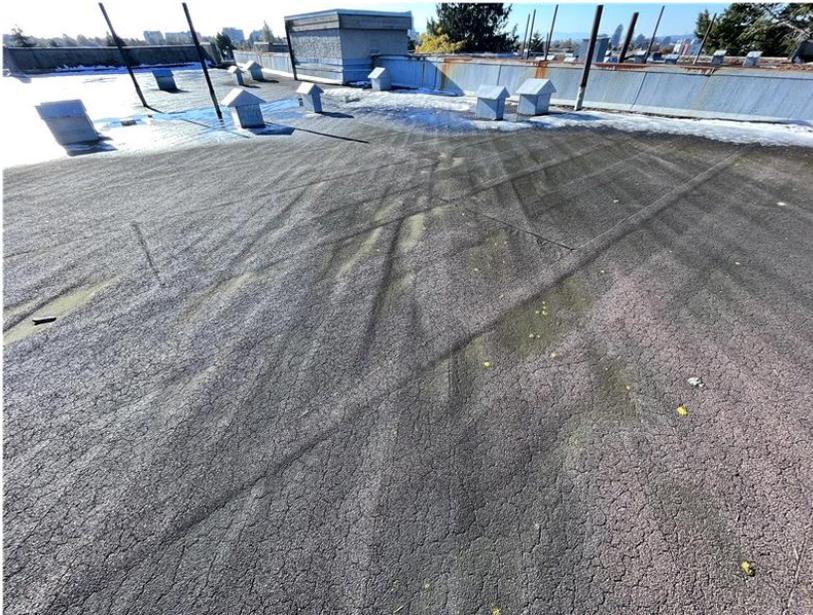
→
Condition: Anomaly
Severity: High
Quantity: 1

View of the wood deck telegraphing through the membrane. This condition was noted throughout the roof level.

Due to the age and condition of the installed roofing assembly, roof replacement is recommended within the next 1-2 years.

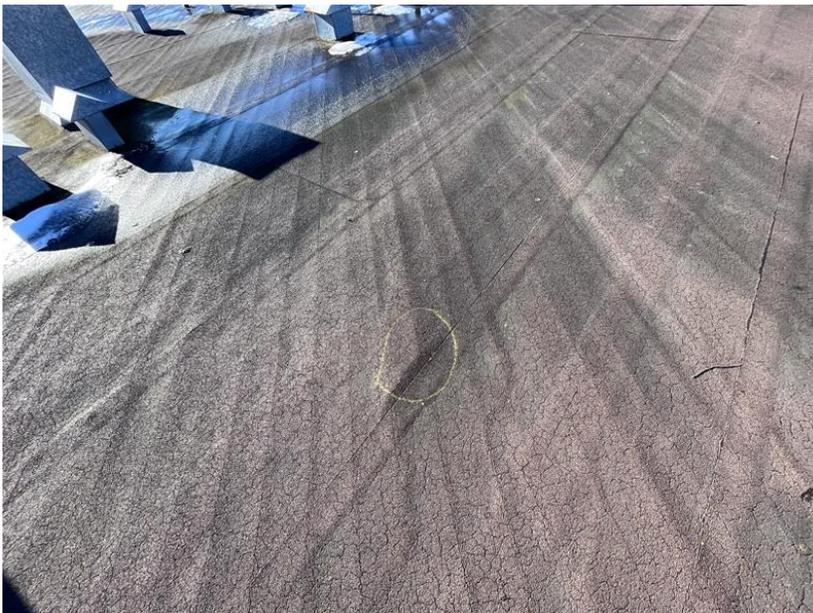
◆
Condition: Blister
Severity: High
Quantity: 1

Blisters are an indication that either air or moisture are trapped within the roofing system. +/- blisters were noted on this roof level.

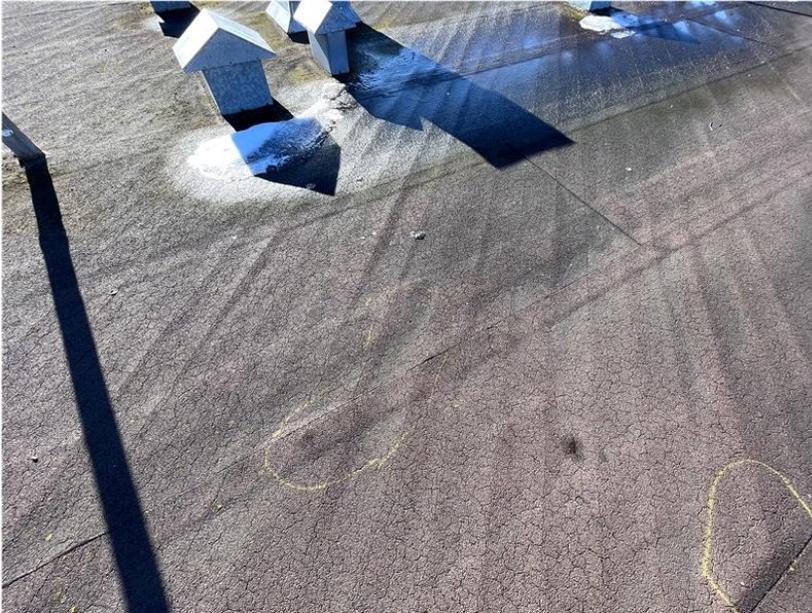
◆
Condition: Blister 1
Severity: High
Quantity: 1

More blisters in the field of this roof level.

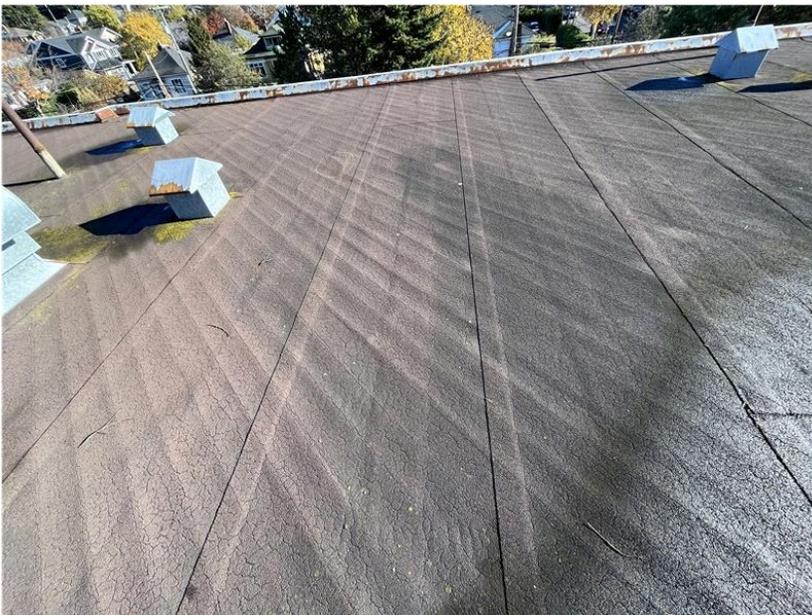
◆
Condition: Blister 2
Severity: High
Quantity: 1

Another blister in the field of this roof level.

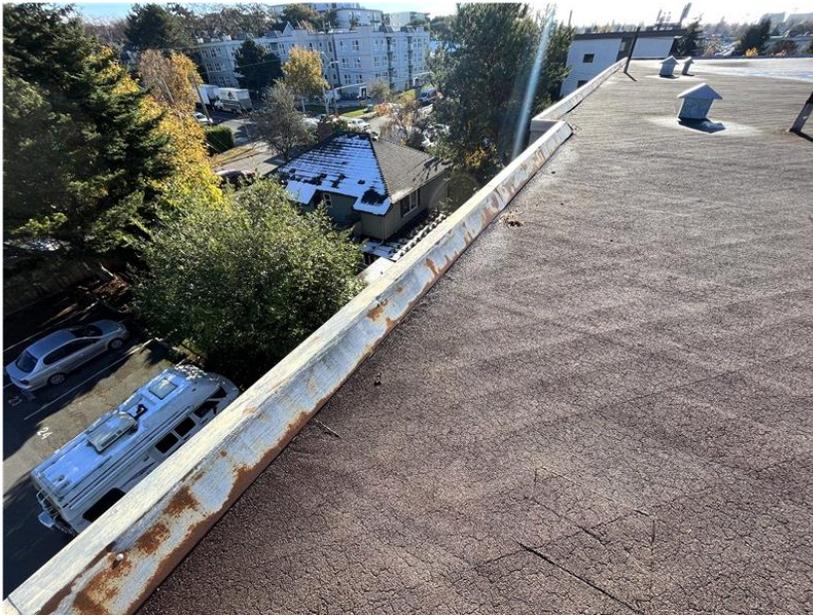
→
Condition: Corrosion
Severity: Medium
Quantity: 1

The perimeter metal flashings are corroded in several locations on this roof level.

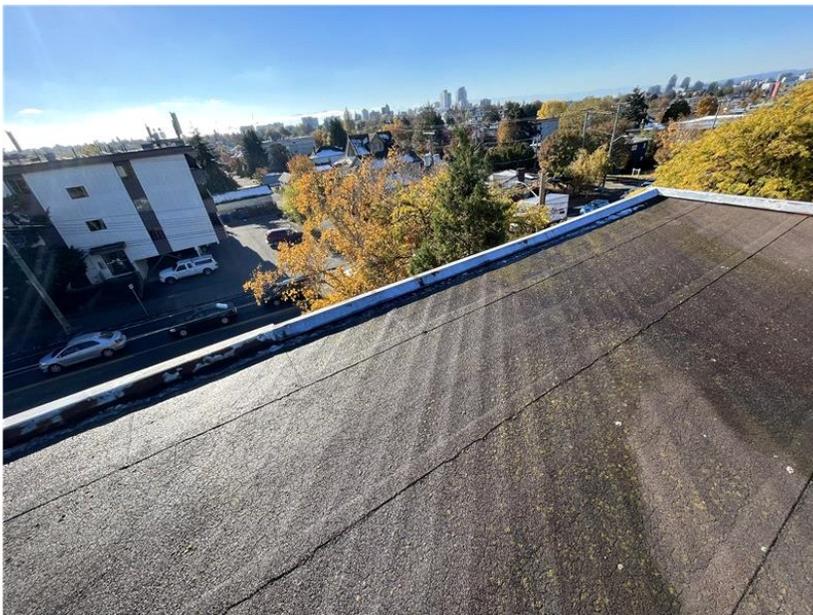
↑
Condition: Corrosion 1
Severity: Medium
Quantity: 1

Another view of the corroded perimeter metal flashings.

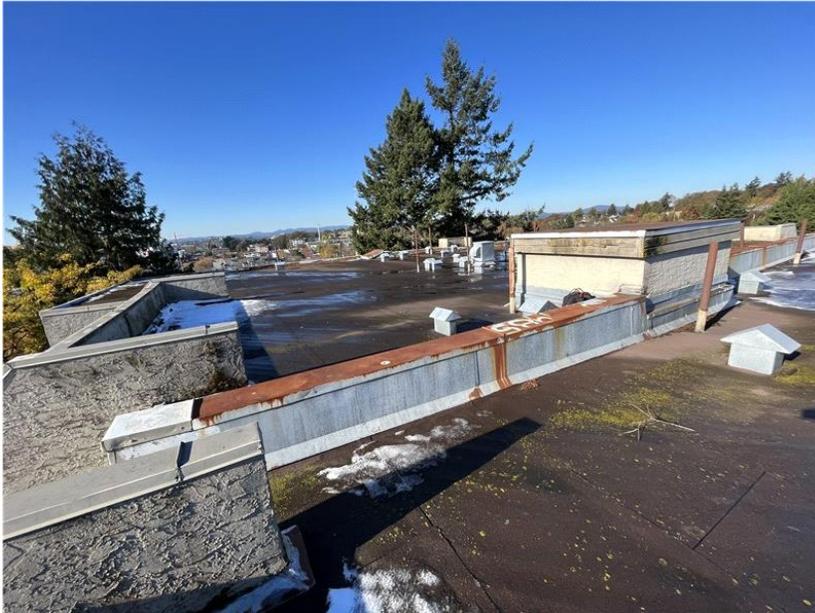
Condition: Corrosion 2
Severity: Medium
Quantity: 1

More corroded metal at the perimeter.

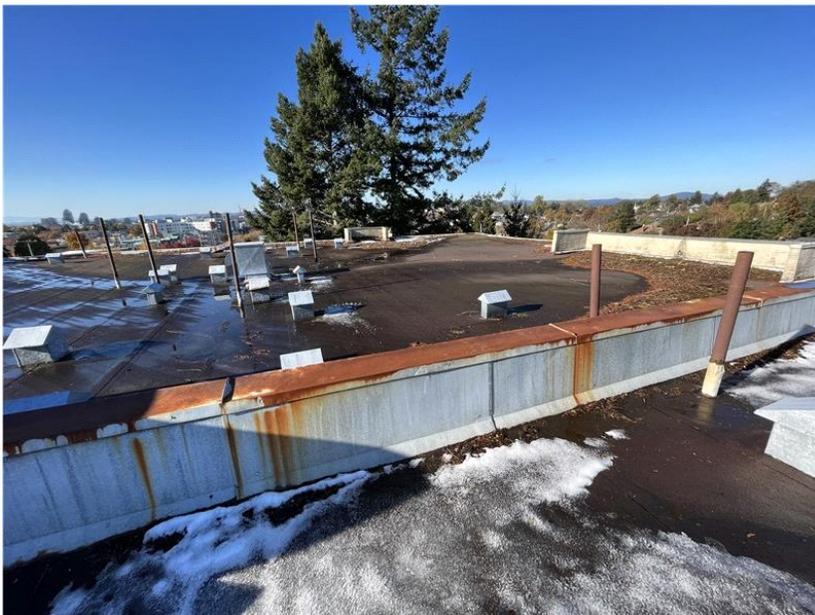
Condition: Corrosion 3
Severity: Medium
Quantity: 1

More corroded metal at the perimeter.

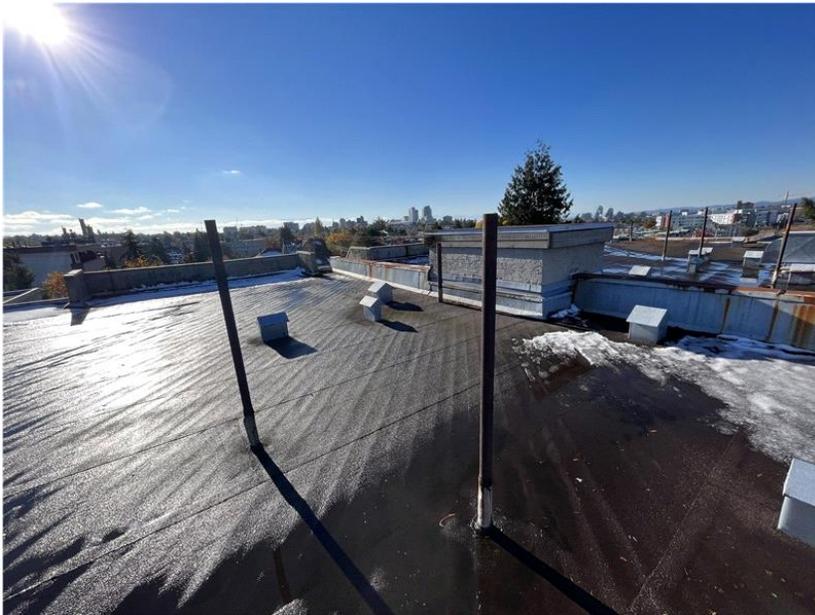
←
Condition: Corrosion 4
Severity: Medium
Quantity: 1

Several corroded soil stacks were also noted.

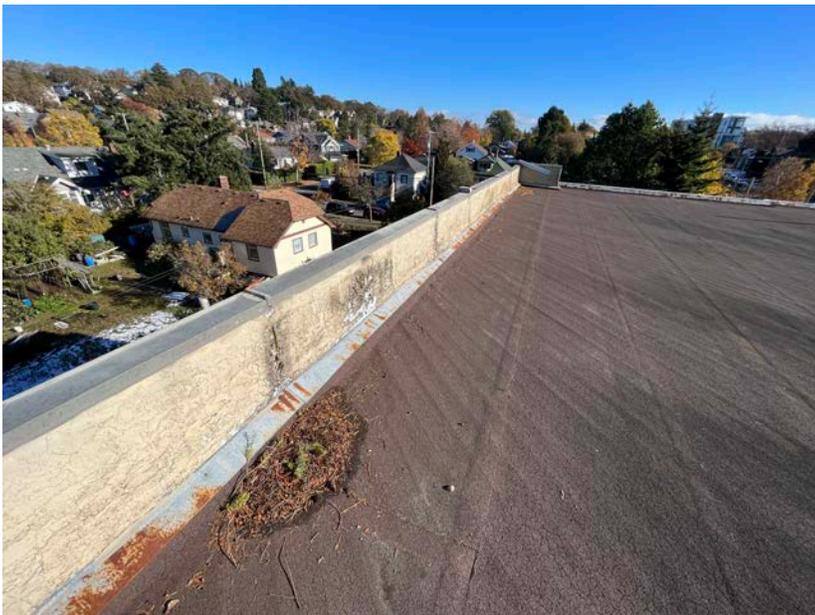
←
Condition: Corrosion 5
Severity: Medium
Quantity: 1

More corroded metal at the perimeter.

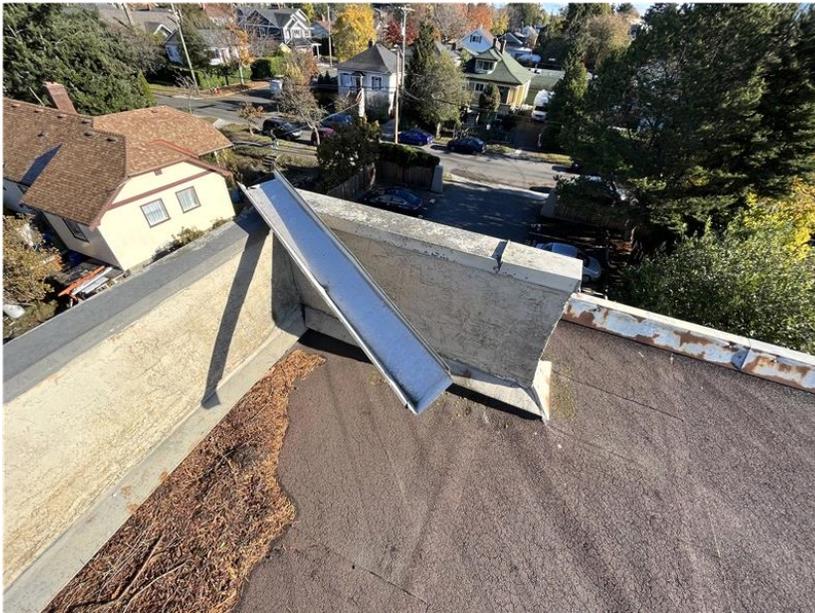
→
Condition: Damaged metal
Severity: Medium
Quantity: 1

Damaged/unsecured metal flashings were observed along the perimeter of this roof level.

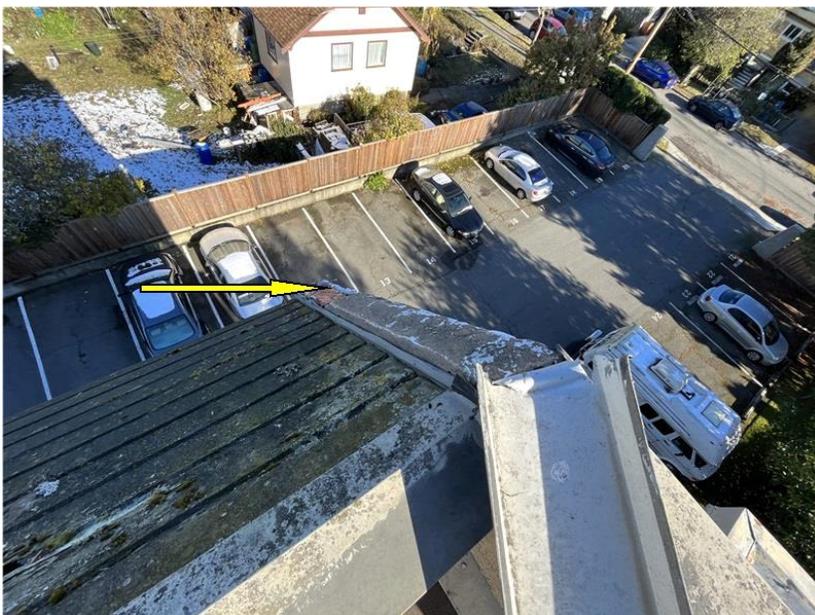
→
Condition: Damaged perimeter
Severity: Medium
Quantity: 1

View of the damaged perimeter.

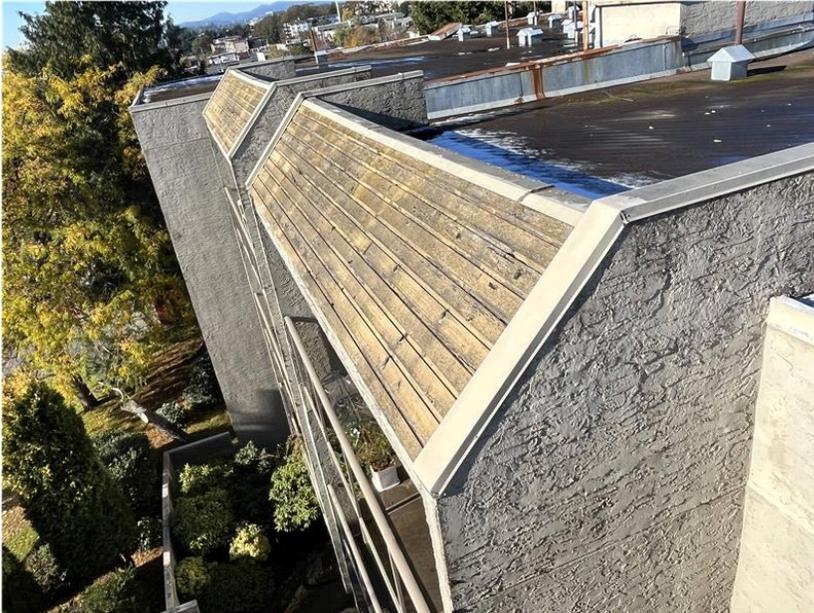
Condition: Perimeter
Severity: Medium
Quantity: 1

View of the deteriorated wood at the perimeter.

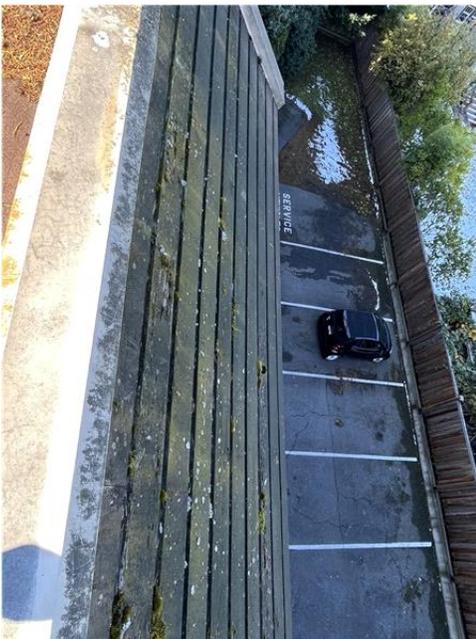
Condition: Perimeter 1
Severity: Medium
Quantity: 1

Another view of the deteriorated wood at the perimeter.

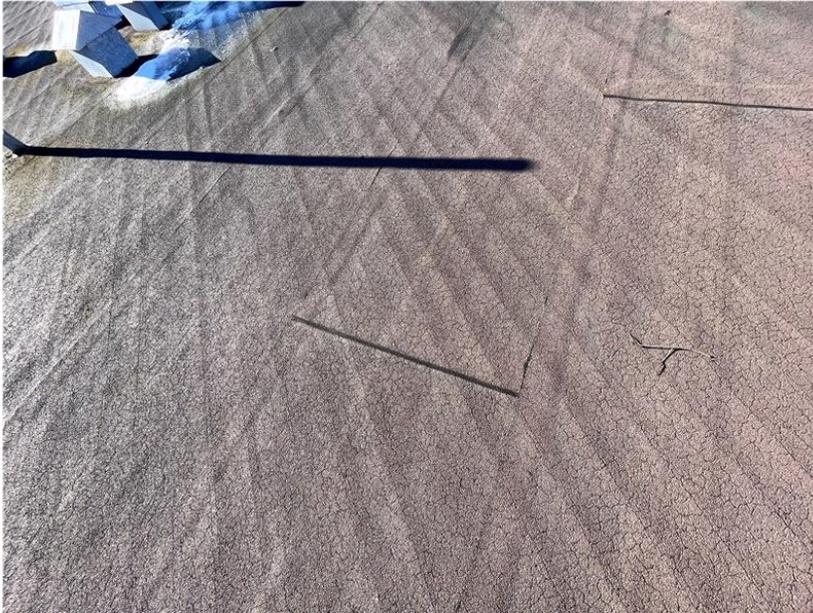
Condition: Slippage
Severity: Medium
Quantity: 1

Slippage has occurred in the field membranes, evidenced by the presence of narrow bare strips perpendicular to the slope.

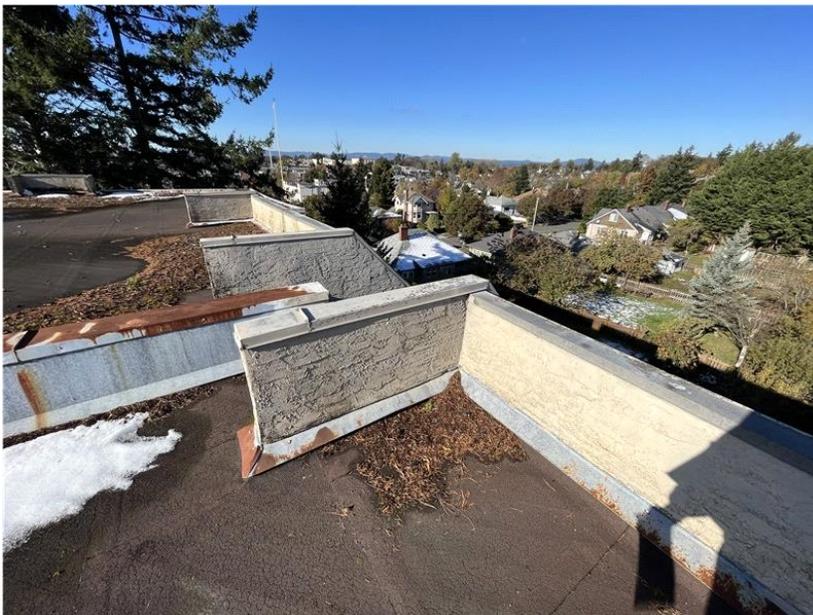
Condition: Organic debris
Severity: Low
Quantity: 1

An accumulation of organic debris was noted at the perimeter of this roof level.

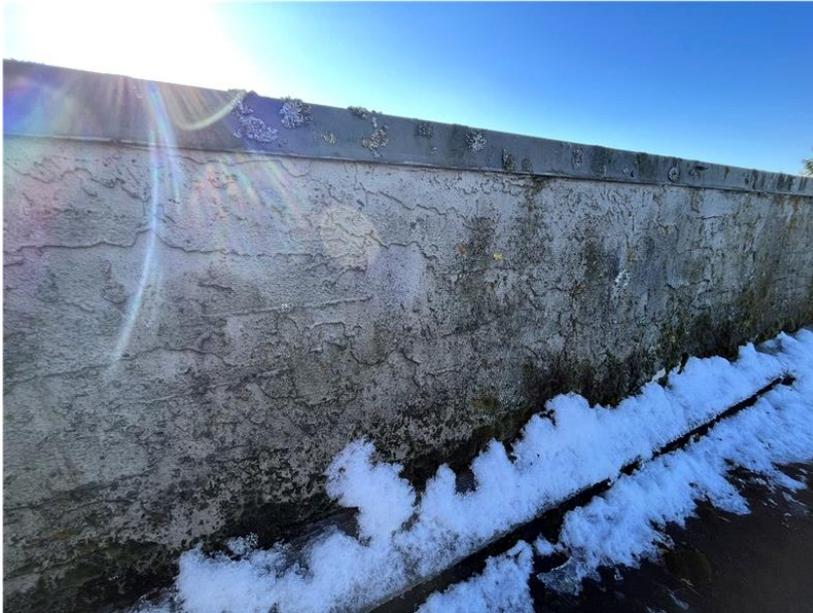
Condition: Vegetation

Severity: Low

View of the moss/staining on the perimeter parapet wall.

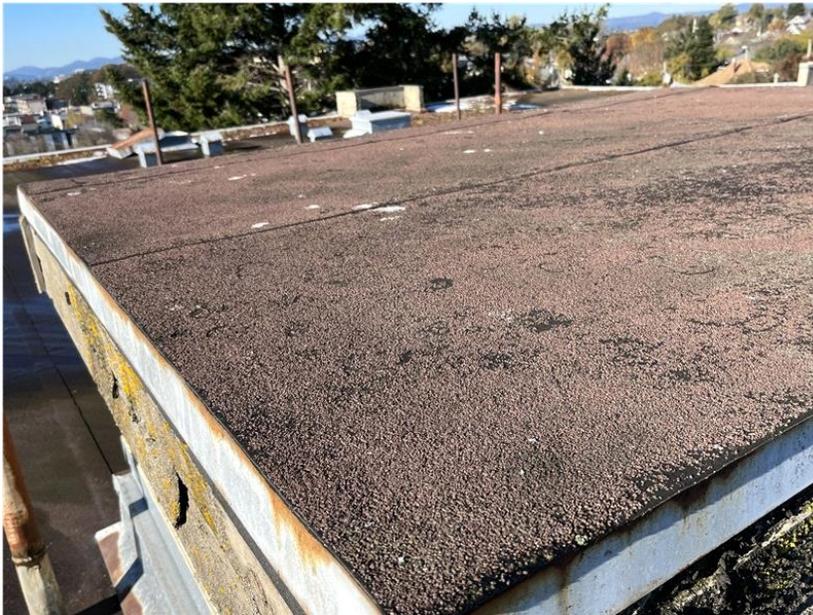
→
Condition: Deteriorated membrane
Severity: High
Quantity: 1

The roofing membrane is deteriorated and should be repaired to avoid further degradation.

Due to the age and condition of the installed roofing assembly, roof replacement is recommended within the next 1-2 years or at the same time as the main roof levels to ensure preferred pricing.

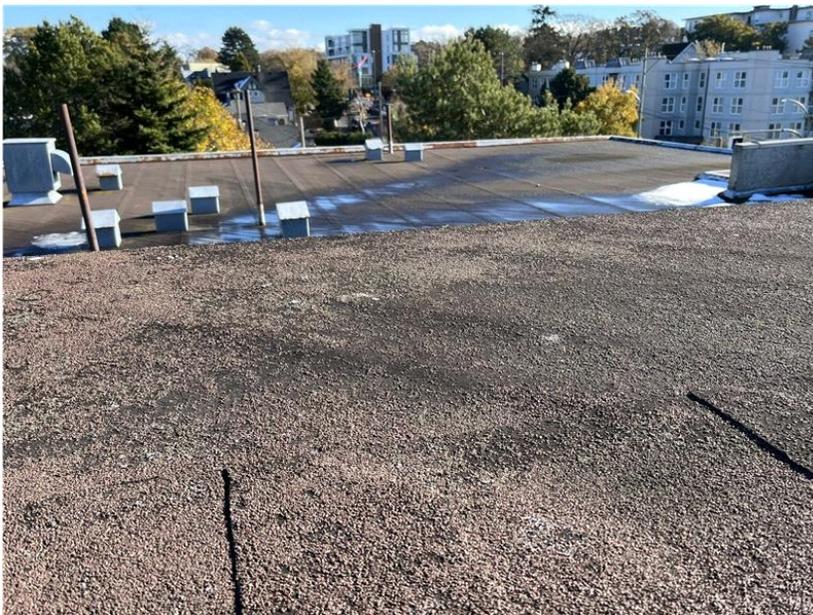
→
Condition: Deteriorated membrane 1
Severity: High
Quantity: 1

Another view of the deteriorated roofing membrane.

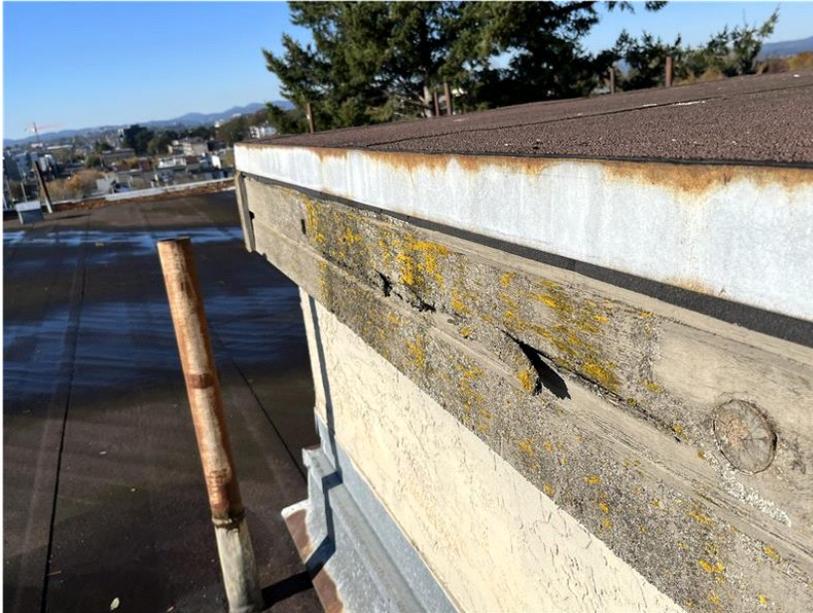
Condition: Deteriorated Wood
Severity: Medium
Quantity: 1

View of the exposed and deteriorated wood at the perimeter.

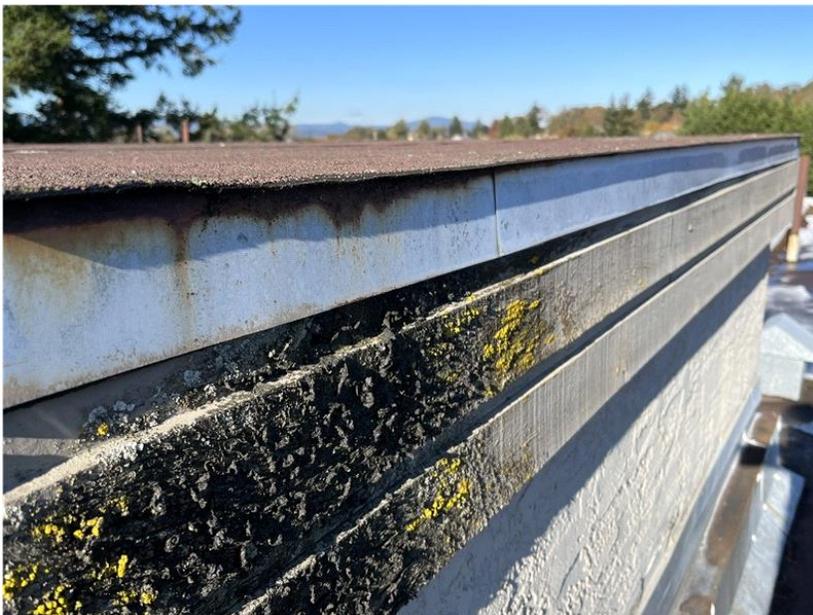
Condition: Deteriorated Wood 1
Severity: Medium
Quantity: 1

Another view of the deteriorated wood and corroded perimeter metal flashings.

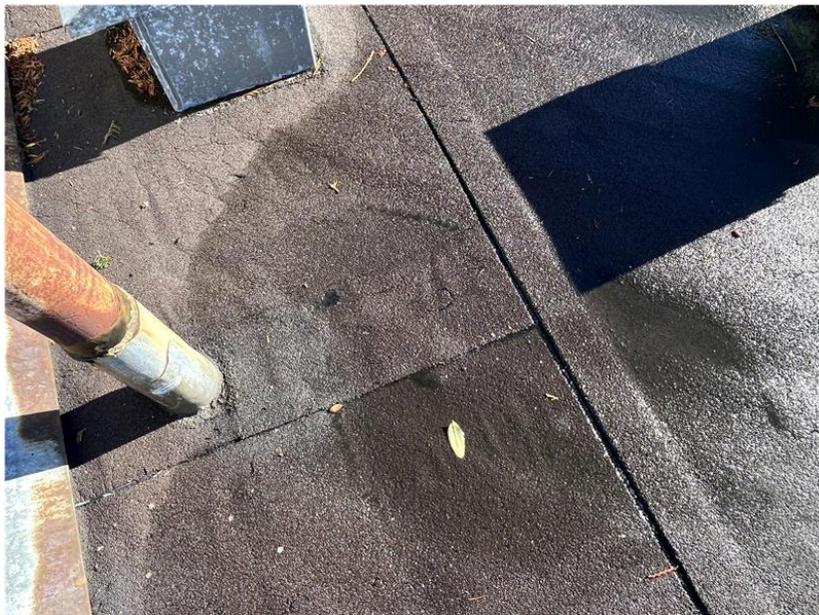
◆
Condition: Blister
Severity: High
Quantity: 1

Blisters are an indication that either air or moisture are trapped within the roofing system. Blisters will continue to grow and can easily be broken by foot traffic on the roof.

Due to the age and condition of the installed roofing assembly, roof replacement is recommended within the next 1-2 years.

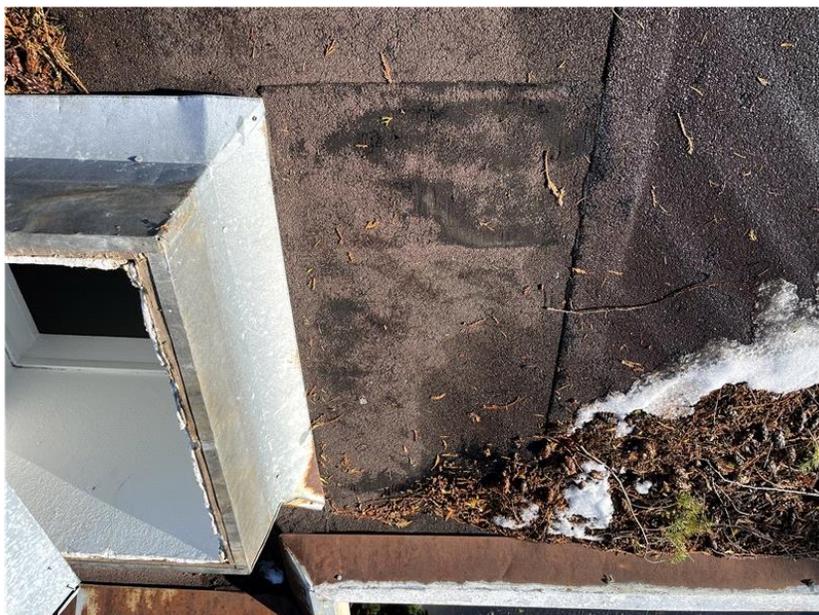
→
Condition: Deteriorated membrane
Severity: High
Quantity: 1

Several areas with deteriorated roofing membrane were noted.

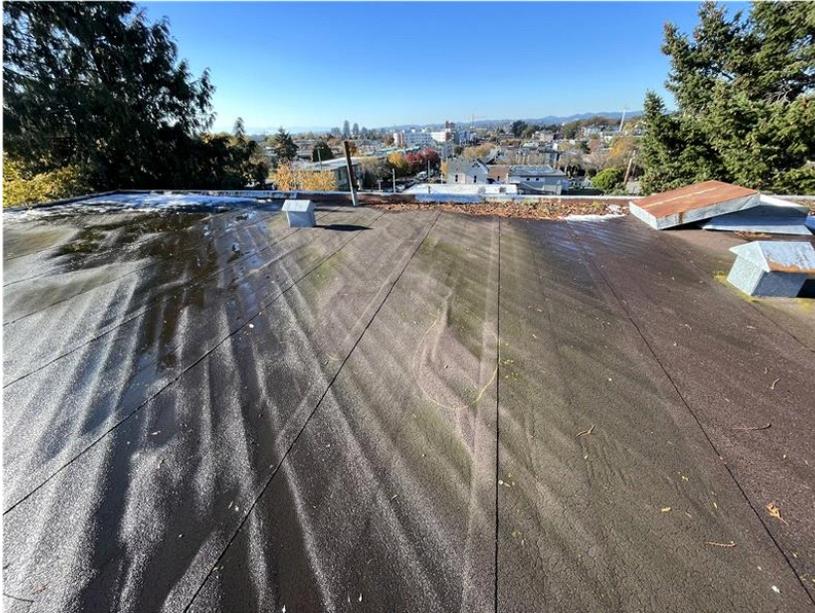
Condition: Ridges
Severity: High
Quantity: 1

View of wrinkled and ridged roofing membrane. Soft spots were also noted on the roof indicative of water in the roofing assembly.

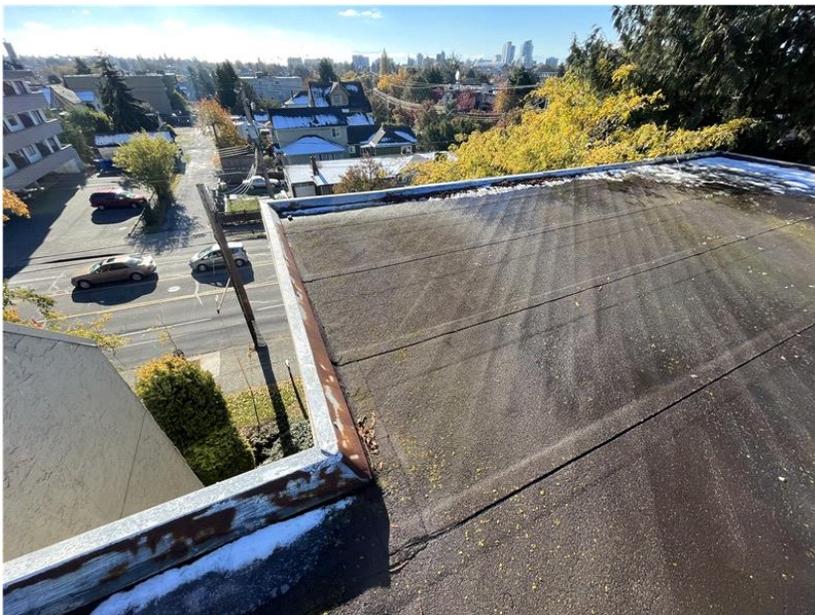
Condition: Corrosion
Severity: Medium
Quantity: 1

The perimeter metal flashings are severely corroded in several locations on this roof level.

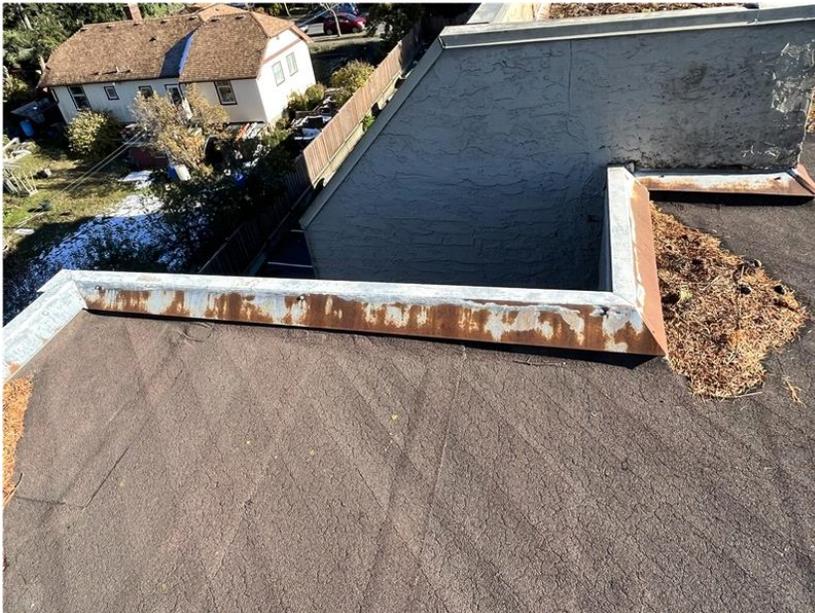
Condition: Corrosion 1

Severity: Medium

More corroded perimeter metal flashings.

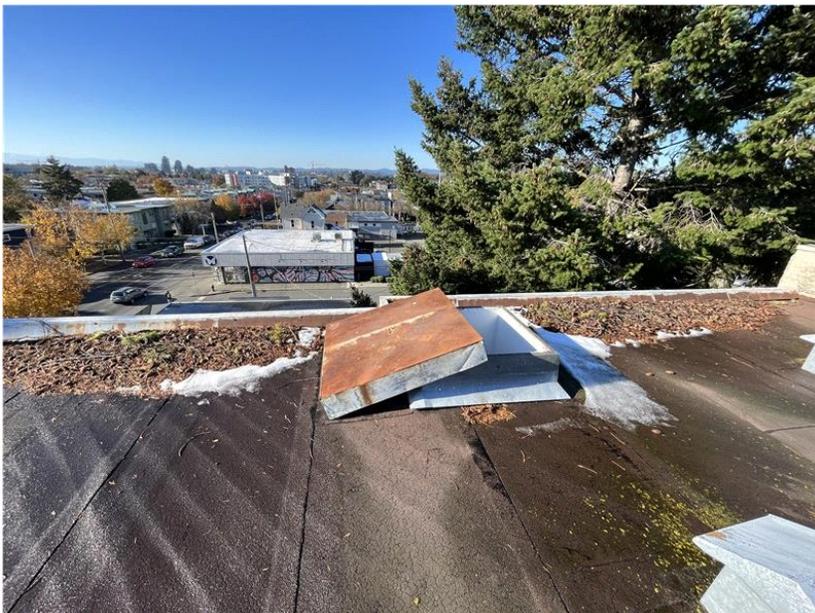
Condition: Corrosion 2

Severity: Medium

View of the corroded roof hatch.

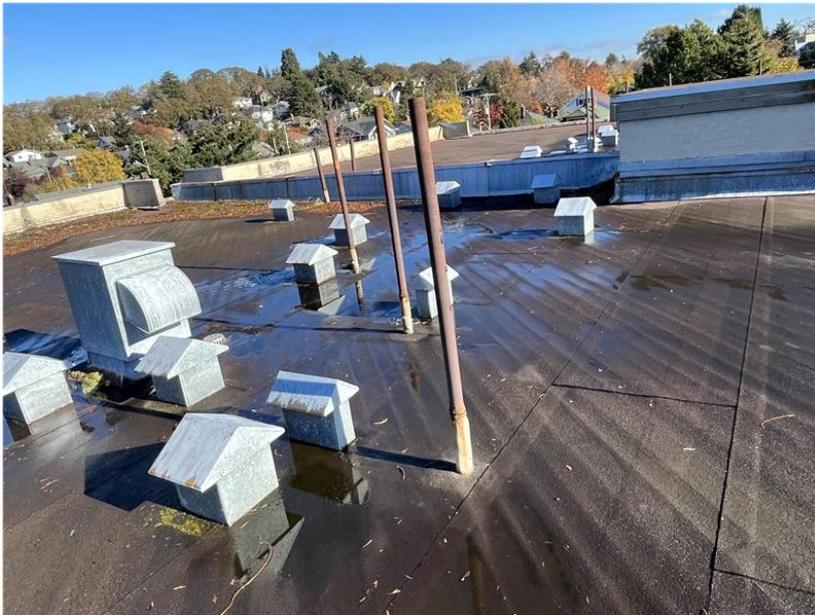
←
Condition: Corrosion 3
Severity: Medium
Quantity: 1

Several corroded soil stacks were also noted on this roof level.

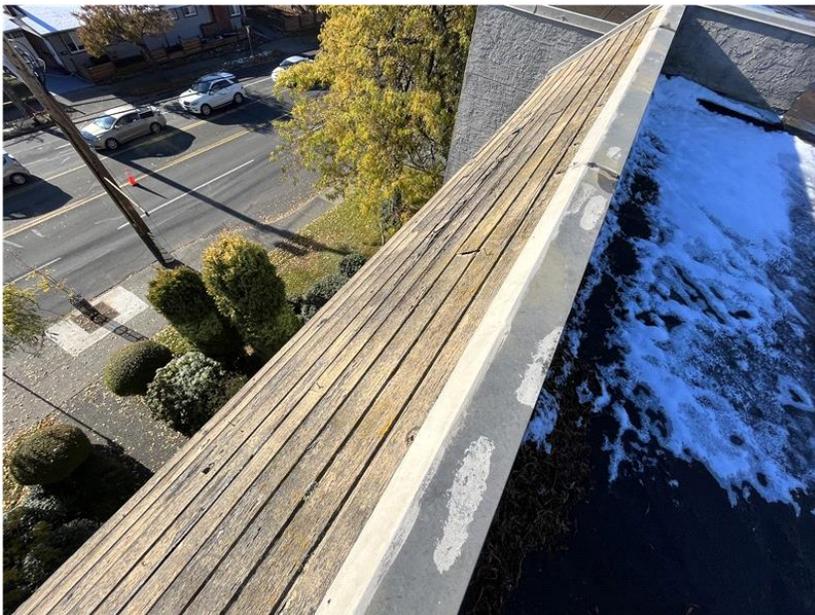
—
Condition: Perimeter
Severity: Medium
Quantity: 1

View of the deteriorated wood fascia at the perimeter.

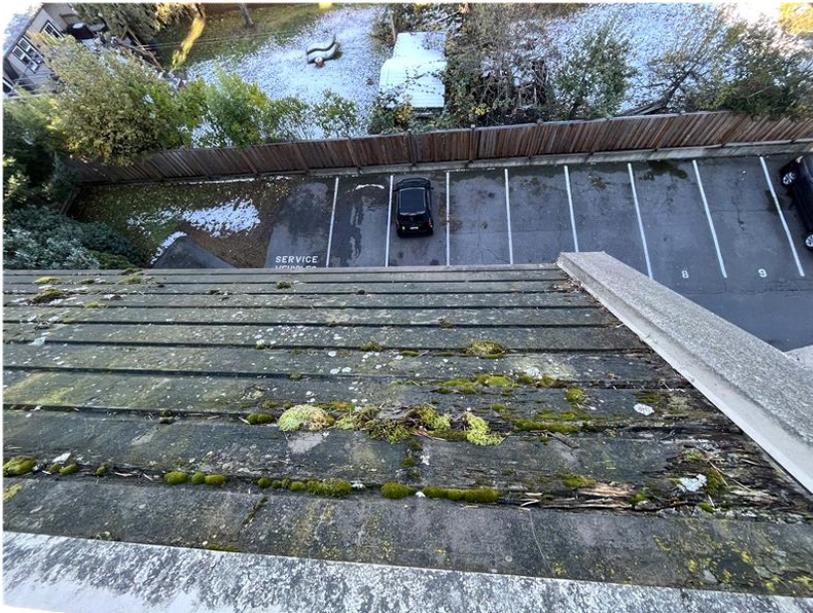
Condition: Perimeter 1
Severity: Medium
Quantity: 1

More deteriorated wood and moss growth on the perimeter wood fascia.

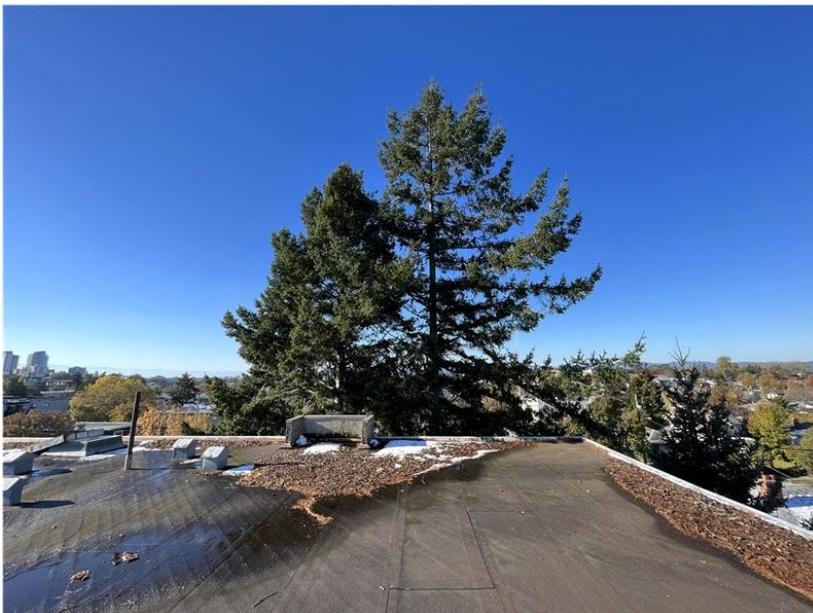
Condition: Organic debris
Severity: Low
Quantity: 1

Large accumulation of organic debris was noted at the perimeter of this roof level.

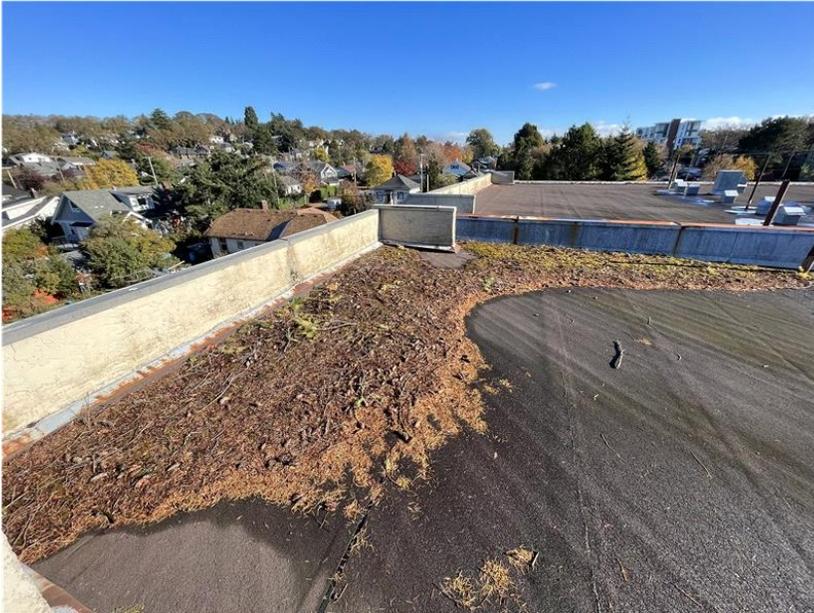
Condition: Organic debris 1

Another view of the organic debris noted at the perimeter.

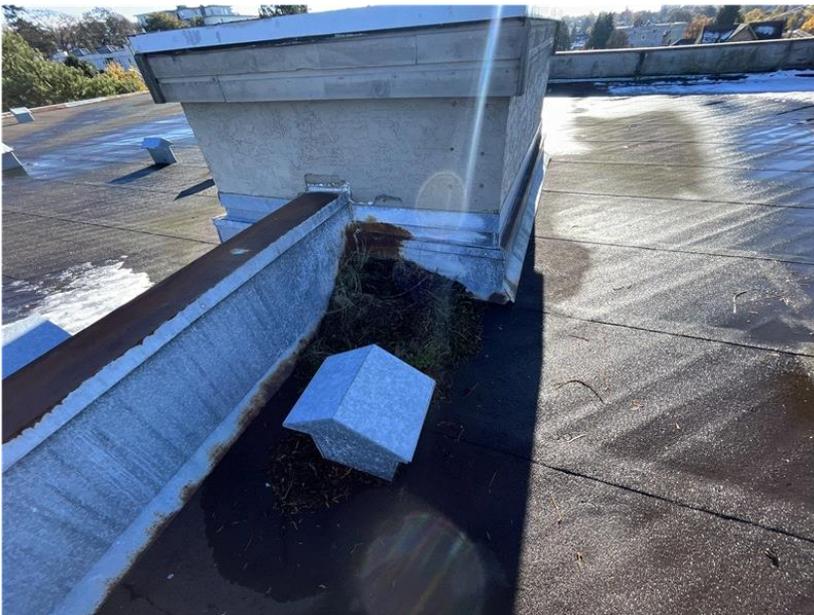
Condition: Organic debris 2

More organic debris.

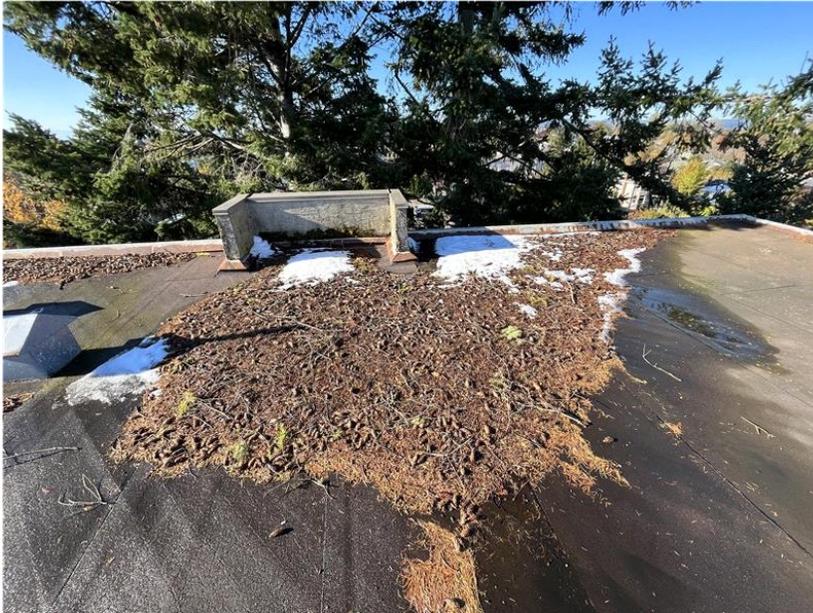
Condition: Organic debris 3

More organic debris.
