BUILDING CONDITION ASSESSMENT

QUEEN ANNE APARTMENTS

12184, 12186, 12188 &
12190 224TH STREET
MAPLE RIDGE, BC

Project No. 22vA094-42

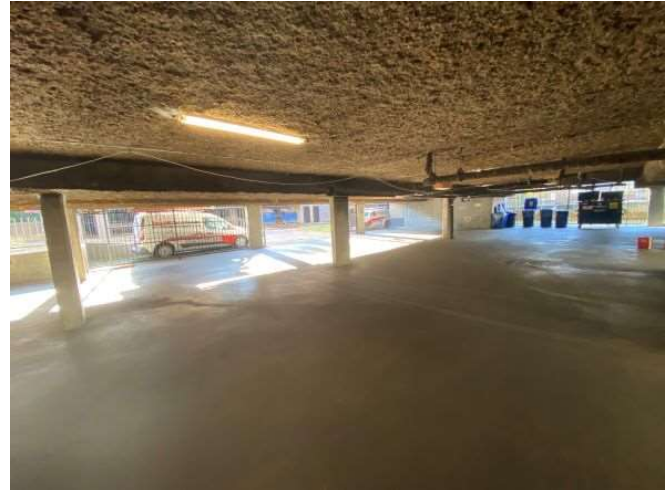
Most of the structural components are concealed from view. We did not see any evidence of unusual settlement, displacement or structural cracking in the areas we reviewed.

Photo 1: Structure on the 1st floor (parking garage) at Building A – Typical.

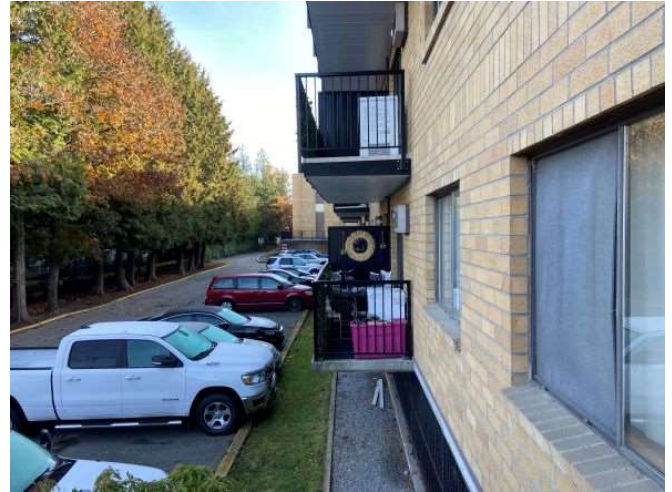
Photo 2: Typical balconies including concrete slab at the 2nd floor and wood structures on the 3rd and 4th floors.

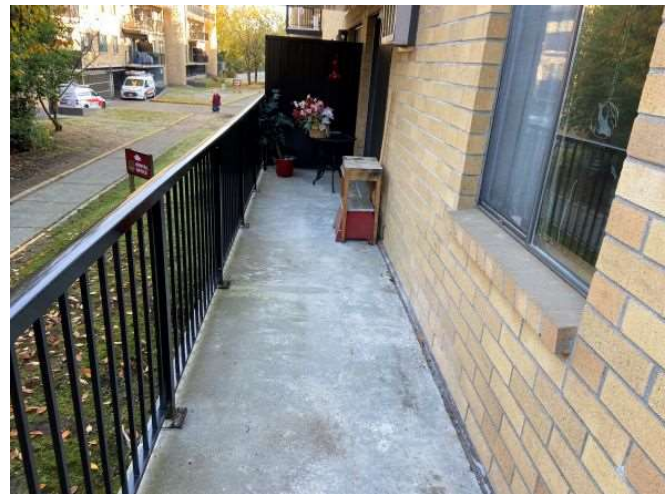
Photo 3: Typical concrete balcony slab.

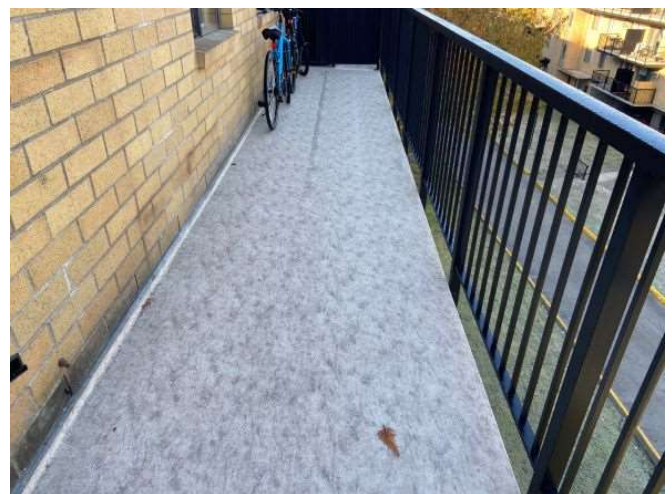
Photo 4: Typical wood frame balcony.

It is imperative that the balcony waterproofing remain watertight to prevent the wood structure below from deteriorating. As such, it should be replaced well before the waterproofing loses its effectiveness. If structural damage to the wood framing is allowed to occur, this can significantly increase the cost of repairs. Given that the balcony waterproofing is new, we do not anticipate replacement being required within the report term. We assume that local repairs to address leaks will be carried out on an as-needed basis funded out of operating budgets.

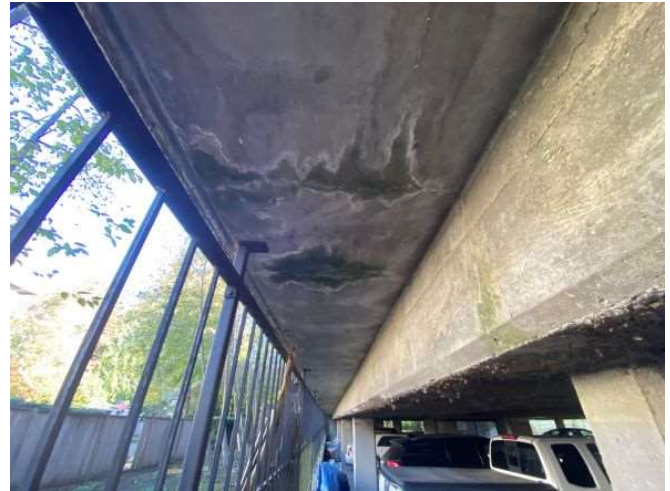
There is localized cracking in the concrete balcony slabs with some staining and evidence of leakage on the soffits. We noted one location where the concrete has spalled off the soffit and requires removal and repair at this time at a cost below the report threshold. No issues were identified with the concrete eyebrows.

The balconies are not waterproofed to protect the concrete and prevent leakage to the areas below. If water is allowed to leak into the concrete, then, depending on the extent of carbonation and/or chlorides within the concrete, there is a chance that the moisture in the concrete will cause the steel reinforcing embedded in the concrete to corrode. This can cause the concrete to deteriorate, resulting in more costly repairs in the future.

Photo 5: Leaking cracks in balcony slab, north elevation of Building A.

The current deterioration is isolated. The concrete balcony slabs should be checked regularly to identify and remove any loose concrete that may form at the slab edges or soffits. We assume this will be done as part of ongoing maintenance. At some point the extent of leakage and concrete deterioration may warrant installation of a waterproofing membrane. The timing for this work should be dependent upon an evaluation of the concrete balconies; pending the results of that evaluation, we have budgeted for balcony waterproofing toward the end of this report term.

Description	Classification	Present Cost	Timing (Year)	Cycle (Years)
Concrete Balcony Slab Repairs and Waterproofing.	2	\$225,000	2030	20

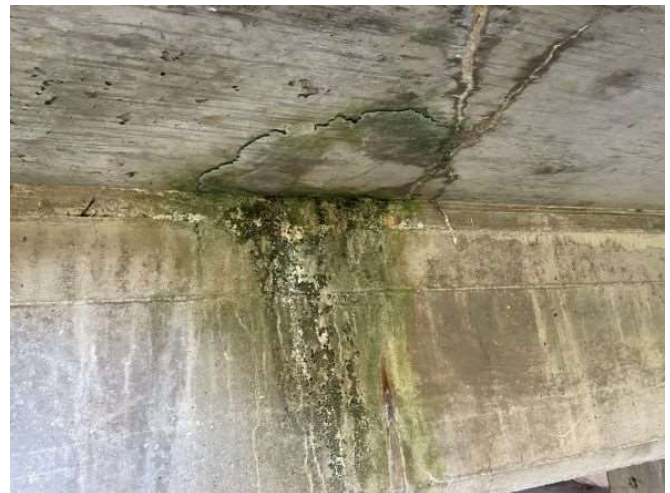
Photo 6: Leaking crack and spalled concrete on 2nd floor slab soffit, south elevation of Building C.

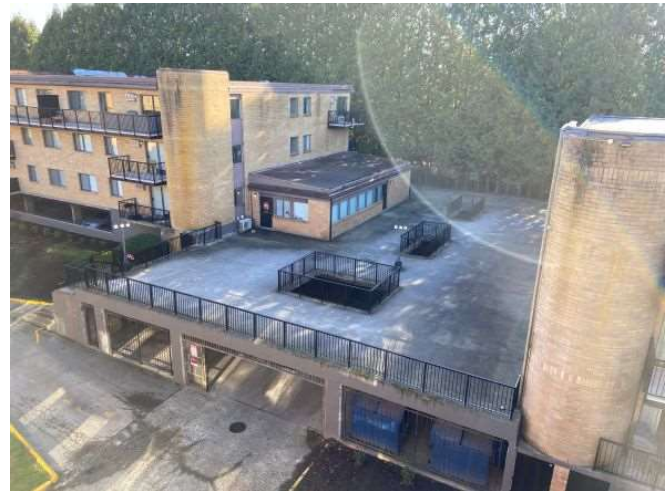
The garage roof slabs are not protected by a waterproofing membrane. During our review we noted active water leakage to varying extents below all three areas of exposed roof slab. Spalled concrete was noted at several soffit locations at Buildings A and B. The soffit at Building C showed extensive concrete delamination, exposed and corroded reinforcing steel. The top surfaces of the roof slabs were chain dragged and only localized areas of “hollow” sounding concrete were encountered. These were typically associated with exposed reinforcing steel that appears to have been laid within insufficient cover.

Photo 7: Building B garage roof deck overview.

Garage Roof Deck Concrete Repairs and Waterproofing.	2	\$772,000	2024	30
--	---	-----------	------	----

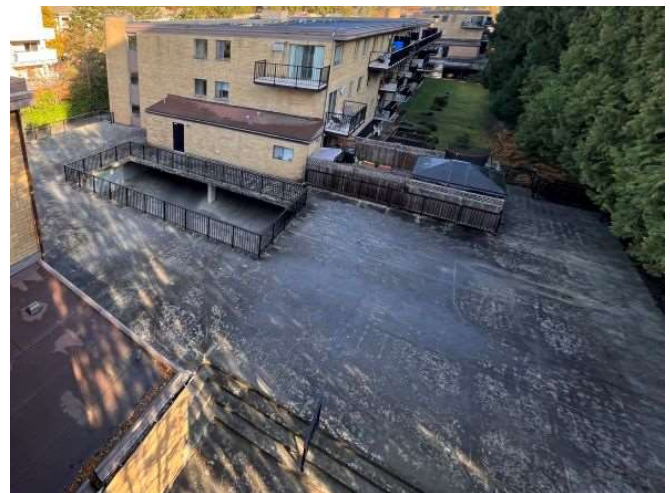
Photo 8: Buildings C/D Garage roof deck overview.

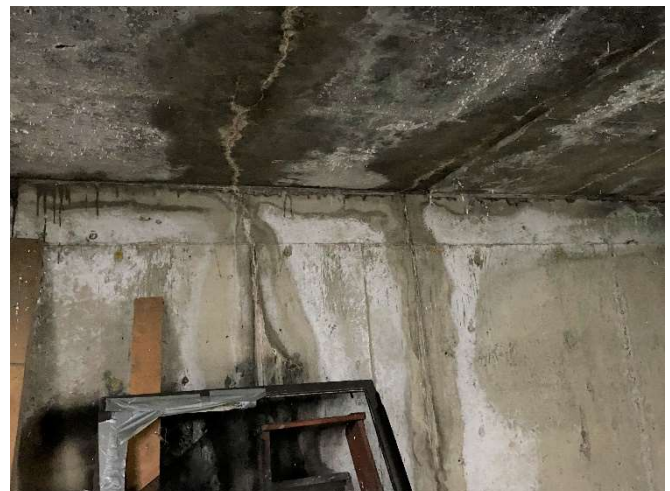
Photo 9: Active water leakage through roof deck at Building A maintenance space

The lack of waterproofing and uncontrolled water leakage has resulted in concrete deterioration ranging from moderate at Buildings A and B to severe at Buildings C and D. Repairs are required to address the current level of concrete deterioration, and should be completed soon to limit ongoing structural deterioration. In the interim, loose concrete at risk of falling should be immediately removed from the underside of the slabs to mitigate the safety risk. The application of a pedestrian waterproofing membrane has also been budgeted in order to mitigate future leakage and deterioration. A condition assessment including chain drag, half cell survey and chloride testing should be completed in 2023 prior to the work in order to clarify conditions and budgets, and to confirm that the slab can continue to be safely used until repairs are completed.

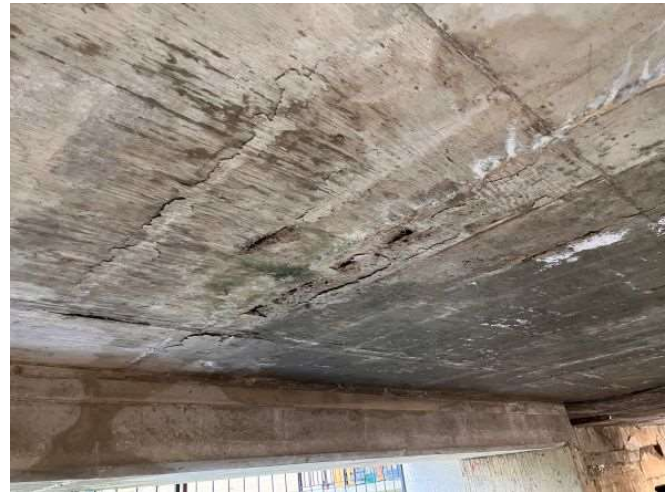
Photo 10: Building B – Soffit delamination and spalling.

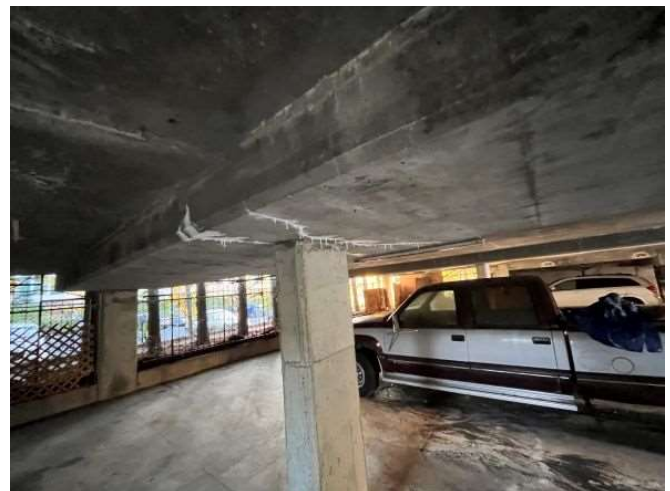
Photo 11: Buildings C/D – Active water leakage.

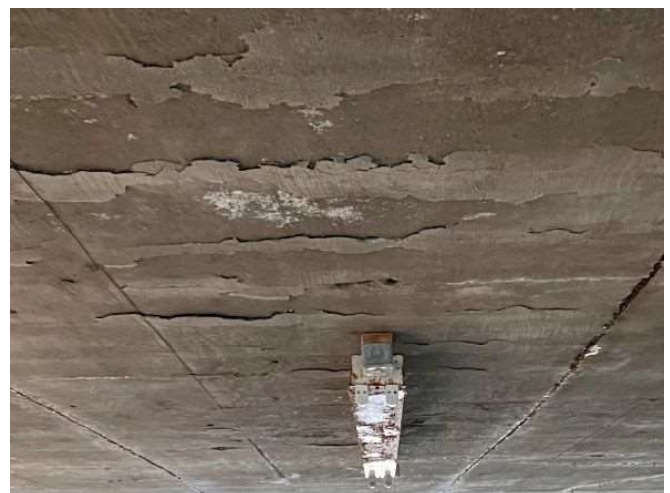
Photo 12: Building A maintenance space - Active water leakage through roof deck and spalling concrete.

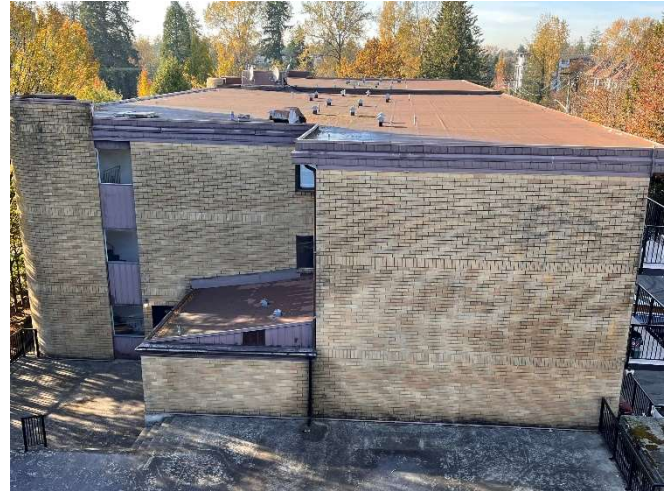
Photo 13: Typical exterior masonry clad walls.

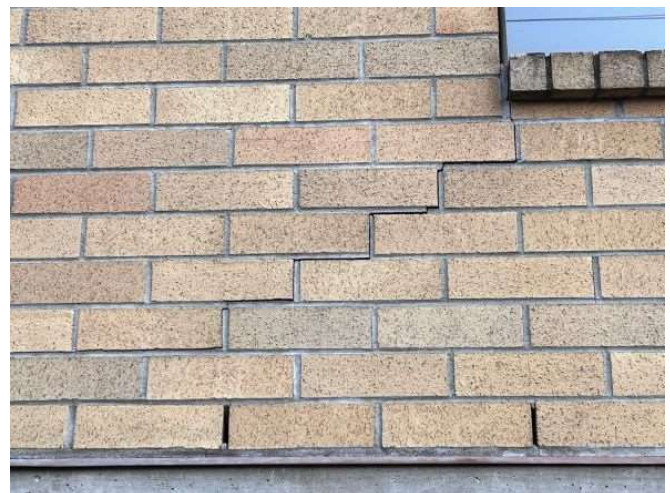
- There is some visible mortar joint deterioration at the knee walls adjacent the south-west stair from the Building C/D garage roof deck to grade. There is no cap stone on the wall at the stairs and no overhang on the adjacent wall which is concentrating water at this location.
- There are vertical and step cracks between window openings, in the field of the wall and at some corner locations.

Photo 14: Step cracking at window opening.

The current masonry deterioration is generally limited and can be addressed in a phased approach as part of regular maintenance at a cost below the report threshold.

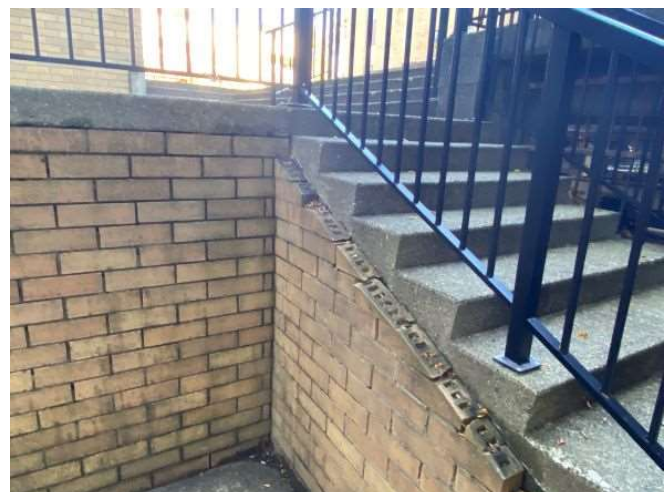
Photo 15: Deteriorated masonry at stairs with missing cap stone.

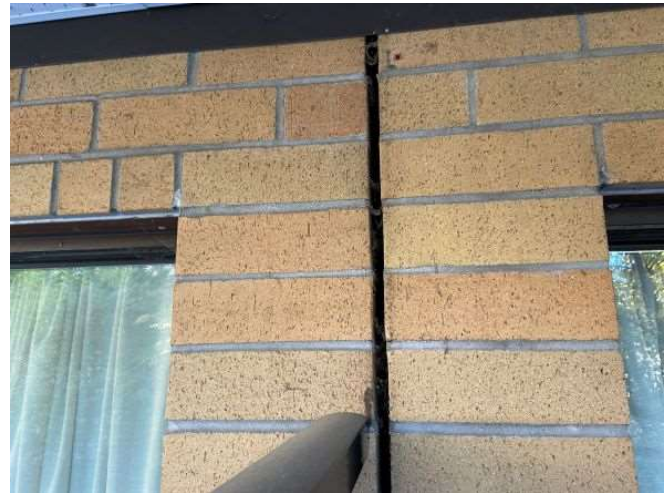
Where checked, the exterior sealants are in poor condition or appear to have never been installed (vertical control joints).

Despite the majority of joint sealants appearing to have never been installed there is very little evidence that this has been detrimental to the cladding performance. We assume that this is largely due to the cladding being a drained system which means the outer surface does not need to be perfectly watertight to perform satisfactorily. However, based on the age of the building and current conditions we have budgeted for general sealant replacement within the report term.

Photo 16: Unsealed masonry control joint.

Description	Classification	Present Cost	Timing (Year)	Cycle (Years)
Sealant Replacement	3	\$250,000	2028	20

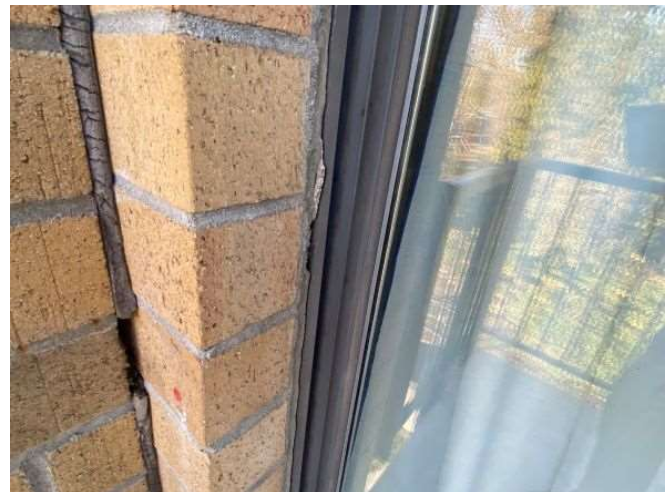
Photo 17: Poor sealant application at door jamb and no sealant at control joint.

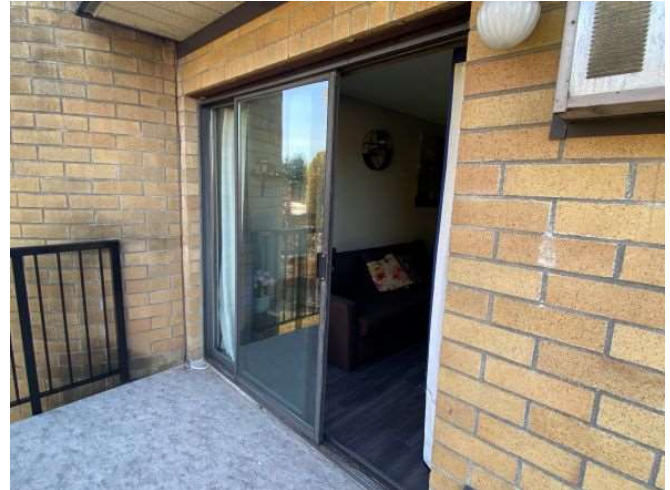
Photo 18: Typical balcony sliding door.

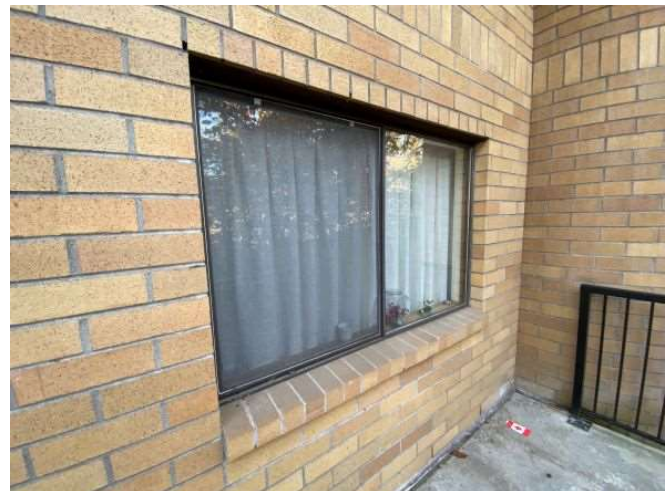
We understand that there are no reports of active water leaks at the windows or exterior doors. However, moderate to severe condensation was noted on a number of the window and balcony door glazing and frame surfaces during our review. The tenants we interviewed reported that this is a typical problem that requires daily attention to keep the moisture under control. Despite this, only local paint deterioration was noted on the interior window sills.

Photo 19: Typical operable window.

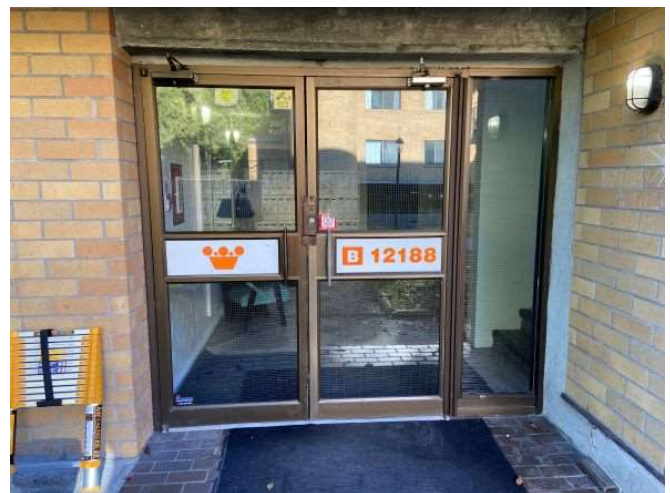
Photo 20: Storefront glazing and entrance door at Building B.

The storefront glazing and other exterior doors were operable where checked. Corrosion of the steel frame and door was recorded at one exit location (NW stair exit Building C). We assume that exterior doors will be repaired or replaced on an as-needed basis funded out of operating budgets. Capital expenditures are not anticipated within the report term.

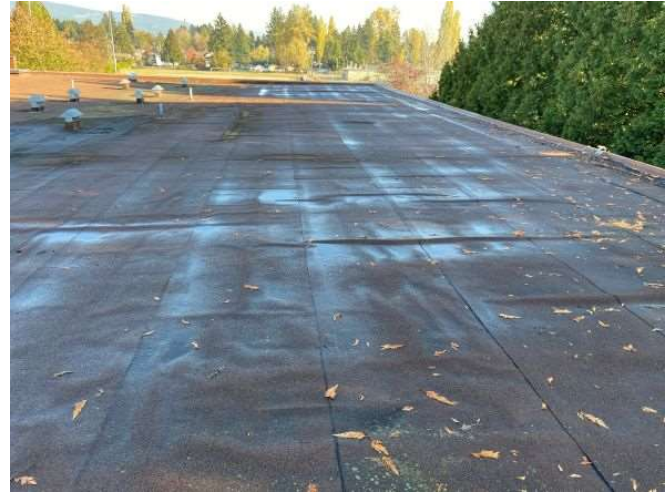
Photo 21: Widespread blisters, ridges and worn membrane on Building B roof.

There are blisters, ridges and cracks, and open seams in the older modified bitumen roofs. There are also areas where water ponds and vegetation growth.

Exposed modified bitumen roofs in the Lower Mainland climate tend to have a serviceable life of 20 years before they need to be replaced. This life expectancy assumes that proper materials were installed at the time of construction and proper application procedures were followed. The main and lower roofs at Buildings A, B and D will require replacement within the report term.

Description	Classification	Present Cost	Timing (Year)	Cycle (Years)
Replace Roof at Building B	3	\$743,000	2024	20
Replace Roof at Building D	3	\$611,000	2025	20
Replace Roof at Building A	3	\$611,000	2029	20

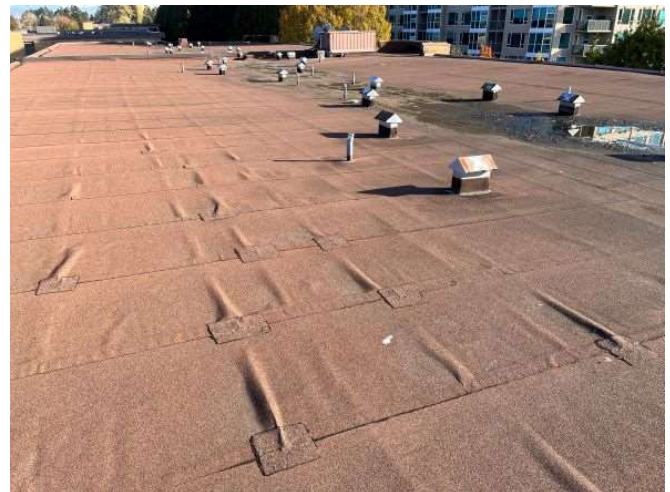
Photo 22: Patches at ridges on Building D.

The membrane on Roofs C and D have been installed perpendicular to the drainage slope which is contrary to roofing standards. The membrane seams are not shingled as a result and do not shed water as easily. It may also have something to do with movement (up slope slumping) observed in the Building D membrane.

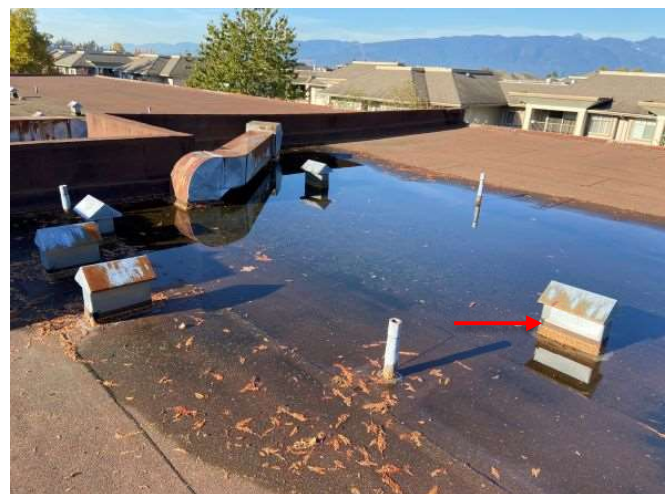
There have been localized issues with water leakage at the roofs resulting in local repairs. From our review, much of this may be the result of blocked drains leading to water depths in excess of penetration flashings. The roofs should be checked regularly and debris (leaves and moss) removed to ensure drainage remains clear.

Photo 23: Extreme ponding water on Building A roof. Note that water level has dropped 3" from max height.

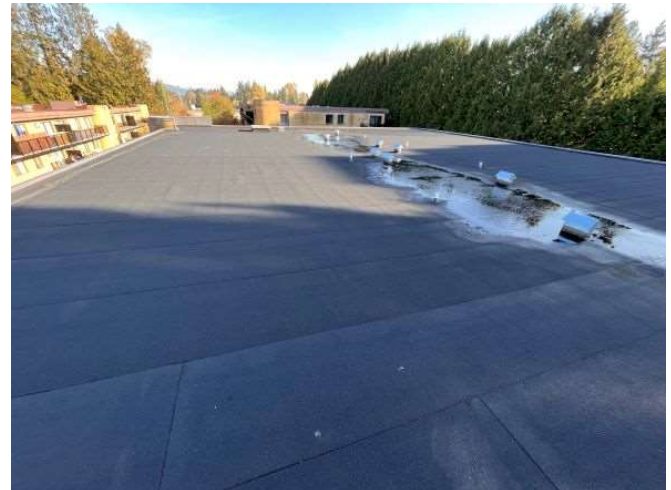
Photo 24: Overview of Building C roof.

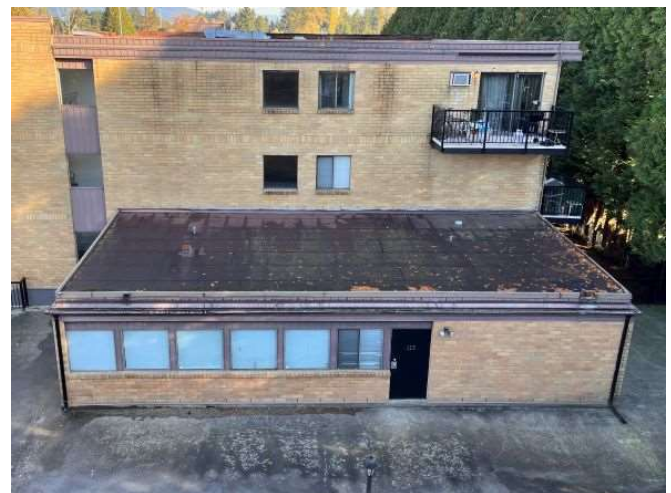
Photo 25: Sloped roof over office space and Unit 115 at Building B.

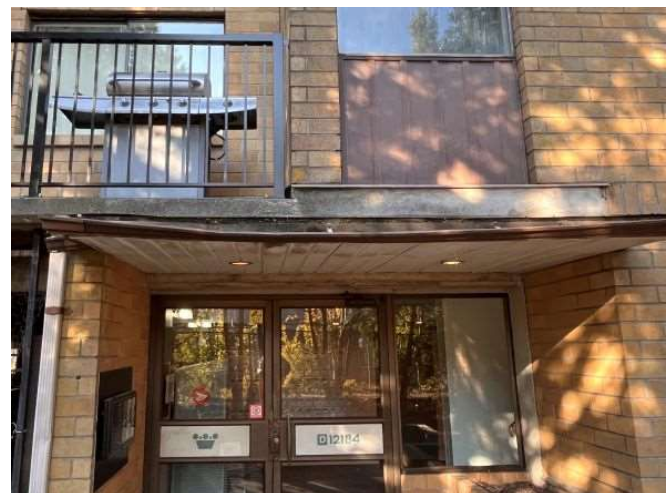
The roofs should be evaluated before replacement. This will provide for a more accurate replacement scope and budget as roofing prices can fluctuate significantly from year to year. The entrance canopy eave framing is sagging. Building D is the worst with the eave framing rotted and the gutter sagging. We assume that local repairs to the roofs will be carried out as needed funded out of operating budgets.

Photo 26: Sagging eave at Building D canopy.

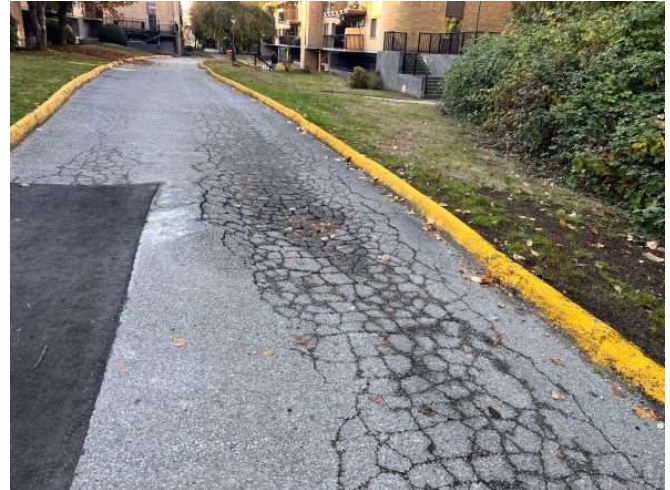
- Extensive cracking and deterioration throughout many asphalt paved areas,
- Cracked and broken curbs, and
- Uneven walking surfaces creating potential trip hazards throughout the complex.

Photo 27: Asphalt pavements at east end of main drive.

As we understand there is no plan for broad scale replacement of the asphalt or concrete paved surfaces, we have budgeted for phased replacement of the paved surface.

Description	Classification	Present Cost	Timing (Year)	Cycle (Years)
Phased Replacement of Asphalt Pavements (30%/phase)	3	\$60,000	2025 2028 2031	3

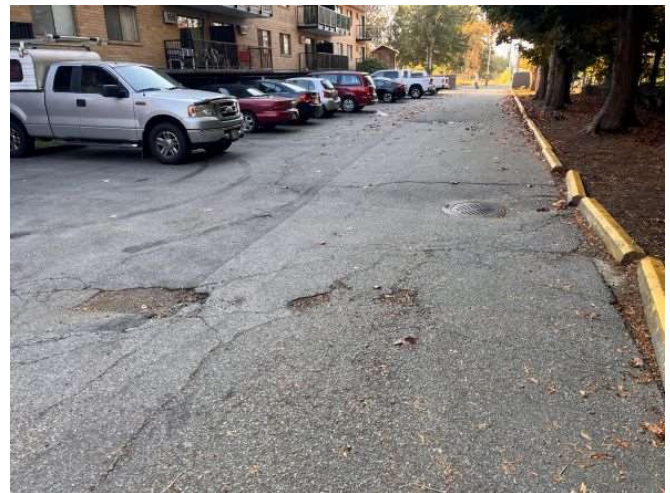
Photo 28: Asphalt pavements at west end of main drive.

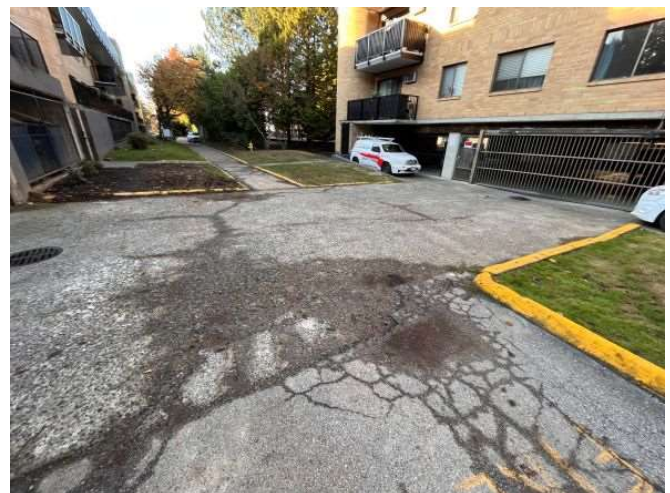
Photo 29: Concrete pavements between Building A and B garages.

Immediate patch repairs are required at some locations to maintain safe conditions, which we assume will be carried out as maintenance at costs below the report threshold.
