# BELLEVUE TOWER WEST

## BUILDING CONDITION ASSESSMENT

195 21st Street, West Vancouver, BC V7V 4A4

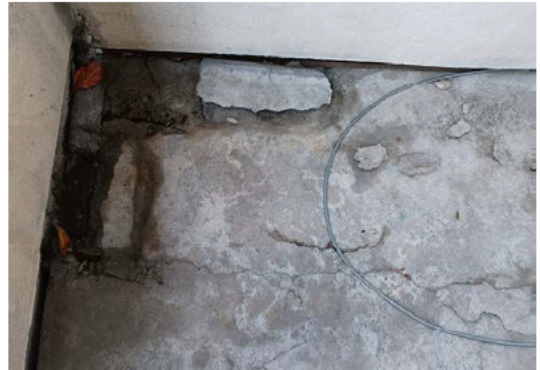
- In general, the balcony slabs and pre-cast concrete guard walls are in poor condition.
- Concrete spalling was observed on the balcony slabs including at the pre-cast to balcony slab connection.
- Corrosion product was observed on the surfaces of some pre-cast panel connection plates.
- At the precast to slab connection point, concrete spalling and exposed reinforcing steel were observed on multiple balconies.

**Photo 2** - Concrete delamination on balcony - slab.

- For the immediate/year 1 timeframe, it is recommended that a site investigation be conducted to visually assess the condition of the precast panel connectors. Understanding the condition of the connections will assist in narrowing down the estimated cost and options for the balcony restoration project. The opinion of probable cost for the on-site investigation ranges from \$15,000 to \$30,000 depending on the percentage of balconies review and connectors exposed.

- In immediate/year 1 timeframe, and assuming that the above assessment recommends balcony remediation, it is recommended that a balcony restoration project be completed to address concrete delaminations and reinforce existing pre-cast panel connections as required. The opinion of probable cost for this project can range from \$500,000 to \$2,000,000 and depends on multiple factors including the concrete repair quantity and the number of precast panel connectors that require repair. (See recommended assessment below). Further and depending upon the assessment, consideration can be given to remove the precast panels and replace them with new aluminum framed railing with glass infill panels. This should be established during the design development process and after an assessment is completed.

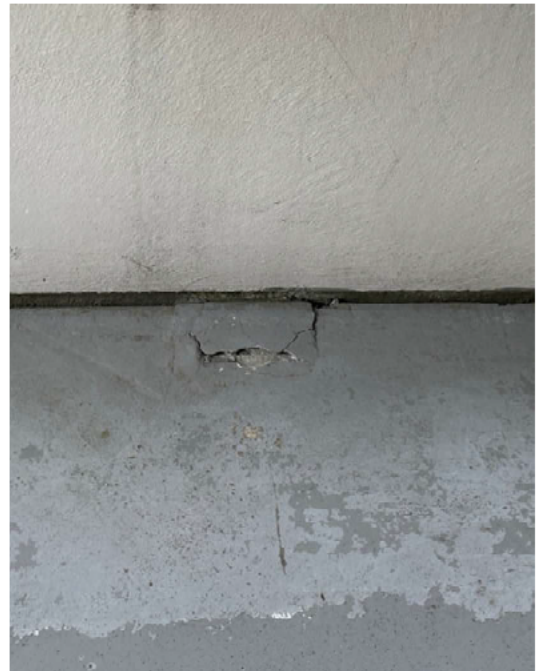
**Photo 3** - Spalling concrete above pre-cast panel connection to the balcony slab.

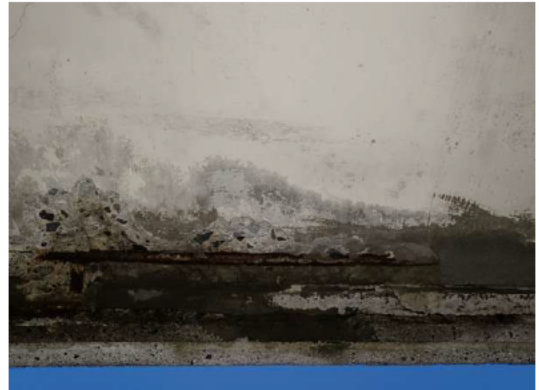
**Photo 4 -** Spalled concrete delamination with exposed reinforcing bar and metal connector.

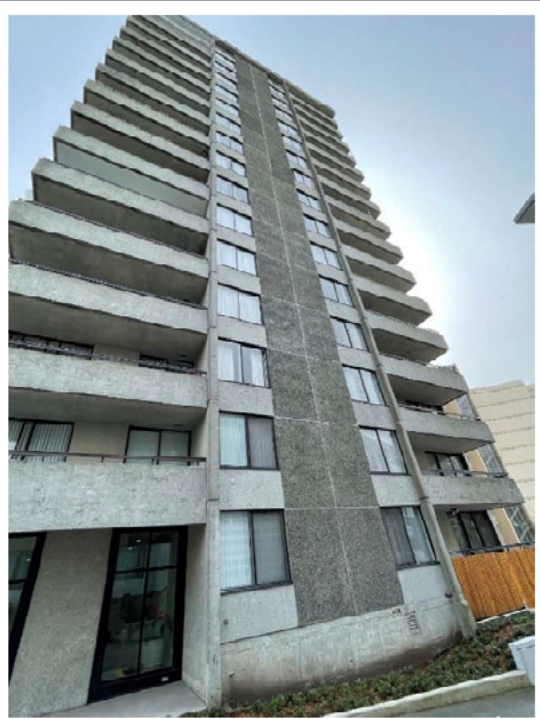
**Photo 5** - General view of north elevation of the building.

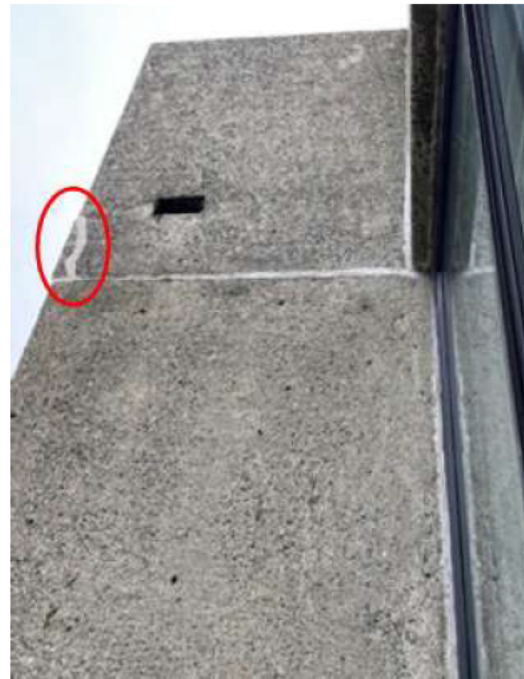
- Cracks were observed on the exterior concrete walls. Some of the cracks appear to have been temporarily sealed by sealant application over the cracks.

**Photo 7 -** Concrete exterior wall. Cracks have been sealed with sealant for a temporary repair.

- In Year 5, it is recommended that an assessment of the exterior concrete walls be completed to monitor the condition of the tower. The Opinion of Probable Cost for this assessment is less than \$5,000.
- In Year 5, it is recommended that an exterior concrete restoration project be anticipated. The cost of this project cannot be identified until the concrete assessment is conducted. However, based on buildings of similar size and condition, it is estimated that the opinion of probable cost for the concrete restoration will be \$200,000.

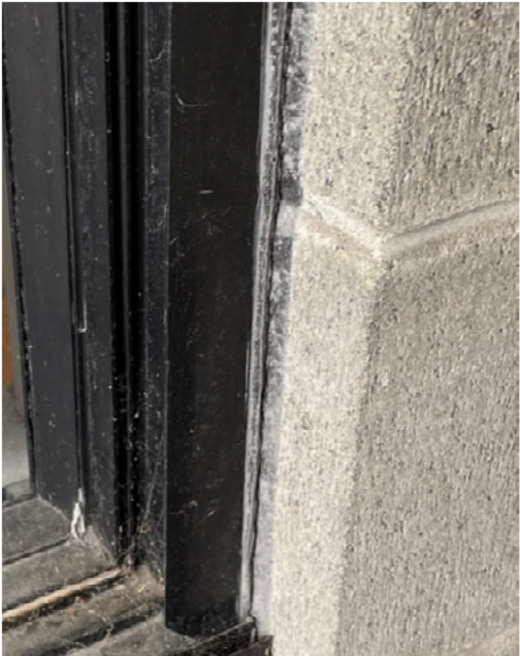
TABLE B2 – SEALANTS	
<b>Condition Assessment</b>	Poor
<b>Estimated Remaining Life</b>	3 years
<b>Project</b>	Sealant renewal
<b>First Occurrence</b>	Years 2 - 3
<b>Recurrence</b>	15 years
<b>Budget</b>	\$250,000
<b>Description</b>	
<ul style="list-style-type: none"><li>Sealant is typically installed at interfaces between dissimilar materials such as around window and door perimeters, between flashing and concrete, and at building penetrations.</li><li>It is also installed as precast concrete panel joints.</li></ul>	
<b>Condition/Observations</b>	
<ul style="list-style-type: none"><li>Sealant at perimeters of windows and doors was observed to be generally in poor condition. The sealant has exceeded its service life as there is no record of sealant replacement within the past 15 years.</li><li>Sealant at concrete to concrete joints was observed to be in poor condition.</li><li>Evidence of sealant failure observed includes loss of elasticity, cracking/cohesive failure, and adhesive failure.</li></ul>

<b>Photo 5</b> - Typical condition of sealant around perimeter of balcony door.

- In years 2 - 3, it is recommended that a sealant replacement project is completed to address sealant at window & door perimeters and concrete joints. We expect this project to cost \$250,000. This project can be completed in tandem with exterior restoration project recommended in Table A.2 & A.3.

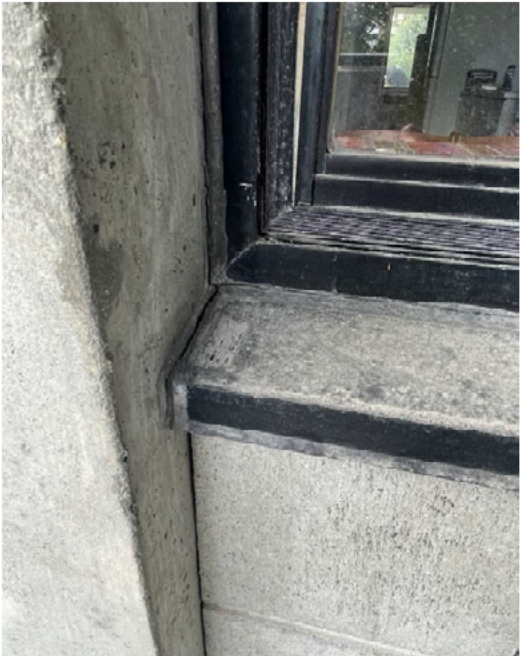
<b>Photo 6</b> - Sealant around perimeter of balcony window.

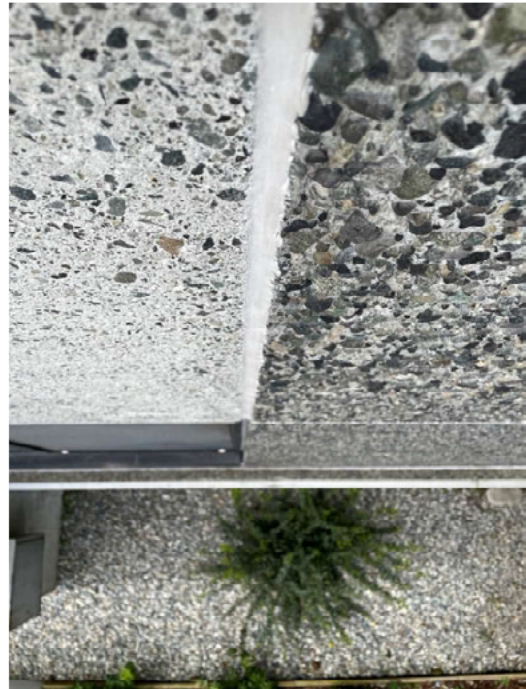
**Photo 7 -** Sealant at concrete to concrete joint.

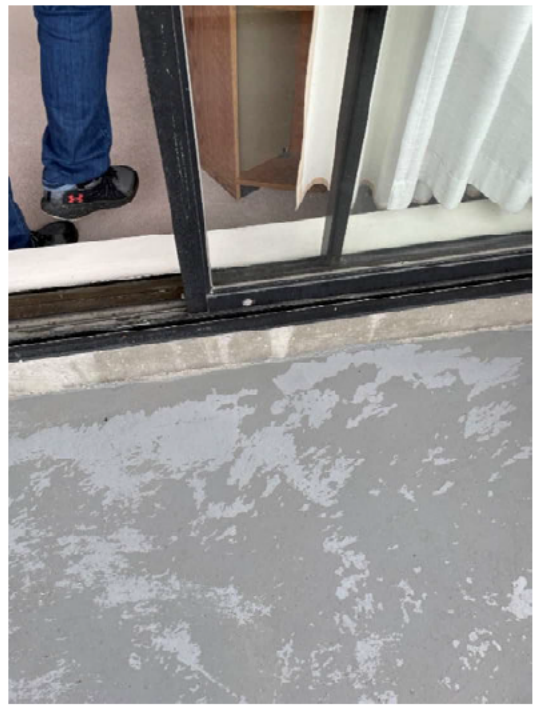
- The balcony guardrails generally appeared to be in fair condition. In general, guardrails appeared to be structurally secure.
- It appears that on multiple balconies, the guardrails have been painted black over their original brown colour. Both the new and original paints were observed to be peeling/flaking.
- The deck coating generally appears to be in poor condition showing signs of chipping and flaking.

**Photo 18 -** Peeling paint on balcony floor.

- In years 2 - 3, after repair of the concrete delaminations in the balcony slabs recommended in Appendix A, it is recommended that a pedestrian deck coating system be applied. This may be completed in tandem with the recommended balcony concrete restoration project (Appendix A). The cost of this pedestrian deck coating project is expected to be \$200,000 if a conventional pedestrian deck coating is installed, or \$100,000 if a Deckote system is installed. If applied, it is recommended that maintenance of the pedestrian deck coating be completed every five years.

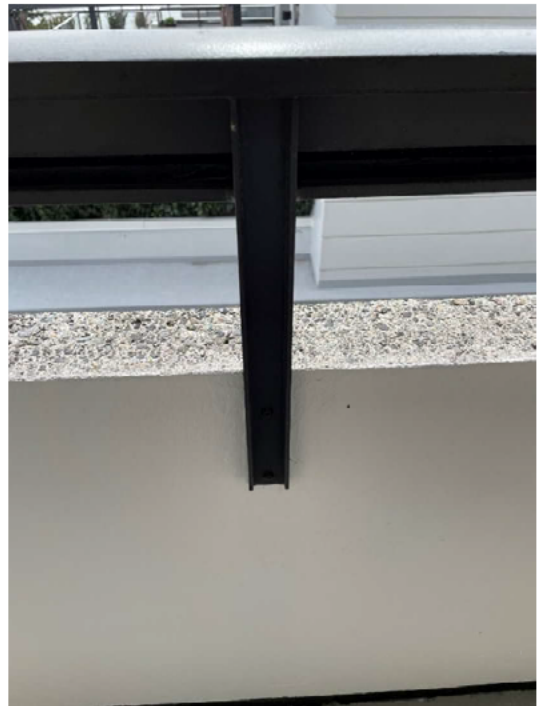
**Photo 20 -** Balcony guardrail connection.
