**FINAL**  
**Baseline Property**  
**Condition Assessment**

4960 and 5050 Sanders Street,  
Burnaby, British Columbia

February 19, 2020

Pinchin File: 270732

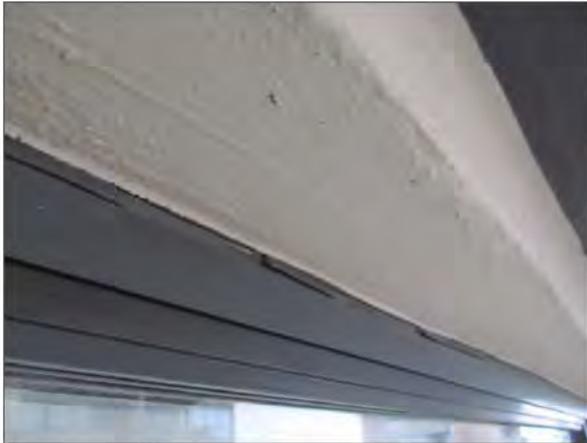
An area of failed sealant was noted adjacent to the sliding glass door of Unit 807 in Site Building B.

| Table 3.3 – Wall Systems | |
|---|---|
| <ul style="list-style-type: none"> <li>Localized areas of failed sealant were noted adjacent to sliding glass doors and windows on the exterior walls of the Site Buildings.</li> </ul> | <ul style="list-style-type: none"> <li>Conduct localized sealant replacement.</li> </ul> |

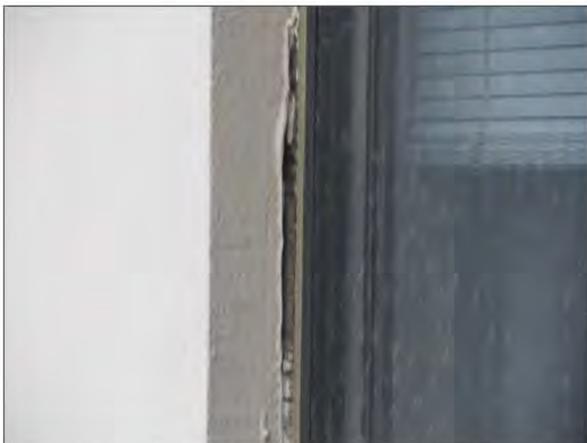
An area of failed sealant was noted in Unit 1202 in Site Building B.

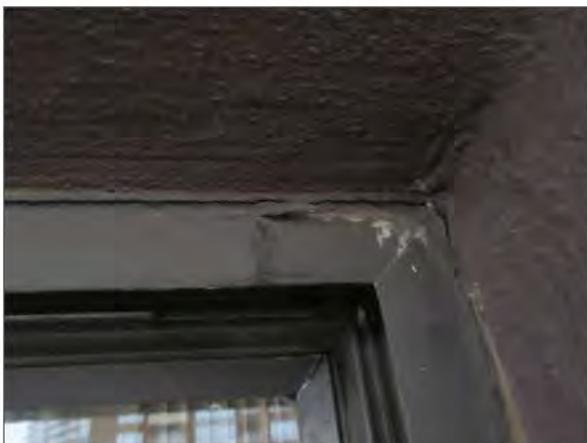
Areas of failed sealant were noted at the balcony door of Unit PH2 in Site Building B.

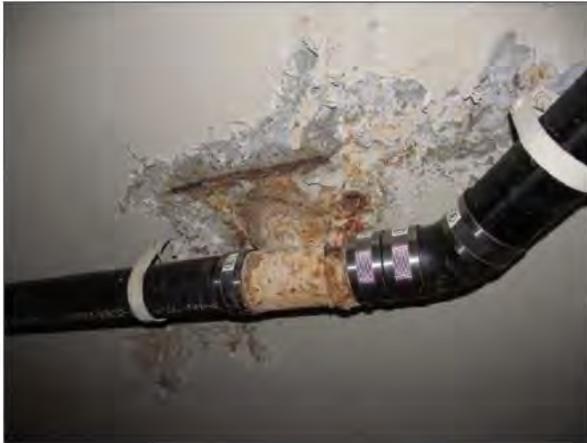
| Table 3.5 – Structural Elements | |
|--|---|
| <ul style="list-style-type: none"> <li>A localized area of exposed and corroded reinforcing steel was noted within a P2 basement storage room within Site Building B.</li> </ul> | <ul style="list-style-type: none"> <li>Conduct localized concrete repair.</li> </ul> |

An area of exposed and corroded reinforcing steel was noted within a P2 basement storage room within Site Building B.

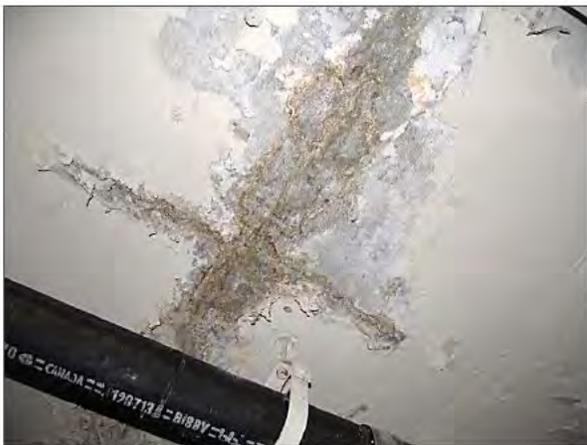
| Table 3.5 – Structural Elements | |
|--|---|
| <ul style="list-style-type: none"> <li>Areas of stained and deteriorated concrete soffit were noted within P2 basement storage rooms within the Site Buildings.</li> </ul> | <ul style="list-style-type: none"> <li>Conduct localized concrete repairs.</li> </ul> |

An area of stained and deteriorated concrete soffit was noted within a P2 basement storage room within Site Building A.

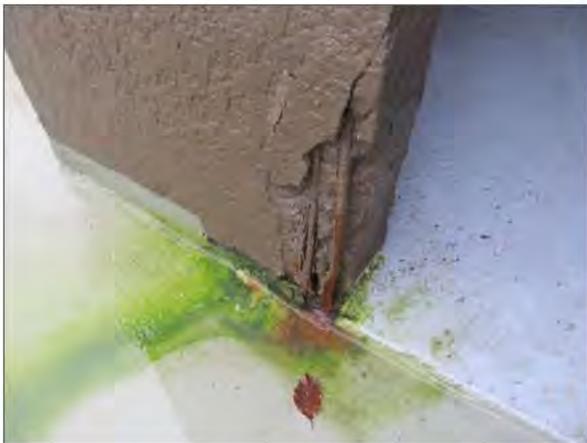
| Table 3.5 – Structural Elements | |
|--|---|
| <ul style="list-style-type: none"> <li>An area of exposed reinforcing steel was noted on the north elevation of the courtyard building containing the pool and the rental office.</li> </ul> | <ul style="list-style-type: none"> <li>Conduct localized concrete repair.</li> </ul> |

An area of exposed reinforcing steel was noted on the north elevation of the courtyard building containing the pool and the rental office.

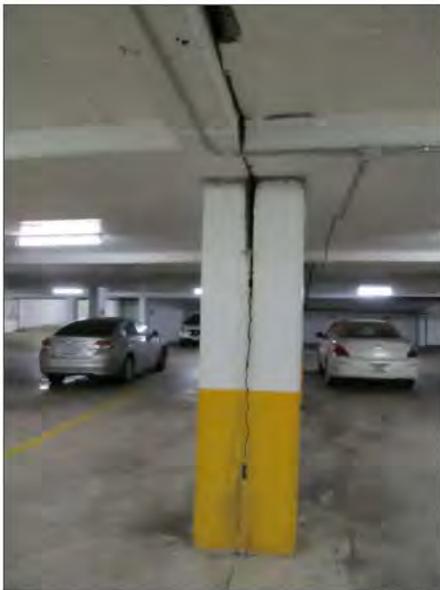
| Table 3.6 – Underground Parking Garage | |
|--|--|
| <ul style="list-style-type: none"> <li>An area of concrete cracking was noted at the location of the UPG expansion joint.</li> </ul> | <ul style="list-style-type: none"> <li>Conduct localized concrete repairs within the UPG.</li> </ul> |

An area of concrete cracking was noted at the location of the UPG expansion joint.

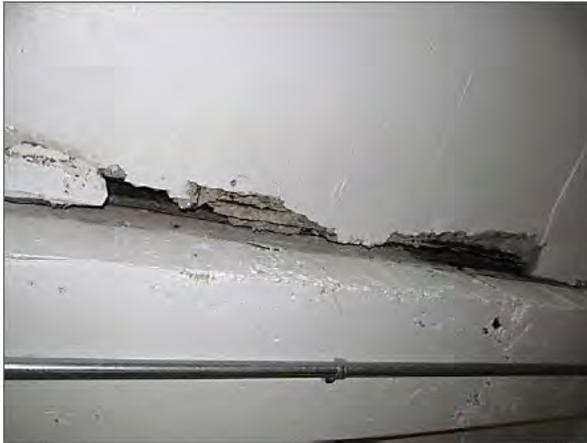
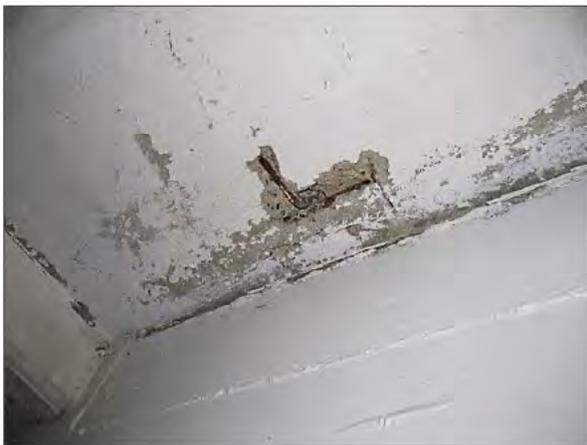
| Table 3.6 – Underground Parking Garage | |
|--|--|
| <ul style="list-style-type: none"> <li>Areas of exposed reinforcing steel within the concrete suspended slab and localized cracking and concrete spalling were noted.</li> </ul> | <ul style="list-style-type: none"> <li>Conduct localized concrete repairs within the UPG.</li> </ul> |

An area of exposed reinforcing steel within the concrete suspended slab was noted.

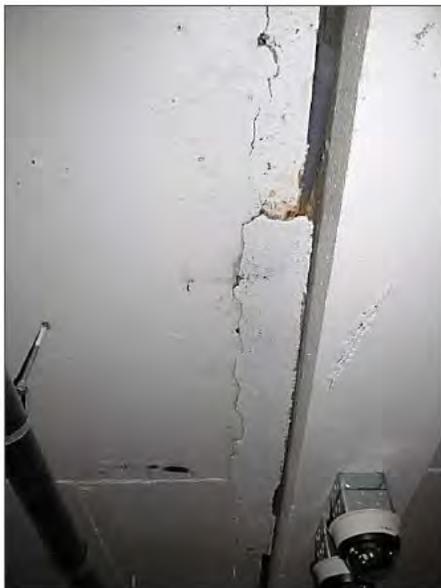
Areas of localized cracking and concrete spalling of the suspended slab were noted.

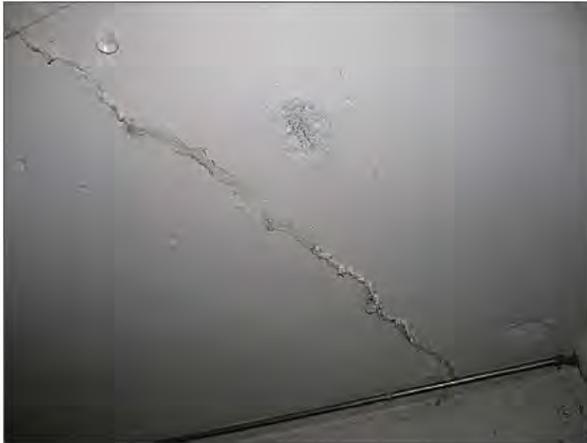
| Table 3.6 – Underground Parking Garage | |
|--|--|
| <ul style="list-style-type: none"> <li>An area of P1 soffit cracking was noted as viewed from P2.</li> </ul> | <ul style="list-style-type: none"> <li>Conduct localized concrete repairs within the UPG.</li> </ul> |

An area of P1 soffit cracking was noted as viewed from P2.

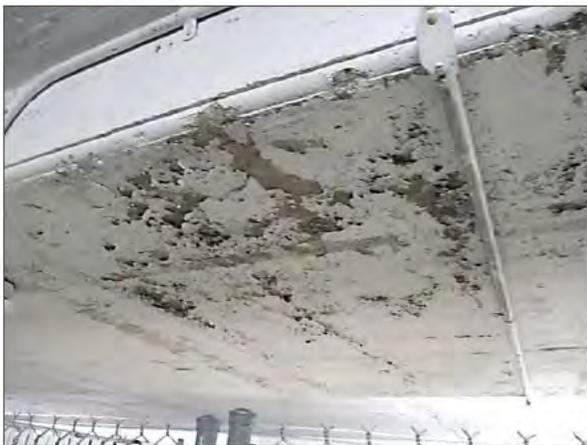
| Table 3.6 – Underground Parking Garage | |
|--|--|
| <ul style="list-style-type: none"> <li>Areas of peeled paint were noted on soffits as viewed from P2.</li> </ul> | <ul style="list-style-type: none"> <li>Repaint affected localized areas within the UPG.</li> </ul> |

Areas of peeled paint were noted on soffits as viewed from P2.

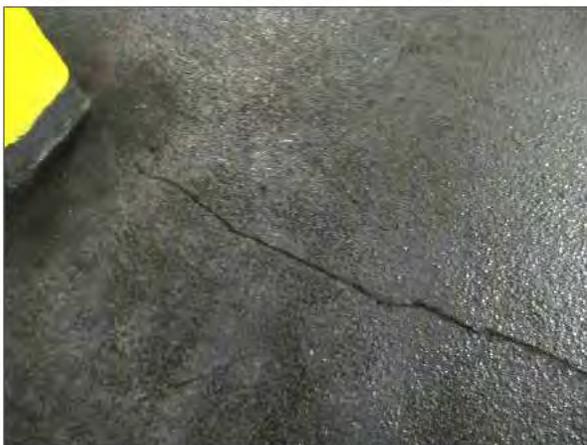
Areas of cracking were noted on P1 within the UPG.

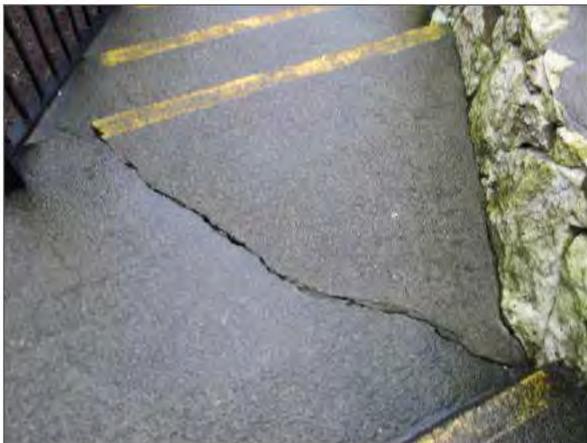
| Table 3.9 – Site Features | |
|---|--|
| <ul style="list-style-type: none"> <li>Areas of cracked concrete walkway were noted on the pedestrian approaches to the Site Buildings.</li> </ul> | <ul style="list-style-type: none"> <li>Seal concrete cracks to prevent further subsequent damage.</li> </ul> |

An area of cracked concrete walkway was noted on the pedestrian approach to Site Building B.

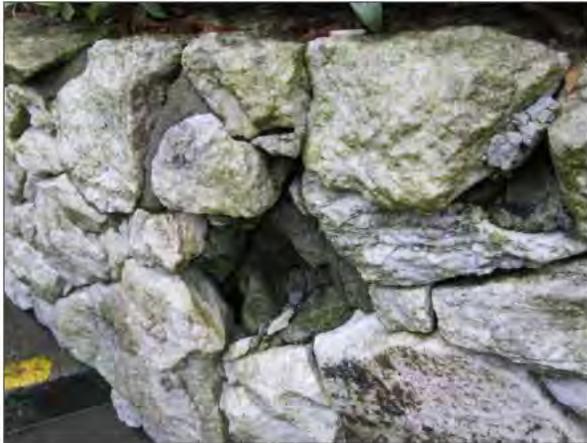
| Table 3.9 – Site Features | |
|---|--|
| <ul style="list-style-type: none"> <li>A missing stone was noted in the stone veneer retaining wall located adjacent to Site Building A.</li> </ul> | <ul style="list-style-type: none"> <li>Conduct localized stone veneer repair.</li> </ul> |

A missing stone was noted in the stone veneer retaining wall located adjacent to Site Building A.

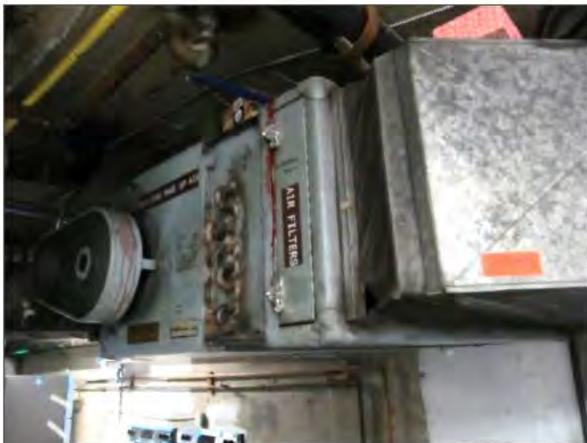
| Table 3.10 – Mechanical Systems (including HVAC, DHW, Plumbing, Laundry and Fire Protection) | |
|---|---|
| <ul style="list-style-type: none"> <li>The two “Recol of Canada” MUA units have attained their PUL.</li> </ul> | <ul style="list-style-type: none"> <li>Pinchin recommends replacement of two MUA units when they are no longer deemed serviceable.</li> </ul> |

General view of a typical "Recold of Canada" MUA unit serving the Site Buildings.

In summary, the mechanical systems within the Site Buildings are currently in serviceable condition. Pinchin recommends that the MUA units be replaced when they are no longer serviceable.

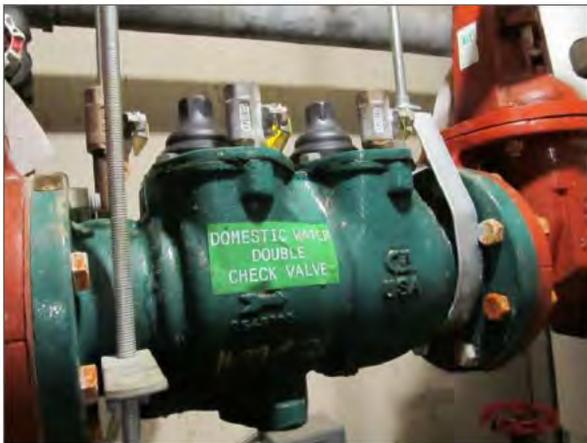
| Table 3.10 – Mechanical Systems (including HVAC, DHW, Plumbing, Laundry and Fire Protection) | |
|---|---|
| <ul style="list-style-type: none"> <li>No inspection tags were observed on the “Conbraco” backflow prevention devices.</li> </ul> | <ul style="list-style-type: none"> <li>Conduct inspections of the “Conbraco” backflow prevention devices.</li> </ul> |

General view of a typical "Conbraco" 4" backflow prevention device serving the Site Buildings.

Note: No inspection tag was observed.
