April 29, 2022

**Subject: Wesley Place – 1022 Nelson St., Vancouver
Parkade Evaluation**

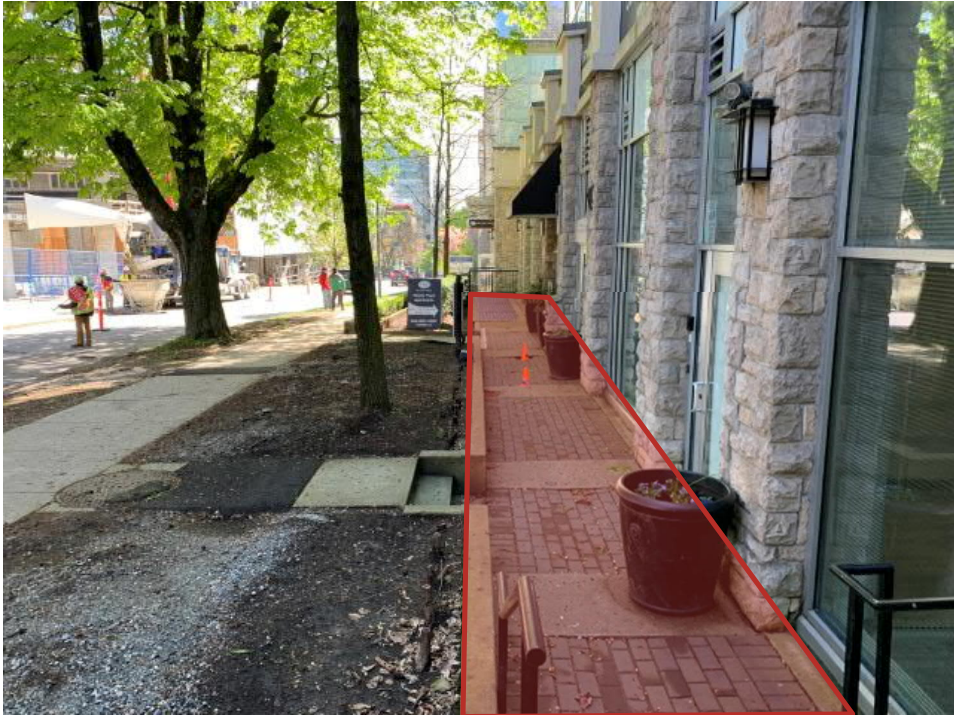
<p>A photograph showing a sidewalk area next to a stone building. A red rectangular area on the sidewalk, outlined in red, indicates the location of a buried garage roof slab. The area is paved with red bricks. A large tree is on the left, and a street with a white tent is visible in the background.</p>	<p>Photo 1:</p> <p>General view of north buried garage roof slab (red area).</p>

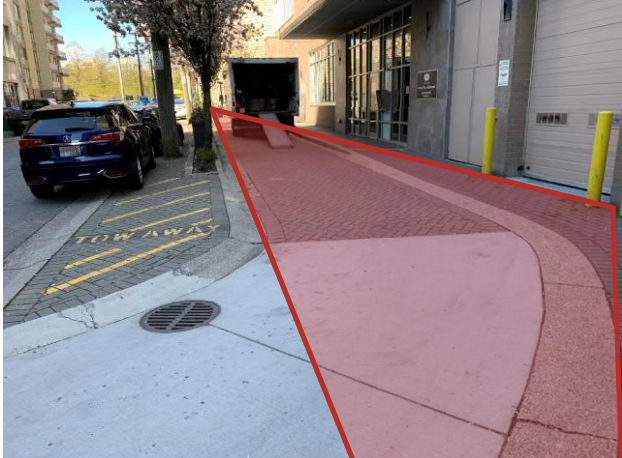
<p>A photograph showing a sidewalk area next to a building with a white garage door. A red rectangular area on the sidewalk, outlined in red, indicates the location of a buried garage roof slab. The area is paved with red bricks. A blue car is parked on the street to the left, and a 'TOW AWAY' sign is visible on the pavement.</p>	<p>Photo 2:</p> <p>General view of south buried garage roof slab (red area).</p>

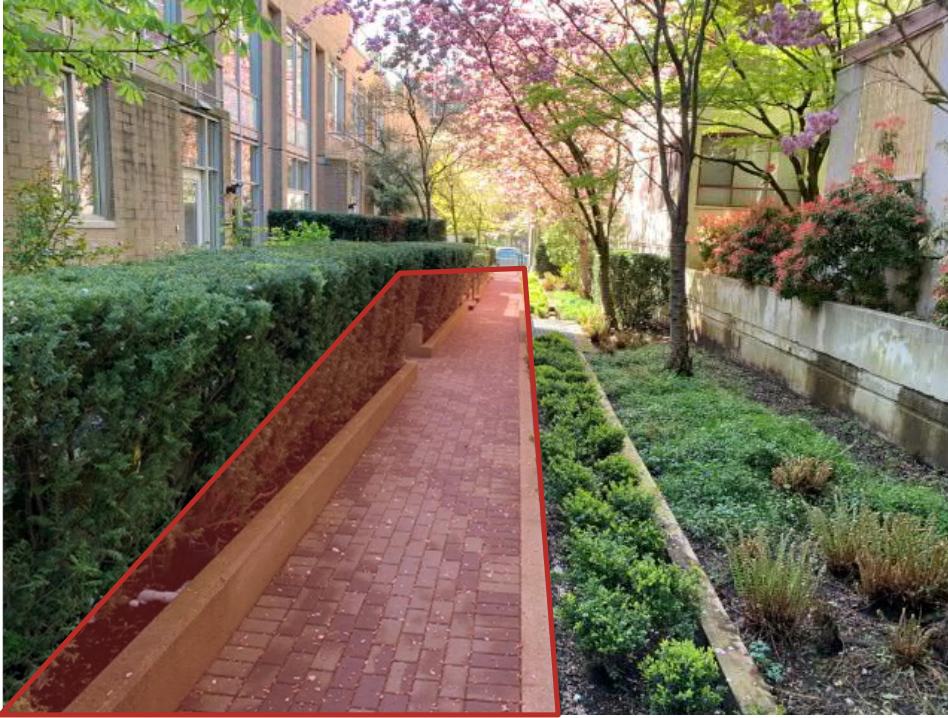
Photo 3:

General view of west buried garage roof slab (red area).

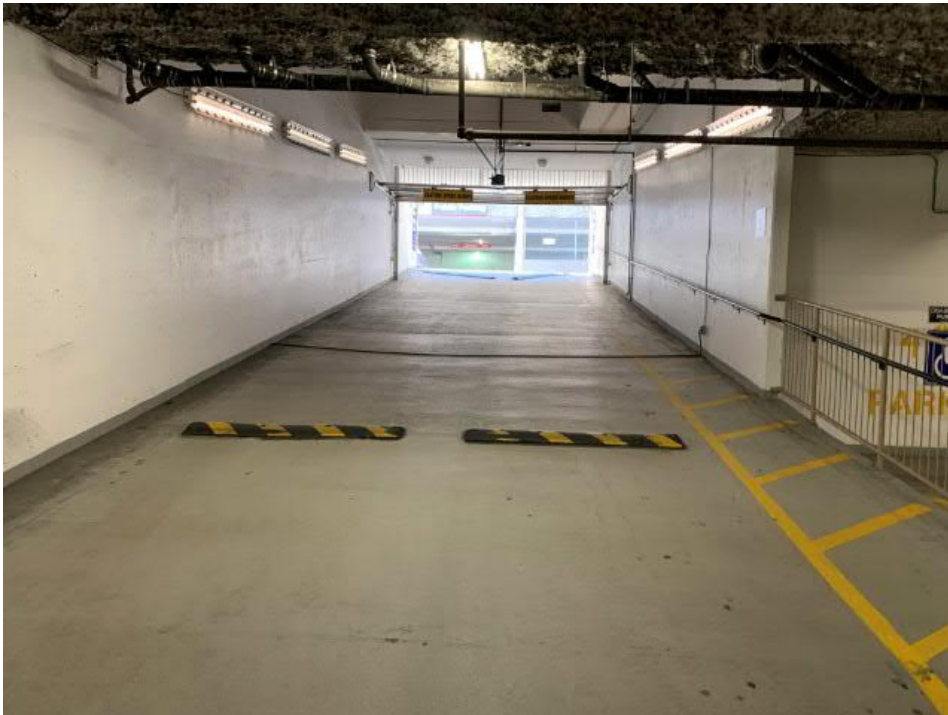
Photo 4:

General view of covered entrance ramp, with traffic membrane.

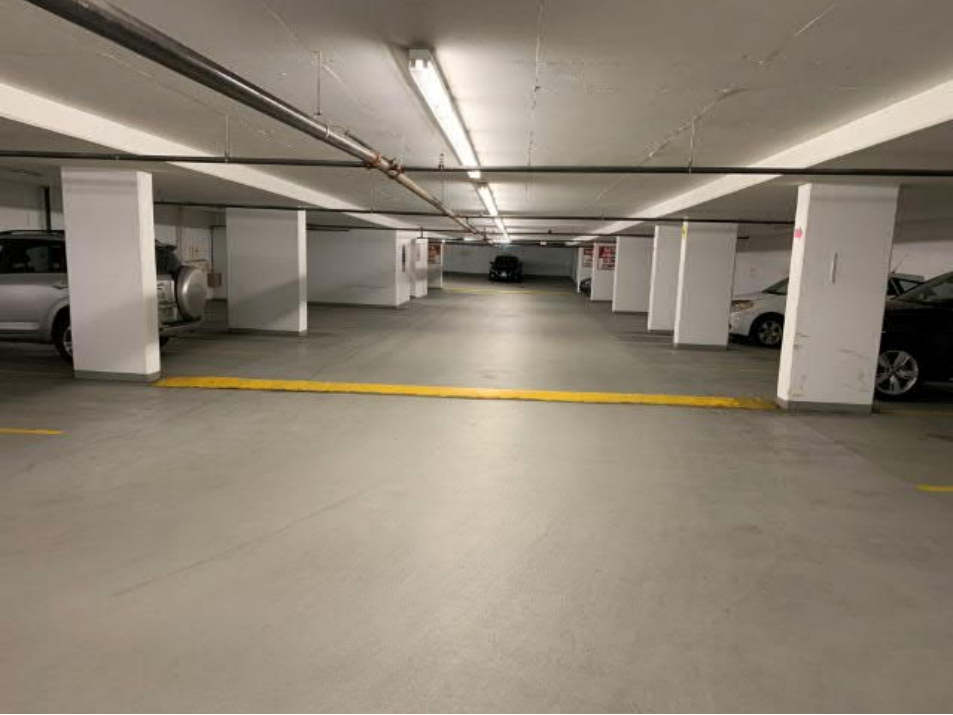
<p>Photo 5:</p> <p>General view of suspended parking slabs protected by a traffic membrane.</p>

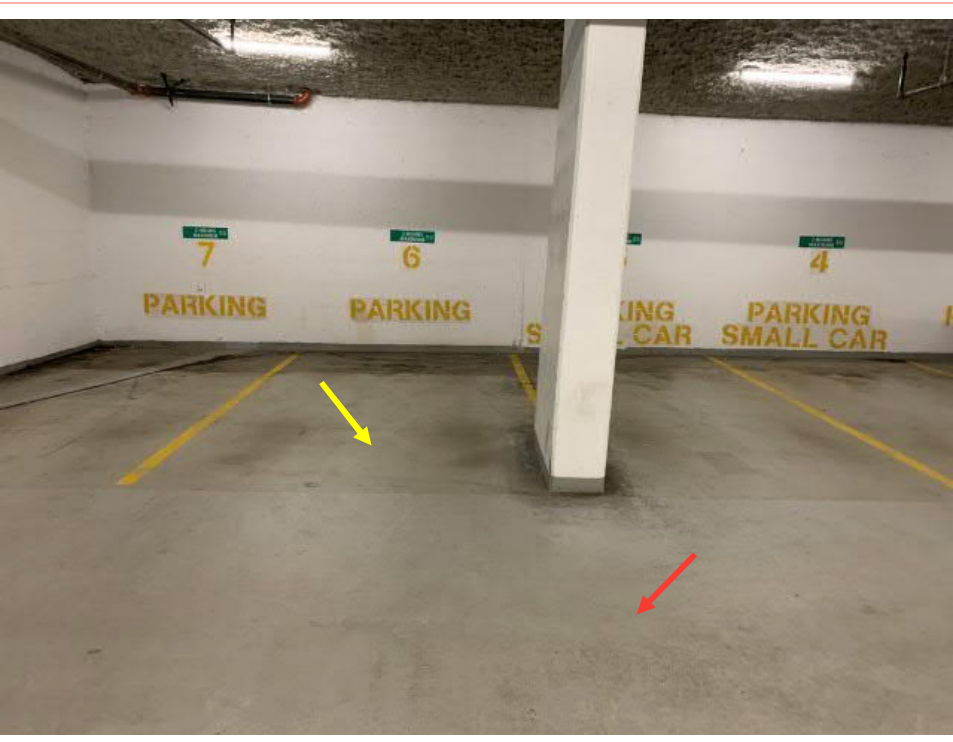
Although the membrane generally appears to be in a serviceable condition, these membranes typically have a service life of 15 to 20 years, depending on product used, and quality of installation. Regular maintenance is required in order to achieve or prolong service life, and it appears that the drive aisle membrane was recoated for this purpose.

<p>Photo 6:</p> <p>Appears drive aisles have been recoated (red arrow), relative to parking stalls (yellow arrow).</p>

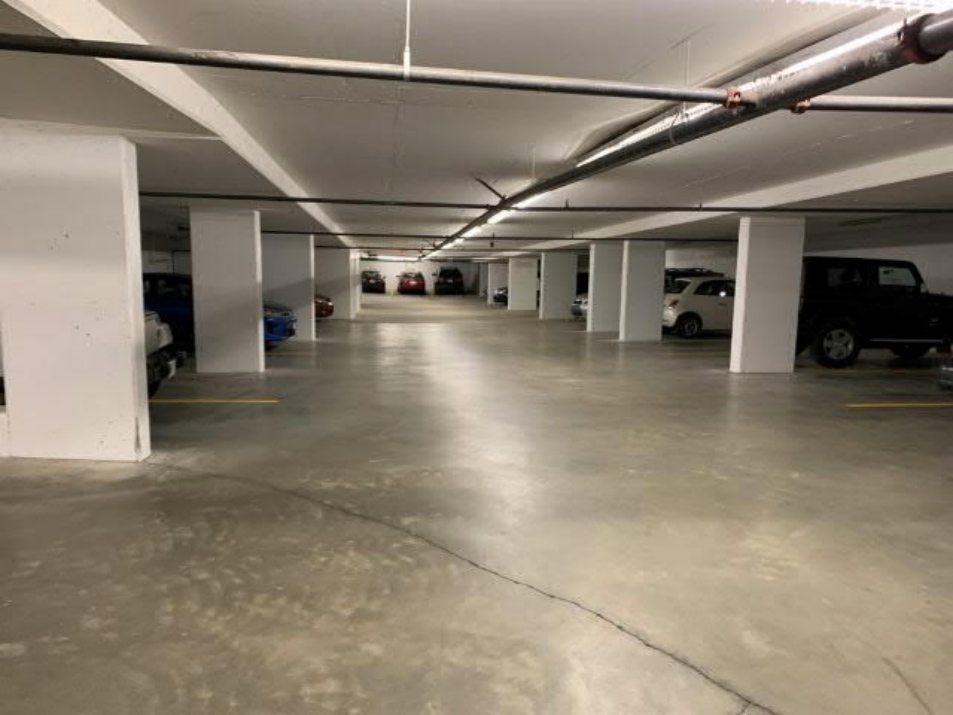
<p>A wide-angle photograph of a multi-level parking garage. The floor is a smooth, light-colored concrete slab. Several white concrete support columns are visible, spaced out across the area. In the background, several cars are parked in designated spaces. A large, dark, cylindrical pipe runs horizontally across the upper portion of the frame, supported by brackets.</p>	<p>Photo 7:</p> <p>General view of P4-Level slab-on-grade.</p>

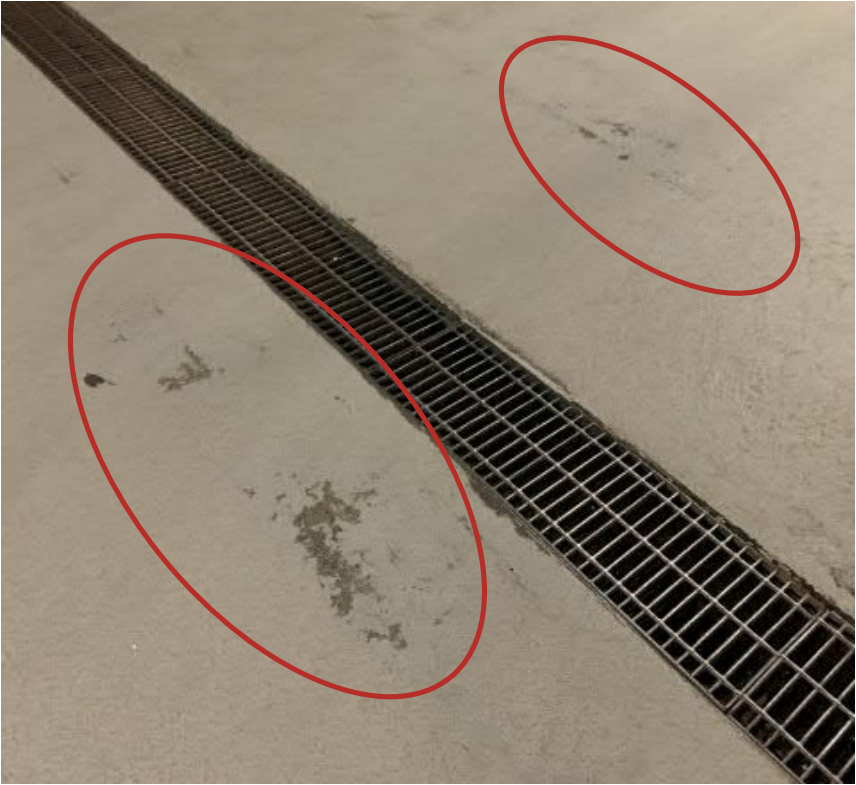
We noted wearing in the traffic membrane at base of ramp, and high traffic turning areas generally on the upper levels of the parkade (see Photos 8 to 10). We also noted evidence of leakage at the trench drain, below area drains, and on the underside of the ramp (see Photos 11 to 13).

<p>A close-up photograph of a concrete floor next to a metal drainage grate. Two red ovals are drawn on the concrete surface, highlighting areas of wear and discoloration in the traffic membrane. The grate is a long, narrow, rectangular metal grid.</p>	<p>Photo 8:</p> <p>Evidence of wear in the traffic membrane at base of ramp.</p>

- Localized waterproofing membrane repairs, along with overlaying the wear course within the drive aisles;
- Membrane application at northwest P1 Water Room and P2 Storage Room;
- Injection waterproofing repairs at leaking foundation wall cracks; and
- Removing evidence of leakage and localized painting on soffits and foundation walls.

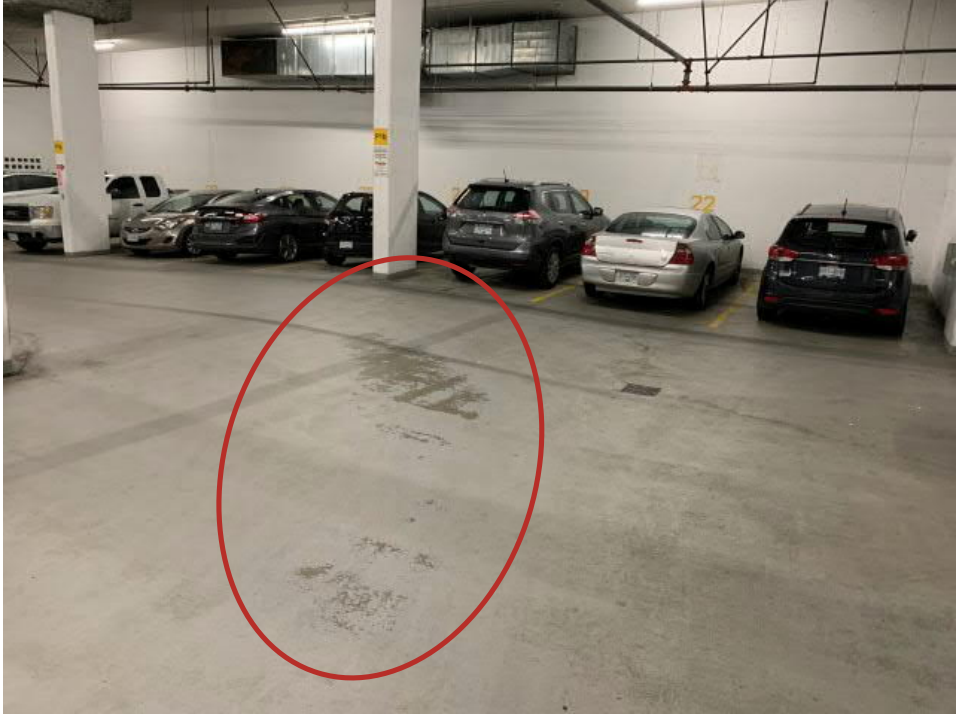
<p>Photo 9:</p> <p>Evidence of wear in the traffic membrane at P1 turning area.</p>

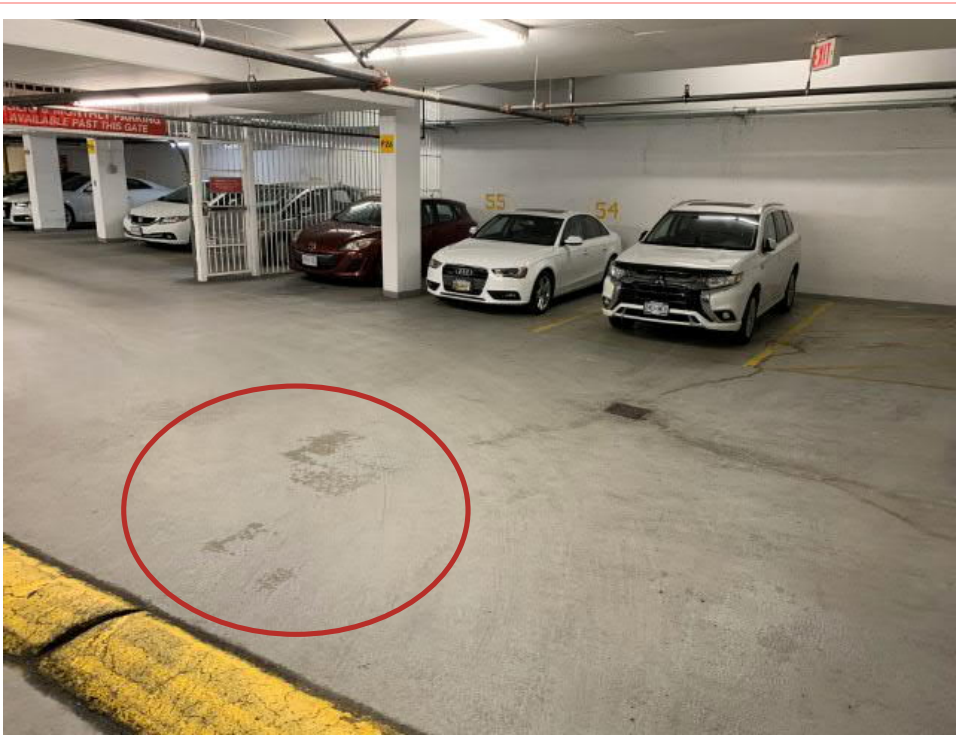
<p>Photo 10:</p> <p>Evidence of wear in the traffic membrane at P1 turning area.</p>

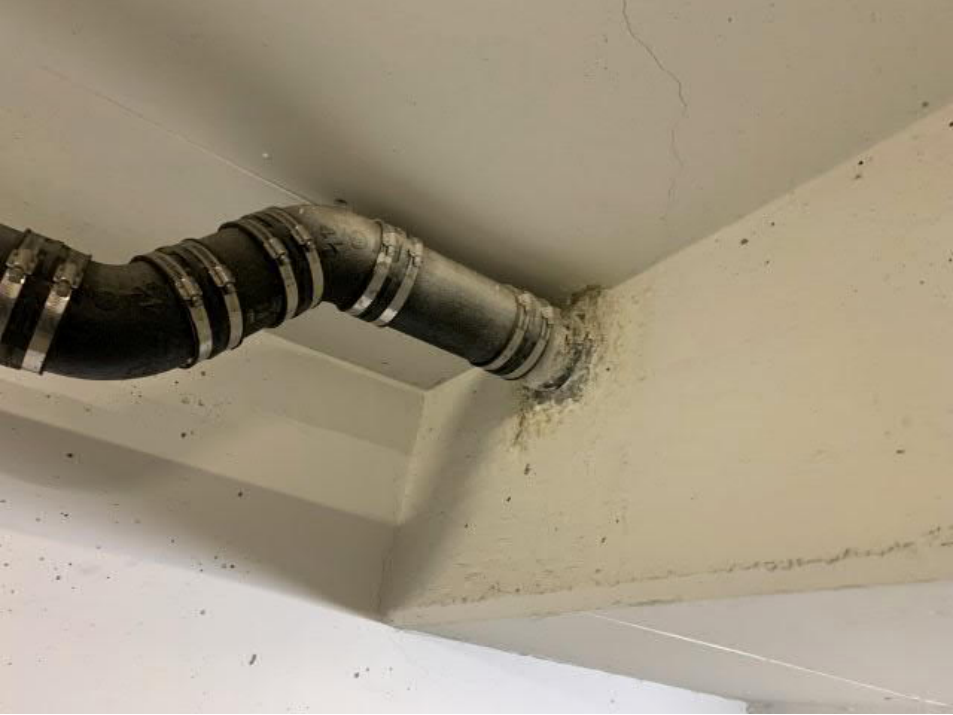
<p>Photo 11:</p> <p>Evidence of leakage at trench drain penetration, below garage access ramp.</p>

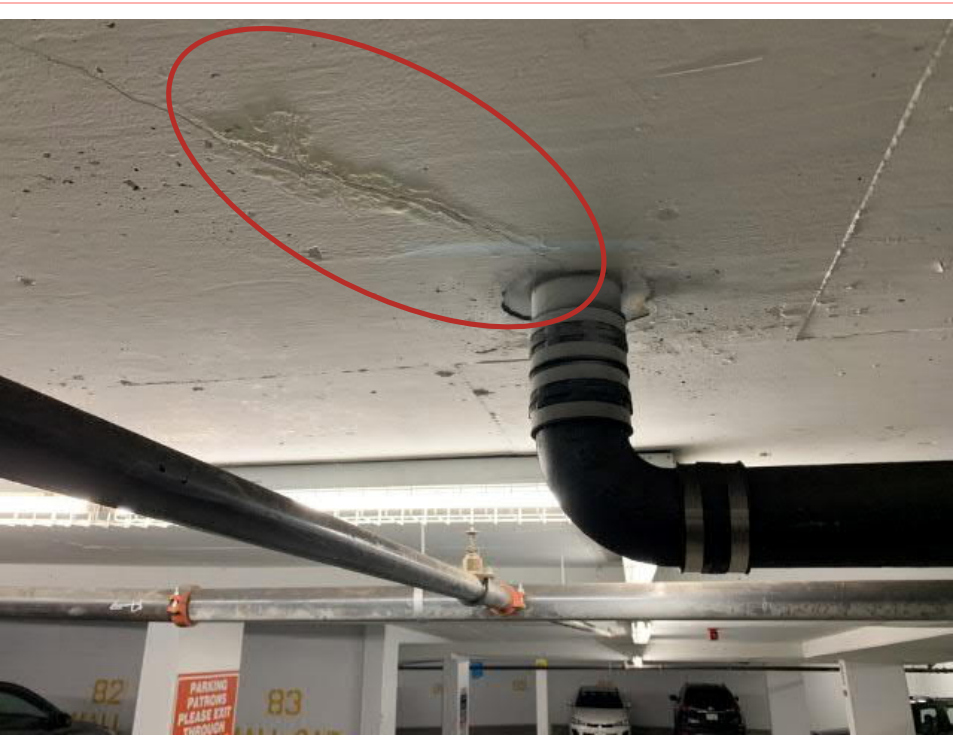
<p>Photo 12:</p> <p>Evidence of leakage at area drain.</p>

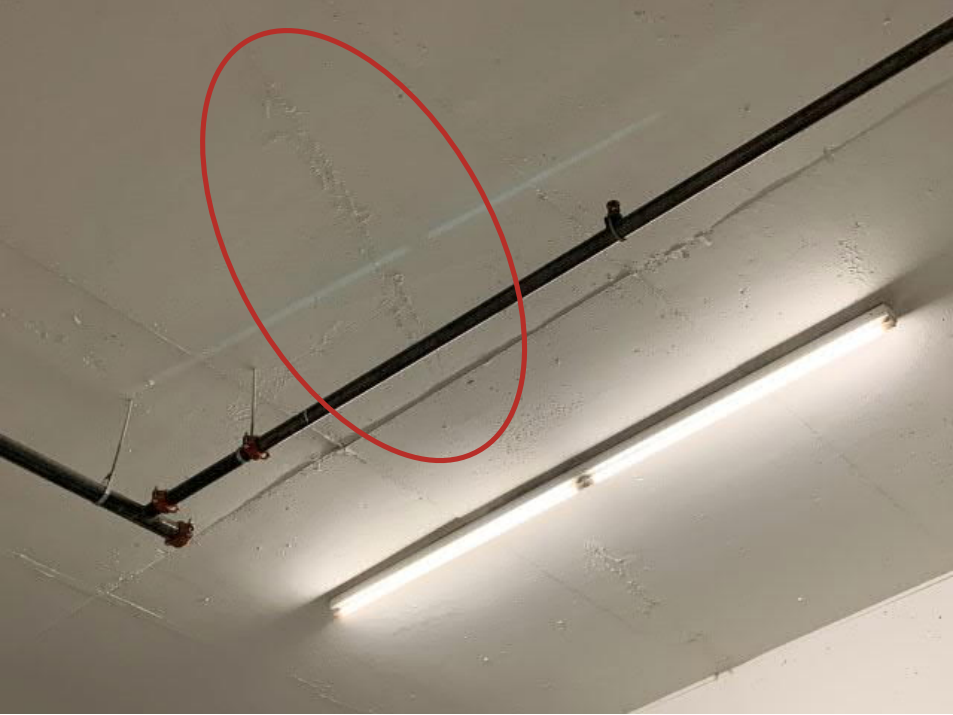
<p>Photo 13:</p> <p>Evidence of leakage below garage entrance ramp.</p>

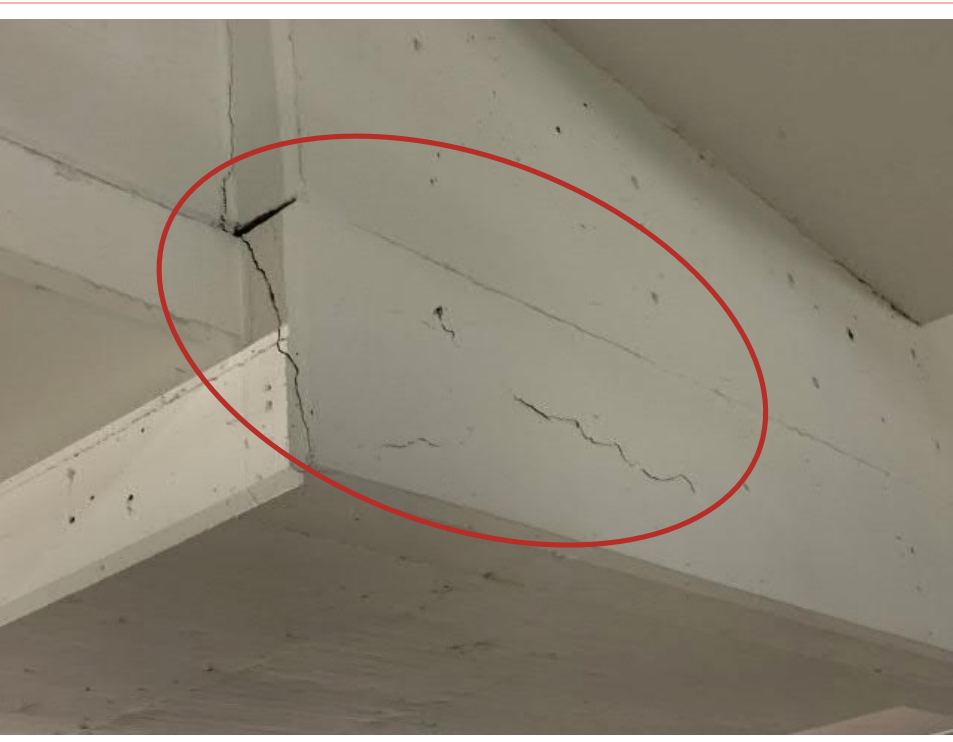
We noted localized concrete deterioration along a slab edge above parking stall 54 on the P2-level (see Photo 14). The concrete deterioration does not appear to be related to leakage, but either the result of thermal movement or settlement.

<p>Photo 14:</p> <p>Localized concrete deterioration above parking stall 54.</p>

Until further repair work is completed, we would recommend removing the deteriorated concrete above parking stall 54, to alleviate risk of property damage or injury of users below.

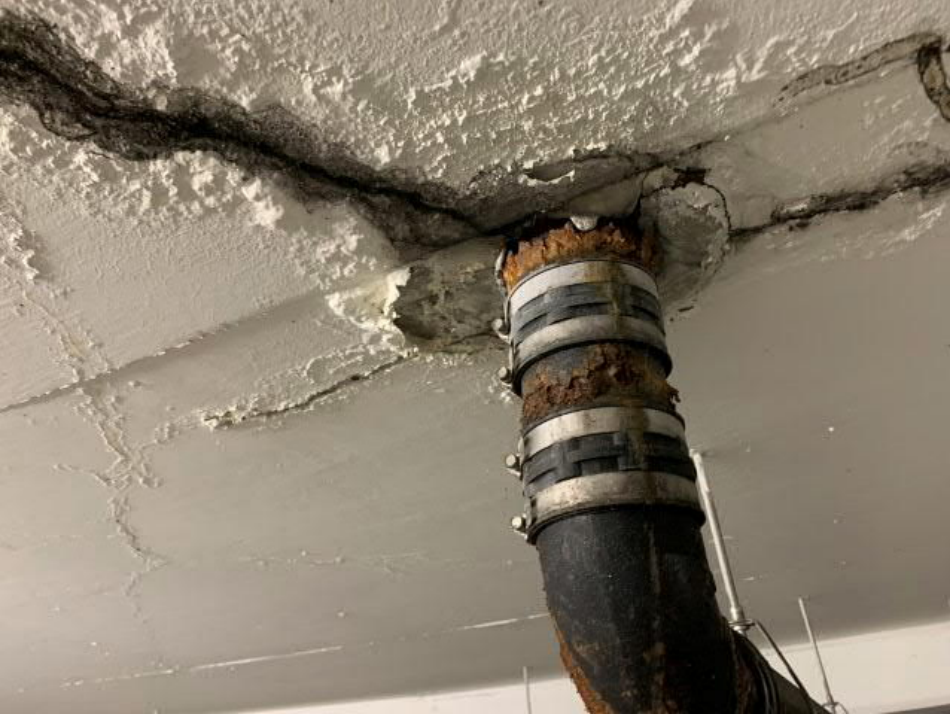
We noted corrosion of an area drain pipe on the P2-level (see Photo 17). This may be a result of leakage from around the drain penetration, or cracks in the drain body itself. This condition may introduce additional water onto the P2-level.

<p>Photo 17:</p> <p>Corroded drain pipe on P2-level.</p>

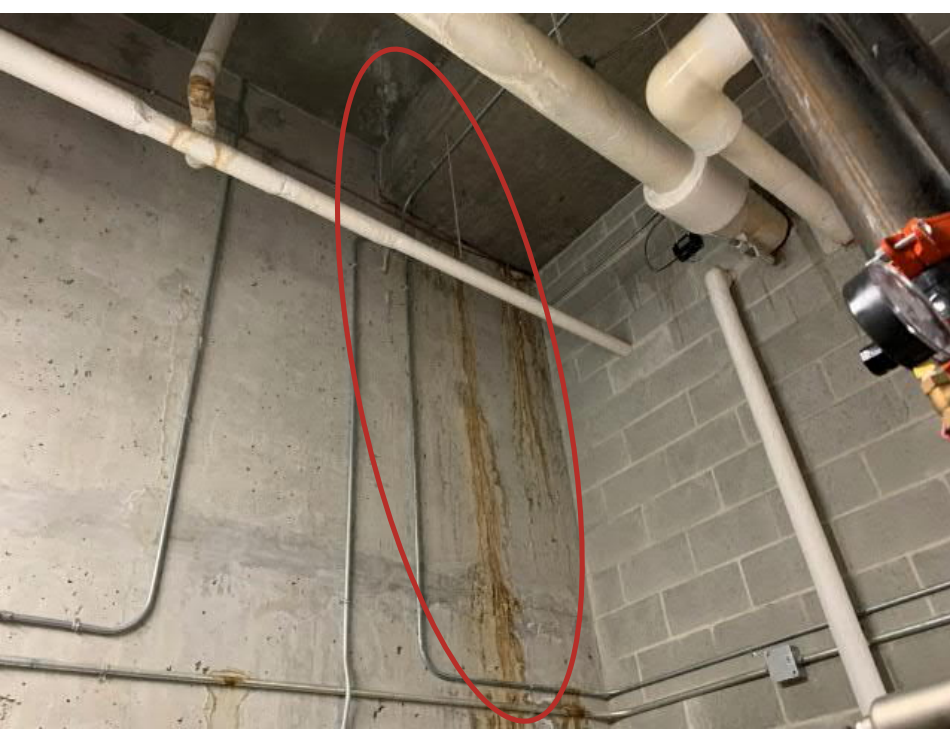
We noted evidence of leakage on the garage roof slab soffit above the P1-level Water Room at the northwest corner of the parkade (see Photo 18). Although there appears to be a membrane applied to the Water Room floor, we noted hairline cracking and evidence of leakage into the P2-level Storage Room below (see Photos 19 to 21). We did not have access into the P2-level Storage Room to confirm if a waterproofing membrane was present; however, there is evidence of leakage on the soffit at the northwest corner of the P3-level (see Photo 22).

At this time, it is not clear if this leakage is the result of leakage through the garage roof slab membrane, the mechanical equipment in the Water Room, or a combination of both. We would recommend addressing the membranes within the parking garage.

<p>Photo 18:</p> <p>Evidence of leakage below garage roof slab, at northwest corner of site, within P1-level Water Room.</p>

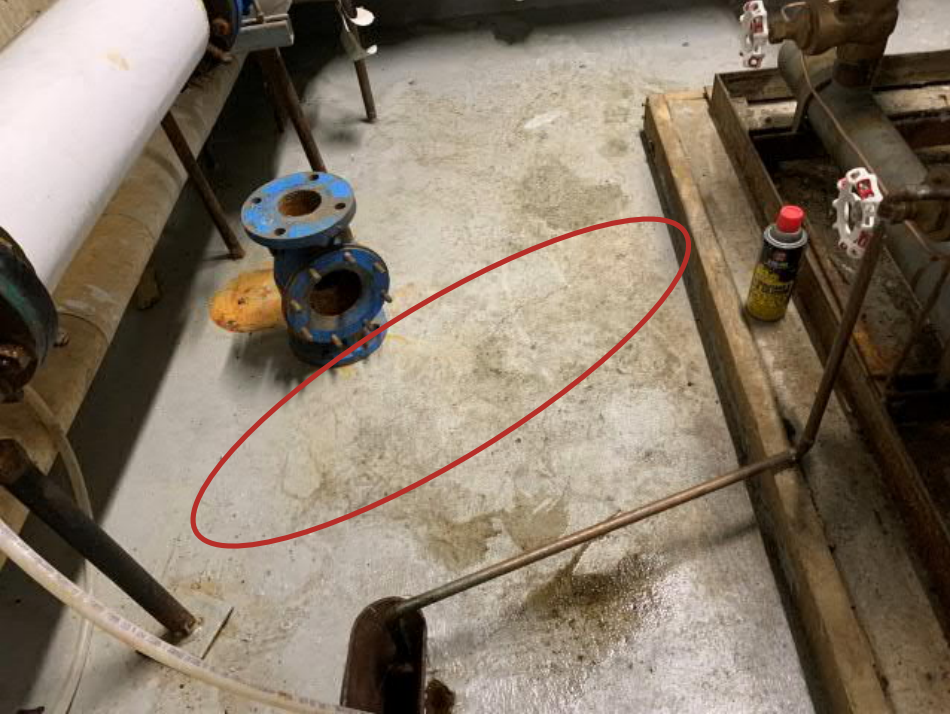
<p>Photo 19:</p> <p>Hairline cracking present in the P1-level Water Room.</p>

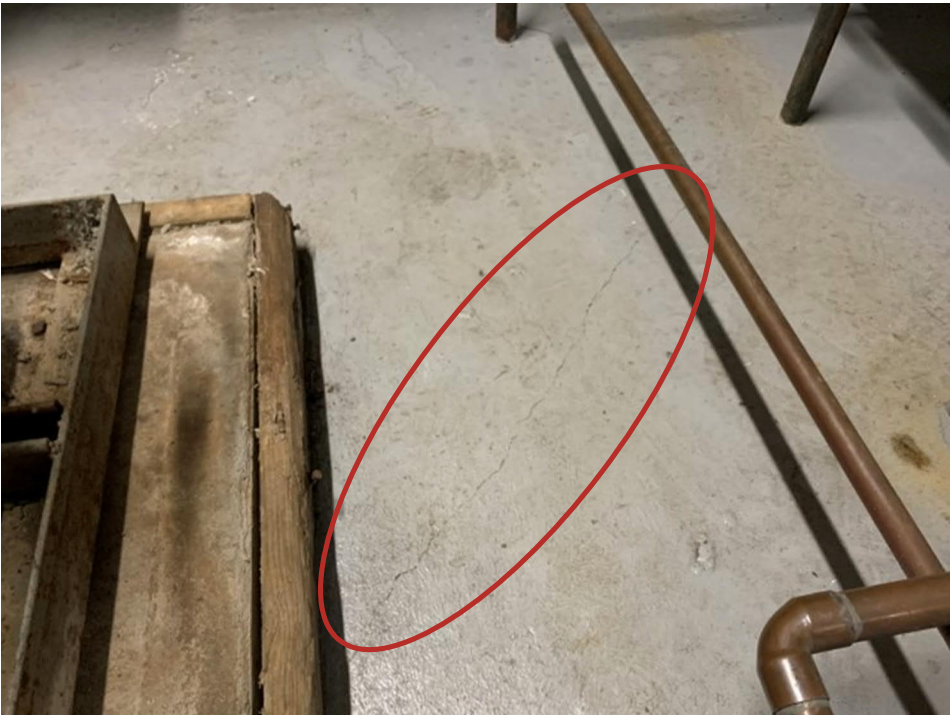
<p>Photo 20:</p> <p>Hairline cracking present in the P1-level Water Room.</p>

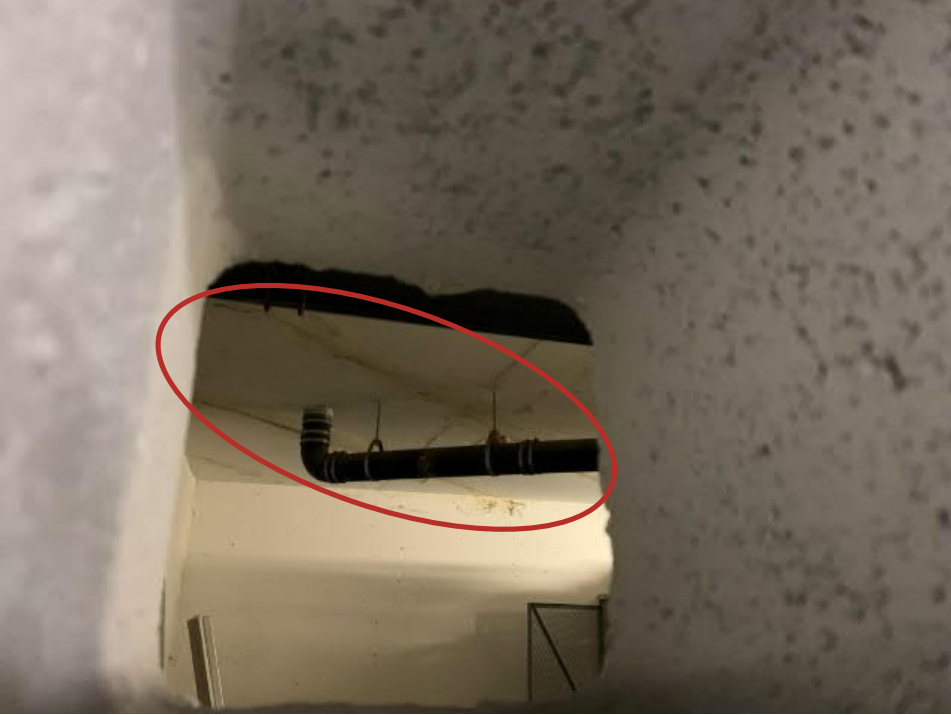
<p>Photo 21:</p> <p>Evidence of leakage on soffit of P2-level Storage Room.</p>

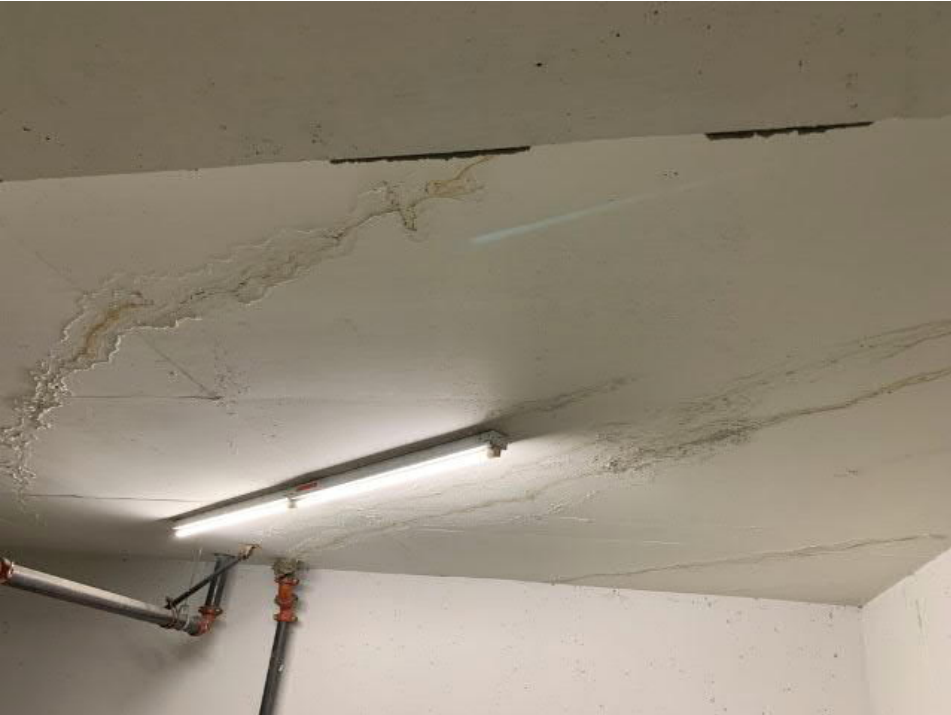
<p>Photo 22:</p> <p>Evidence of leakage on soffit at northwest corner of P3-level.</p>
