Site Review Report # 01

Reviewed By:	Sangtae Han	Date of Review(s):	January 16, 2025
Address:	4960 Sanders St, Burnaby, BC	Time:	10:00 AM – 10:30 AM
Job Description:	Suite Upgrades	Contractor:	All Professional Trades
Project #:	2302.017	No. of Employees:	1
Permit #:	BLD23-01004	Weather:	3 °C Cloudy

Ref. 2302.017-E-SRR-4960-SRR-01-FNL

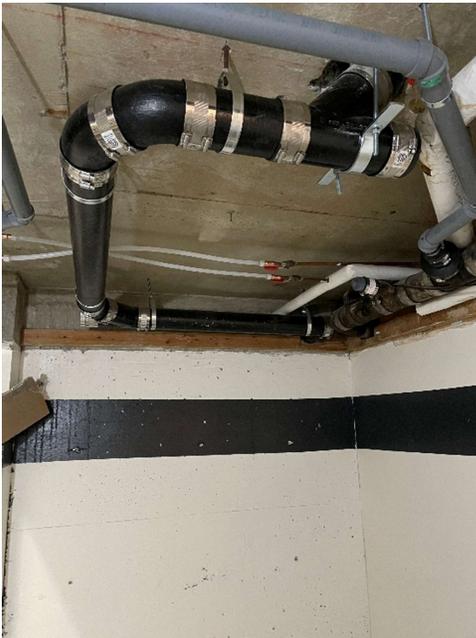
Photo 1.1 – 04/05 stack re-routed

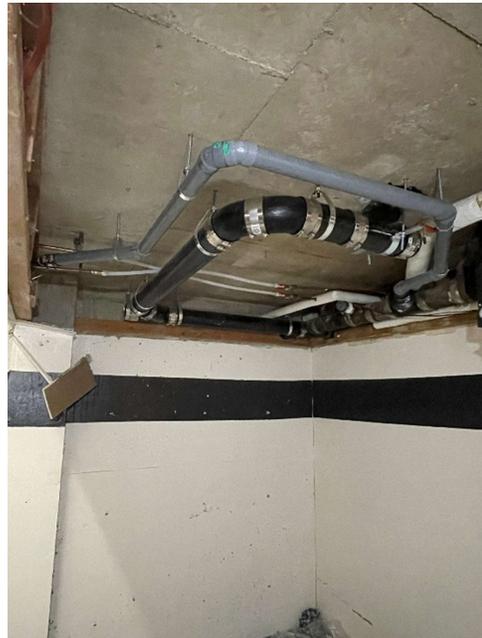
Photo 1.2 – 04/05 stack re-routed

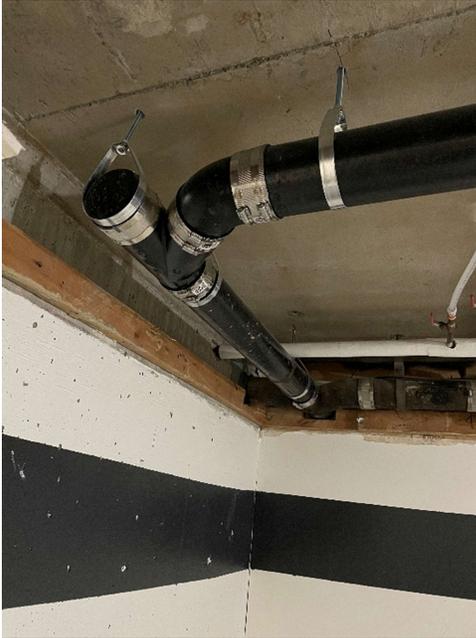
Photo 1.3 – A new cleanout within 05/06 stack re-route

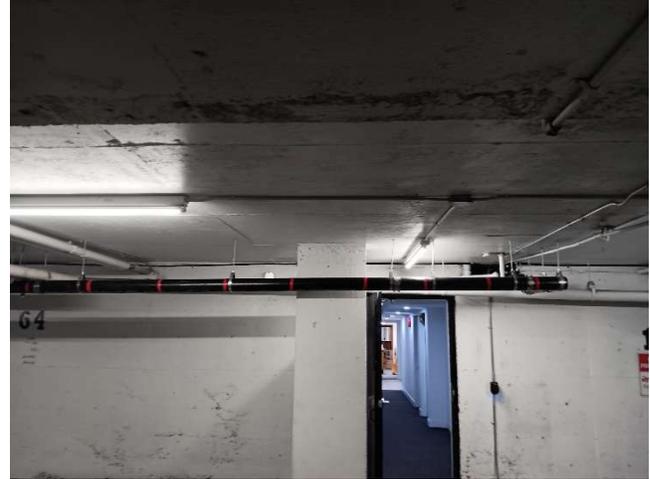
Photo 1.4 – 06 stack re-routed

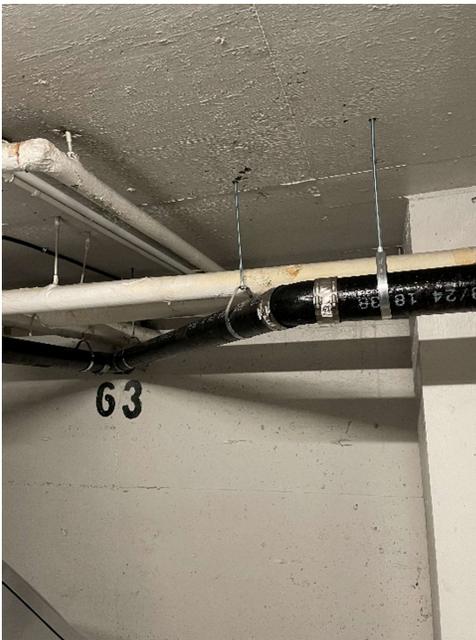
Photo 1.5 – 06 stack re-routed and connected to

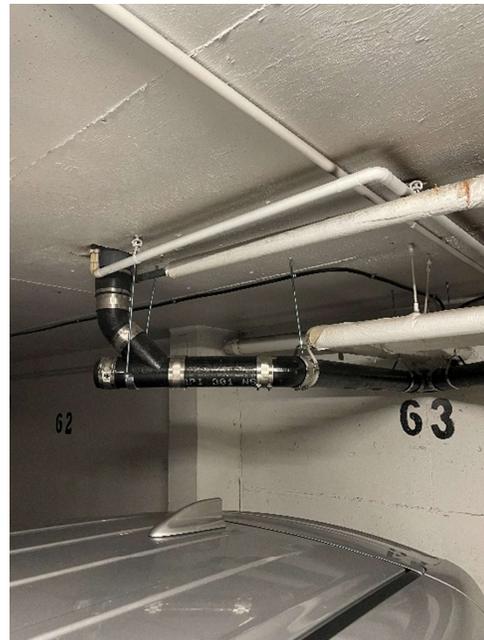
Photo 1.6 – 07 stack re-piped with cast iron and with bigger pipes
