## Roof Condition Report - Terraces on Tenth, New Westminster

**Pinnacle Group Inc.**

5/22/2018

28-484

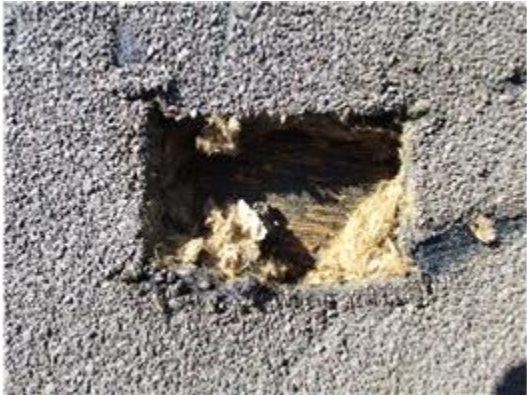
Roof Core

Core Sample

The core cut was taken to verify the roof condition and composition in this particular location on the roof. The roofing assembly is:

- 2 Plies of Modified Bituminous Membranes
- 1/2" Fibreboard Insulation
- Wood Deck

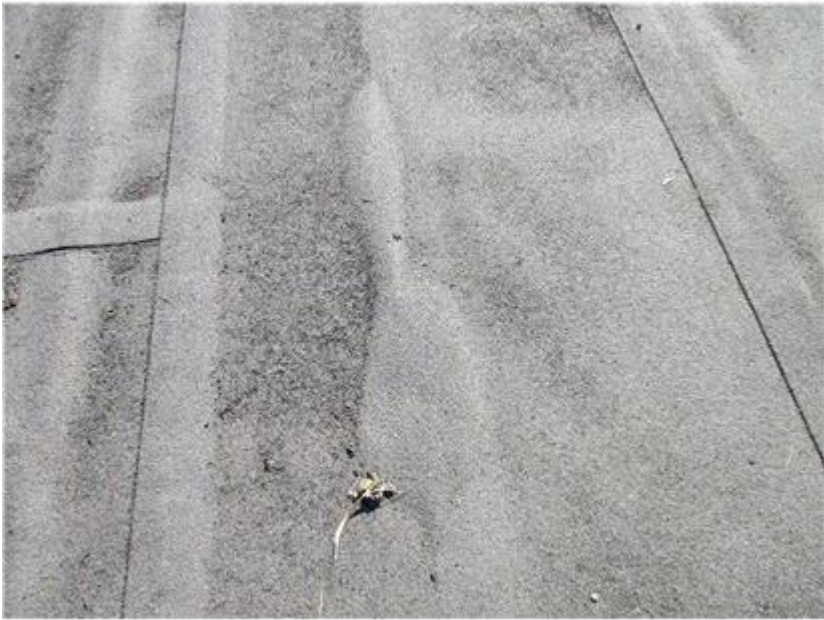
**Condition:** Blister  
**Severity:** High  
**Quantity:** 1

Numerous (+/-50) blisters were noted on this roof level. Blisters are an indication that either air or moisture are trapped within the roofing system.

The severe ridging and blistering should be monitored for further development at this time.

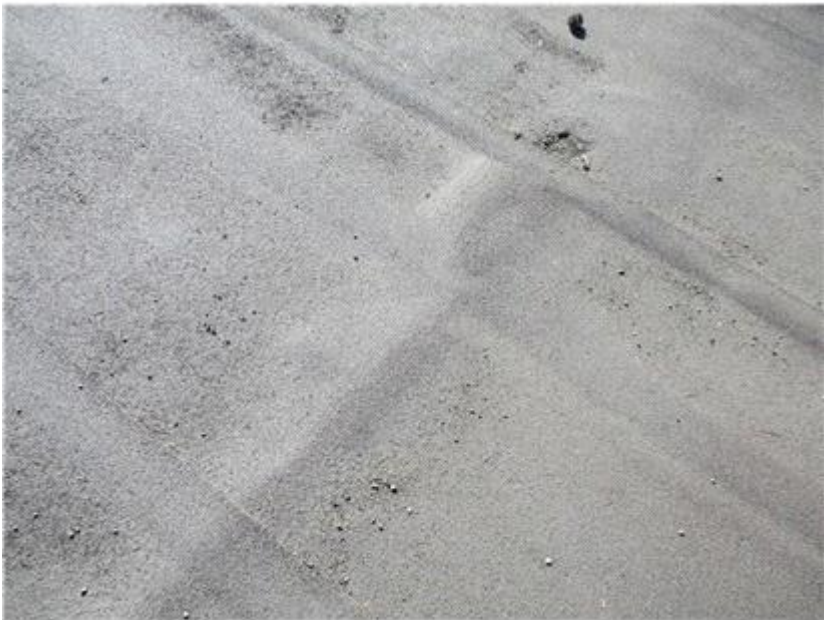
**Condition:** Blister 1  
**Severity:** High  
**Quantity:** 1

Another typical blister located in the field of the roof.

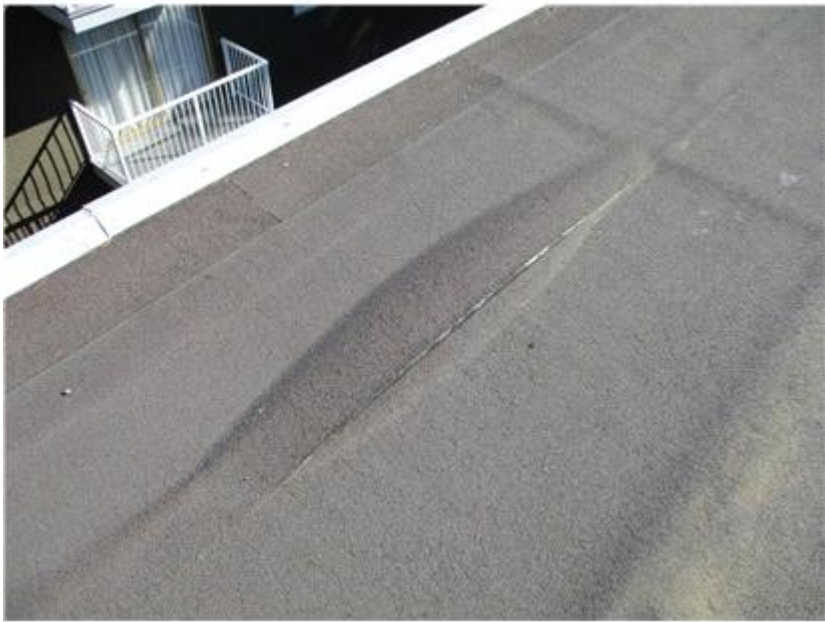
**Condition:** Blister 2  
**Severity:** High  
**Quantity:** 1

Another large blister near the roof perimeter.

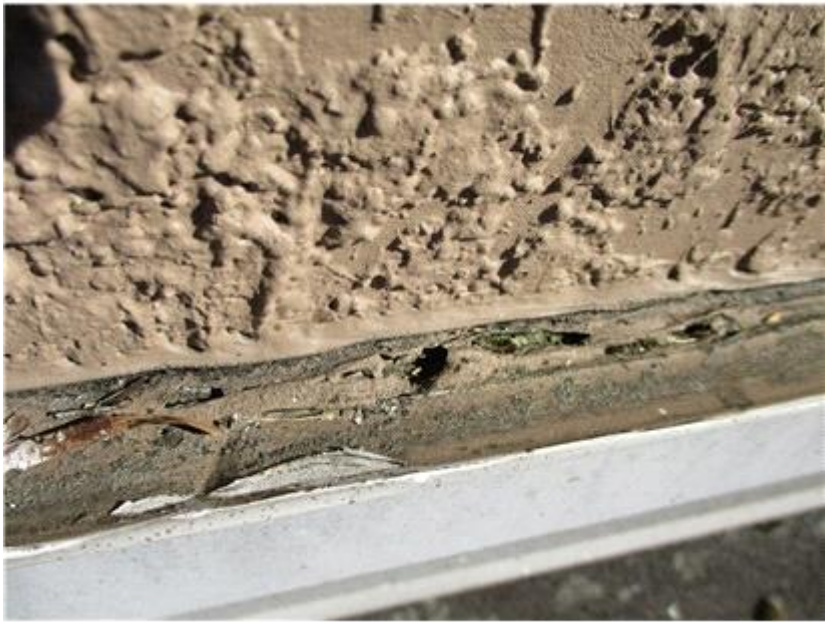
**Condition:** Counterflashing- sealant  
**Severity:** High  
**Quantity:** 2

The sealant at the wall reglet or the top of counterflashing is missing or no longer functioning, possibly allowing water to channel behind the counterflashing.

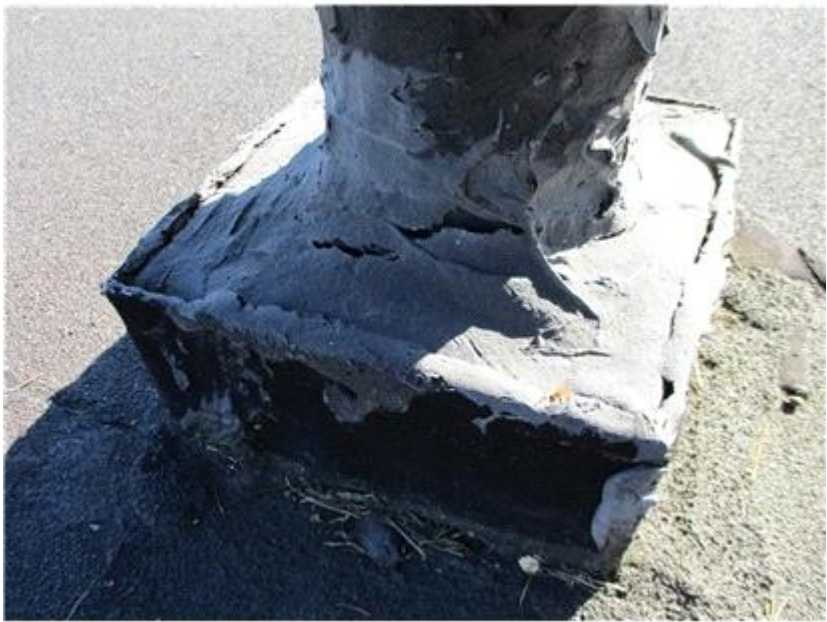
**Condition:** Pitch pan sealant  
**Severity:** High  
**Quantity:** 1

The mastic is low and/or open in a pitch pan on this roof level. This condition may be allowing water to enter into the roofing assembly and/or building.

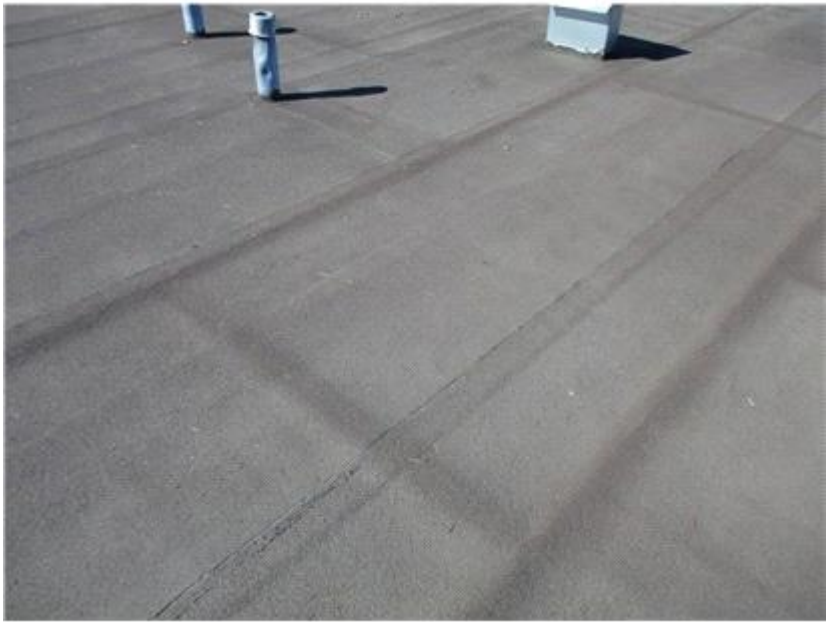
**Condition:** Ridges  
**Severity:** High  
**Quantity:** 1

Ridges were noted throughout this roof level. Ridges usually form over voids between insulation boards and can be very harmful to the roofing system.

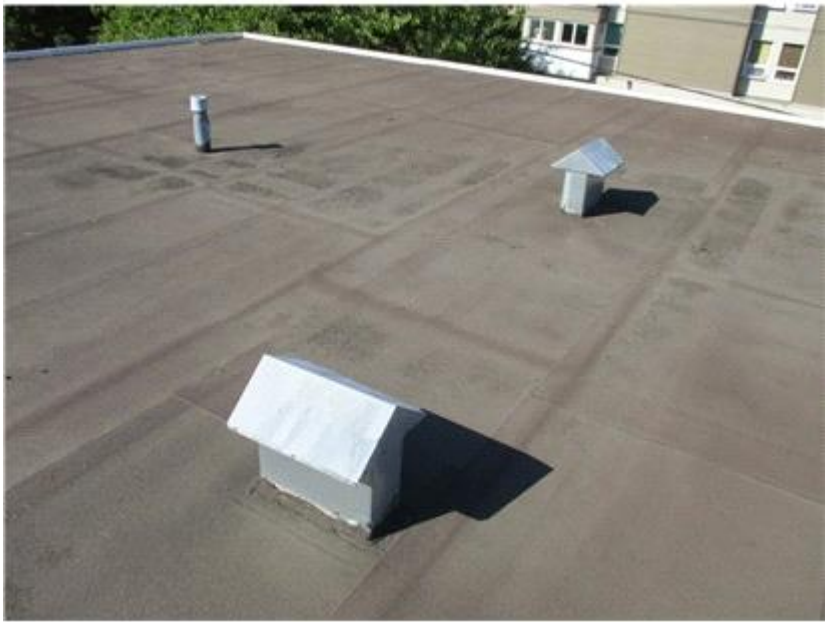
**Condition:** Ridges 1  
**Severity:** High  
**Quantity:** 1

More ridges noted throughout this roof level.

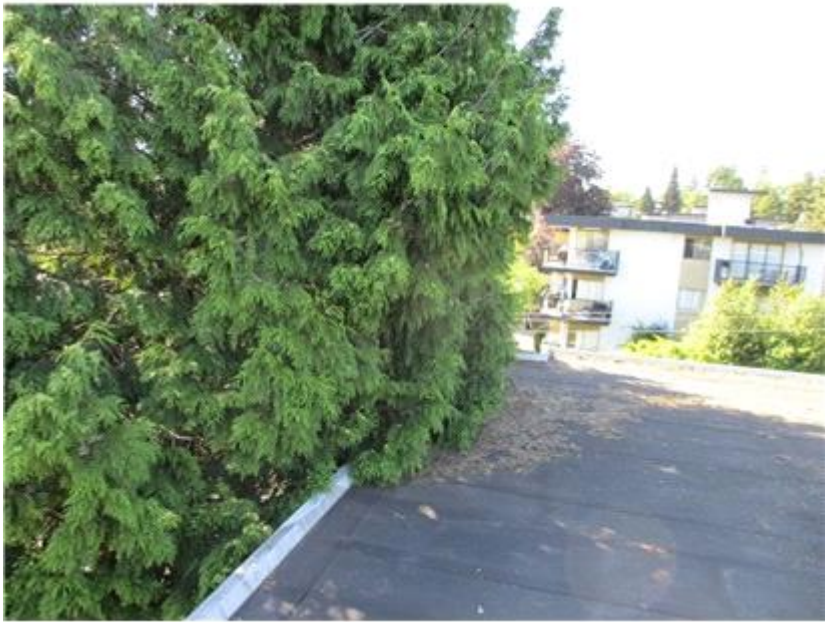
**Condition:** Overhanging Trees  
**Severity:** Medium  
**Quantity:** 1

Overhanging trees were noted along the perimeter of this roof level. The tree branches may scrape the roofing membranes and cause premature erosion in this area.

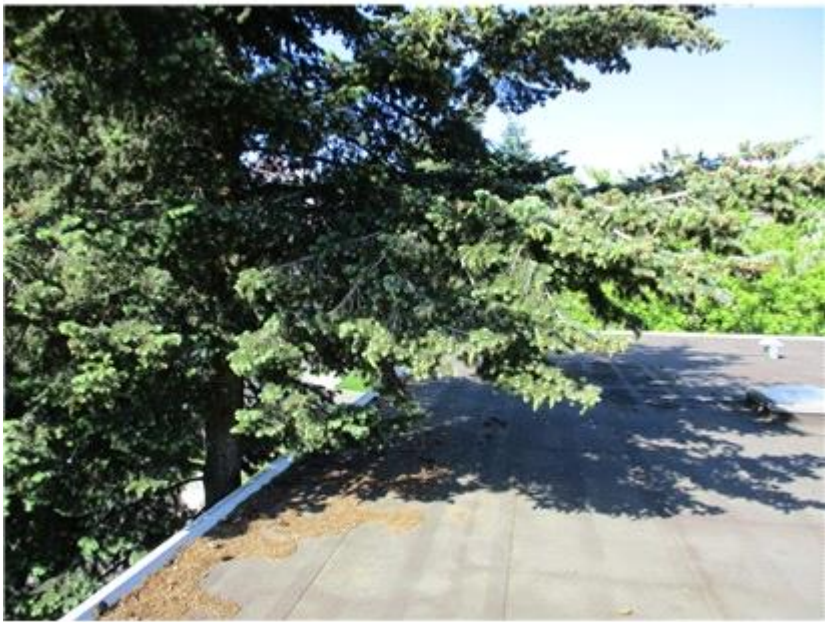
More overhanging trees depositing debris onto the roof.

**Condition:** Overhanging Trees 1  
**Severity:** Medium  
**Quantity:** 1

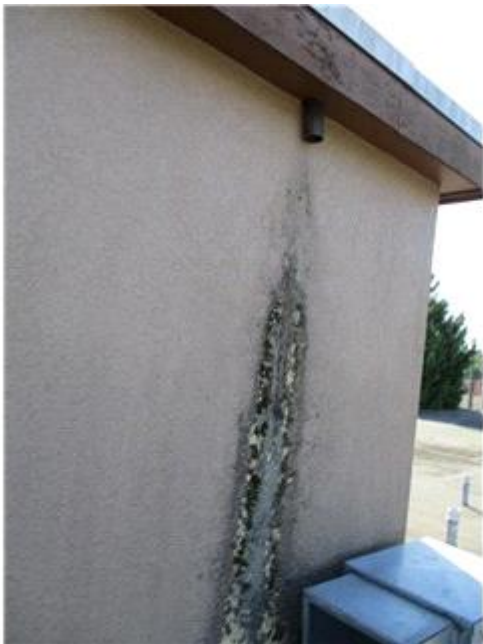
The downspout is missing from the scupper on this roof level. The draining water is staining the wall and may cause premature membrane erosion on the lower roof level.

**Condition:** Scupper- down spout loose/  
**Severity:** Medium  
**Quantity:** 1

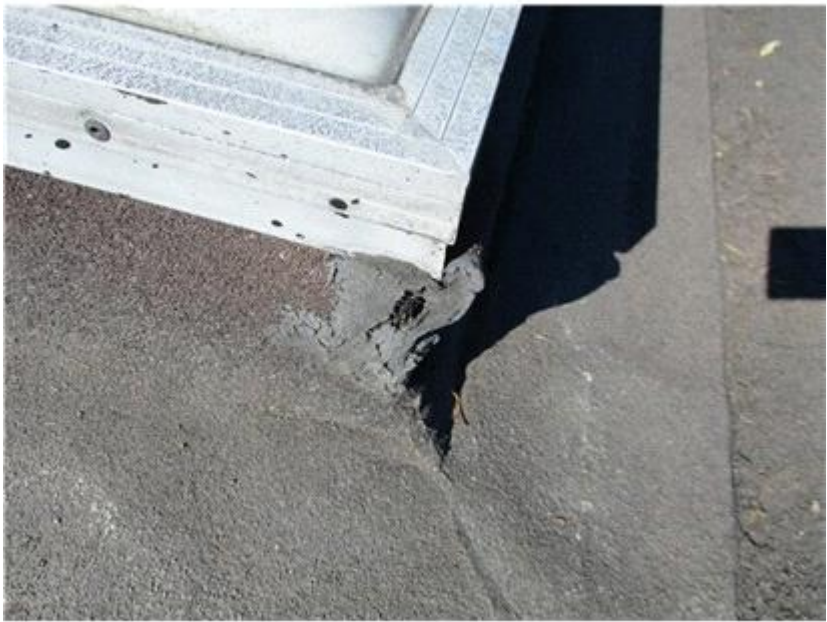
**Condition:** Sealant failure  
**Severity:** Medium  
**Quantity:** 1

Overview of open and deteriorated mastic in the corner of the unit. This condition may be allowing water to enter the roofing assembly and/or building.

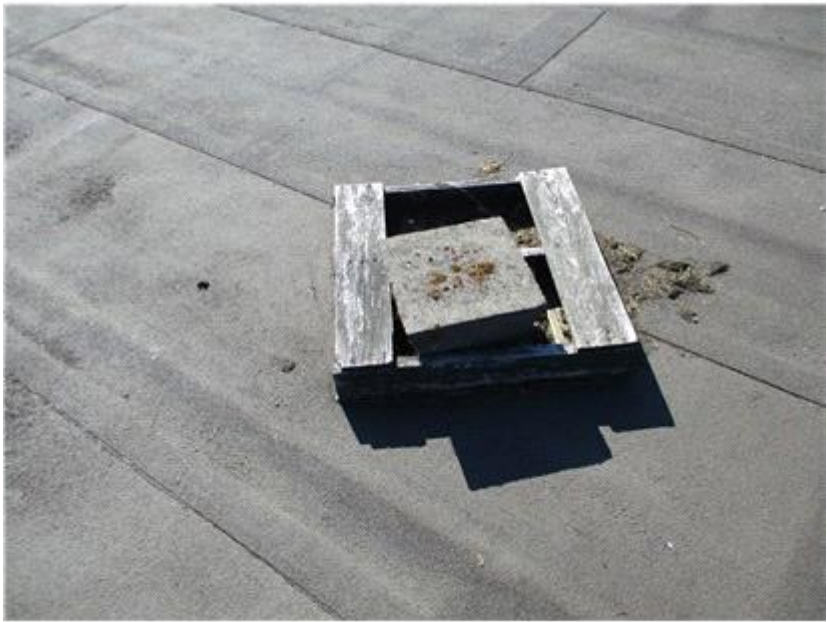
**Condition:** Debris on roof  
**Severity:** Low  
**Quantity:** 1

Areas of scattered rooftop debris were noted lying directly on the surface of the roof. All non-essential items should be immediately removed.

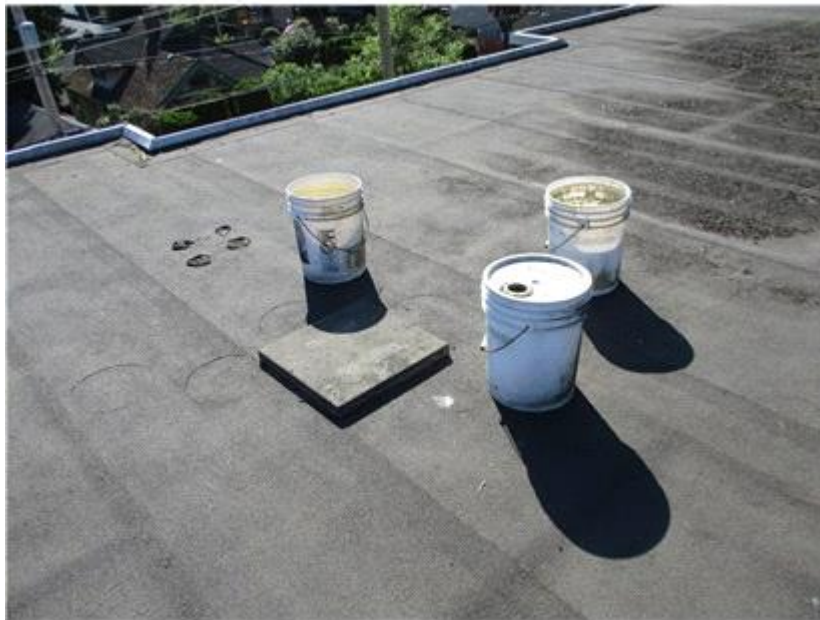
**Condition:** Debris on roof 1

**Severity:** Low

More rooftop debris.

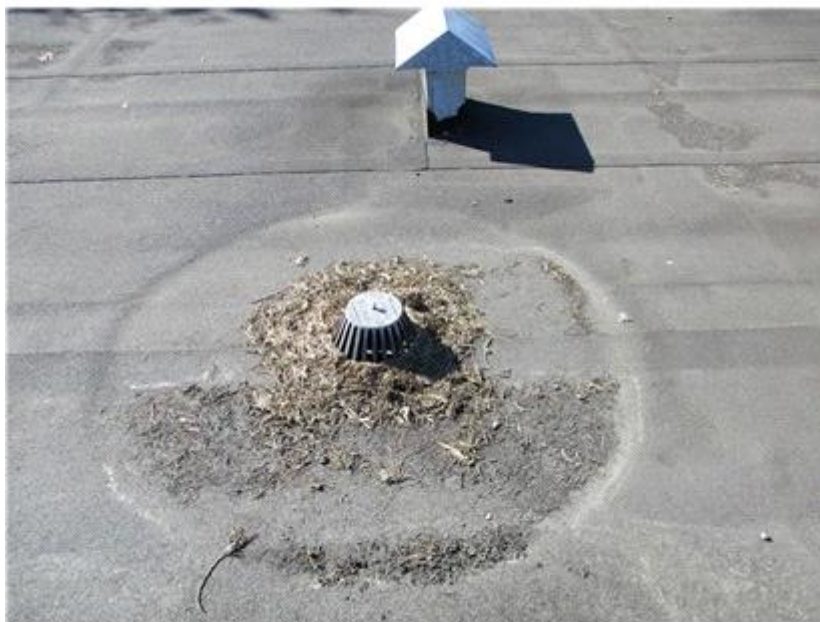
**Condition:** Drain- vegetation build up

**Severity:** Low

Vegetation build-up is preventing proper drainage of the roof.

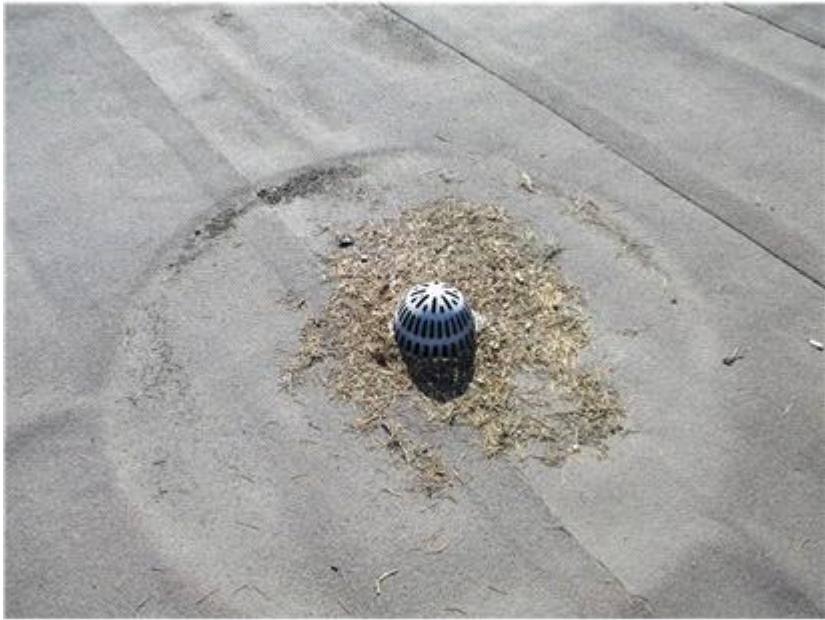
**Condition:** Drain- vegetation build up 1  
**Severity:** Low  
**Quantity:** 1

More debris blocking proper drainage at another roof drain.

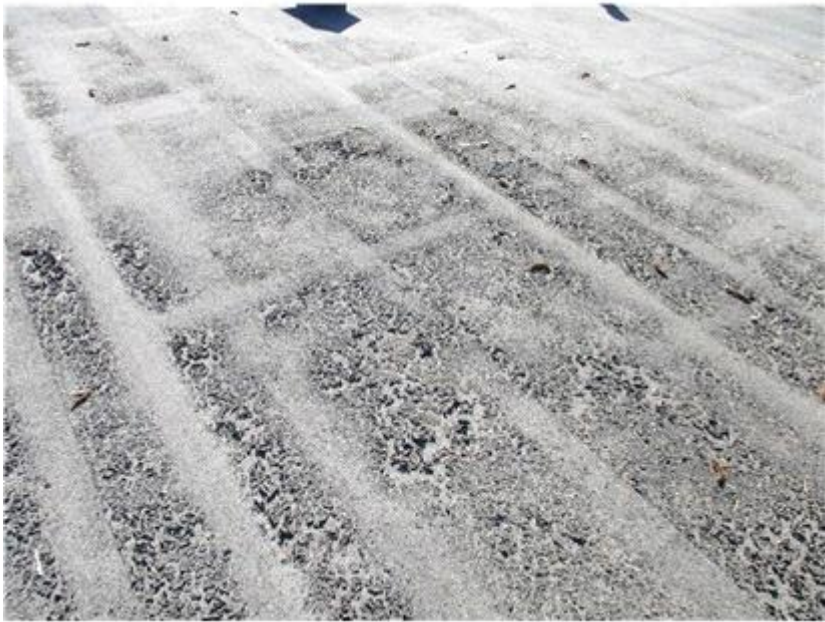
**Condition:** Organic debris  
**Severity:** Low  
**Quantity:** 1

An accumulation of organic debris was noted on this roof level.

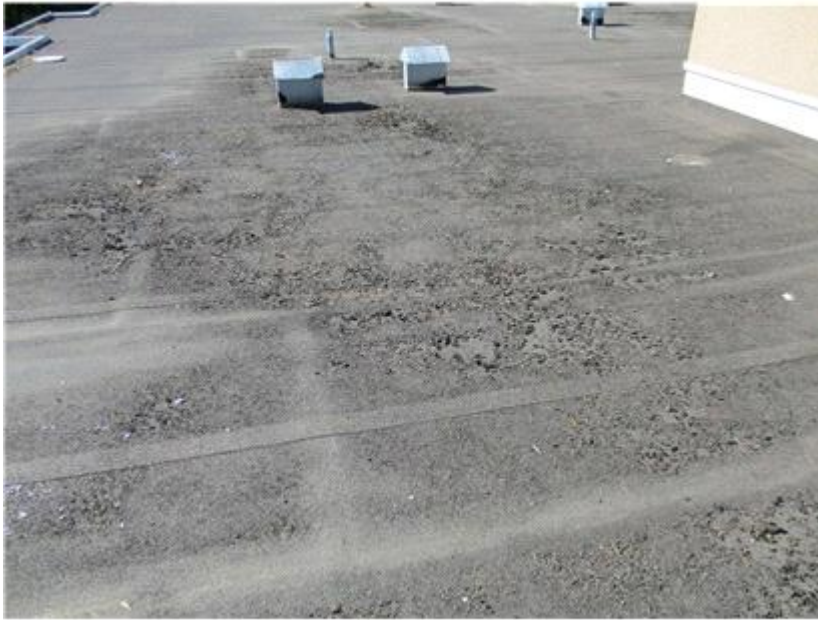
**Condition:** Organic debris 1

**Severity:** Low

More organic debris throughout this roof level.

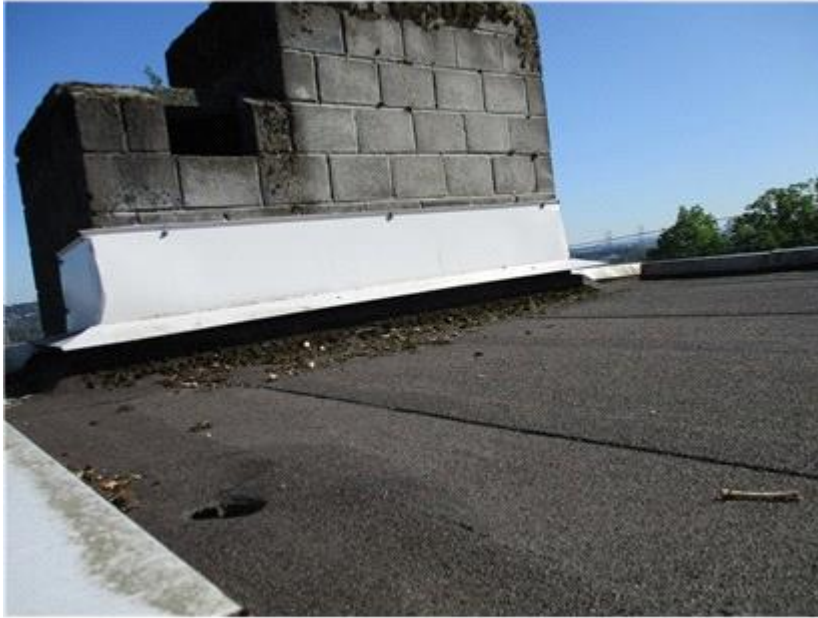
**Condition:** Organic debris

**Severity:** Low

An accumulation of organic debris was noted on this roof level.

- Clear the roof and roof drain of all debris
