## Roof Condition Report - Carlton Park Gardens - 10851 Mortfield Road, Richmond, BC

**Inspection Date:**

7/20/2022

221073

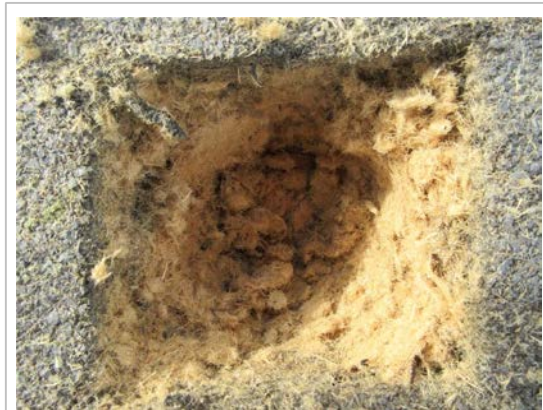
Core Sample

The core cut was taken to verify the roof condition and composition in this particular location on the roof. The roofing assembly is:

- 2 Plies of Modified Bituminous Membranes (mopped)
- 2" Fibreboard Insulation (mopped)
- Kraft Paper Vapour Retarder
- Wood Deck

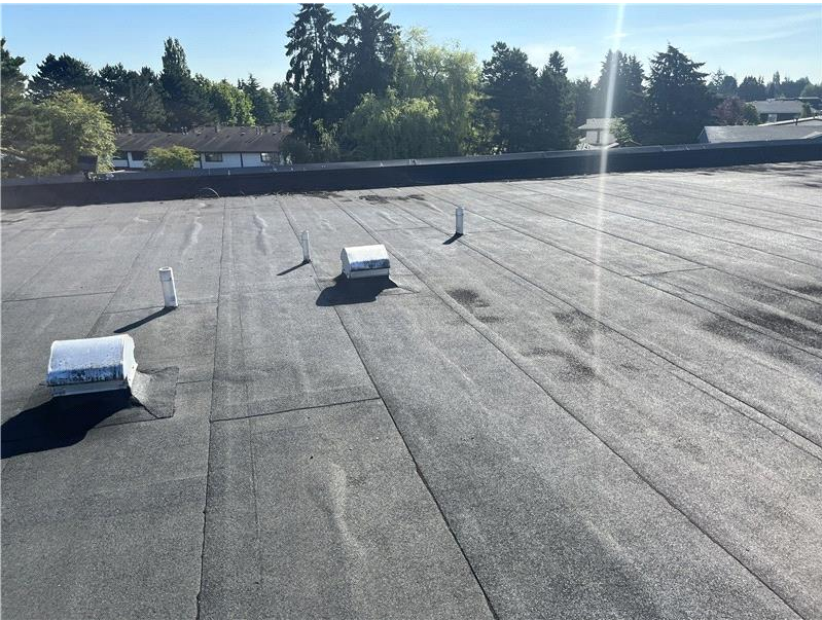
**Condition:** Blister  
**Severity:** High  
**Quantity:** 4

Several blisters were noted on this roof level. Blisters are an indication that either air or moisture are trapped within the roofing system.

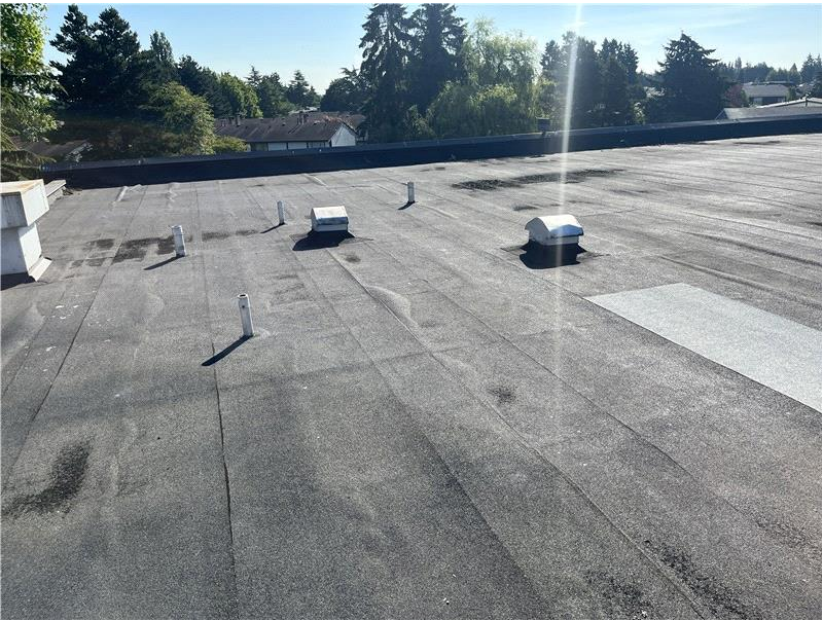
**Condition:** Blister 1  
**Severity:** High  
**Quantity:** 2

More blisters located in the field of the roof.

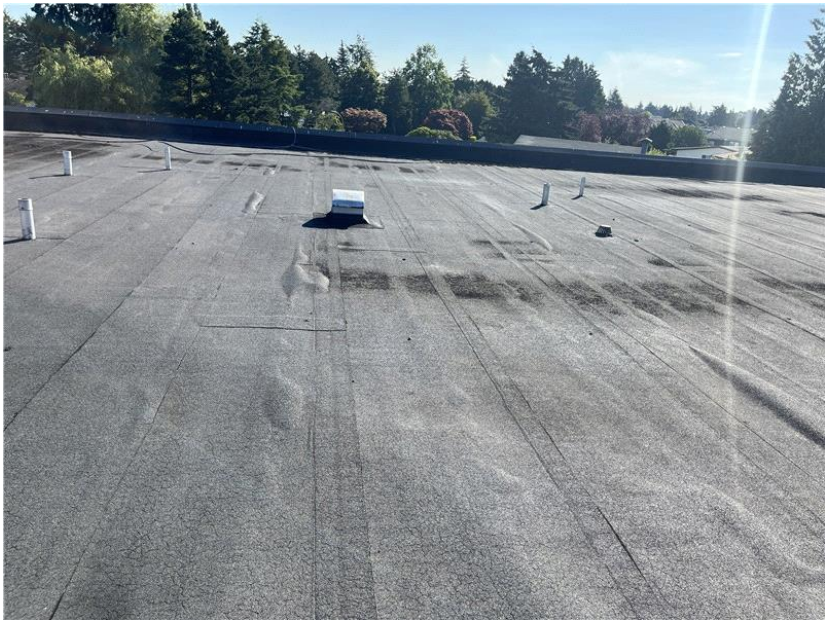
**Condition:** Blister 2  
**Severity:** High  
**Quantity:** 1

Another view of the blisters.

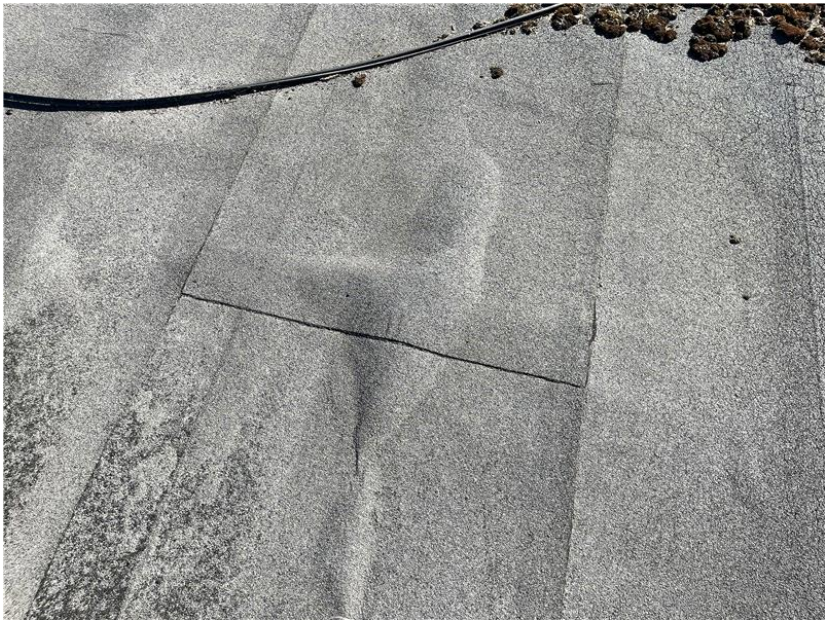
**Condition:** Blister 3  
**Severity:** High  
**Quantity:** 1

Another typical blister located in the field of the roof.

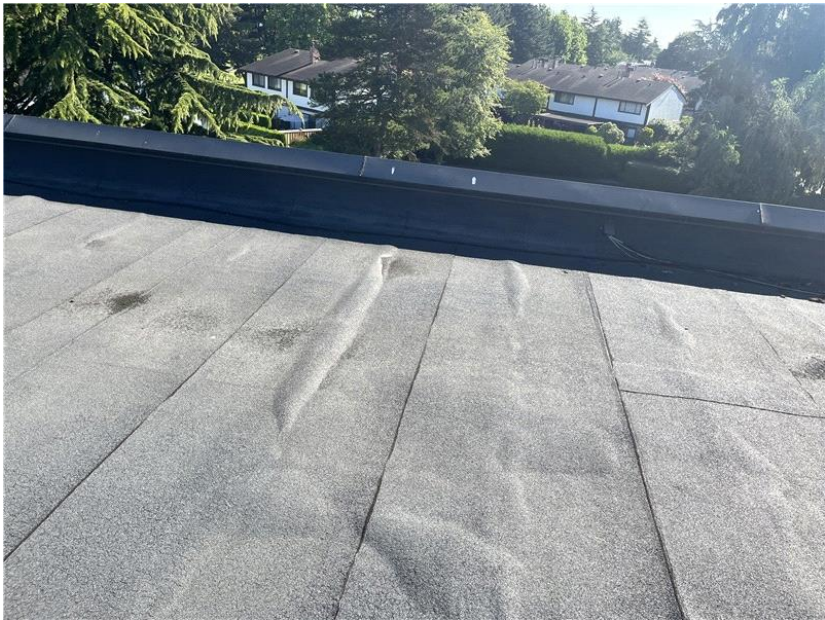
**Condition:** Blister 4  
**Severity:** High  
**Quantity:** 1

More blisters located in the field of the roof.

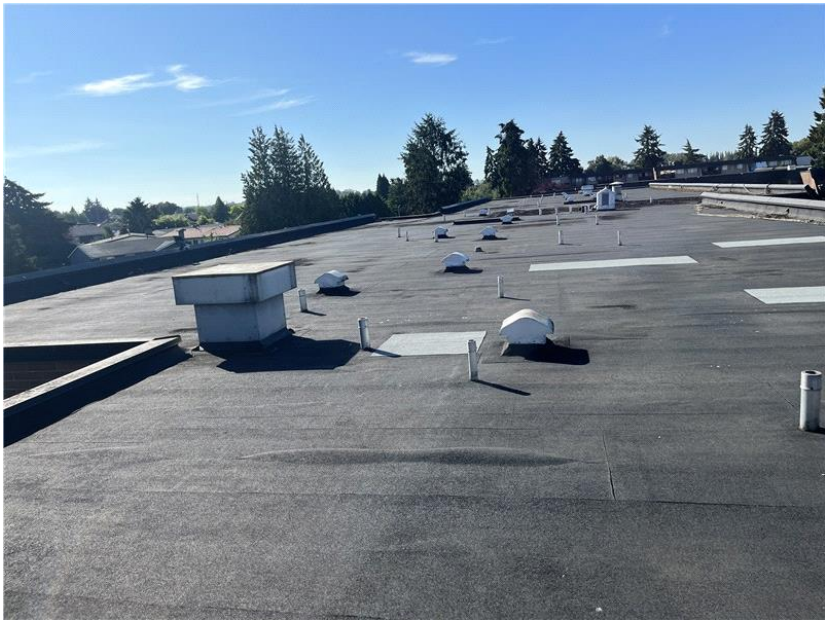
**Condition:** Blister 5  
**Severity:** High  
**Quantity:** 1

Another large blister located in the field of the roof.

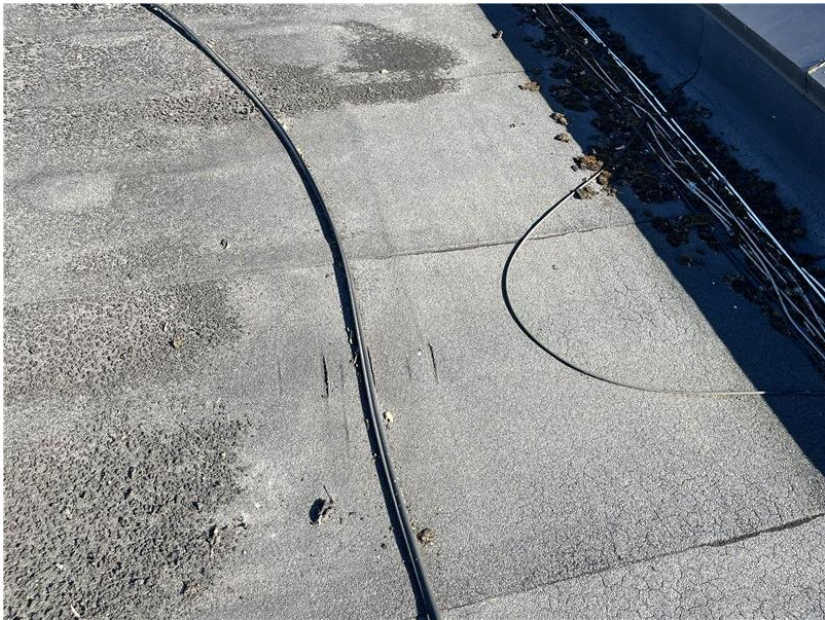
**Condition:** Deteriorated membrane  
**Severity:** High  
**Quantity:** 1

The modified bituminous cap sheet is cracking throughout the field of the roof. This condition was also noted in previous report.

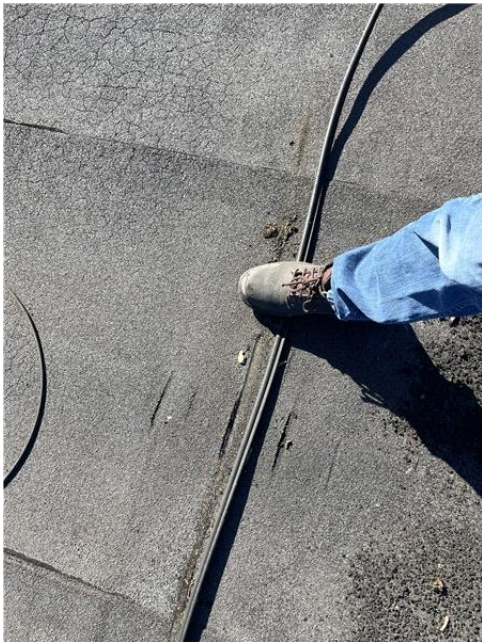
**Condition:** Deteriorated membrane 1  
**Severity:** High  
**Quantity:** 1

Another area with damaged cap sheet due to the cables lying directly on the membrane.

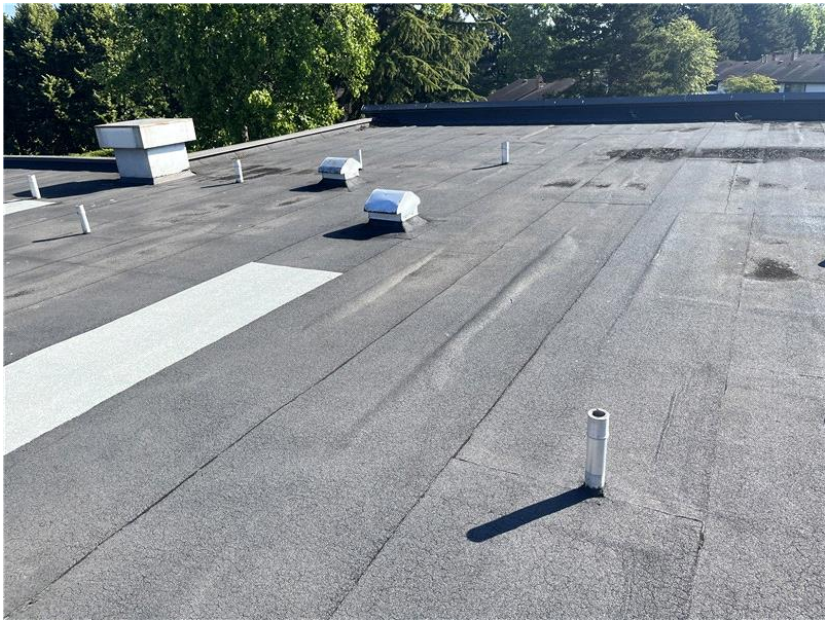
**Condition:** Ridges  
**Severity:** High  
**Quantity:** 1

There are numerous ridges and areas with wrinkled membrane throughout this roof level.

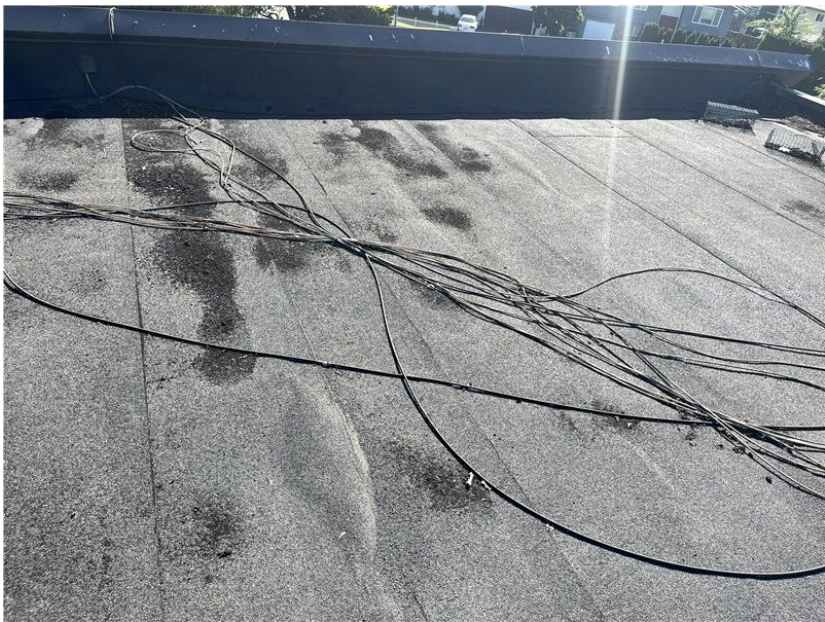
**Condition:** Missing insulation support  
**Severity:** Medium  
**Quantity:** 1

There are several wires running over the roof. Over time, the movement of the wires across the cap sheet membranes can cause damage to the underlying roof.

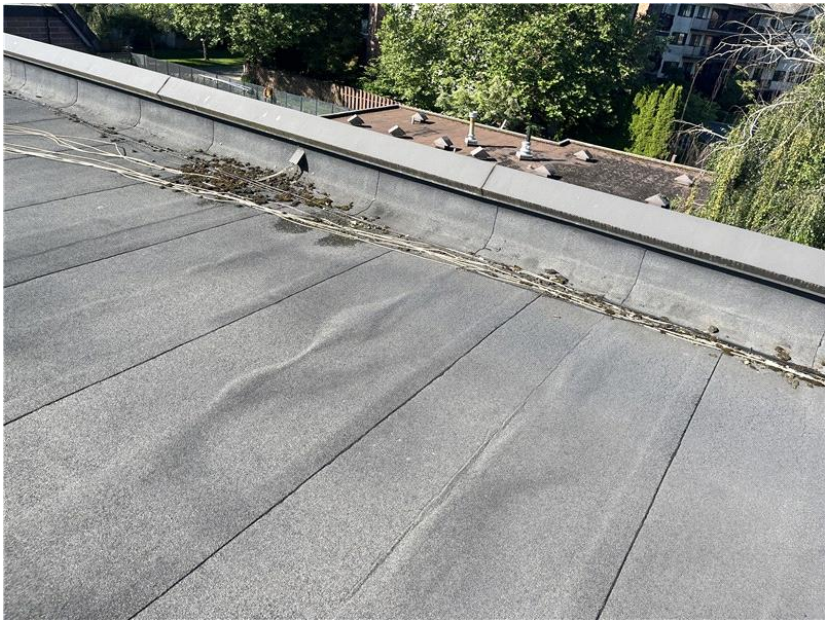
**Condition:** Missing insulation support 2  
**Severity:** Medium  
**Quantity:** 1

Another view of the cables directly on the membrane. More blisters and organic debris also noted.

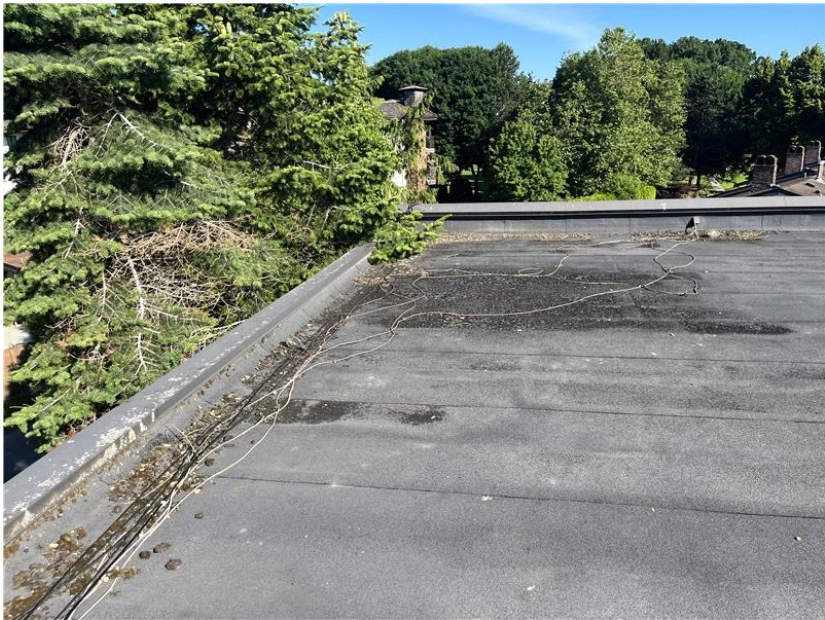
**Condition:** Overhanging Trees  
**Severity:** Medium  
**Quantity:** 1

Overhanging trees were noted along the perimeter of this roof level.

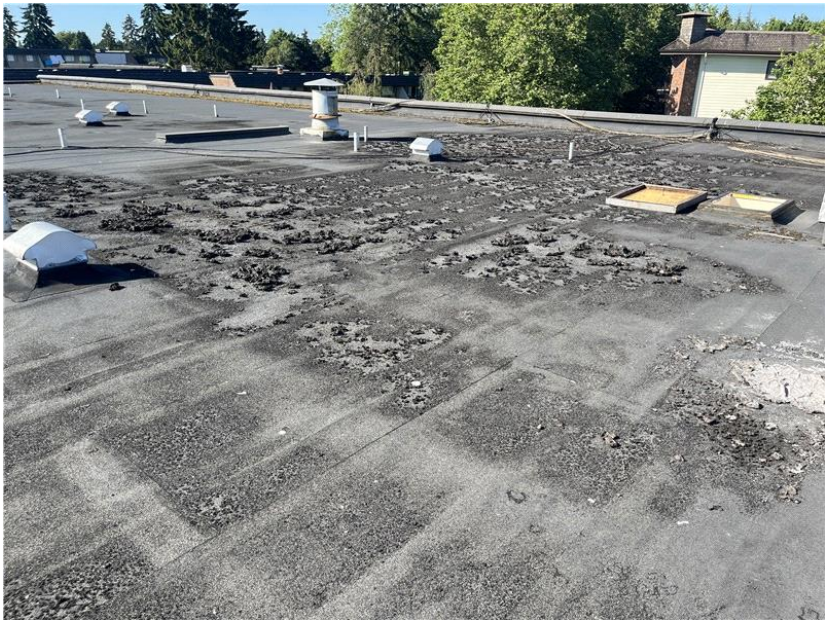
**Condition:** Ponding  
**Severity:** Medium  
**Quantity:** 1

Large areas with evidence of ponding water and organic debris were observed on this roof level.

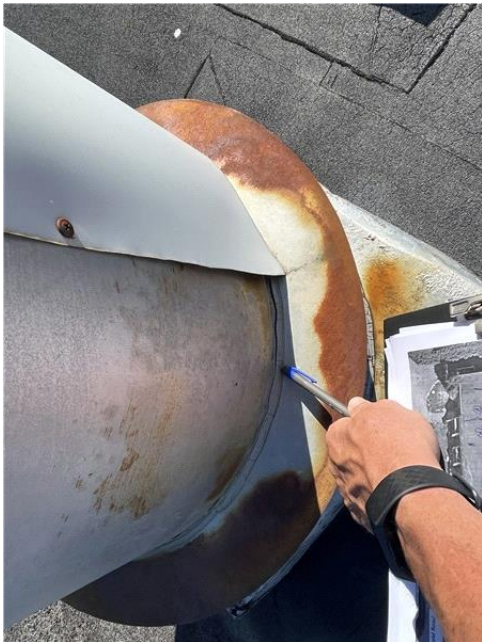
**Condition:** Sealant failure at stack  
**Severity:** Medium  
**Quantity:** 1

The sealant around the rain collar of this furnace stack is open and deteriorated. This condition may be allowing water to enter the roofing assembly and/or building.

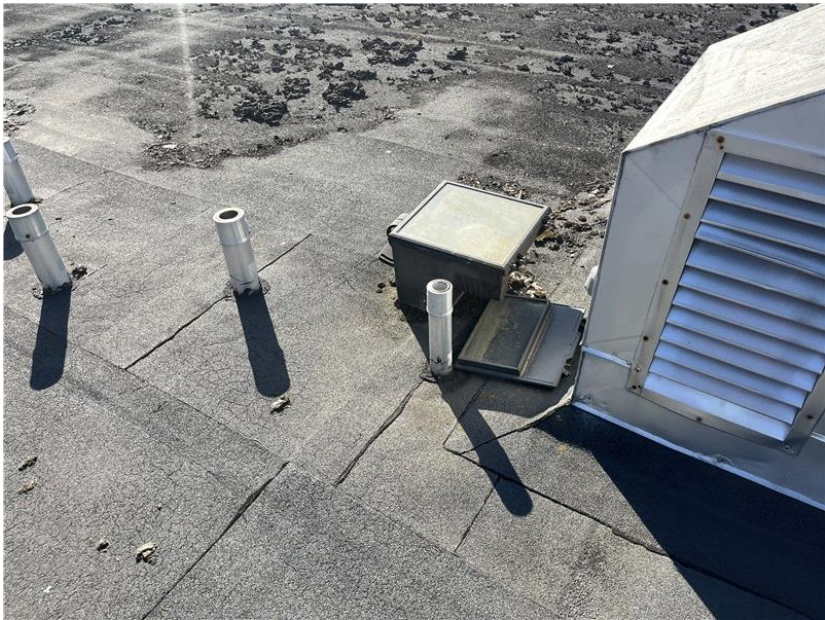
**Condition:** Debris on roof  
**Severity:** Low  
**Quantity:** 1

Areas of scattered rooftop debris were noted lying directly on the surface of the roof. All non-essential items should be immediately removed.

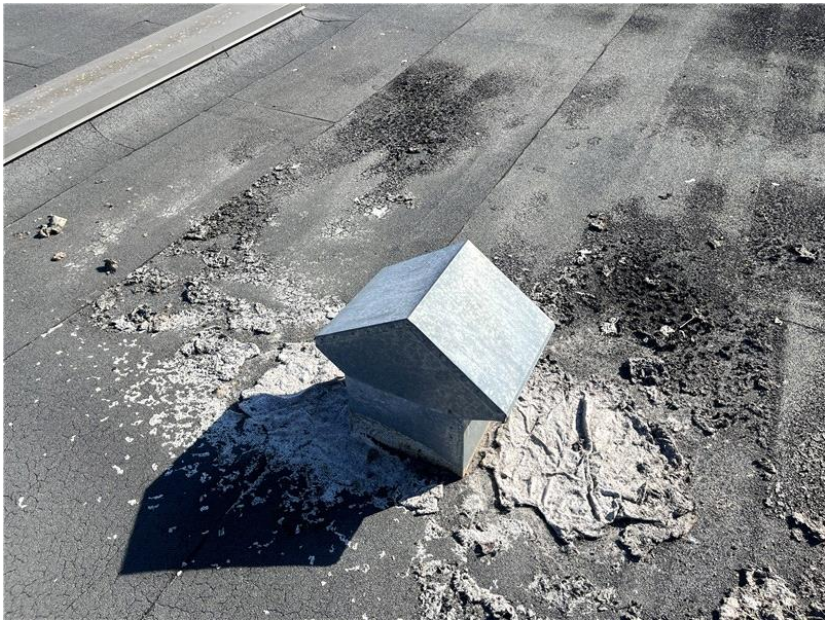
**Condition:** Debris on roof 1  
**Severity:** Low  
**Quantity:** 1

More debris and lint to be cleared off the roof and the dryer vent.

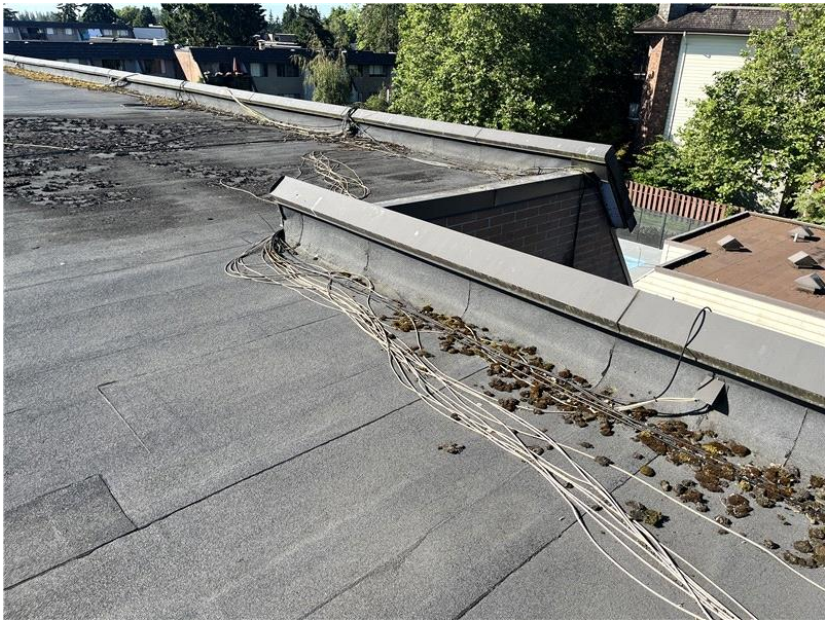
**Condition:** Organic debris  
**Severity:** Low  
**Quantity:** 1

An accumulation of organic debris was noted on this roof level.

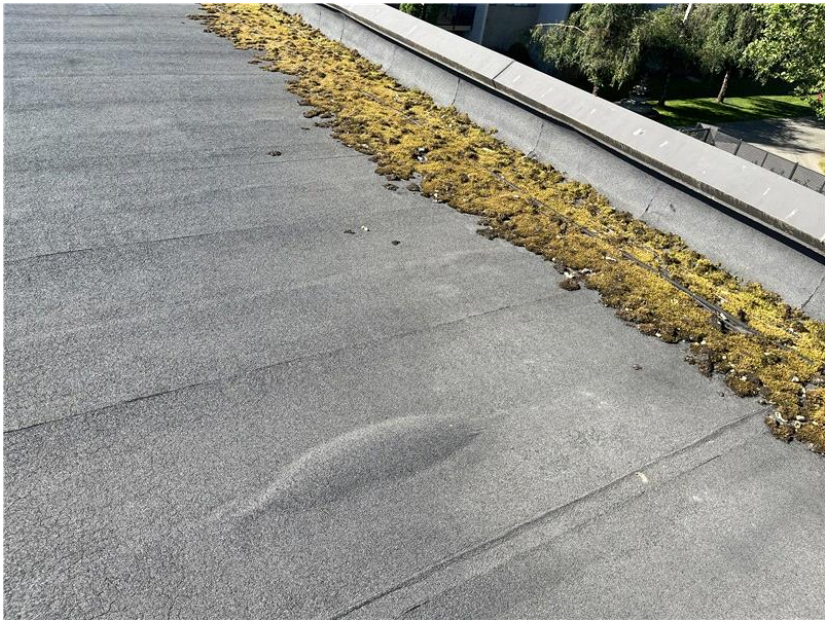
**Condition:** Organic debris 1  
**Severity:** Low  
**Quantity:** 1

More organic debris and vegetation to be cleared off the roof surface.

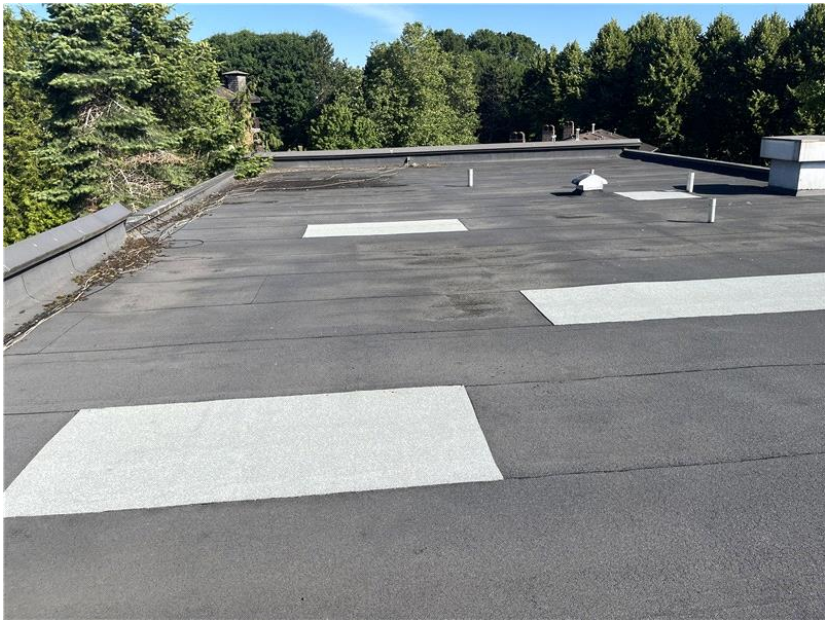
**Condition:** Repairs  
**Severity:** Low  
**Quantity:** 1

View of the repairs completed previously.

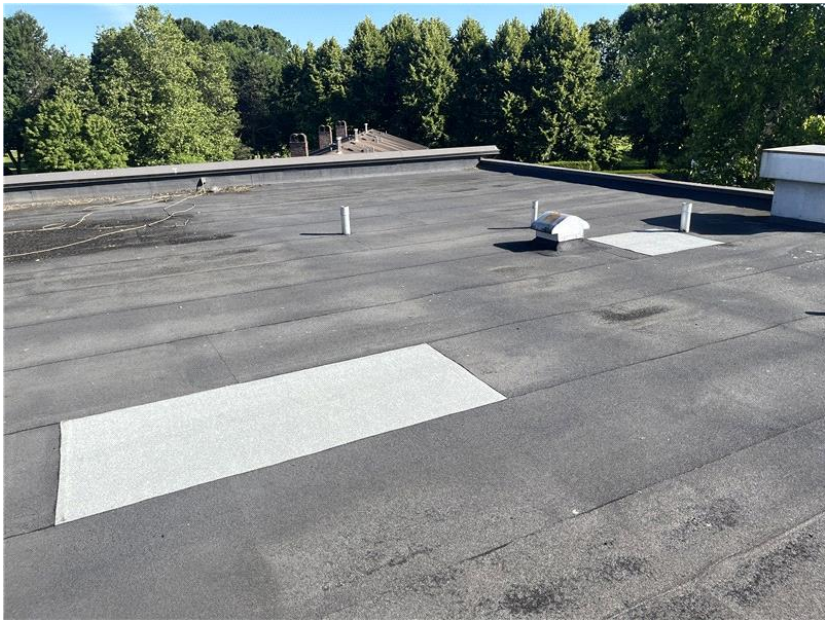
**Condition:** Repairs 1  
**Severity:** Low  
**Quantity:** 1

More modified bitumen membrane repairs completed previously.
