## Roof Condition Report - Hartnell House - 1204 Yates Street, Victoria, BC

**Inspection Date:**

11/9/2022

221234

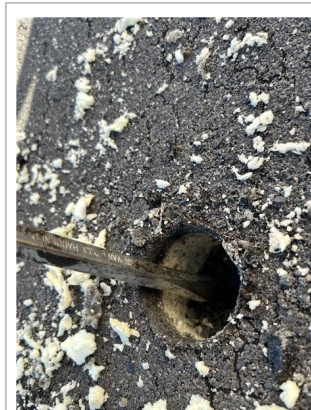
Core Sample

The core cut was taken to verify the roof condition and composition in this particular location on the roof. The roofing assembly is:

- 2 Ply Modified Bitumen Roofing Membrane
- 0.5" Fibreboard
- 2.5" Polyisocyanurate Insulation
- Wood Deck

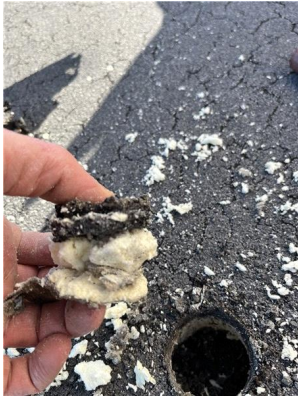
Core Sample 1

Another view of the roofing assembly:

- 2 Ply Modified Bitumen Roofing Membrane
- 0.5" Fibreboard
- 2.5" Polyisocyanurate Insulation
- Wood Deck

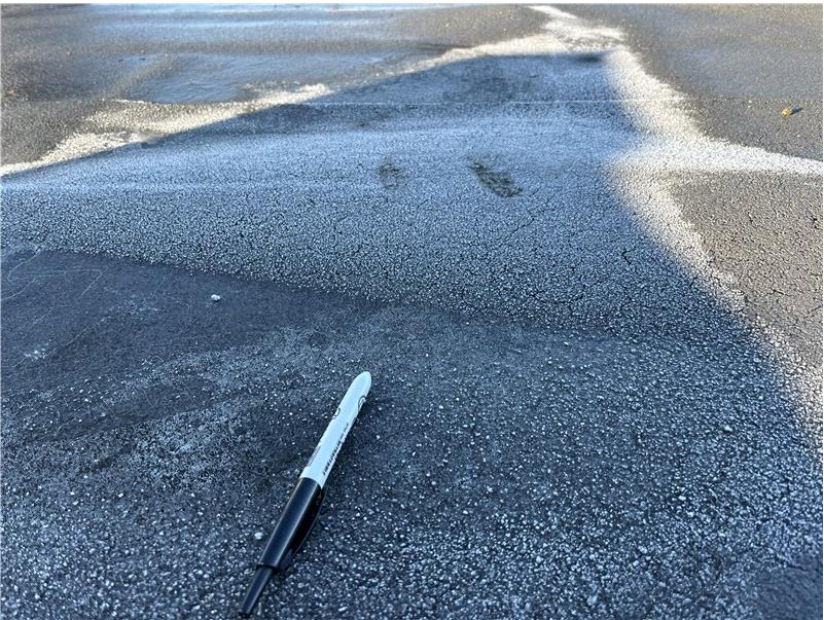
Condition: Blister  
Severity: High  
Quantity: 1

Blisters are an indication that either air or moisture are trapped within the roofing system. Blisters will continue to grow and can easily be broken by foot traffic on the roof. +/-20 blisters were noted on the roof.

Due to the age and condition of the installed roofing assembly, roof replacement should be scheduled in the next 1-2 years.

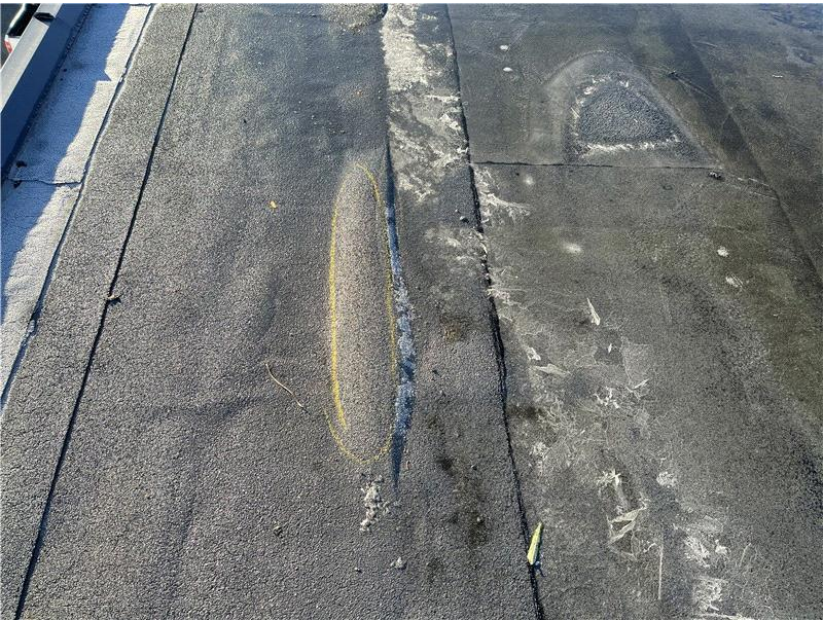
Condition: Blister 1  
Severity: High  
Quantity: 1

Another typical blister.

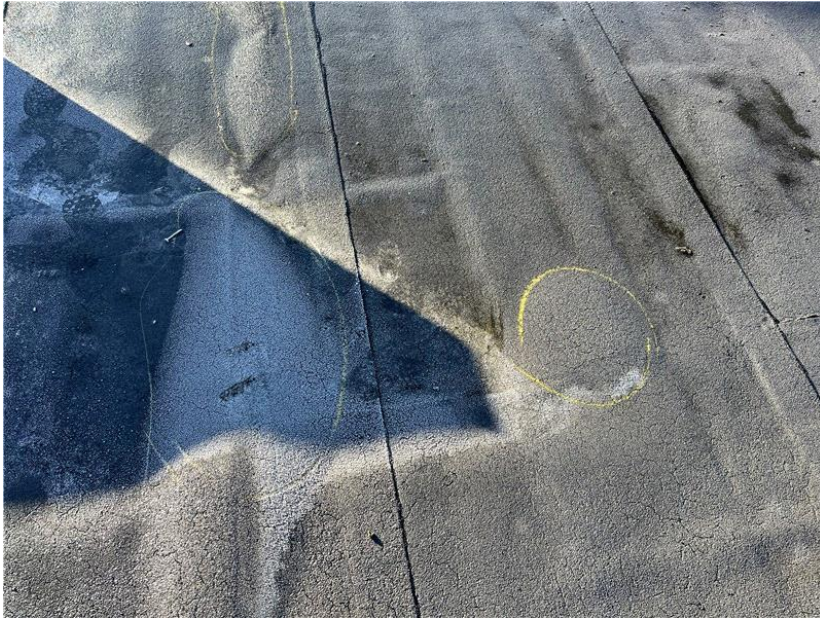
♦  
**Condition:** Blister 2

**Severity:** High

More blisters in the modified bitumen membrane.

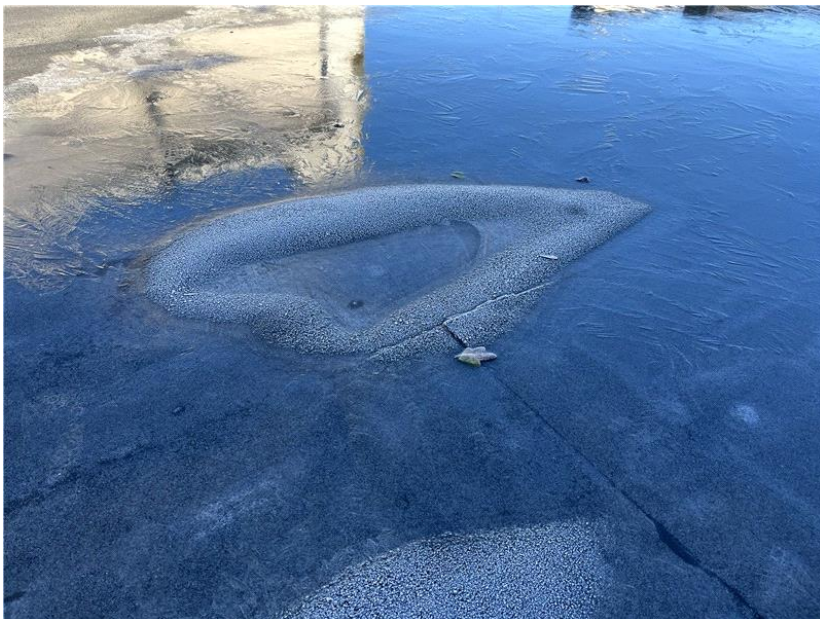
♦  
**Condition:** Blister 3

**Severity:** High

Another large blister and water ponding.

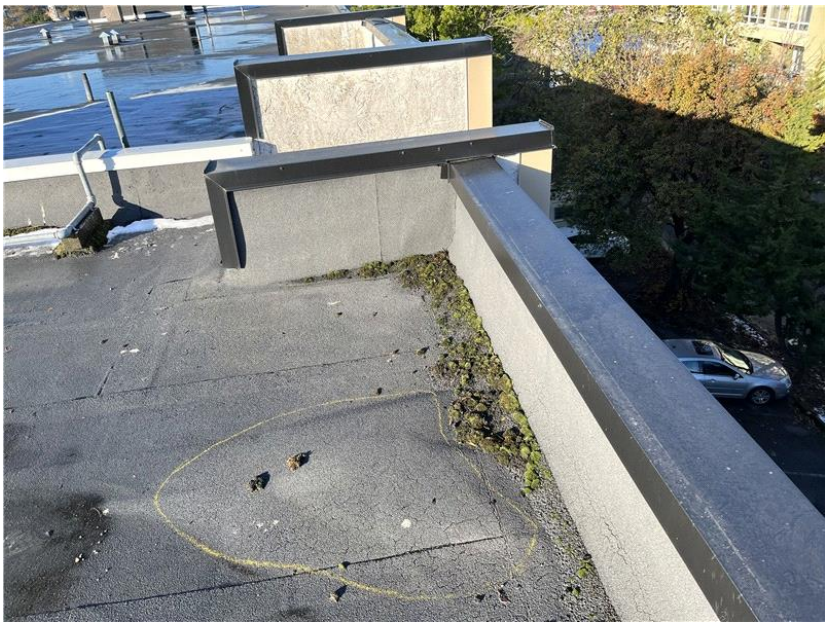
Condition: Blister 4  
Severity: High  
Quantity: 1

Another large blister near the perimeter.

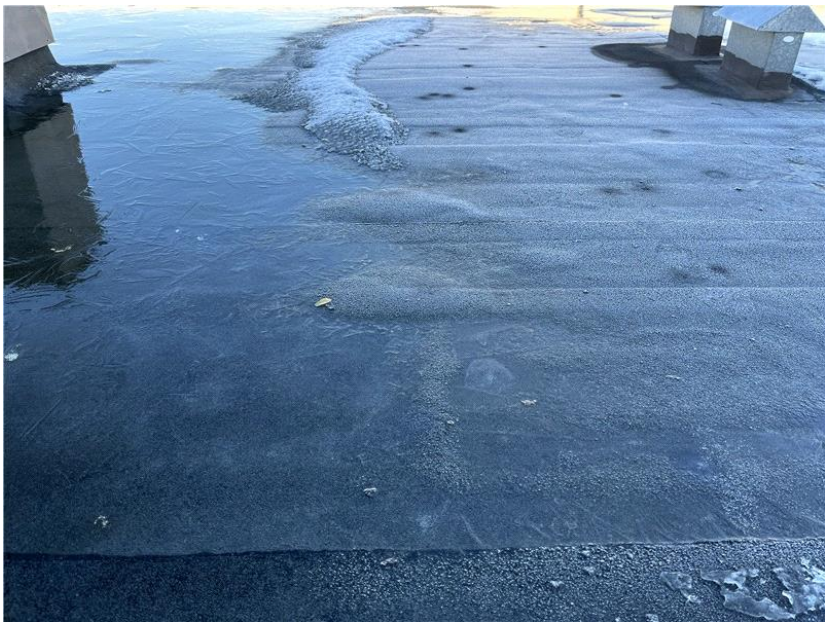
Condition: Blister 5  
Severity: High  
Quantity: 1

More blistered roofing membrane.

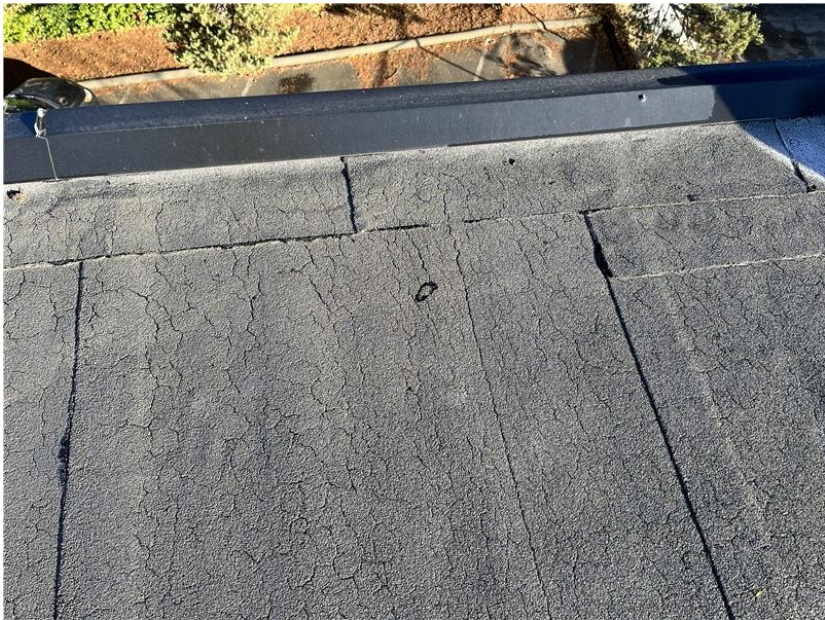
**Condition:** Deteriorated membrane  
**Severity:** High  
**Quantity:** 1

Several areas with damaged/cracked membrane were noted throughout this roof level.

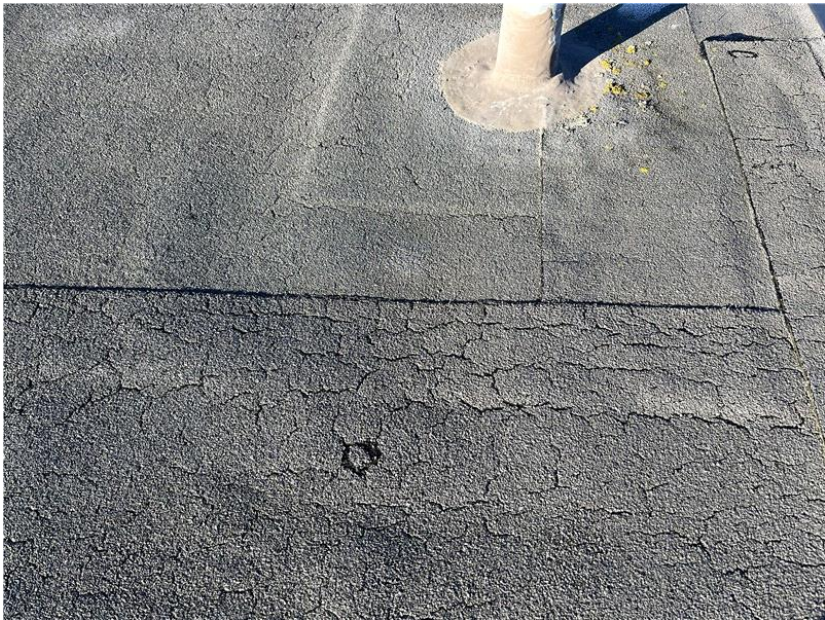
**Condition:** Deteriorated membrane 1  
**Severity:** High  
**Quantity:** 1

Another area around the soil stack with damaged and cracked membrane.

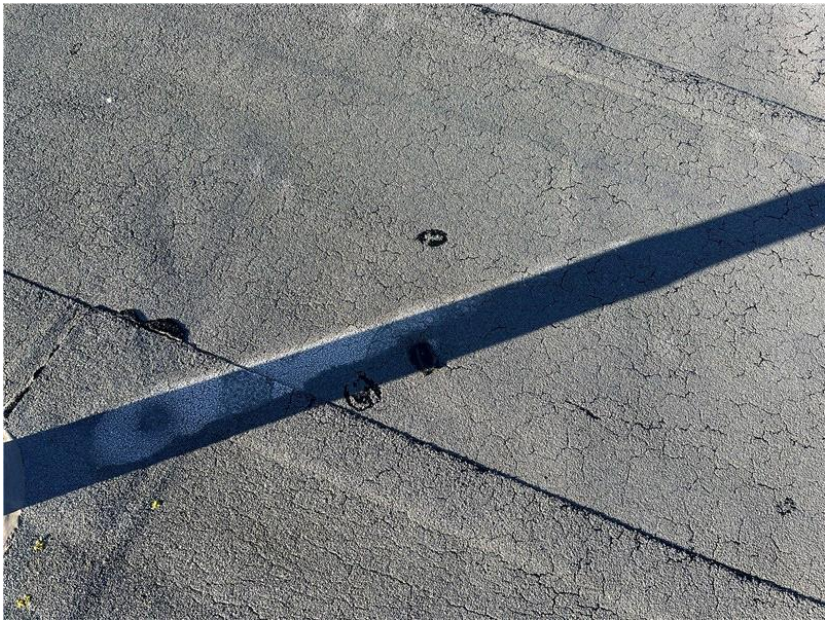
More damaged membrane.

→  
**Condition:** Deteriorated membrane 2  
**Severity:** High  
**Quantity:** 1

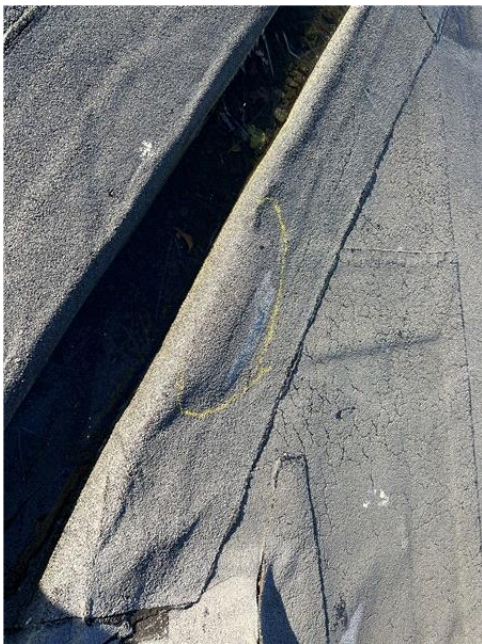
More damaged, wrinkled and blistered membrane.

↑  
**Condition:** Deteriorated membrane 3  
**Severity:** High  
**Quantity:** 1

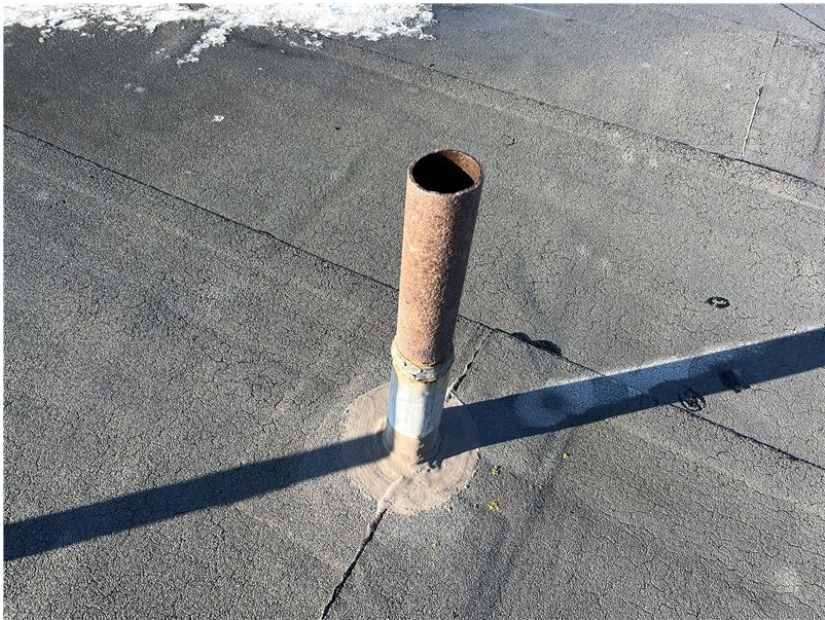
**Condition:** Corrosion  
**Severity:** Medium  
**Quantity:** 1

Several corroded soil stacks were noted on this roof level.

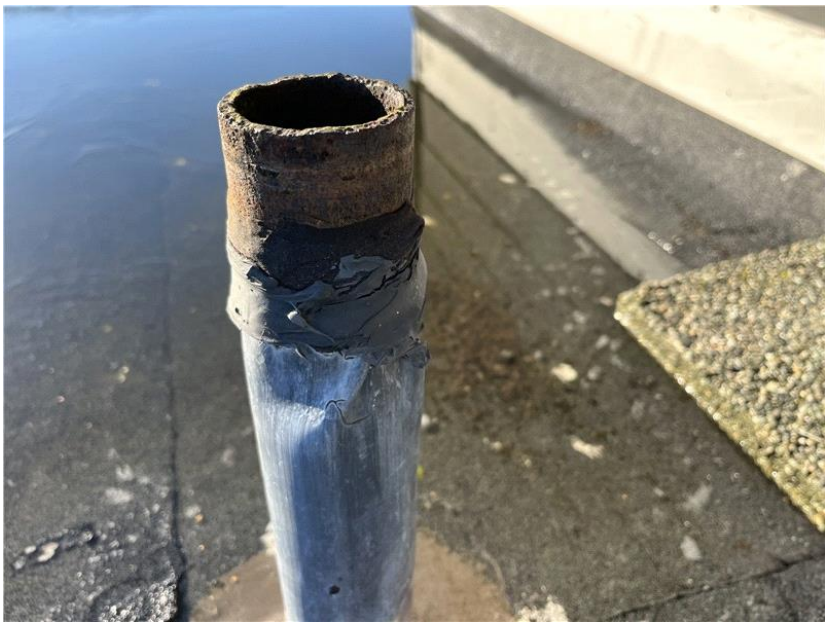
**Condition:** Corrosion 1  
**Severity:** Medium  
**Quantity:** 1

View of another corroded/damaged soil stack.

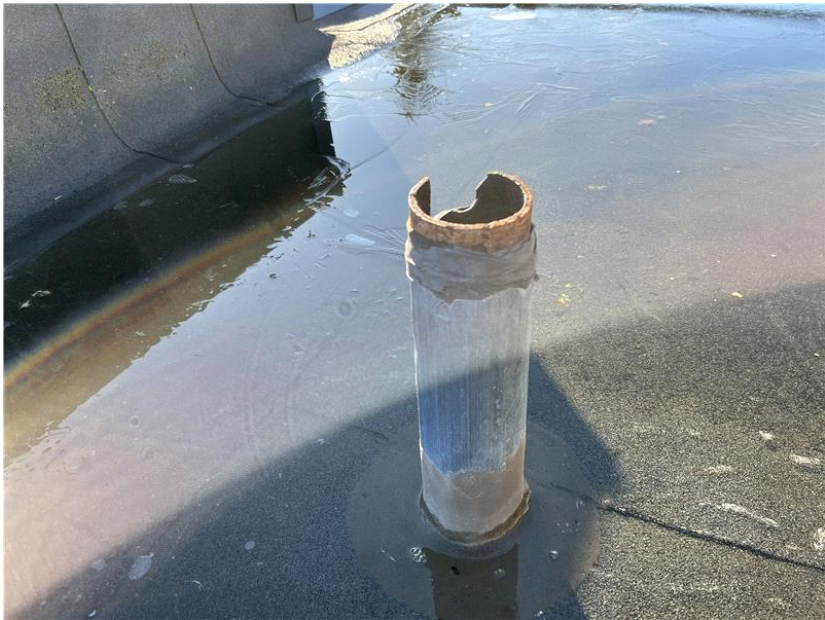
**Condition:** Corrosion 2  
**Severity:** Medium  
**Quantity:** 1

Another corroded/damaged soil stack.

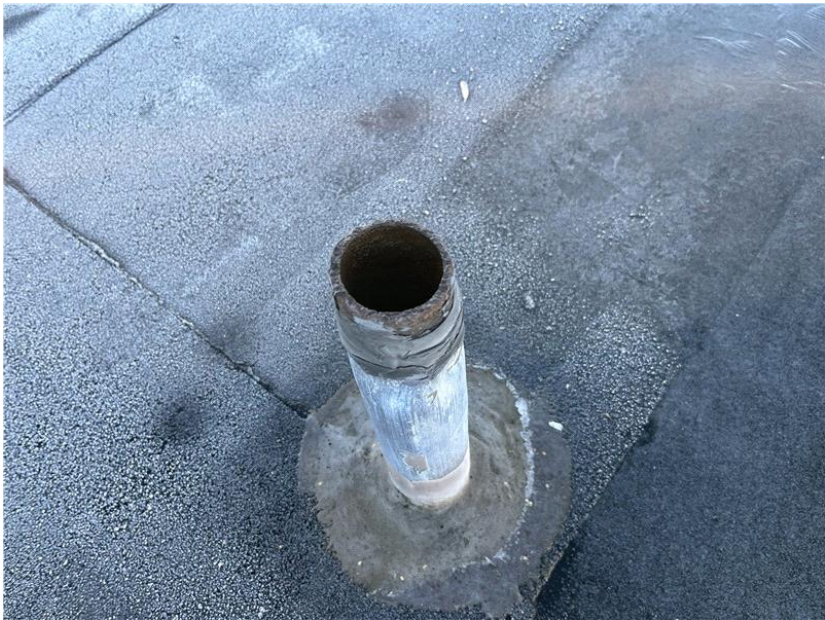
**Condition:** Missing stack cap  
**Severity:** Medium  
**Quantity:** 1

There is a missing stack cap around this soil stack. This condition may be allowing water to enter the roofing assembly and/or building.

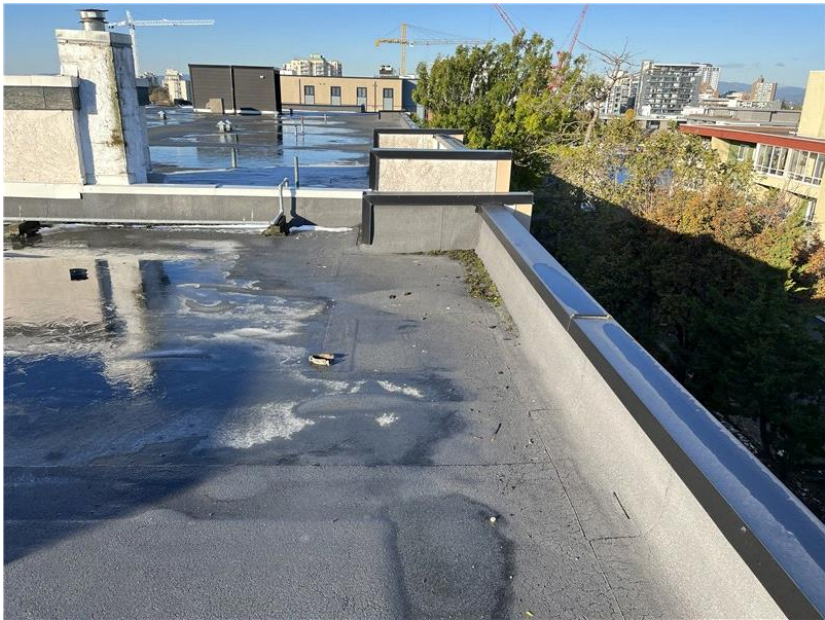
**Condition:** Organic debris  
**Severity:** Low  
**Quantity:** 1

An accumulation of organic debris was noted on this roof level.

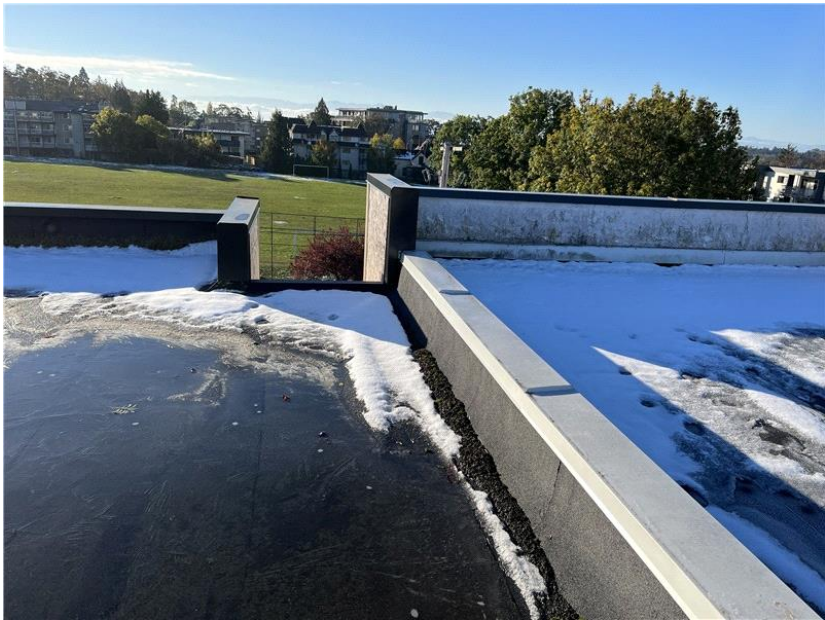
**Condition:** Organic debris 1  
**Severity:** Low  
**Quantity:** 1

More organic debris at the perimeter.

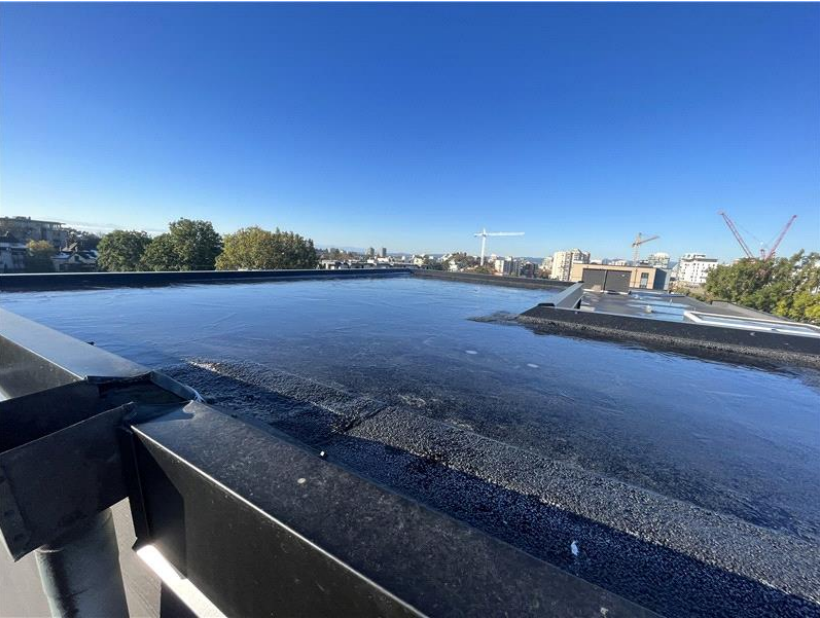
**Condition:** Deteriorated membrane  
**Severity:** High  
**Quantity:** 1

The roofing membrane is deteriorated with several under water blisters also noted.

Due to the age and condition of the installed roofing assembly, roof replacement should be scheduled in the next 1-2 years or at the same time as the main roof level to ensure preferred pricing.

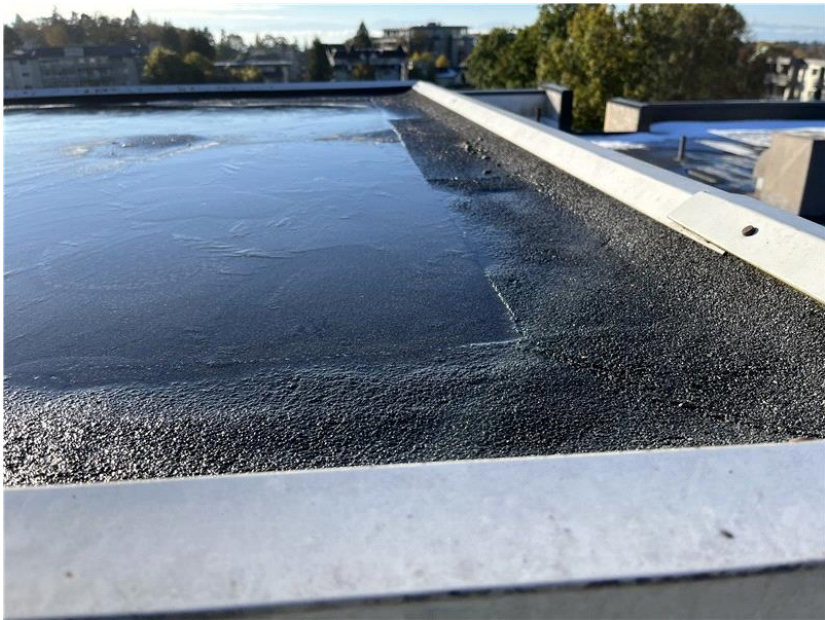
Condition: Blister  
Severity: High  
Quantity: 1

View of ponding and under water blisters that were observed on this roof level .

Due to the age and condition of the installed roofing assembly, roof replacement should be scheduled in the next 1-2 years or at the same time as the main roof level to ensure preferred pricing.

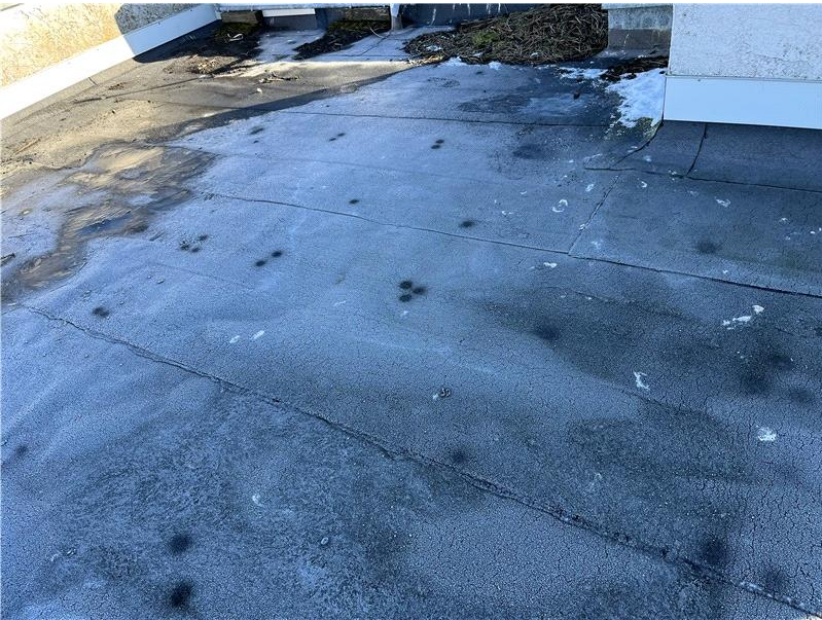
Condition: Blister  
Severity: High  
Quantity: 1

Blisters are an indication that either air or moisture are trapped within the roofing system. Blisters will continue to grow and can easily be broken by foot traffic on the roof. +/-50 blisters were noted on the roof.

Due to the age and condition of the installed roofing assembly, roof replacement should be scheduled in the next 1-2 years.

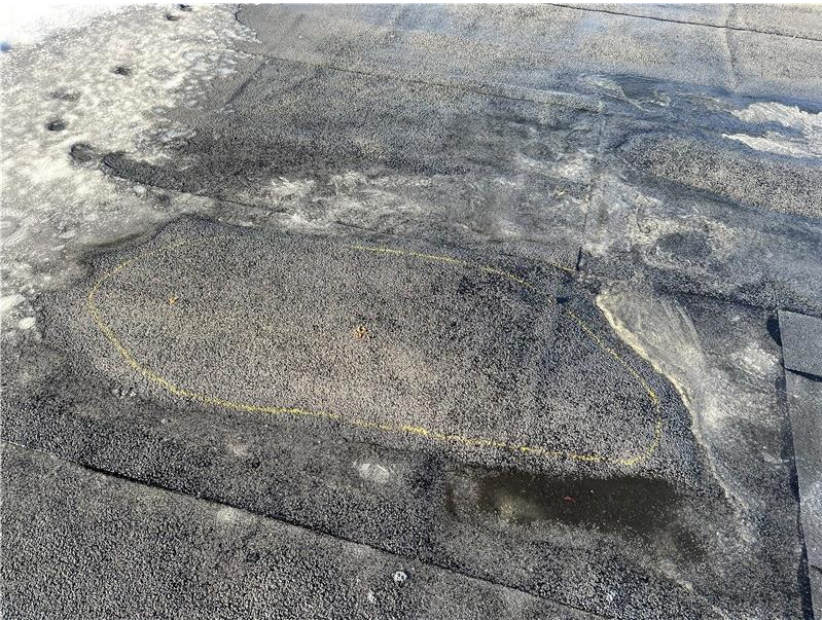
Condition: Blister 1  
Severity: High  
Quantity: 1

Another typical blister.

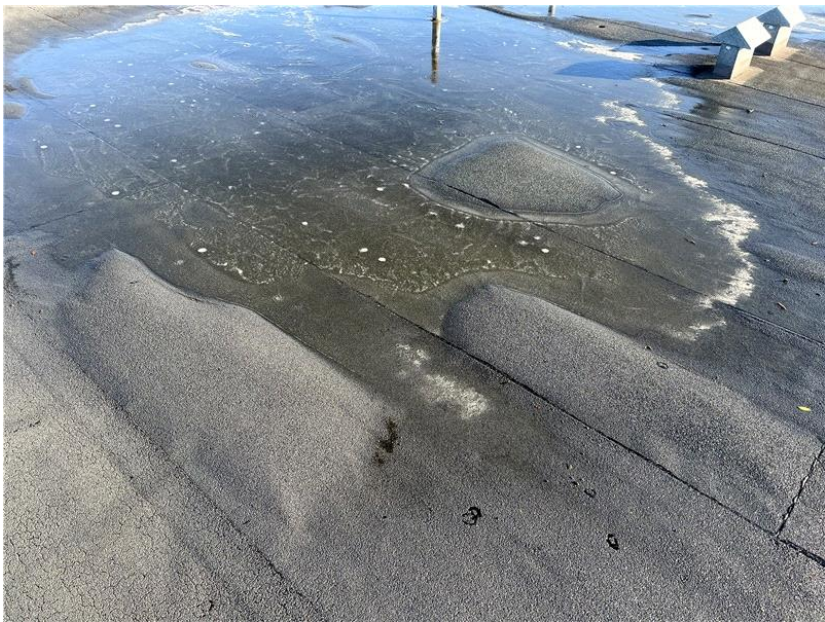
**Condition:** Blister 2  
**Severity:** High  
**Quantity:** 1

More blisters in the modified bitumen membrane.

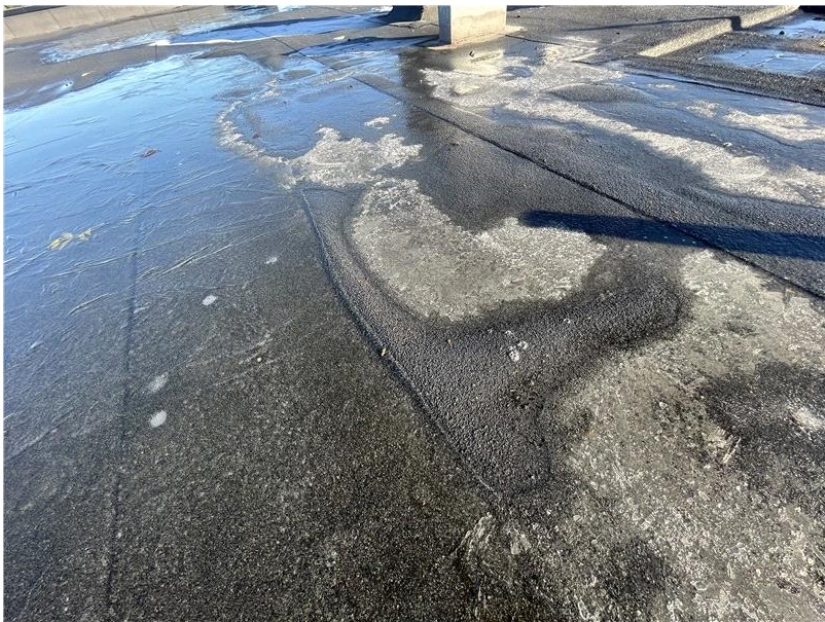
**Condition:** Blister 3  
**Severity:** High  
**Quantity:** 1

Another large blister and water ponding.

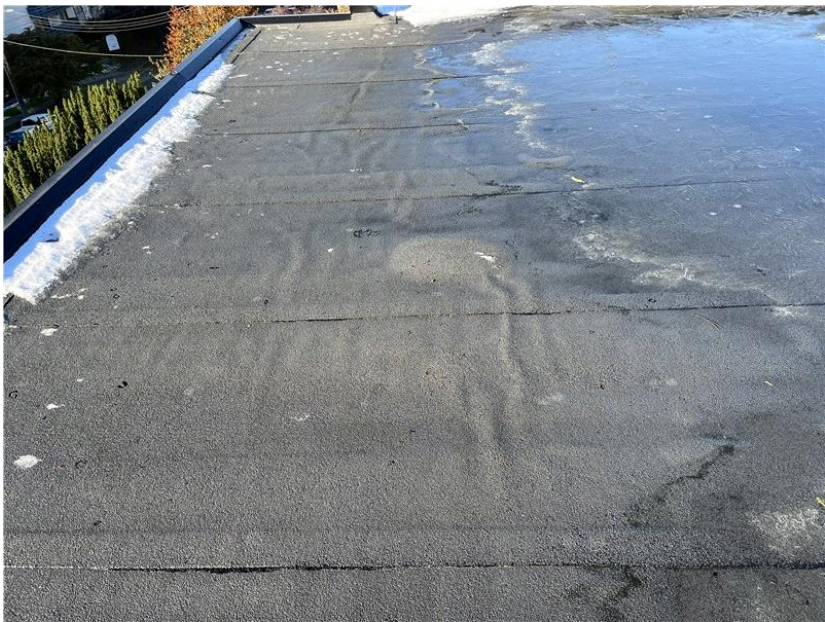
**Condition:** Blister 4  
**Severity:** High  
**Quantity:** 1

More blisters near the perimeter.

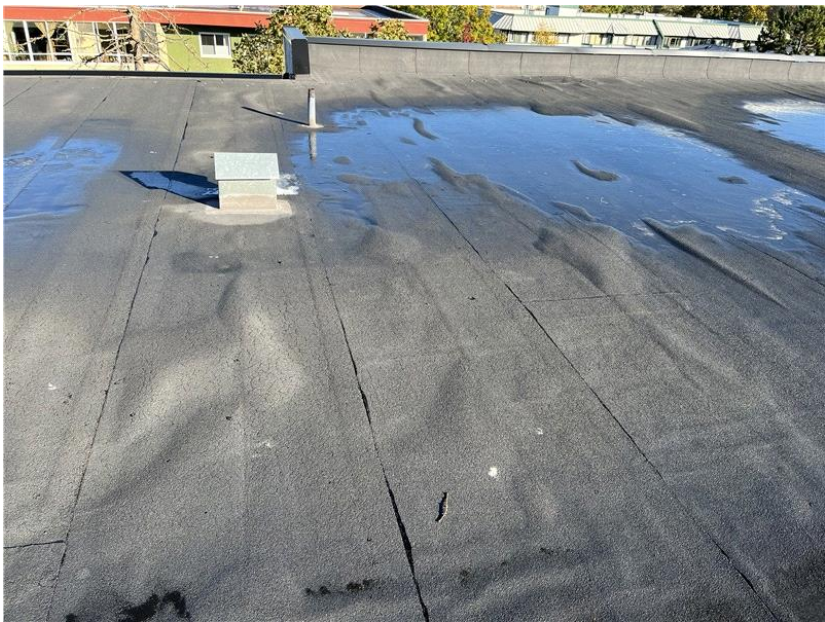
**Condition:** Blister 5  
**Severity:** High  
**Quantity:** 1

More blistered roofing membrane and areas with water ponding.

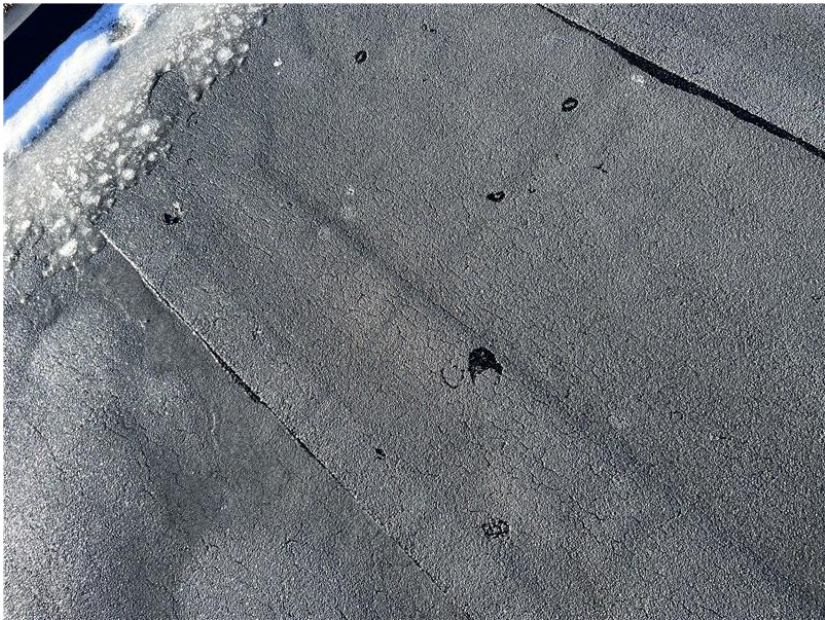
**Condition:** Deteriorated membrane  
**Severity:** High  
**Quantity:** 1

Several areas with damaged/cracked membrane were noted throughout this roof level.

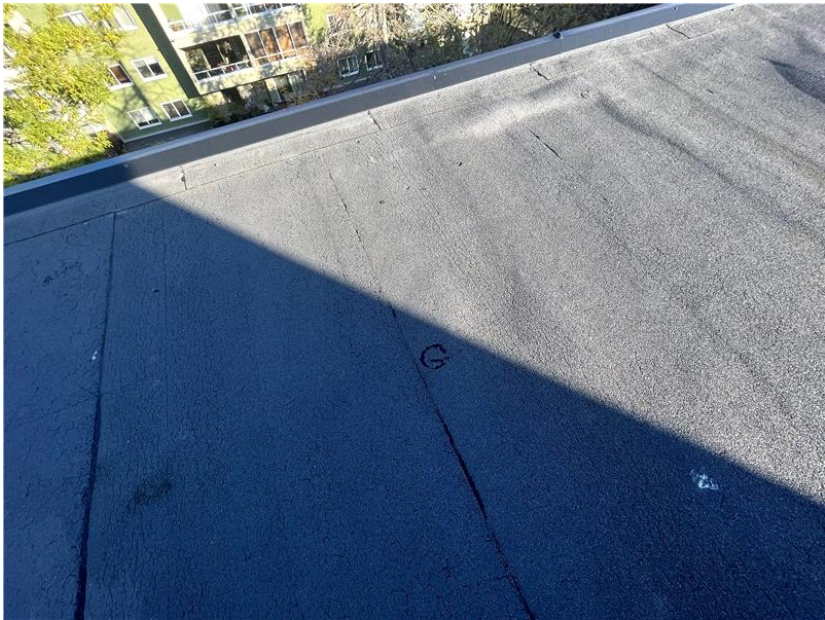
**Condition:** Deteriorated membrane 1  
**Severity:** High  
**Quantity:** 1

Another area near the perimeter with damaged membrane.

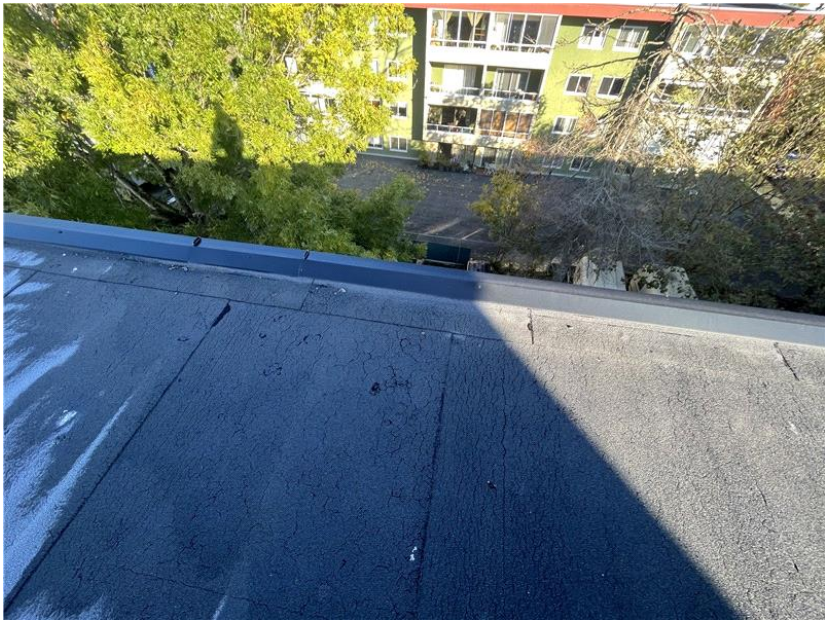
**Condition:** Deteriorated membrane 2  
**Severity:** High  
**Quantity:** 1

More damaged and cracked membrane.

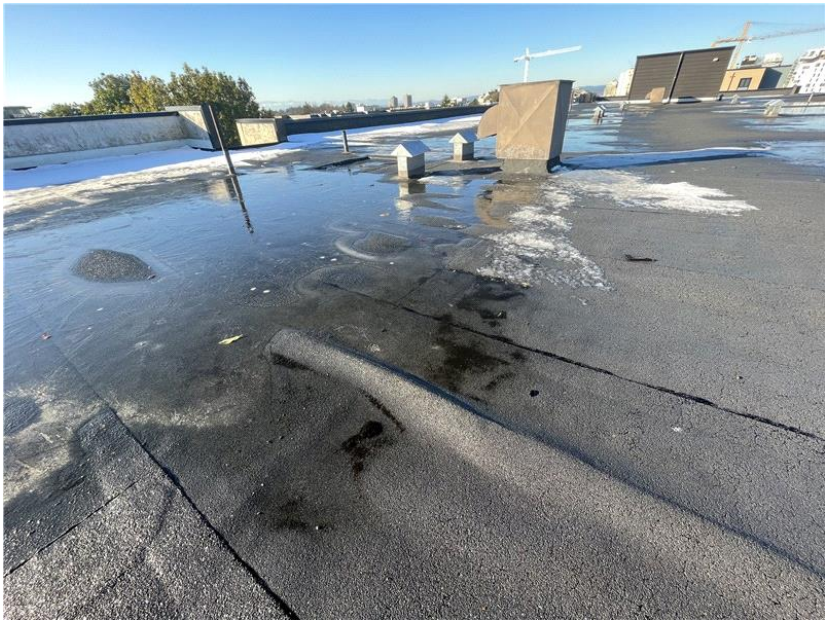
**Condition:** Ridges  
**Severity:** High  
**Quantity:** 1

Another overview of the ridged and blistered membrane.

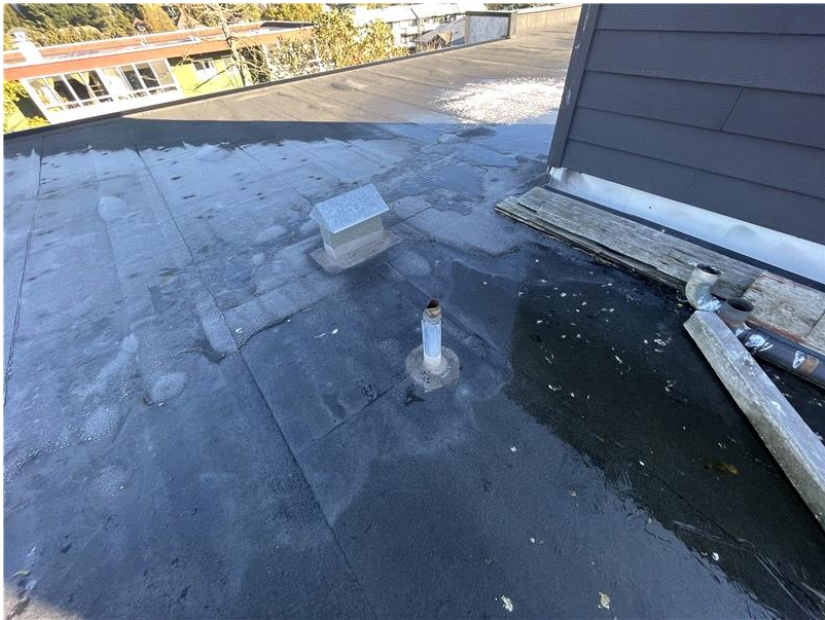
**Condition:** Corrosion  
**Severity:** Medium  
**Quantity:** 1

View of a corroded/damaged soil stack that was noted on this roof level.

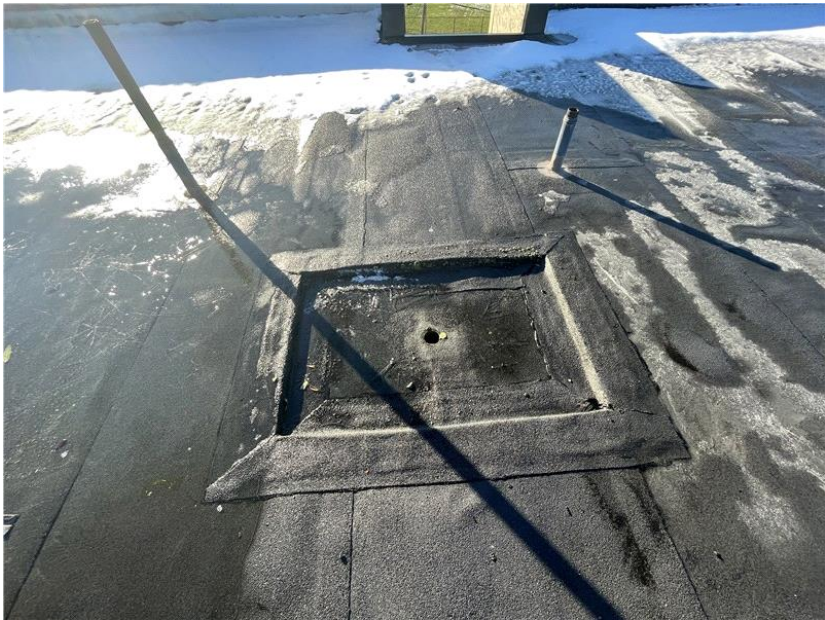
**Condition:** Drain- Strainer missing  
**Severity:** Medium  
**Quantity:** 1

The drain strainer is missing. Without the screen in place, roofing debris may be able to enter the drainage system and impede proper water flow.

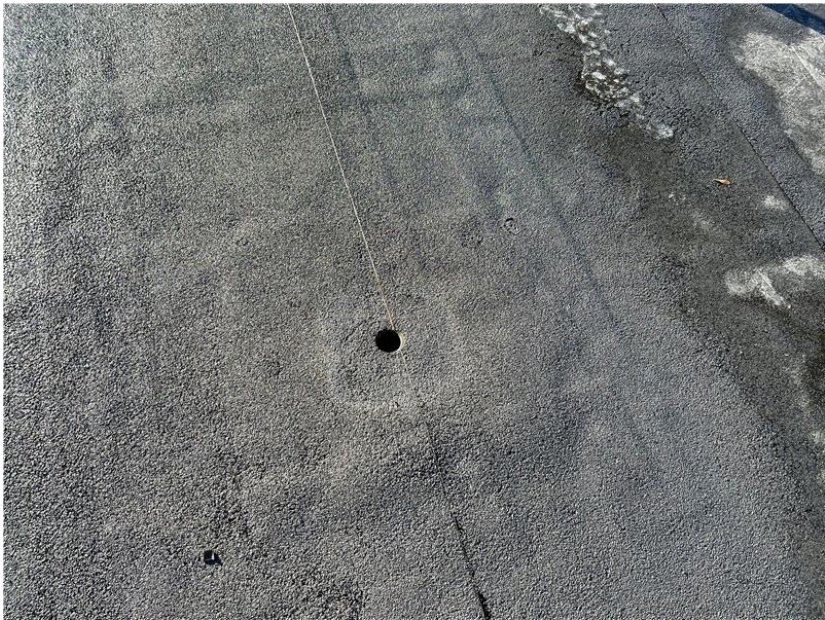
**Condition:** Drain- Strainer missing 1  
**Severity:** Medium  
**Quantity:** 1

Another drain with missing drain guard.

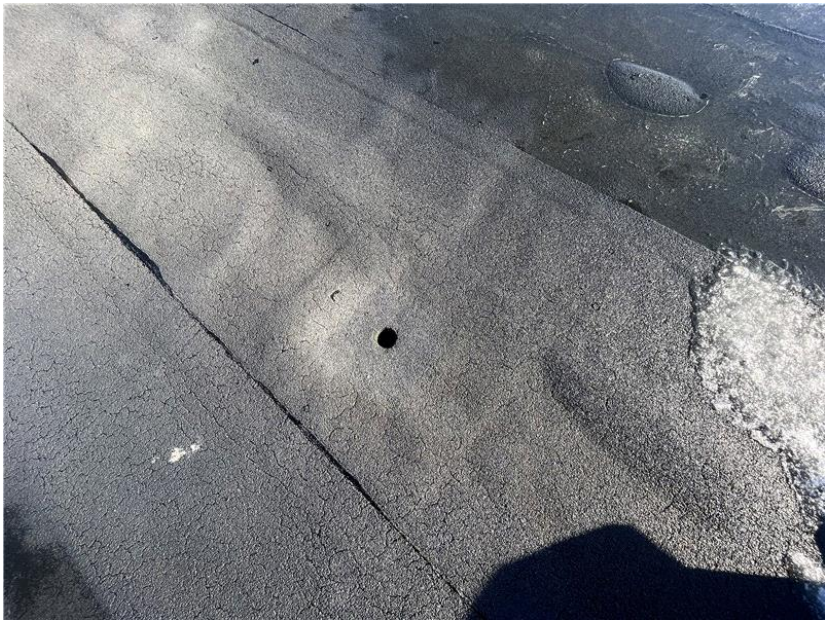
**Condition:** Drain- Strainer missing 2  
**Severity:** Medium  
**Quantity:** 1

Another drain with missing drain guard.

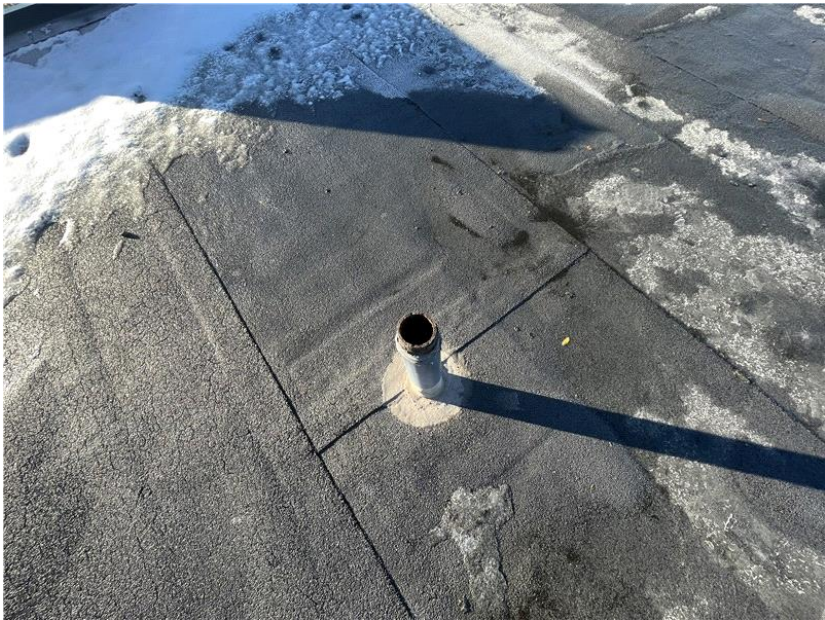
**Condition:** Missing stack cap  
**Severity:** Medium  
**Quantity:** 1

There is a missing stack cap around this soil stack. This condition may be allowing water to enter the roofing assembly and/or building.

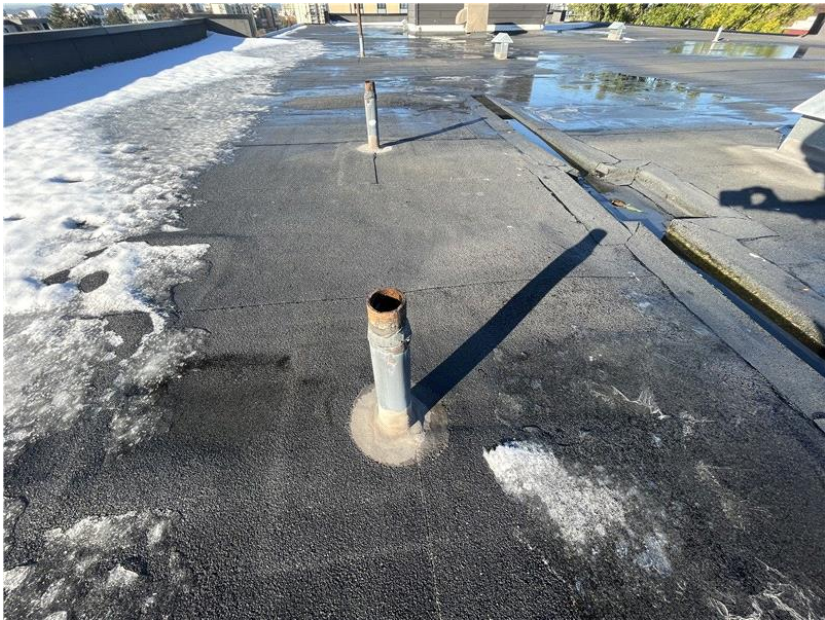
**Condition:** Missing stack cap 1  
**Severity:** Medium  
**Quantity:** 1

Another soil stack with missing cap.

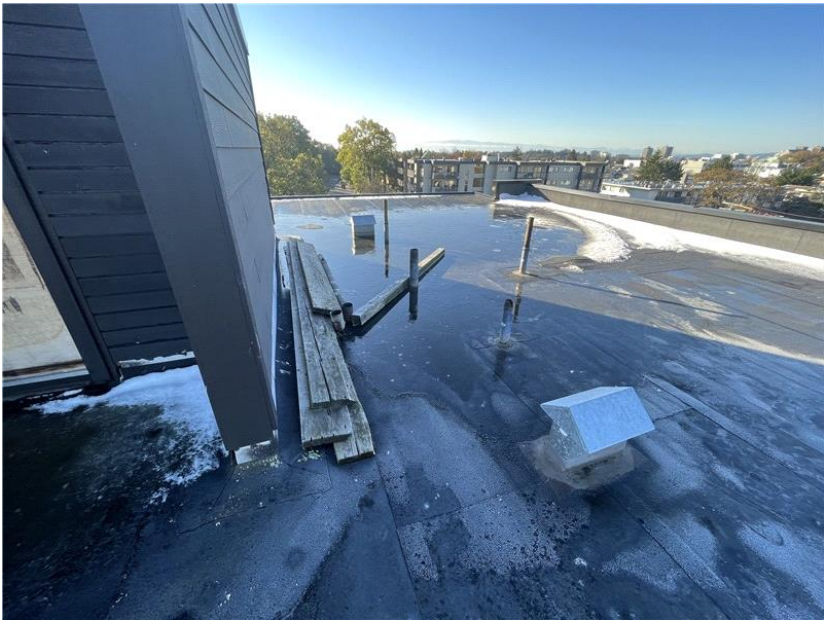
**Condition:** Debris on roof  
**Severity:** Low  
**Quantity:** 1

Areas of scattered rooftop debris were noted lying directly on the surface of the roof. All non-essential items should be immediately removed.

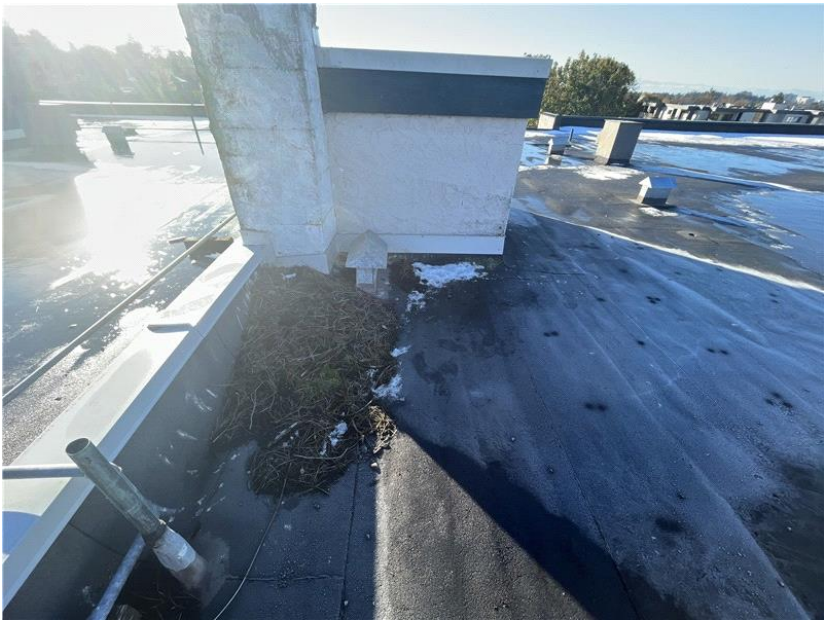
**Condition:** Organic debris  
**Severity:** Low  
**Quantity:** 1

An accumulation of organic debris was noted on this roof level.
