## BUILDING CONDITION ASSESSMENT

### WESTPORT

1021 4<sup>TH</sup> AVE.,  
NEW WESTMINSTER

*Project No. 22vA094-15*

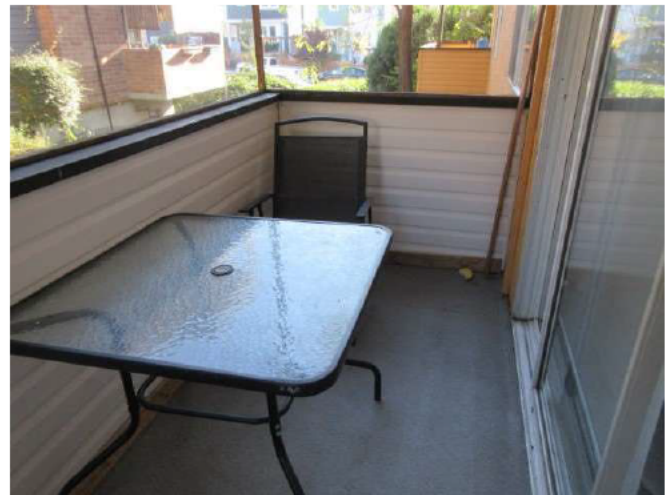
*Photo 2: Typical balcony.*

The remaining balconies and guards appeared to be in fair to good condition.

It is imperative that the balcony waterproofing at the wood-framed balconies remain watertight to prevent the wood structure below from deteriorating. The waterproofing should be replaced well before it loses its effectiveness. If structural damage to the wood framing has occurred, this can significantly increase the cost of repairs. There is no venting installed at the underside of the balconies, so any moisture in the concealed soffit space below the waterproofing will not dry out resulting in damages to the wood support framing and decking. Perforated soffit panels should be installed to replace the board materials which would provide the best means of ventilation. Pending a further evaluation and complete accounting of the condition of all balconies, we have budgeted for phased replacement of the waterproofing, partitions and soffits.

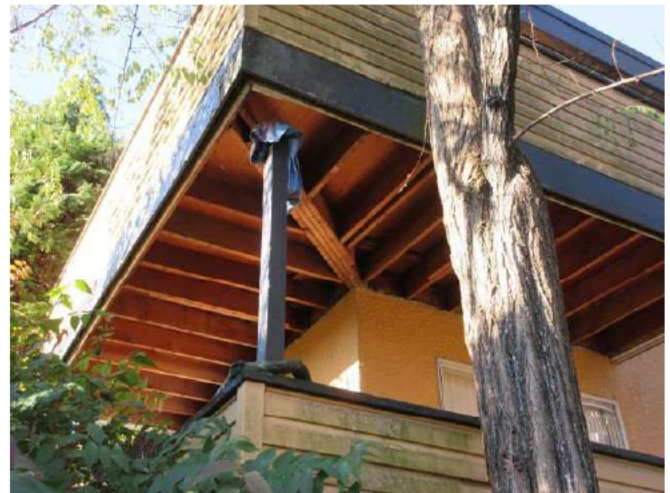
The soffits of the eight corner balconies at the 2<sup>nd</sup> and 3<sup>rd</sup> floor had been removed at the time of our visit exposing the underside of the wood support framing. Some the wood framing was rotted. The corner posts are not properly aligned above and below each other, they do not have proper bearing support at the top and bottom and one of the posts has been removed at the north-east corner of the building.

*Photo 3: Balcony structure.*

We were not provided any information regarding the balconies where soffits had been removed other than once wood rot was found, the balconies were further investigated as to the extent of required repairs. We understand that, as a result of this investigation, reportedly it has been determined that the corner posts are not required to support the balconies. This should be confirmed by a structural engineer and shored in place until confirmed. Pending further information, we have included a placeholder budget to repair the corner balconies, including new waterproofing and new soffits. We have assumed that perforated soffit panels will be installed to allow adequate ventilation of the concealed framing below the waterproofing.

| Description | Classification | Present Cost | Timing (Year) | Cycle (Years) |
|---|---|---|---|---|
| Repair and Re-waterproof Corner Balconies | 3 | \$150,000 | 2023 | N/A |

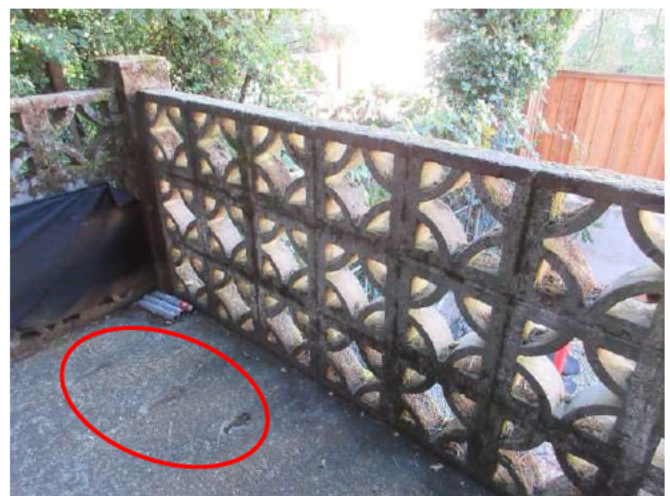
*Photo 4: Typical 1<sup>st</sup> floor balcony/patio guard; note three locations of exposed reinforcing steel within the red oval.*

The top surface of the concrete 1<sup>st</sup> floor balconies/patios is deteriorated at some locations with concrete spalls and exposed steel reinforcing. Only some of the balconies/patios have been painted. These balconies/patios should be waterproofed to protect the concrete and prevent water from leaking into the garage below. The precast unit guards are climbable resulting in a risk to the Owner where there is a potential significant fall opposite the guards, which is at several of the 1<sup>st</sup> floor balconies/patios. We have budgeted for local concrete repairs and waterproofing of the 1<sup>st</sup> floor balconies/patios, including replacement of guards where there is a potential significant fall.

| Description | Classification | Present Cost | Timing (Year) | Cycle (Years) |
|---|---|---|---|---|
| Waterproof 1 <sup>st</sup> Floor Balconies/Patios and Replace Guards | 1 | \$140,000 | 2023 | 20 |
