Roof Condition Report - Queen Anne Apartments - 12188 224 Street, Maple Ridge, BC

Tri-Tech Pinnacle Group Inc.

9/20/2022

221246

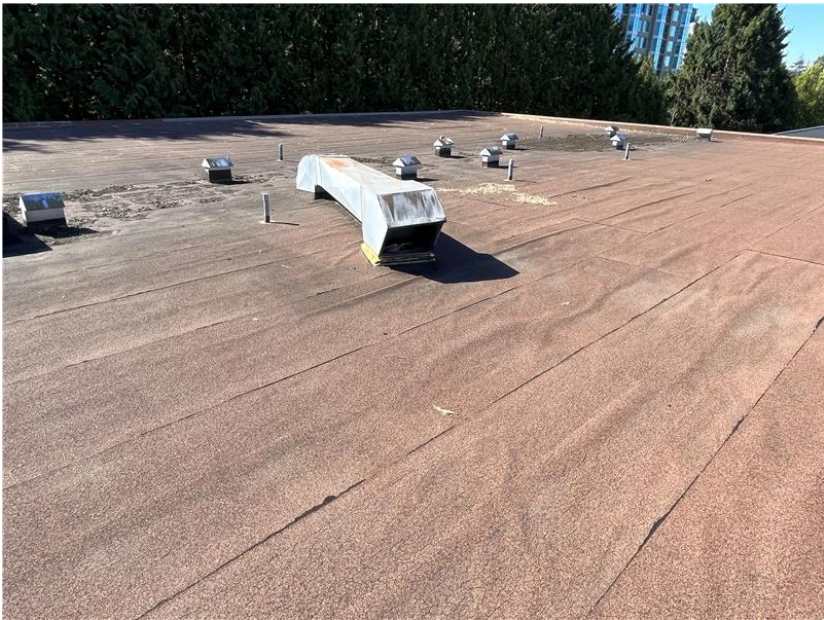
◆
Condition: Blister
Severity: High
Quantity: 1

Numerous blisters were noted on this roof level. Blisters are an indication that either air or moisture is trapped within the roofing system.

Due to the age and condition of the installed roofing assembly, roof replacement should be scheduled as soon as budgeting permits.

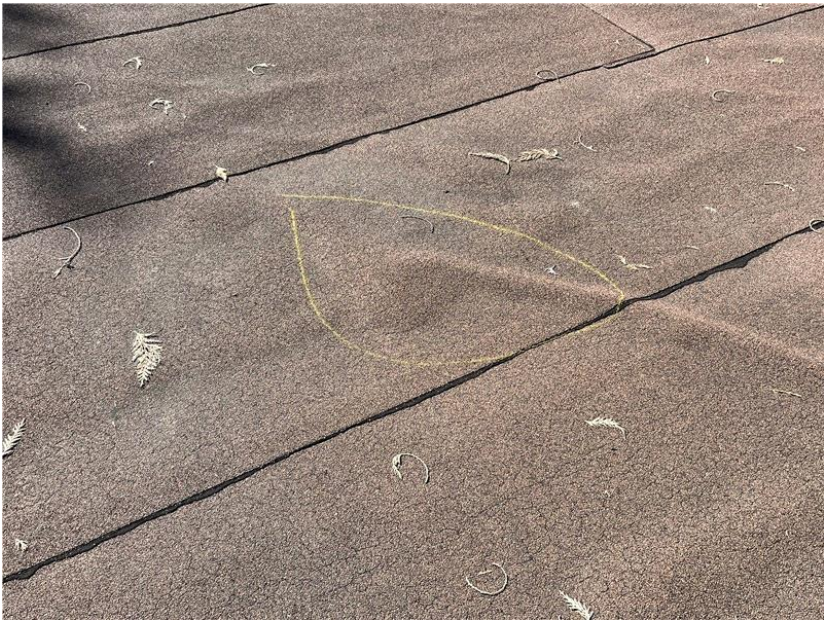
◆
Condition: Blister 1
Severity: High
Quantity: 1

Close up of a large blister in the modified bitumen membrane.

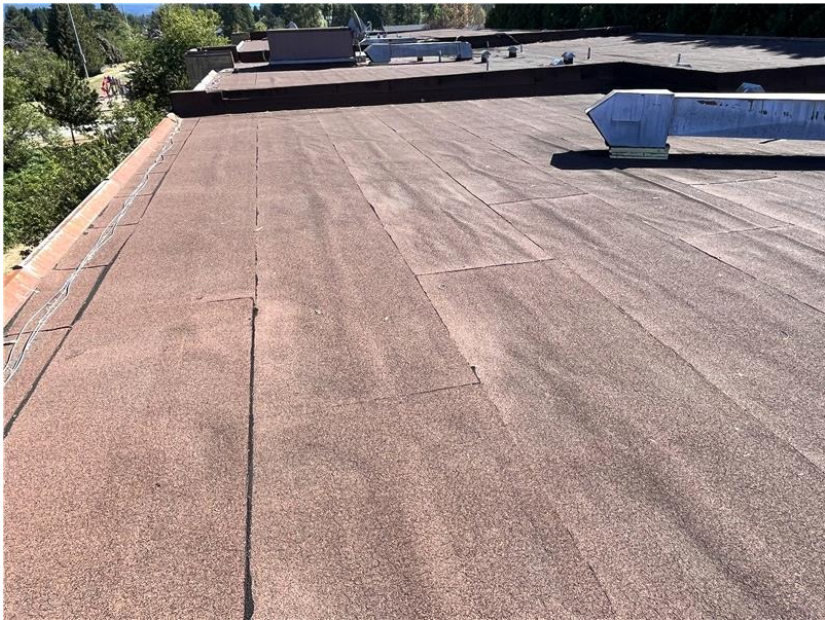
Condition: Blister 2
Severity: High
Quantity: 1

More blisters in the modified bitumen membrane.

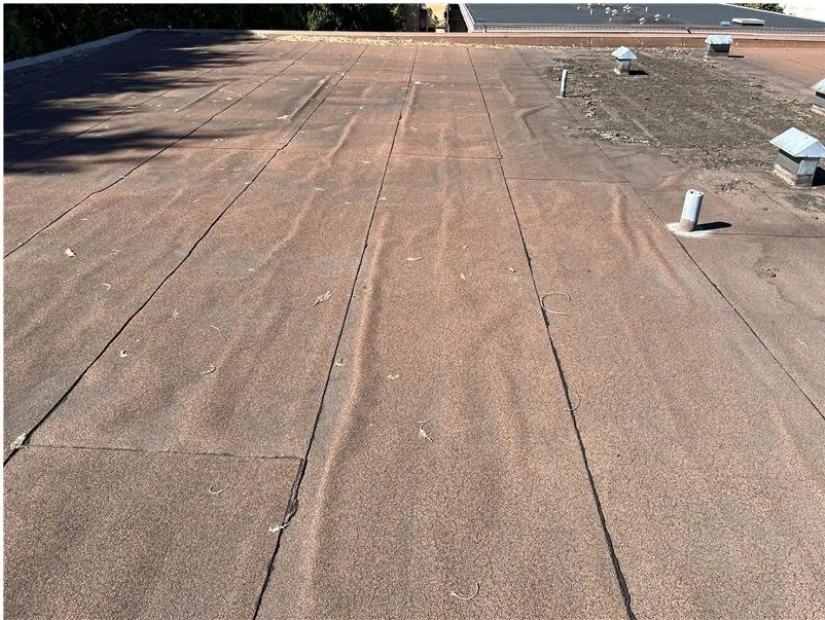
Condition: Blister 3
Severity: High
Quantity: 1

More blisters in the modified bitumen membrane.

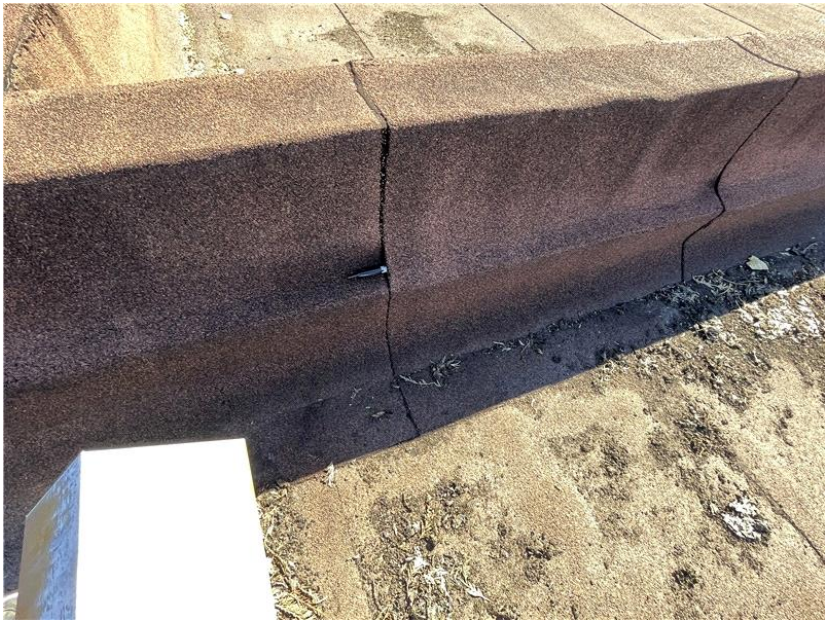
→
Condition: Open seam
Severity: High
Quantity: 1

Open flashing membranes were noted at the perimeter of this roof level. This condition may be allowing water to enter the roofing assembly and/or building.

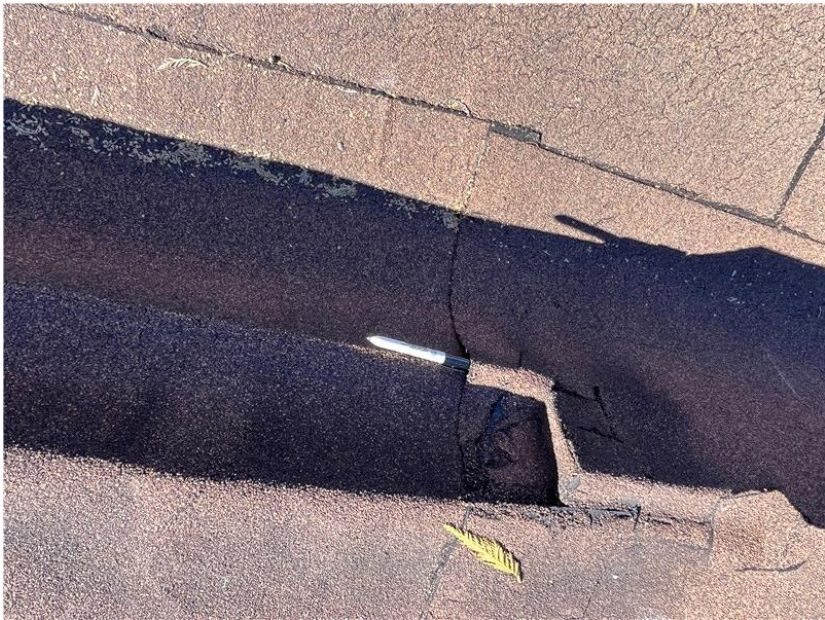
→
Condition: Open seam 1
Severity: High
Quantity: 1

More open membrane.

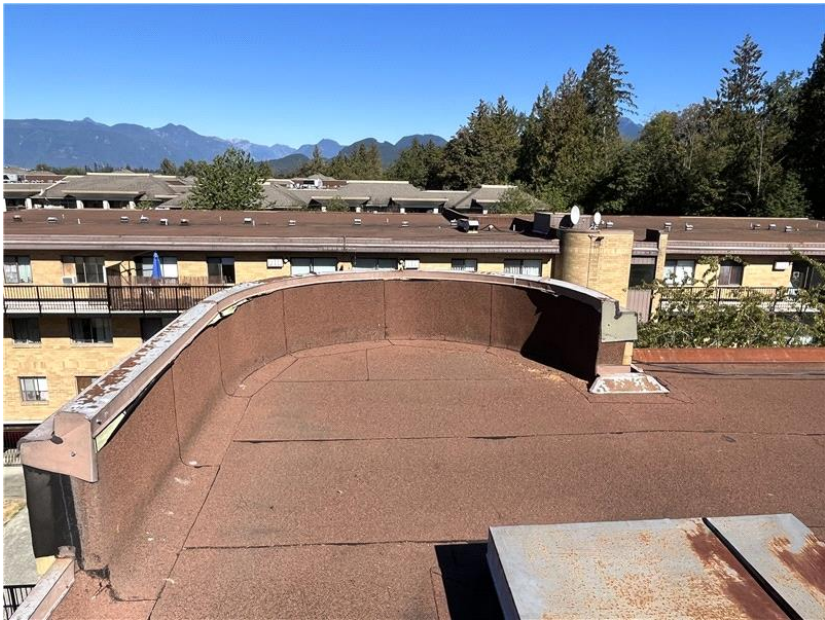
Condition: Corrosion
Severity: Medium
Quantity: 1

The perimeter metal flashings are corroded in several locations on this roof level.

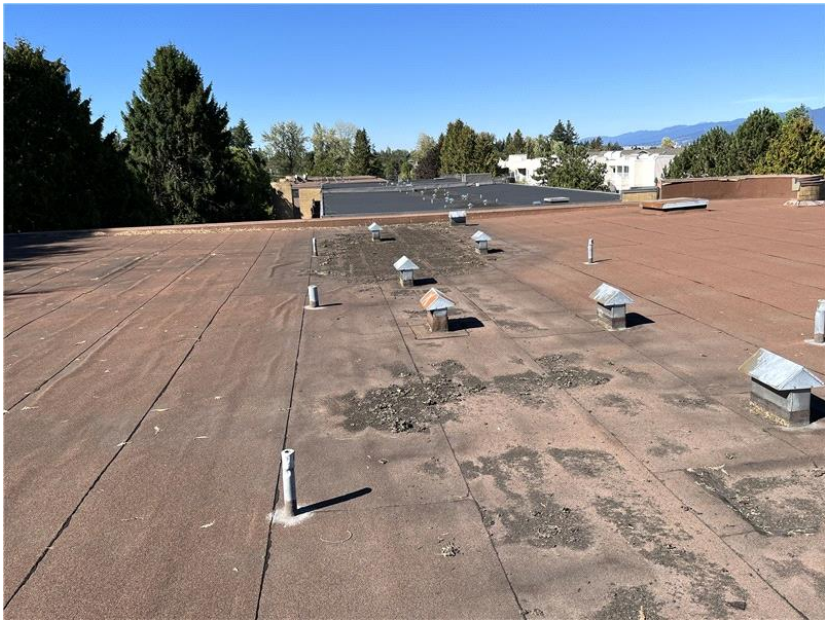
Condition: Organic debris
Severity: Low
Quantity: 1

An accumulation of organic debris was noted on this roof level.

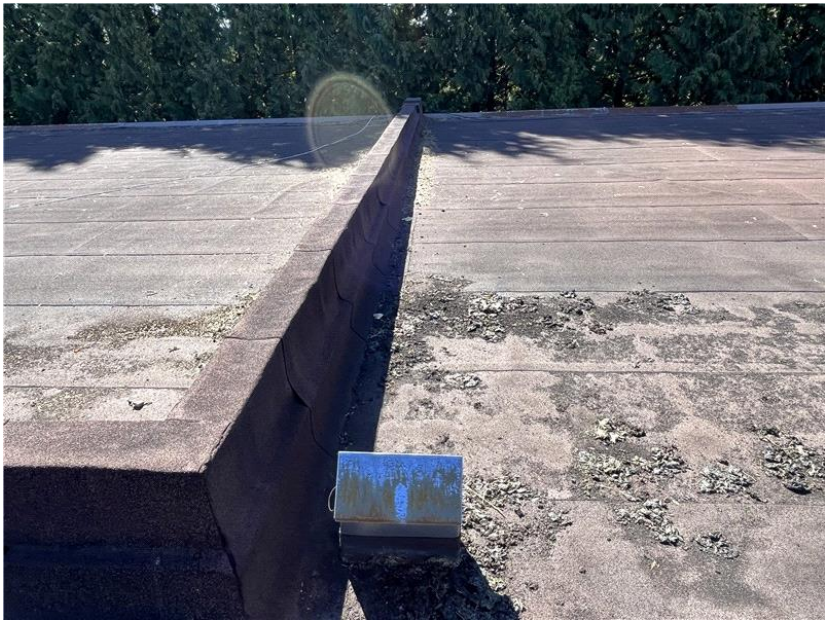
Condition: Organic debris 1
Severity: Low
Quantity: 1

More organic debris.

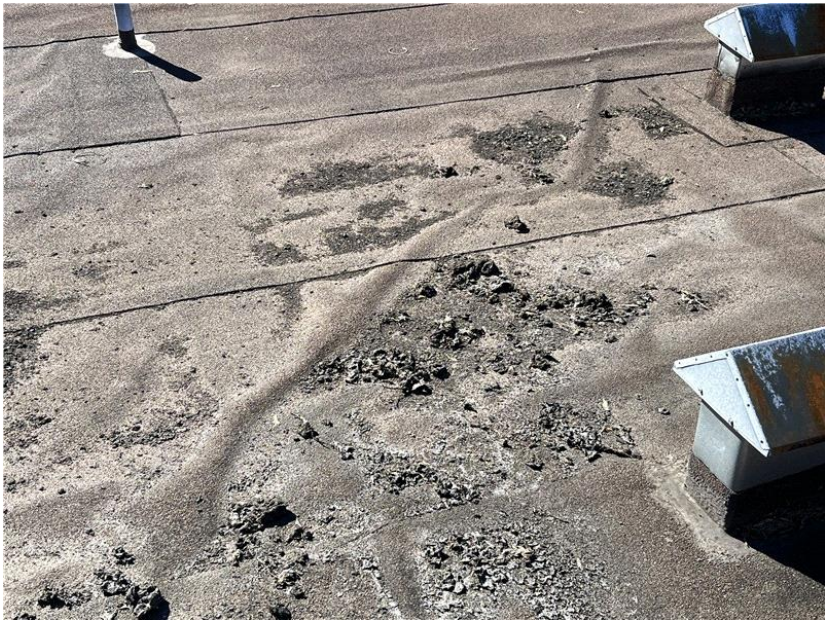
Condition: Blister
Severity: High
Quantity: 1

Numerous blisters were noted on this roof level. Blisters are an indication that either air or moisture is trapped within the roofing system.

Due to the age and condition of the installed roofing assembly, roof replacement should be scheduled as soon as budgeting permits.

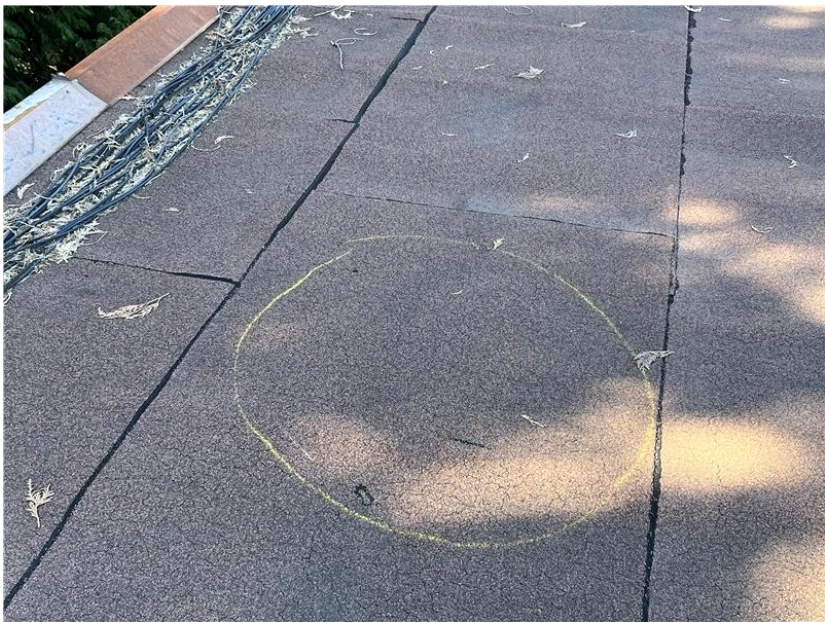
Condition: Blister 1
Severity: High
Quantity: 1

Close up of a large blister in the modified bitumen membrane.

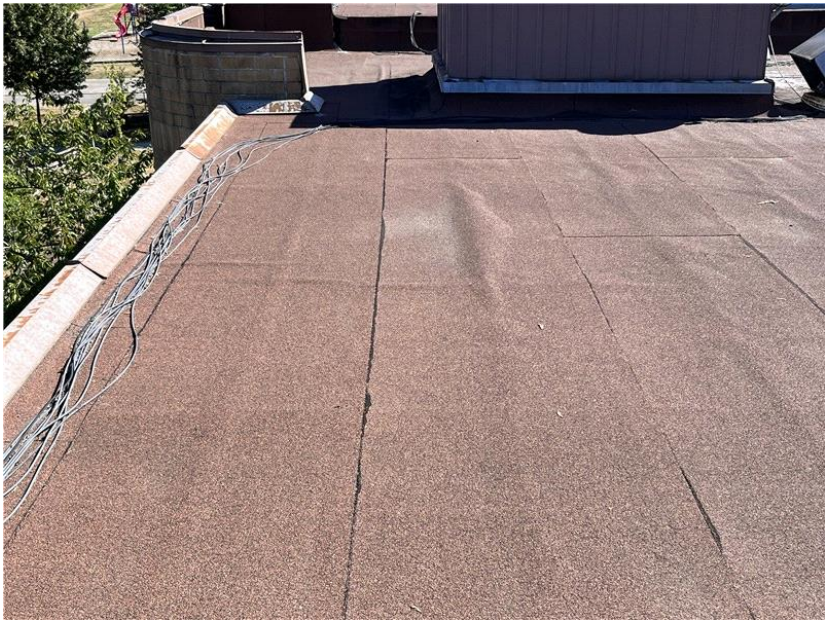
Condition: Blister 2
Severity: High
Quantity: 1

More blisters in the modified bitumen membrane.

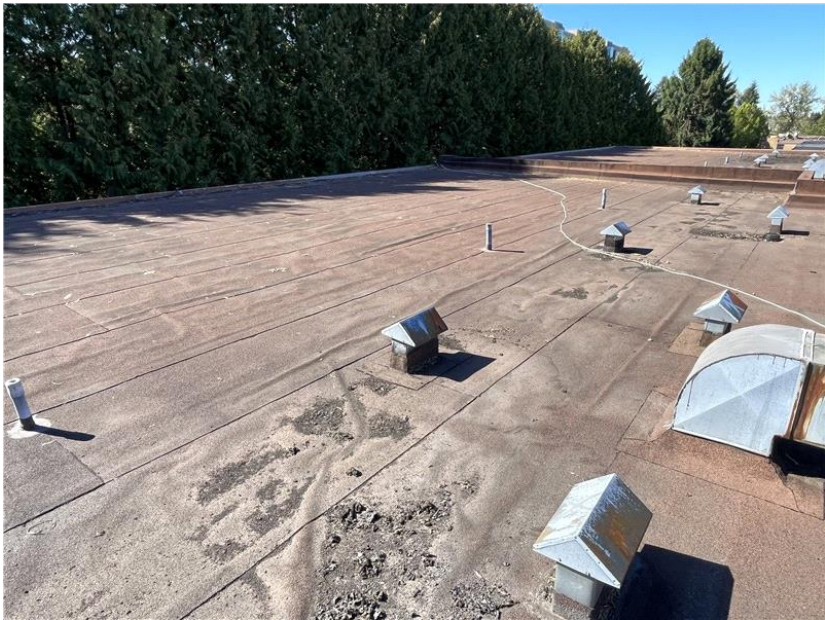
Condition: Blister 3
Severity: High
Quantity: 1

More blisters in the modified bitumen membrane.

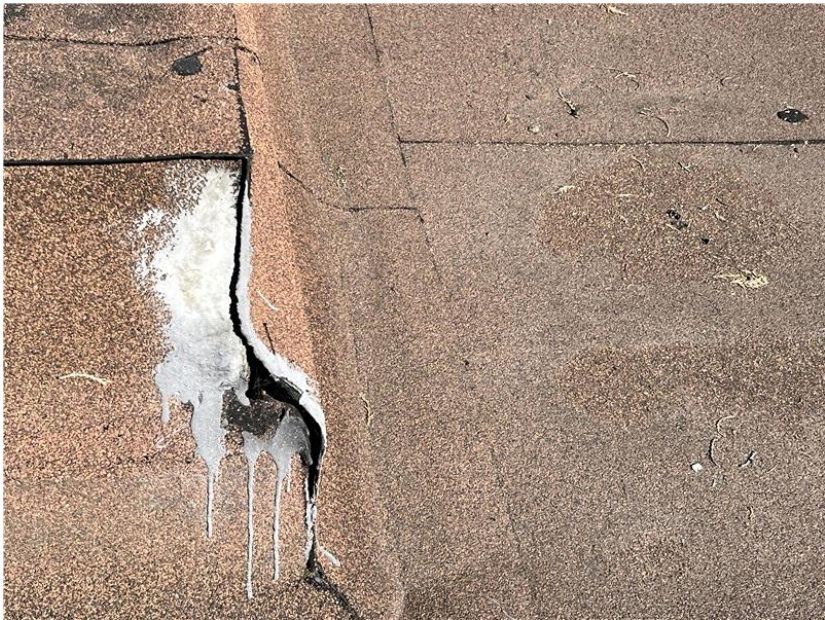
Condition: Improper repair
Severity: High
Quantity: 1

View of an improper repair in the field of this roof level.

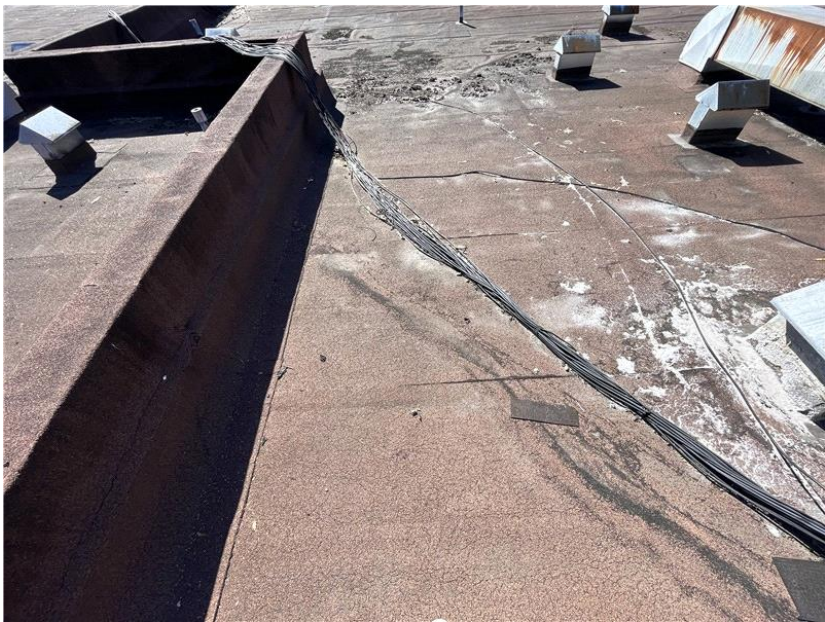
Condition: Improper repair 1
Severity: High
Quantity: 1

More improper/temporary repair in the field of this roof level.

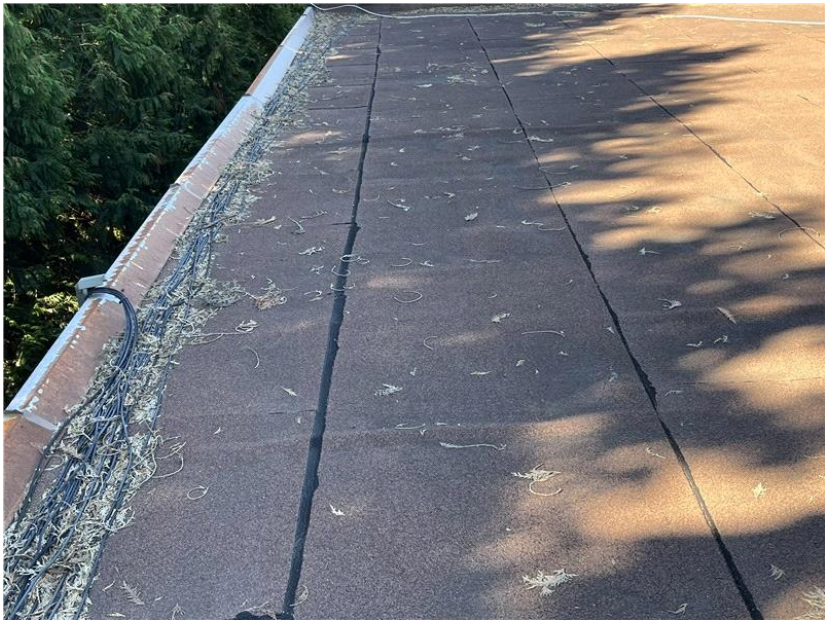
Condition: Missing support
Severity: High
Quantity: 1

All cables should be properly supported off the roof surface.

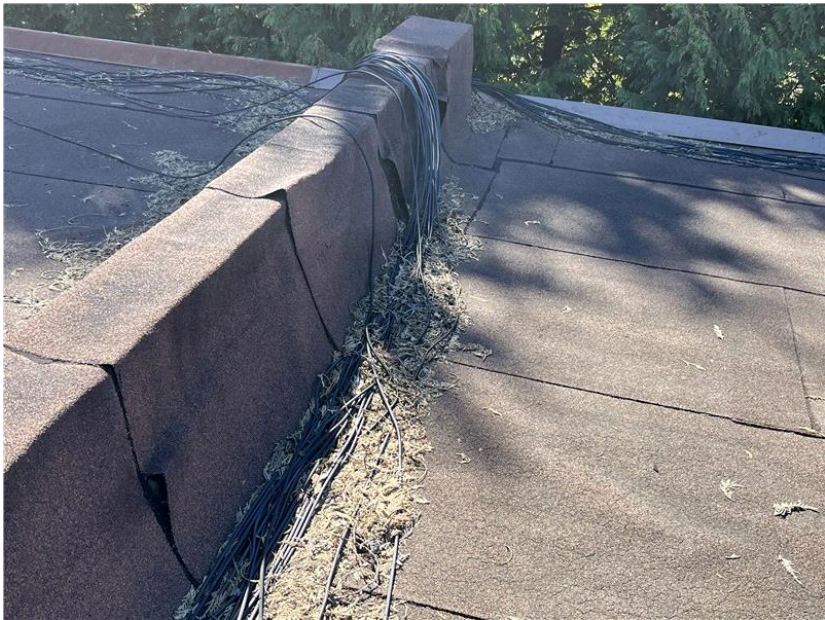
Condition: Open seam
Severity: High
Quantity: 1

Open flashing membranes were noted at the perimeter of this roof level. This condition may be allowing water to enter the roofing assembly and/or building.

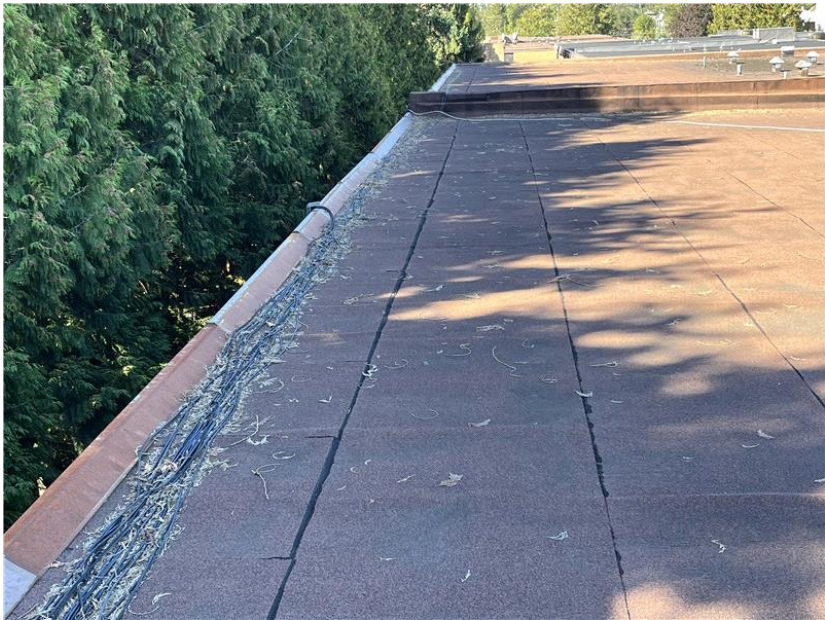
Condition: Corrosion
Severity: Medium
Quantity: 1

The perimeter metal flashings are corroded in several locations on this roof level.

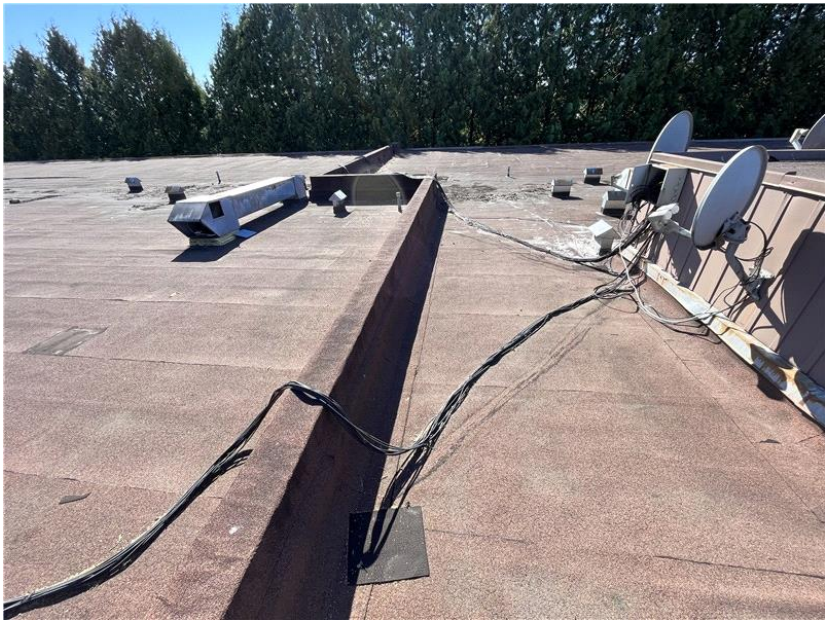
Condition: Electrical box
Severity: Medium
Quantity: 1

View of the open electrical box.

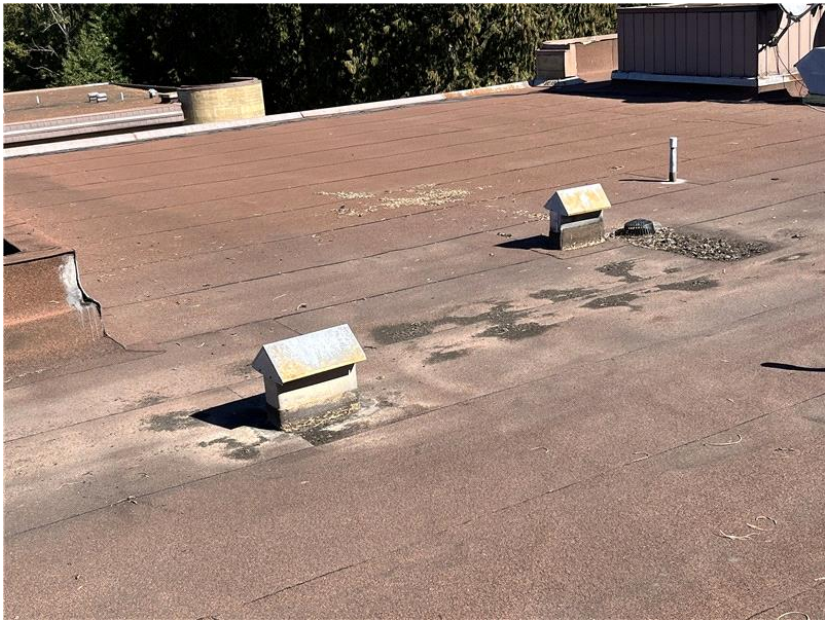
Condition: Organic debris
Severity: Low
Quantity: 1

An accumulation of organic debris was noted on this roof level.

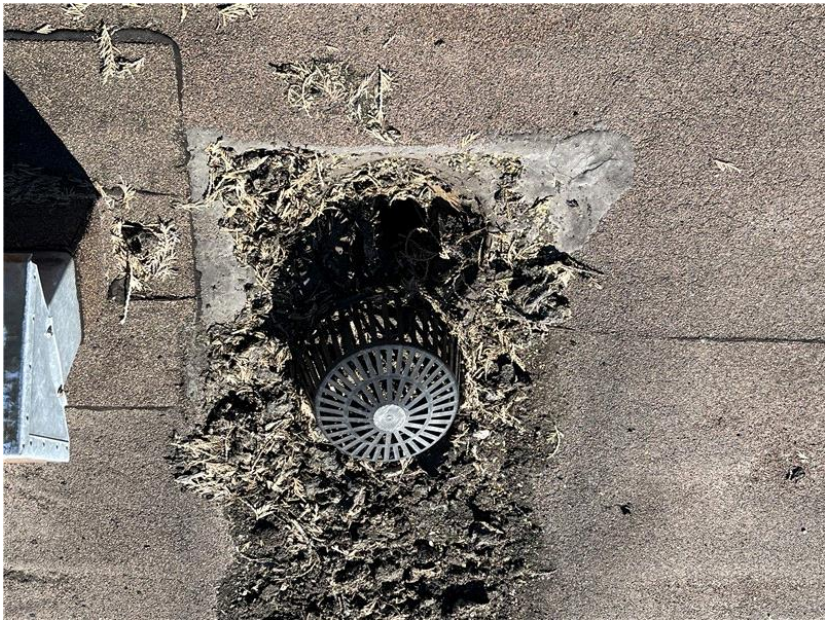
Condition: Organic debris 1
Severity: Low
Quantity: 1

Close up of the organic debris around the roof drain.

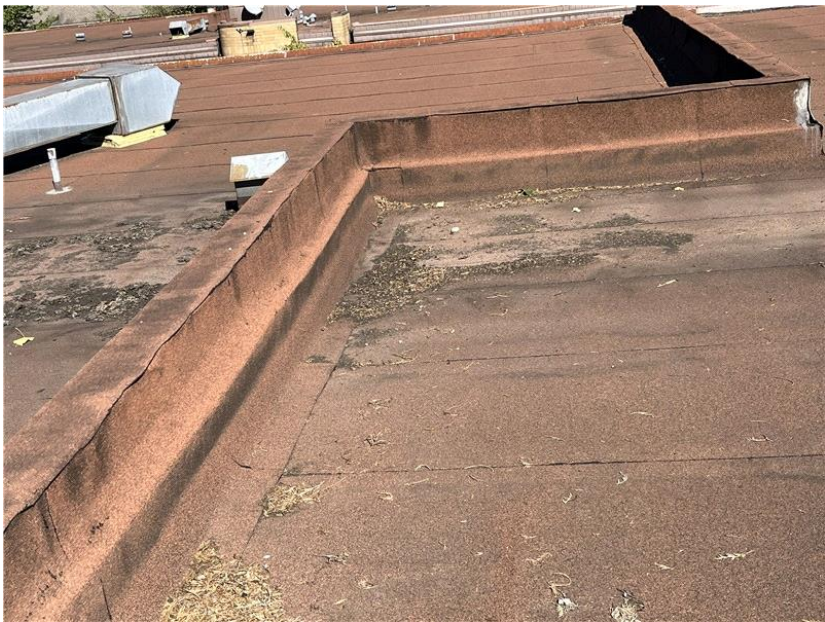
Condition: Organic debris 2
Severity: Low
Quantity: 1

More organics and discoloured membrane.

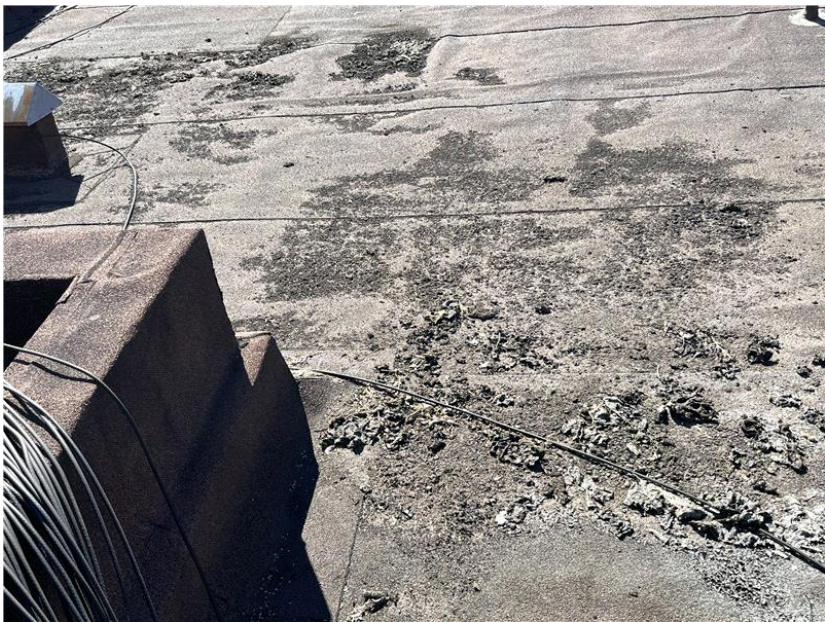
Condition: Organic debris 3
Severity: Low
Quantity: 1

More organic debris.

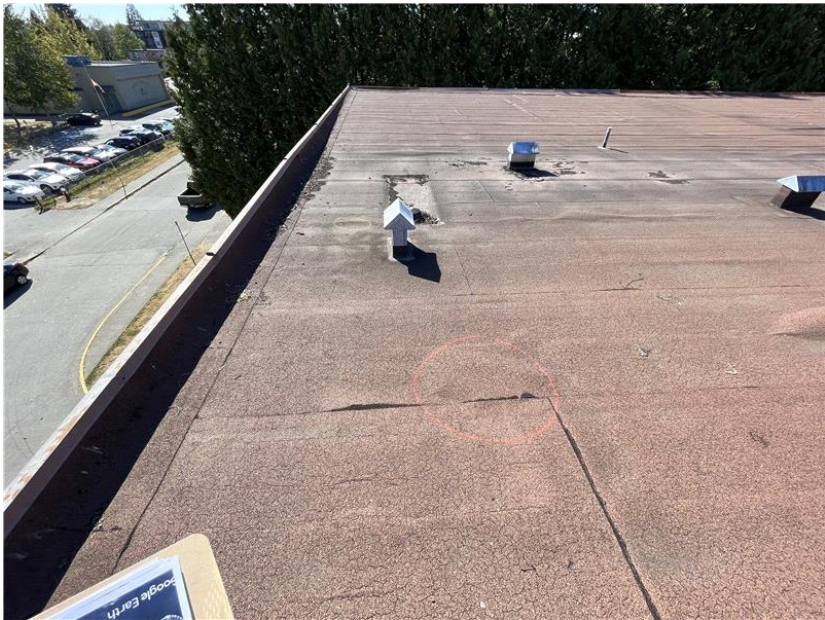
Condition: Blister
Severity: High
Quantity: 1

Numerous blisters were noted on this roof level. Blisters are an indication that either air or moisture is trapped within the roofing system.

Due to the age and condition of the installed roofing assembly, roof replacement should be scheduled as soon as budgeting permits.

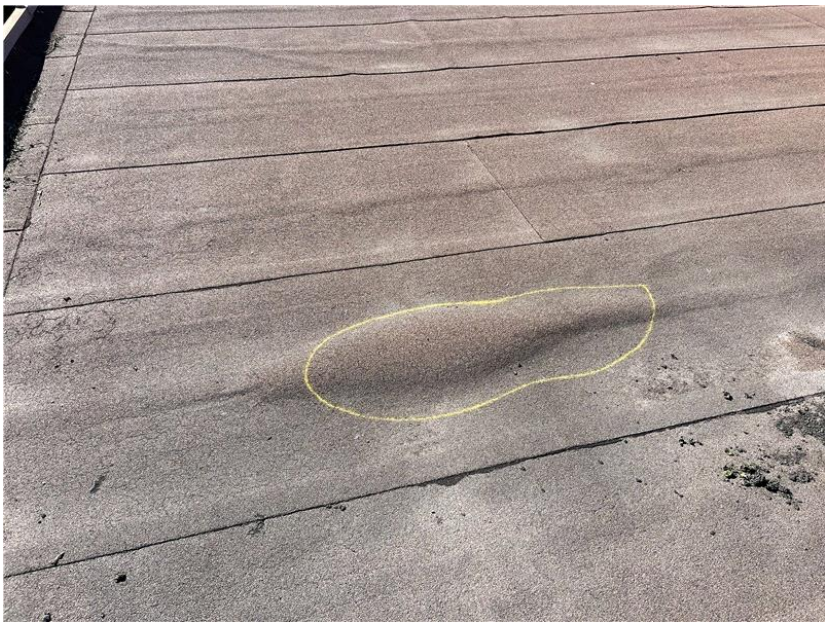
Condition: Blister 1
Severity: High
Quantity: 3

Close up of a large blister in the modified bitumen membrane.

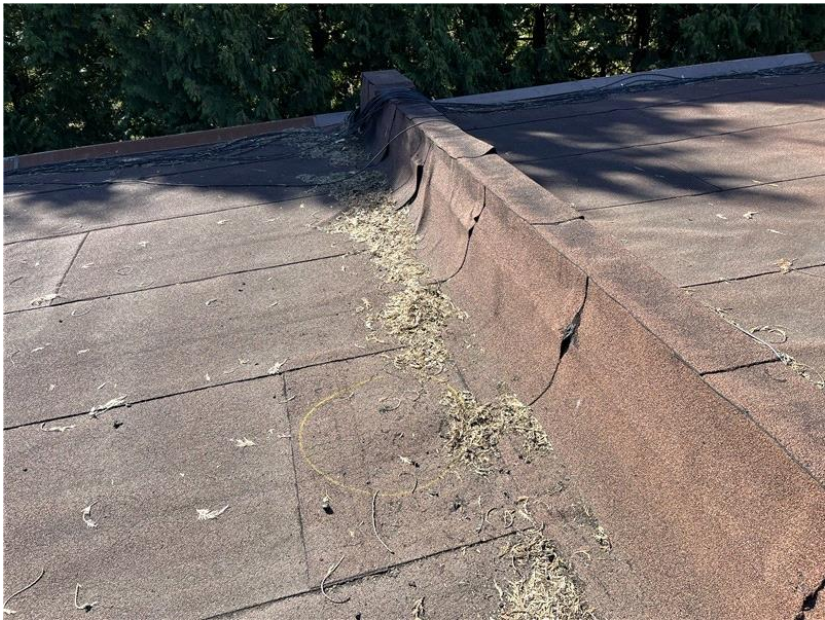
Condition: Blister 2
Severity: High
Quantity: 1

Another blister in the modified bitumen membrane.

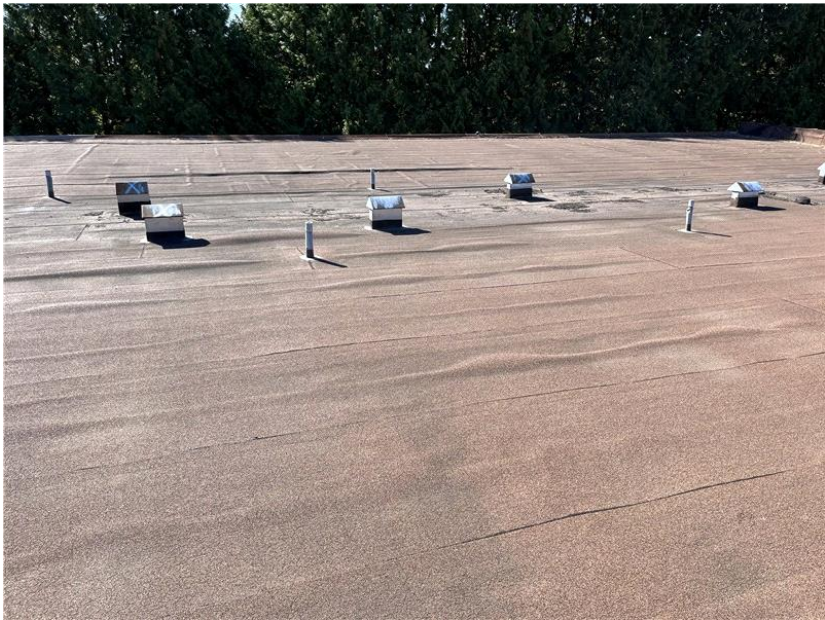
Condition: Blister 3
Severity: High
Quantity: 1

More blisters in the modified bitumen membrane.

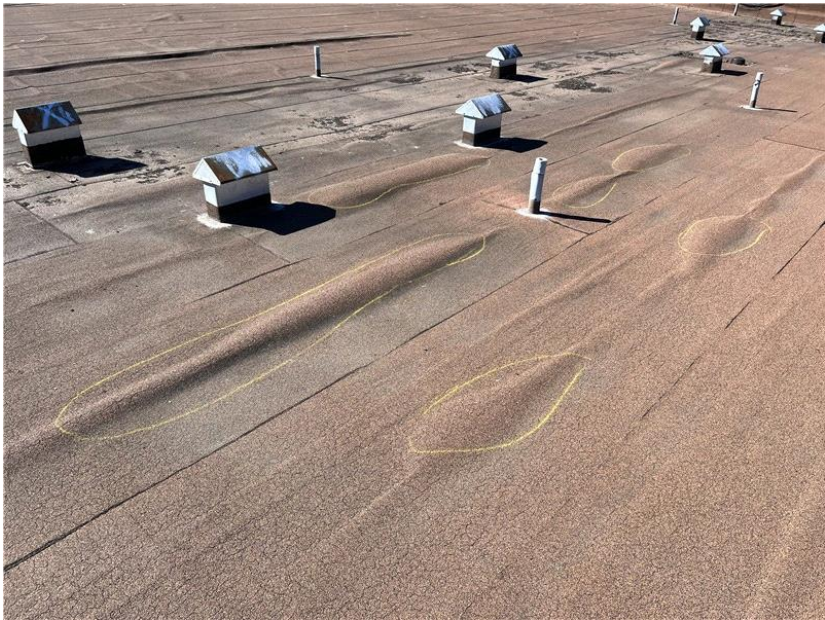
Condition: Blister 4
Severity: High
Quantity: 1

More blistered field membrane.

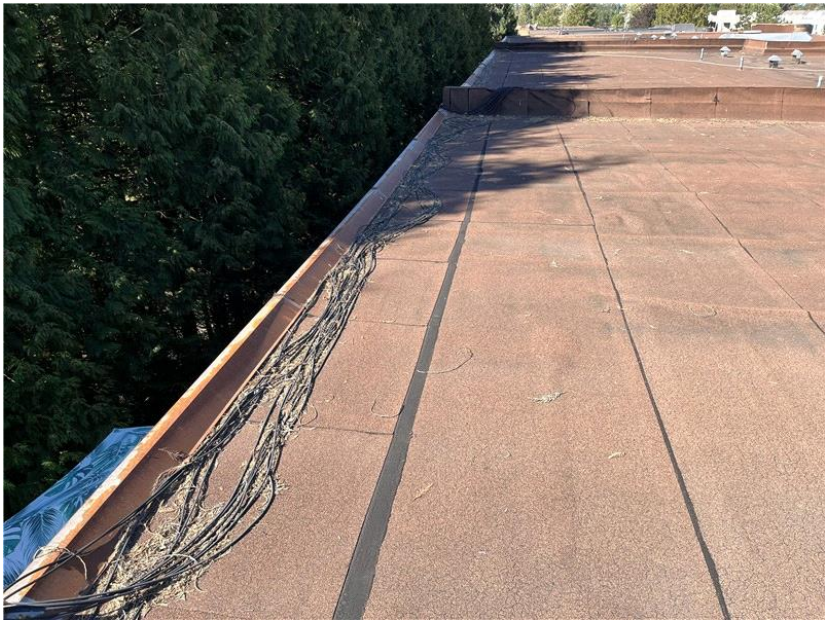
Condition: Missing support
Severity: High
Quantity: 1

All cables should be properly supported off the roof surface.

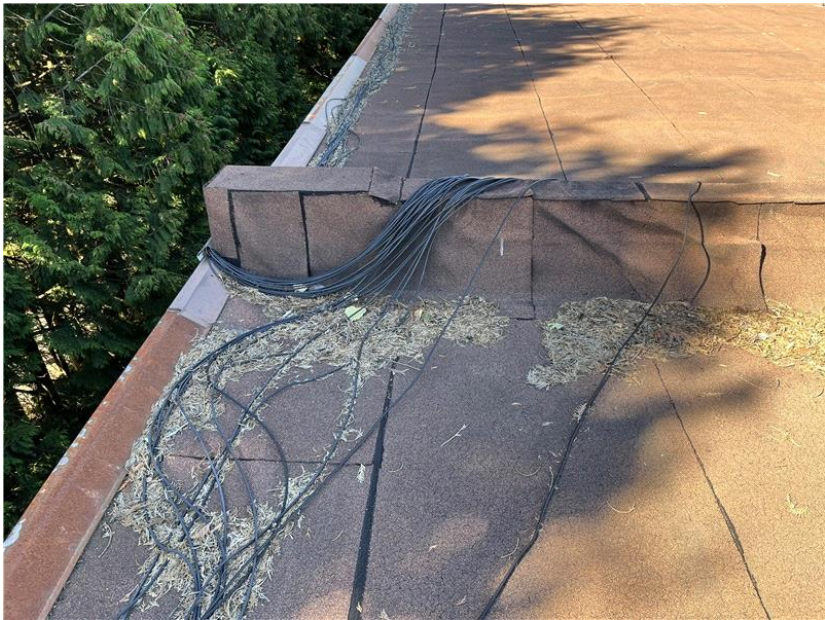
Condition: Missing support 1
Severity: High
Quantity: 1

More cables to be properly supported off the roof surface.

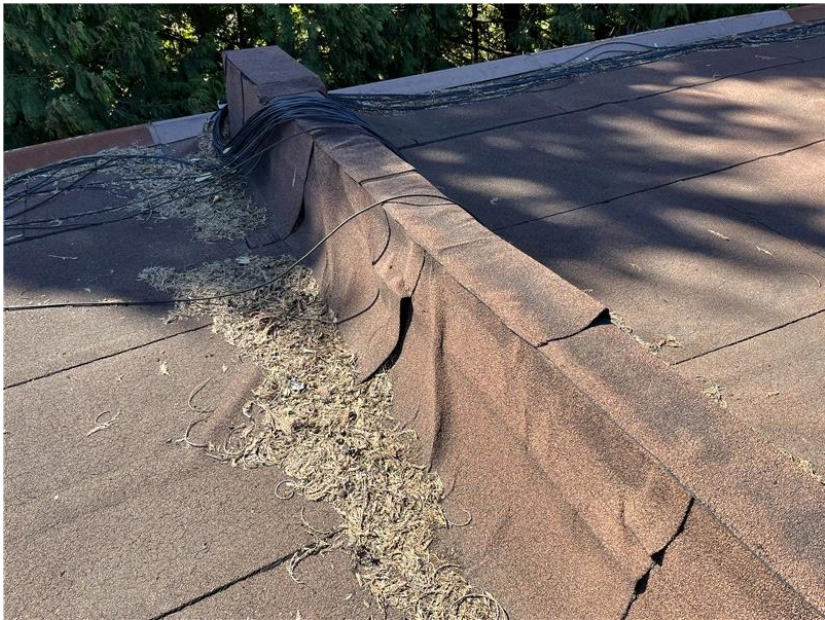
Condition: Open seam
Severity: High
Quantity: 1

Open flashing membranes were noted at the perimeter of this roof level. This condition may be allowing water to enter the roofing assembly and/or building.

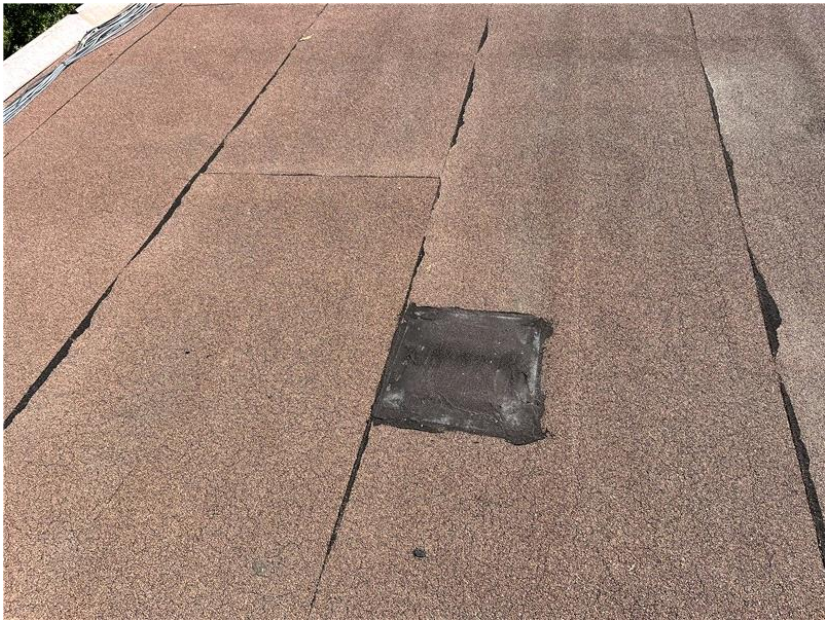
Condition: Repair
Severity: High
Quantity: 1

View of previously completed repair.

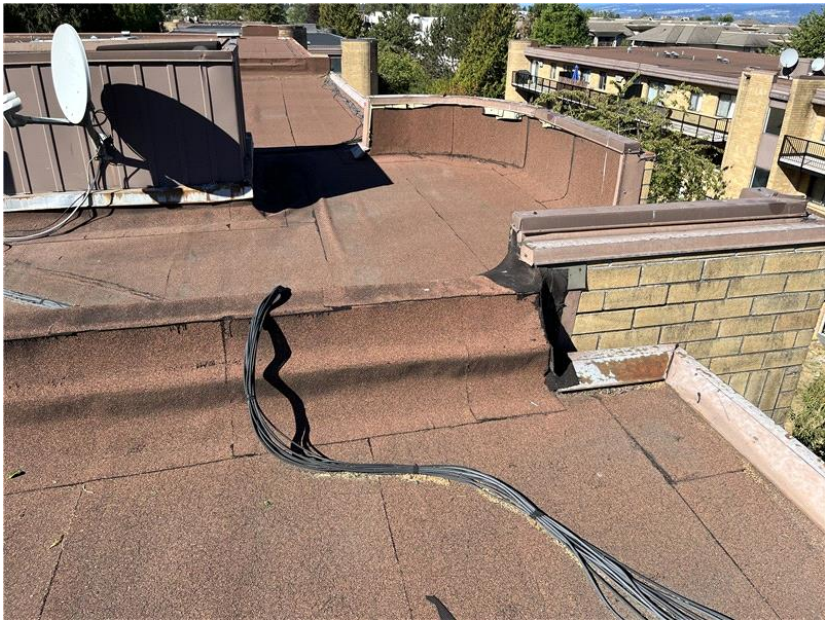
Condition: Repair 1
Severity: High
Quantity: 1

View of another previously completed temporary repair at the parapet.

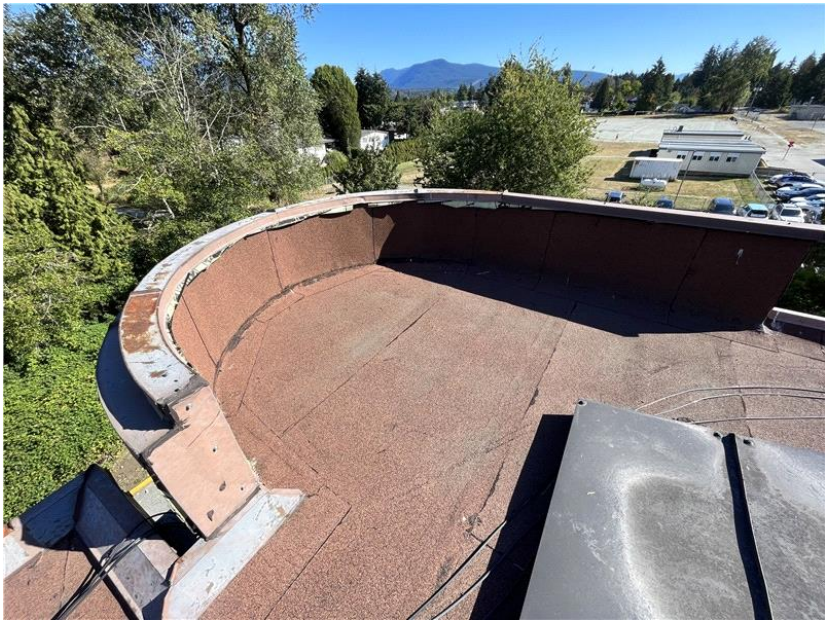
Condition: Corrosion
Severity: Medium
Quantity: 1

The perimeter metal flashings are corroded in several locations on this roof level.

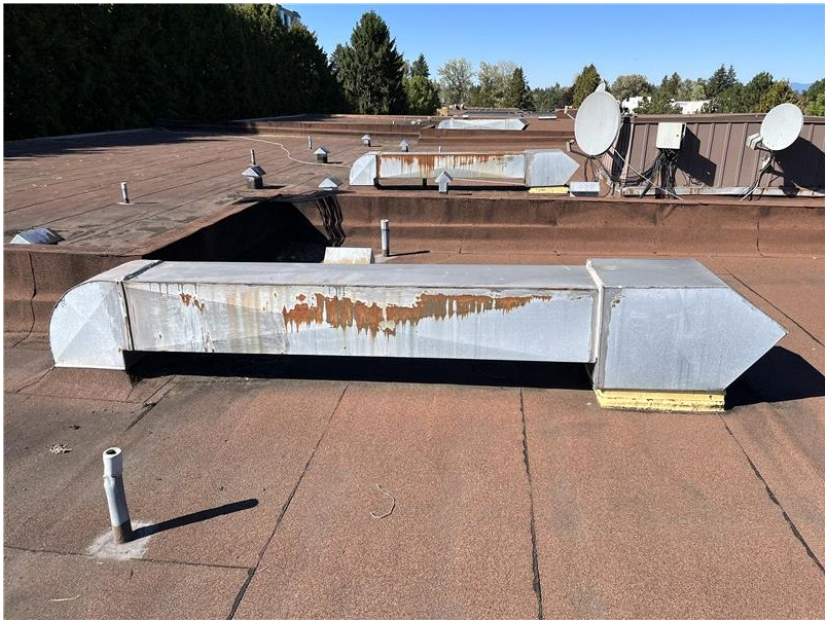
Condition: Corrosion 1
Severity: Medium
Quantity: 1

View of the corroded ductwork.

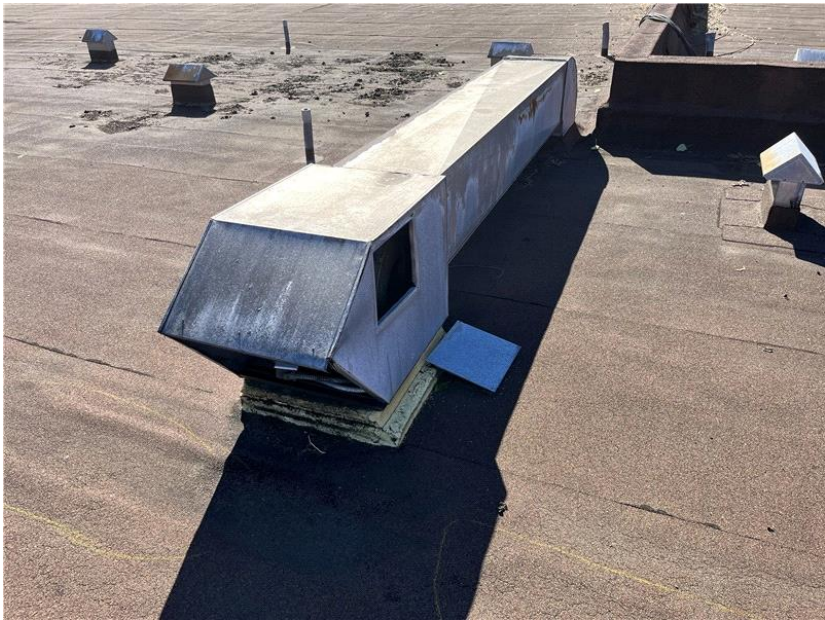
Condition: Equipment Curb
Severity: Medium
Quantity: 0

View of the unsecured access panel.

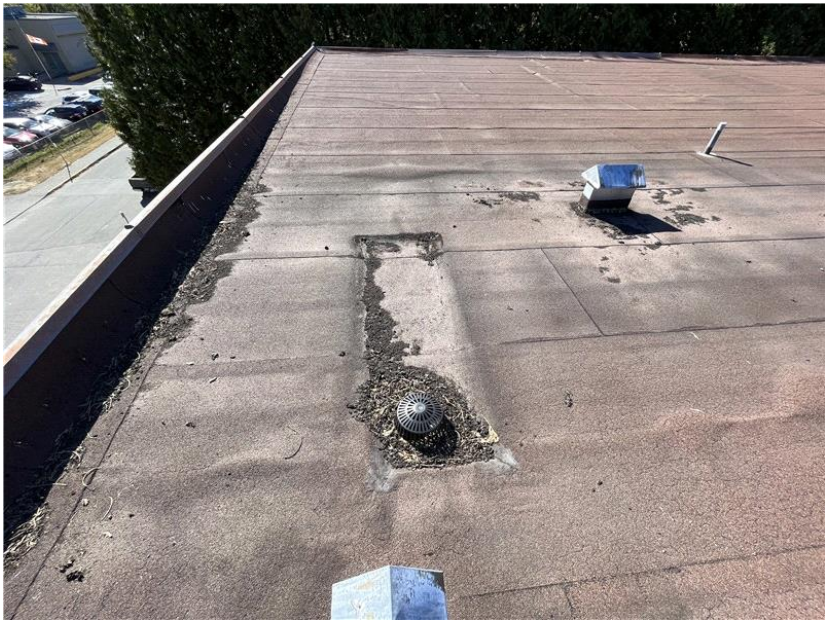
Condition: Organic debris
Severity: Low
Quantity: 1

An accumulation of organic debris was noted on this roof level.

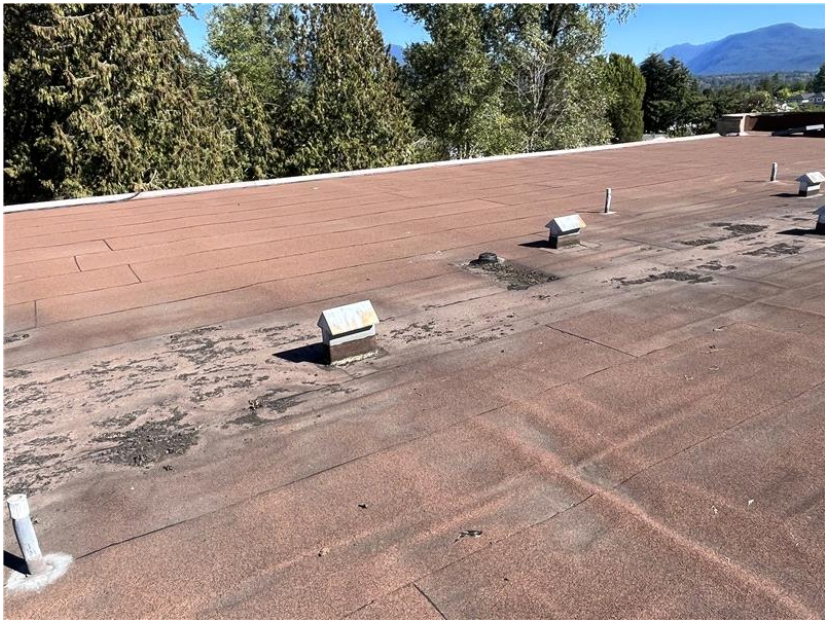
Condition: Organic debris 1
Severity: Low
Quantity: 1

More organic debris on this roof level.

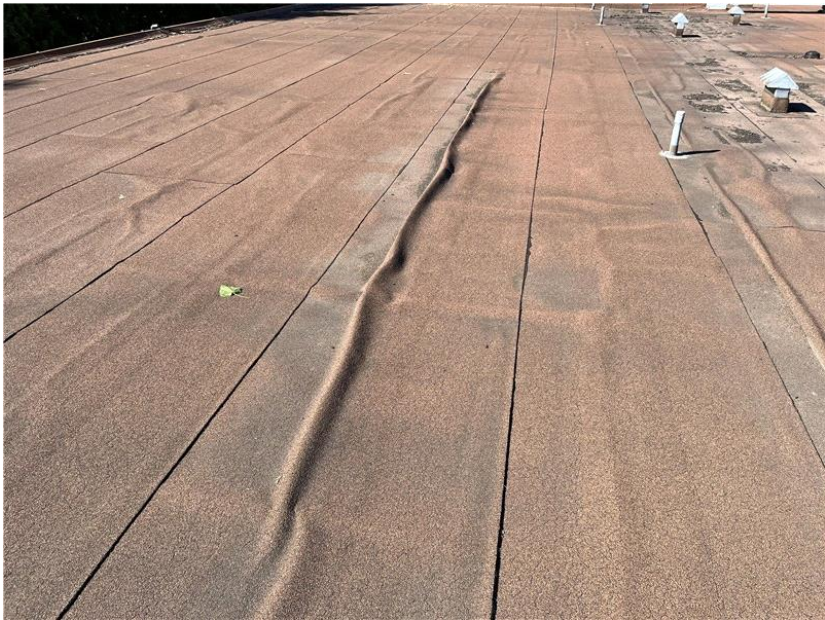
Condition: Ridges
Severity: Low
Quantity: 1

View of the wrinkles and ridges in the field membrane.

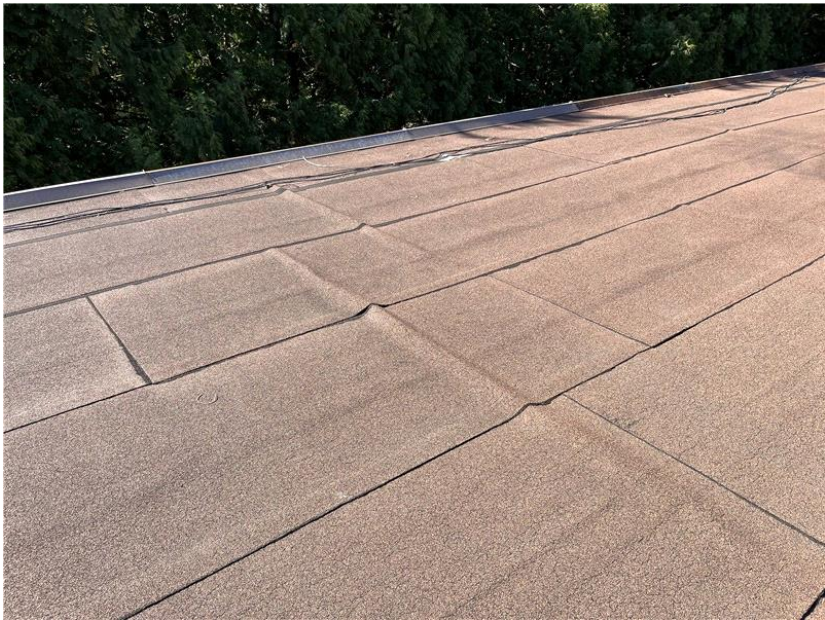
View of more wrinkles and ridges in the field membrane.

Condition: Ridges 1
Severity: Low
Quantity: 1

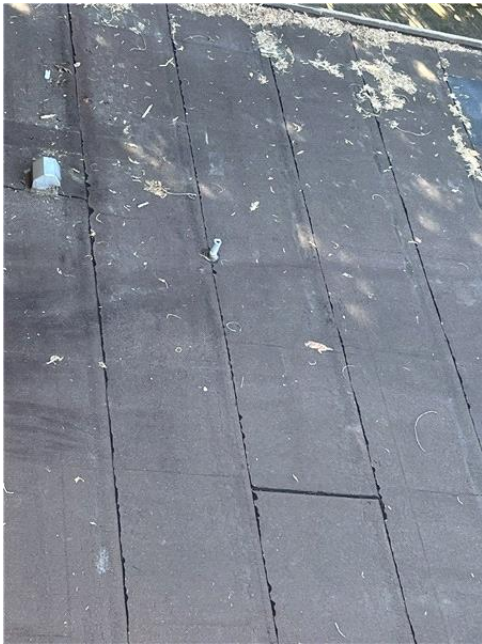
Condition: Blister
Severity: High
Quantity: 1

View of blisters and organics on the roof. Blisters are an indication that either air or moisture are trapped within the roofing system.

Due to the age and condition of the installed roofing assembly, roof replacement should be scheduled as soon as budgeting permits.

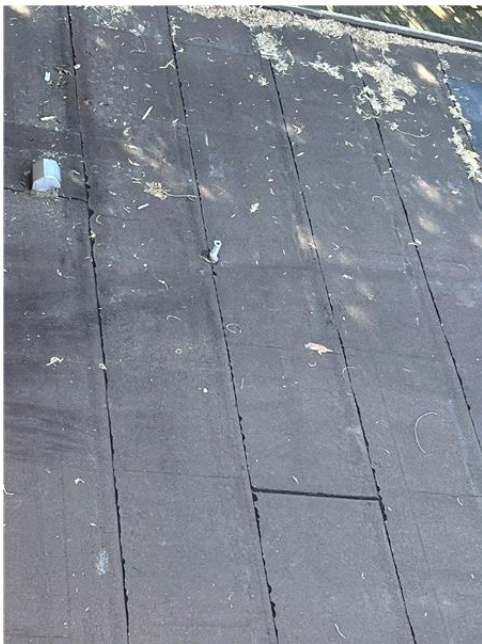
Condition: Slippage
Severity: Medium
Quantity: 1

Slippage has occurred in the field membranes, evidenced by the presence of narrow bare strips perpendicular to the slope.

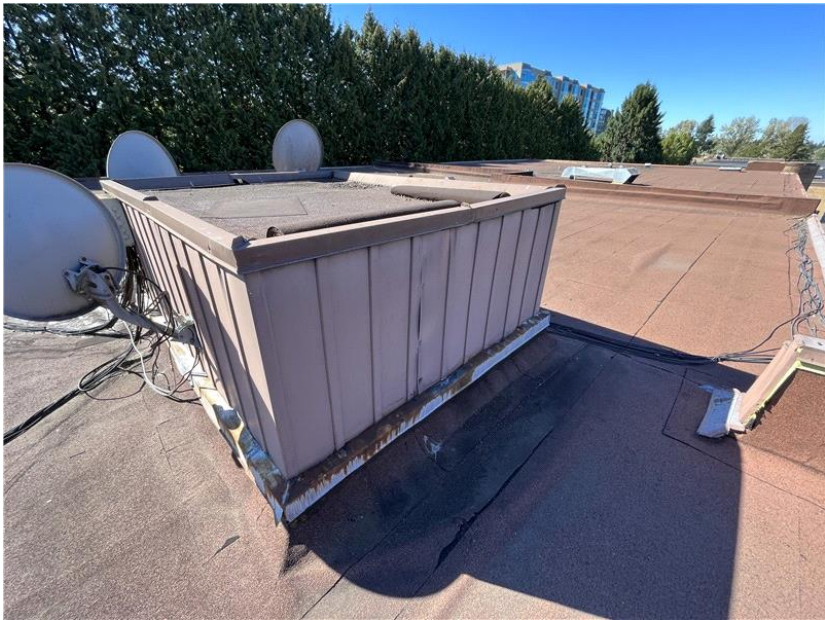
Condition: Corrosion
Severity: Medium
Quantity: 1

View of the severely corroded metal flashings on this roof.

Due to the age of this small elevator shaft roof, roof replacement should be scheduled as soon as budgeting permits or at the same time as the main roof level.
