RR Roof Rider Ltd

Jan 29, 2026 | 27 Photos

# 855 Vancouver Street - Summary of the Roof Condition

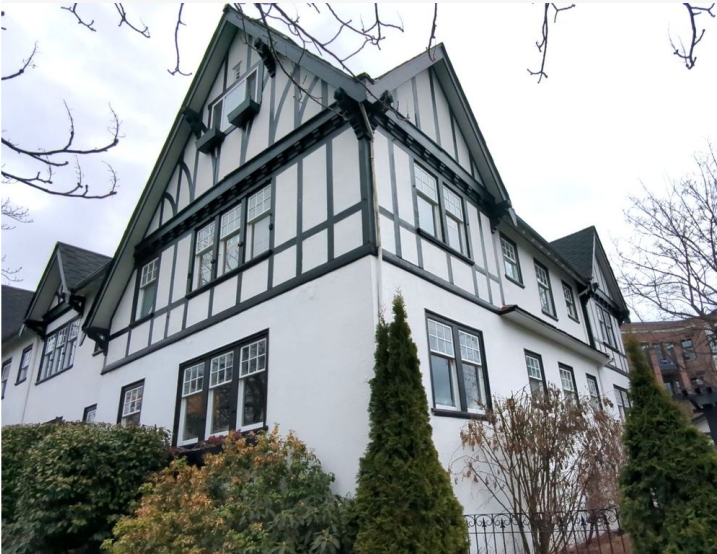
The main facet of the roof was under a very large tarp.

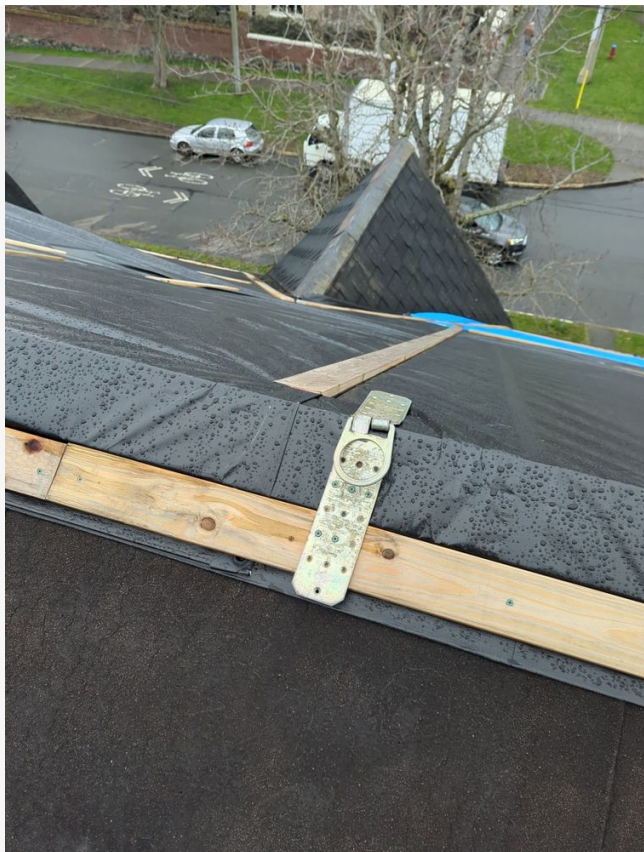
The tarp from above.

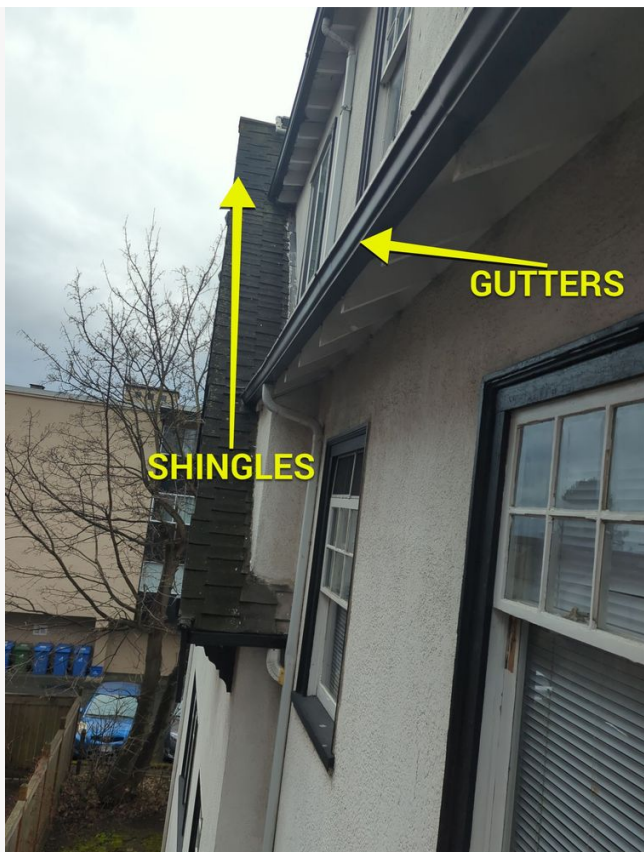
The gutters and downspouts were well passed the end of their service life.  
The shingles were also well passed their service life.

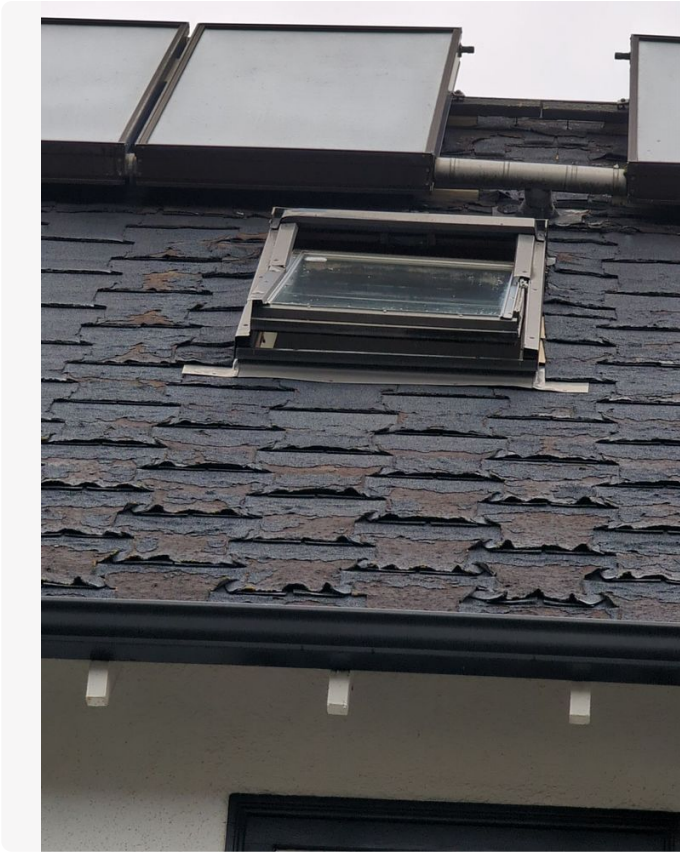
As you can see here the shingles were de-granulated and curling up. Definitely in need of replacement. The skylight was also well passed it service life.

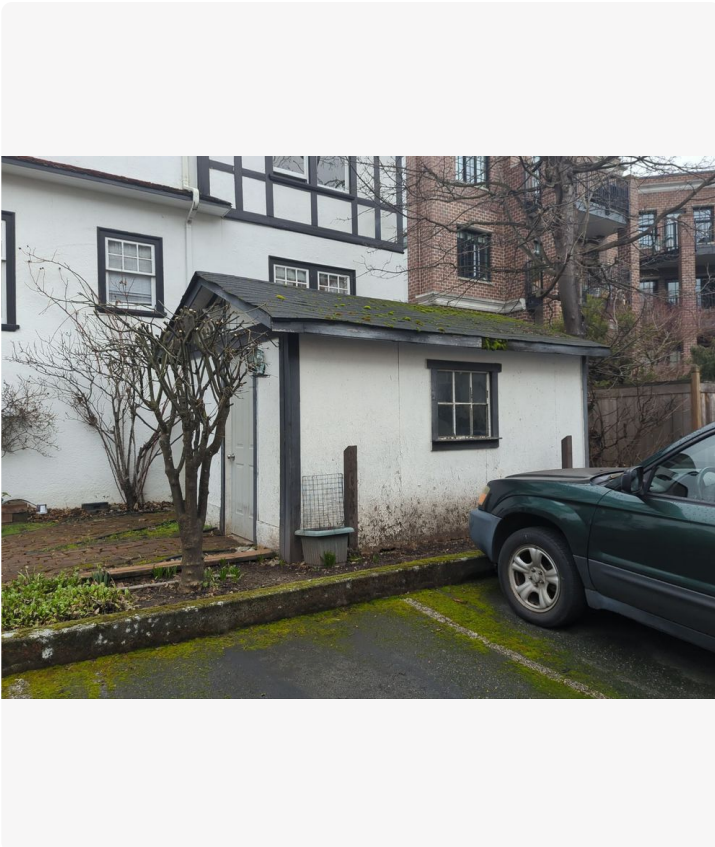
This storage shed was in similiar condition and needed to be re-roofed.

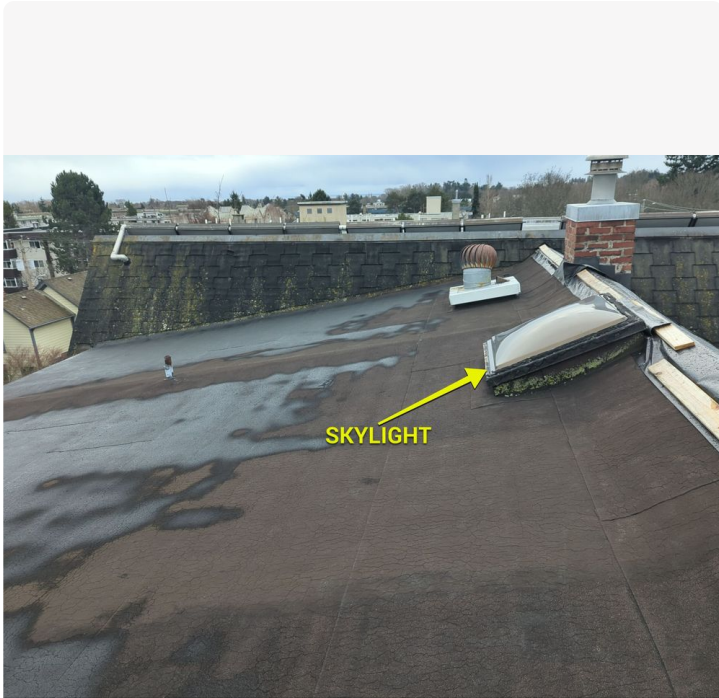
- This skylight was passed it's service life
- The flat roof was aged and needing replacement

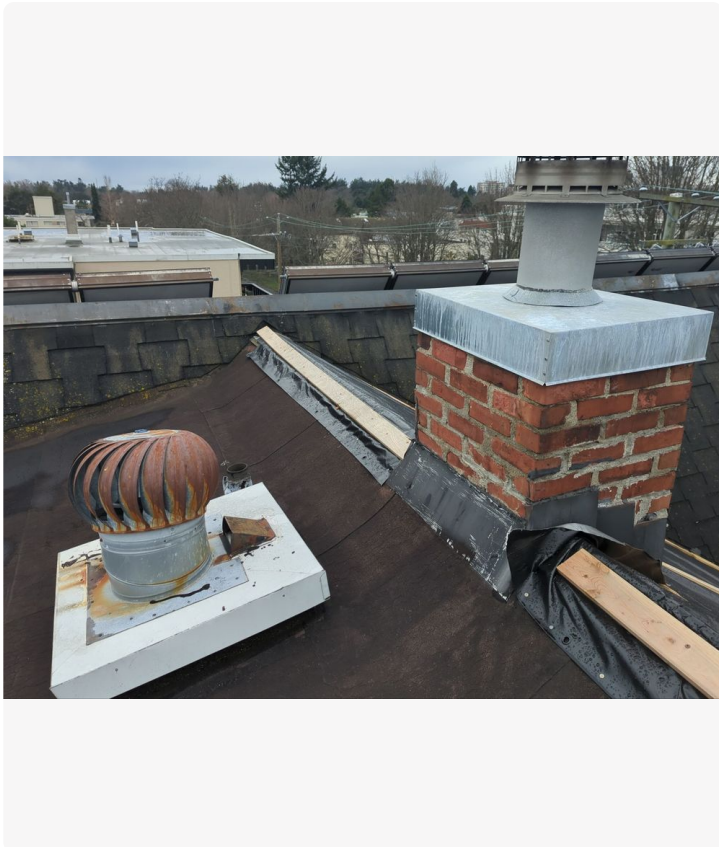
- The chimney needed repointing and a new cap
- The vent was rusty and non-fuctional

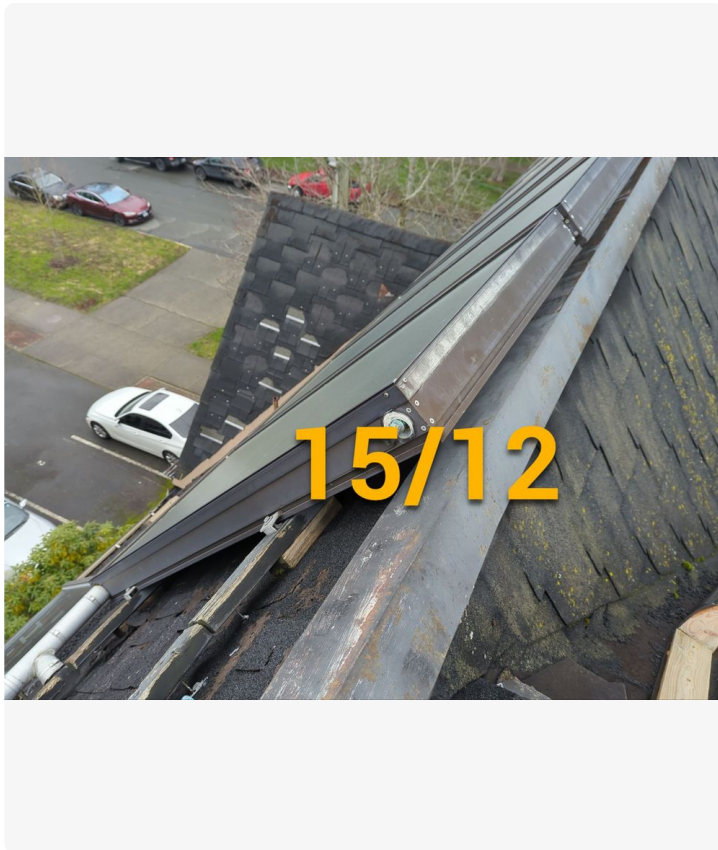
These solar panels were no longer needed but a difficult installation to remove safely.

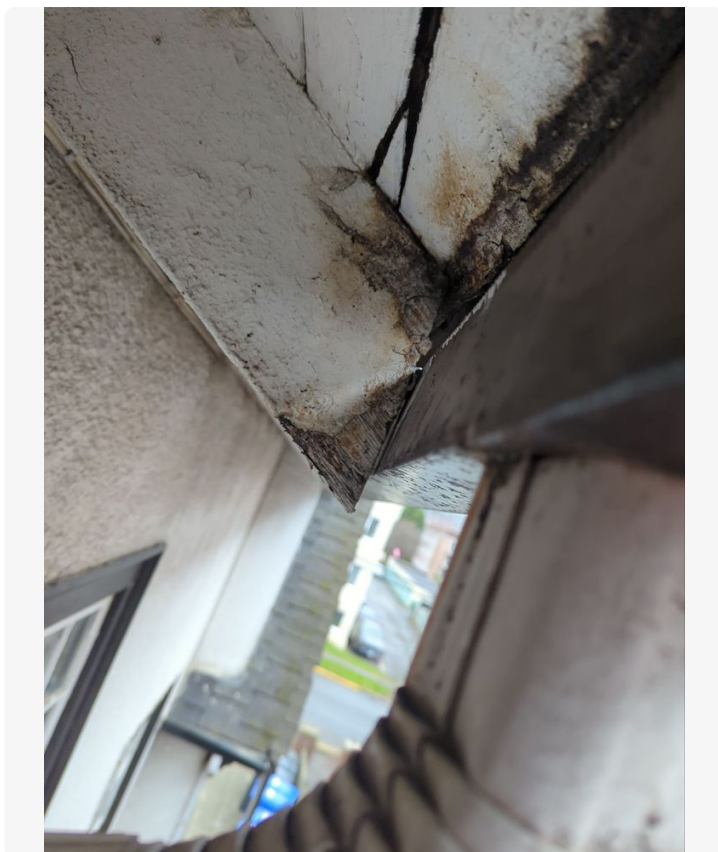
There was a lot of water damage to leading edges of the roof + the sheathing.

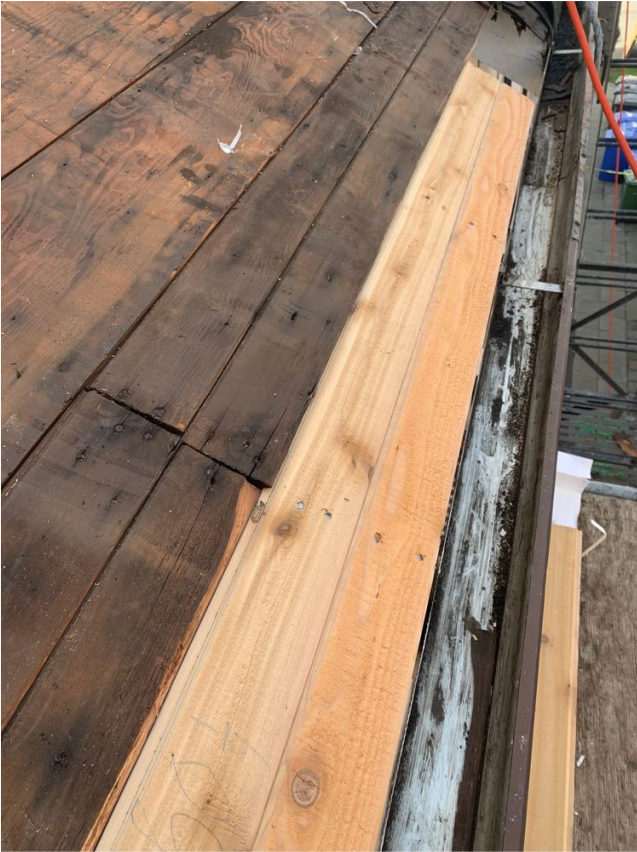
Many boards had to be replaced once we started the installation.

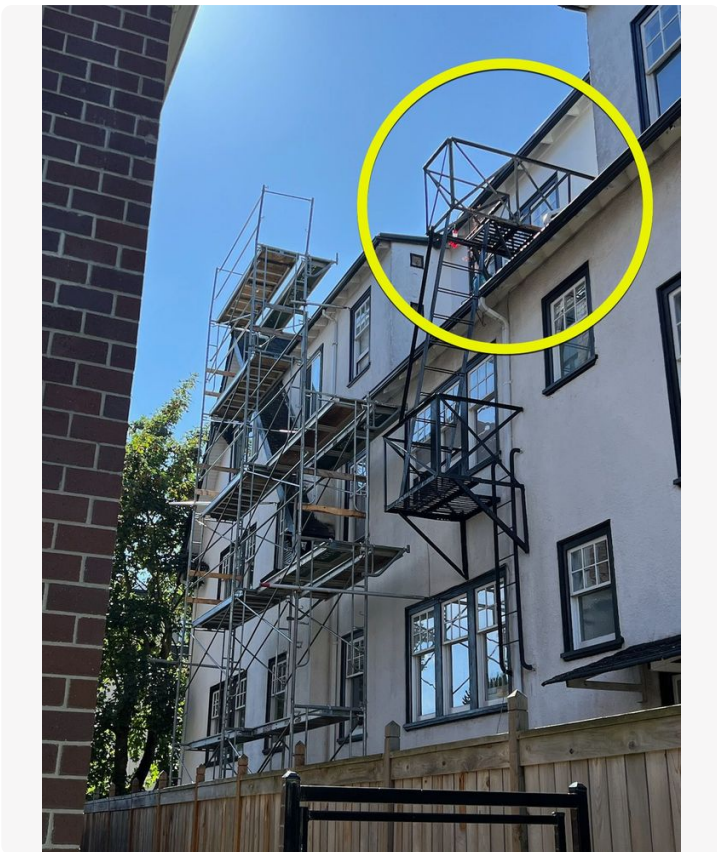
This fire escape needed a lot of work to keep it functional for the long term.

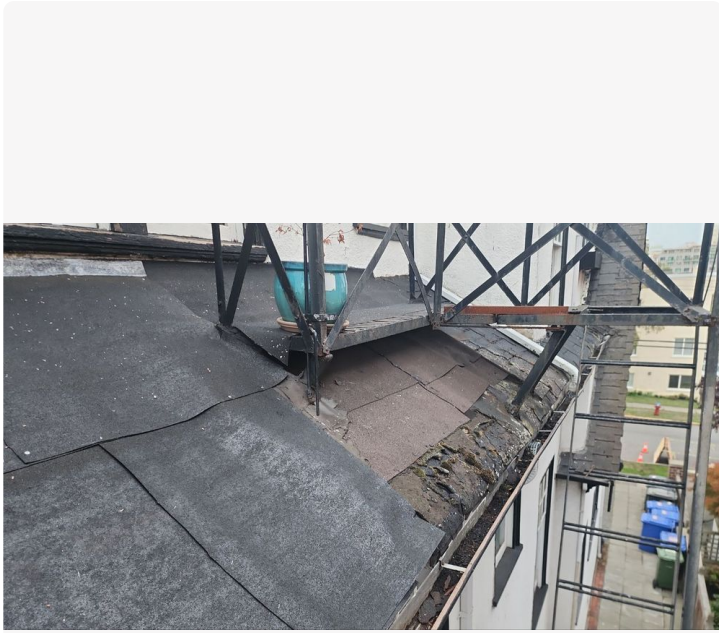
The bottom had been left open and was leaking.  
This could have lead to structural issues in the long term.

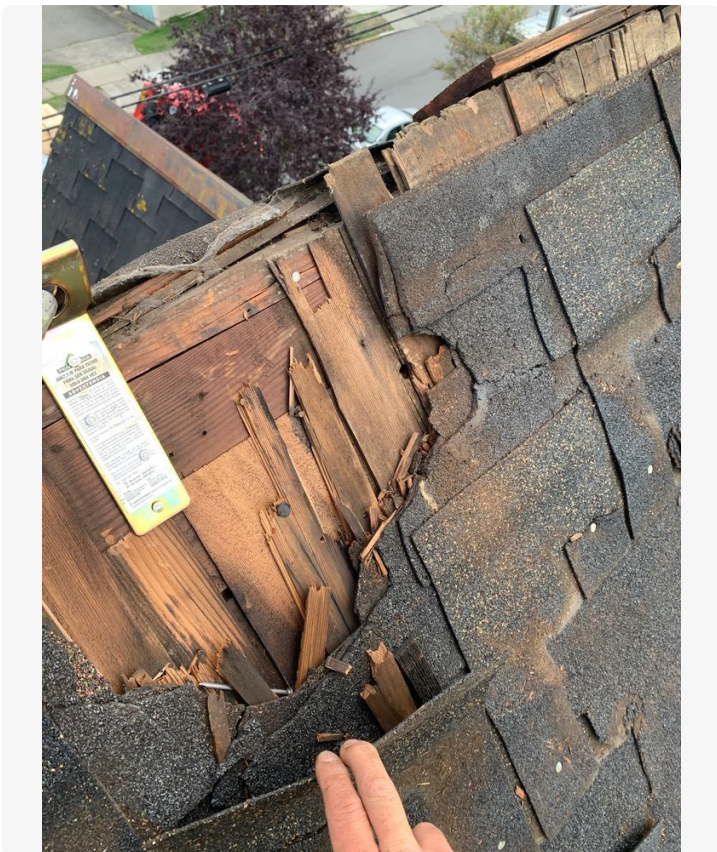
There were 3 layers of roofing to be removed on this project. A lot of work and disposal costs. Especially since you cannot mix wood and asphalt anymore for the landfill.

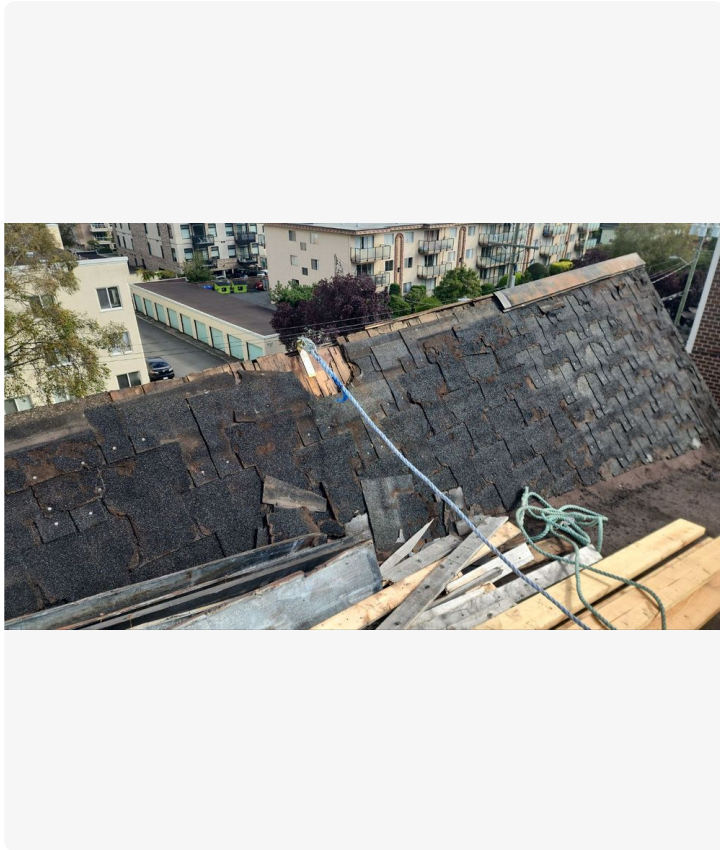
You can see the condition of the shingles + the many layers here.

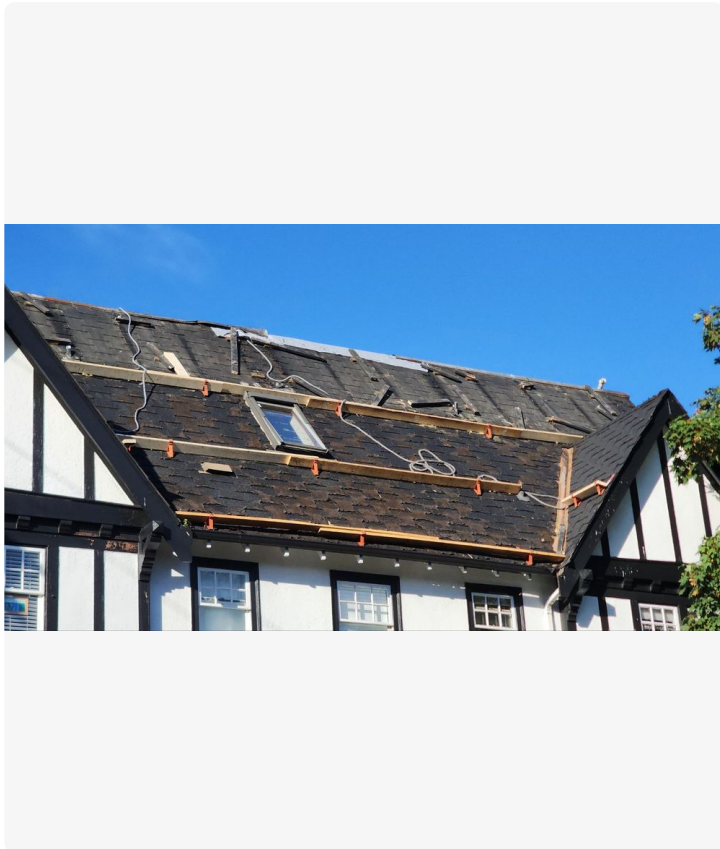
A very steep roof = difficult installation + safety measures such as scaffolding, flagging, closing walkways, permits..etc

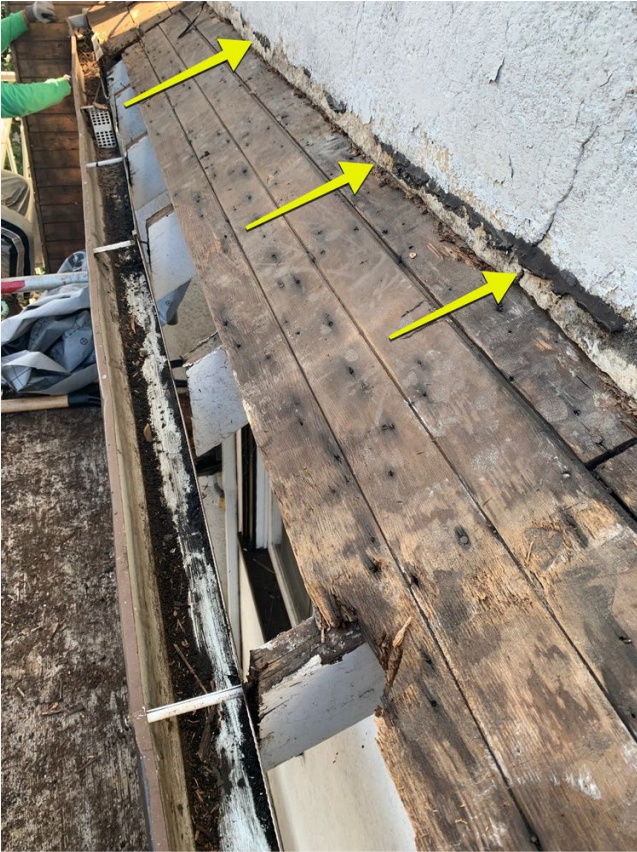
Much of the lower edges of the siding were damaged and needed to be mitigated for the new roof.

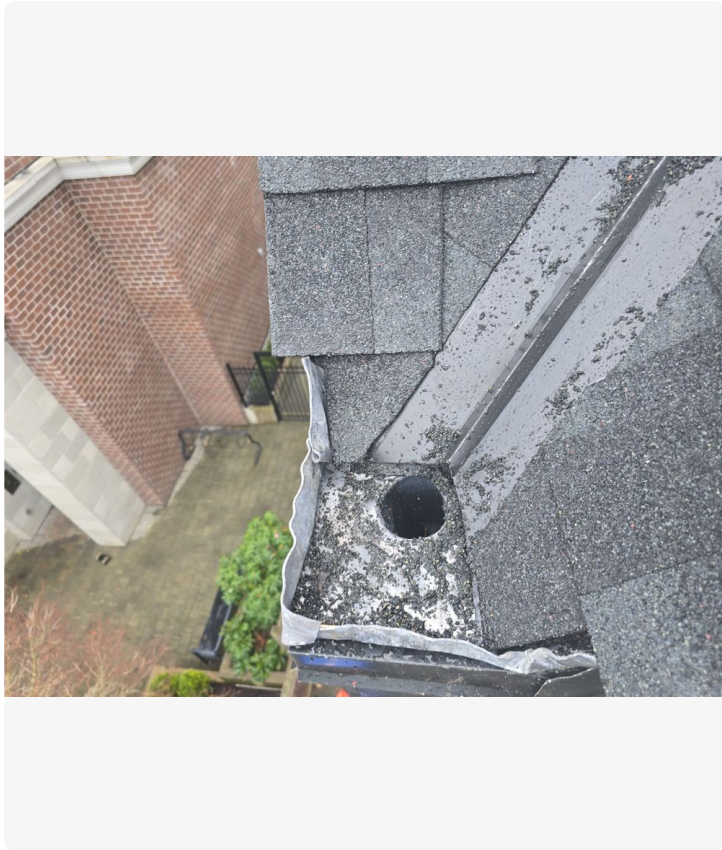
All these drain corners were rotted out and required a reasonable amount of repairs.

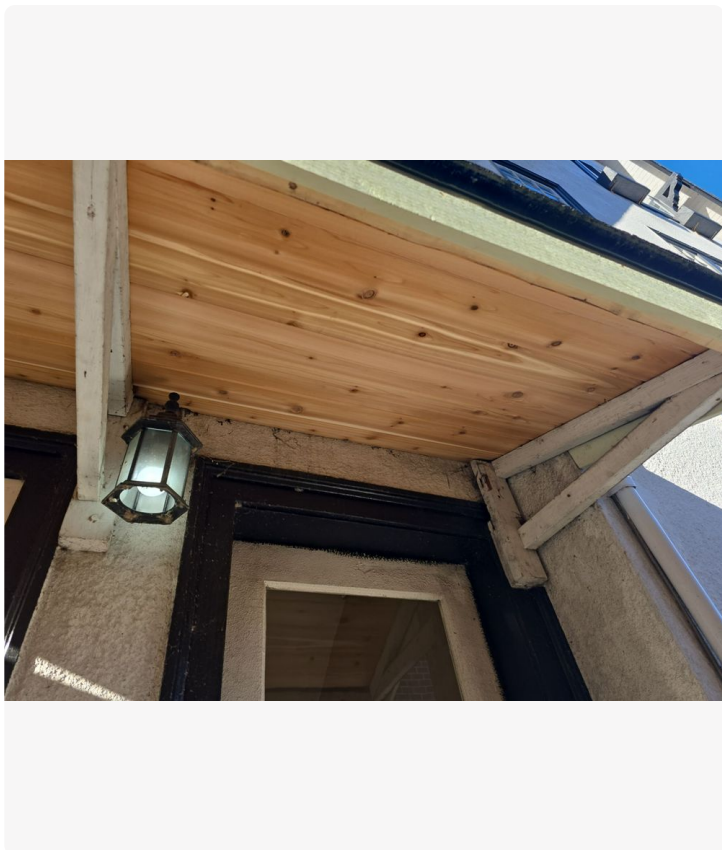
The lower awning roof required rebuilding.
