# TRI-TECH PINNACLE

## Roof Condition Report - Island Manor Apartments - 1855 Fort Street, Victoria, BC

**Report Number:**

221235

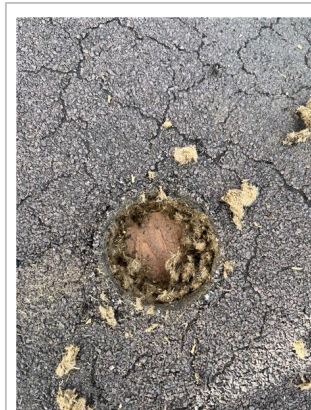
Core Sample

The core cut was taken to verify the roof condition and composition in this particular location on the roof. The roofing assembly is:

- 2 Ply Modified Bitumen Roofing Membrane
- 0.5" Fibreboard
- Wood Deck

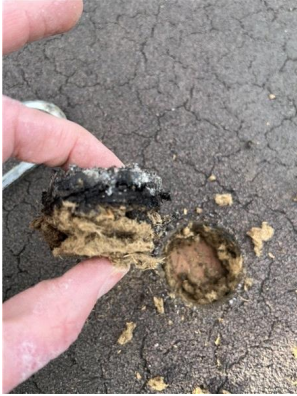
Core Sample 1

Close up of the roofing assembly:

- 2 Ply Modified Bitumen Roofing Membrane
- 0.5" Fibreboard
- Wood Deck

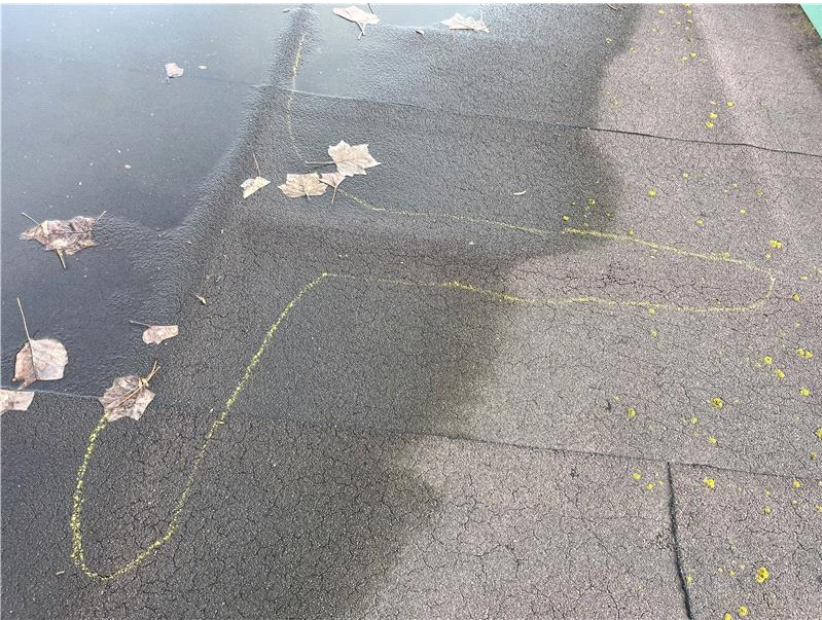
◆  
**Condition:** Blister  
**Severity:** High  
**Quantity:** 4

Blisters are an indication that either air or moisture are trapped within the roofing system. +/-20 blisters were noted on this roof level.

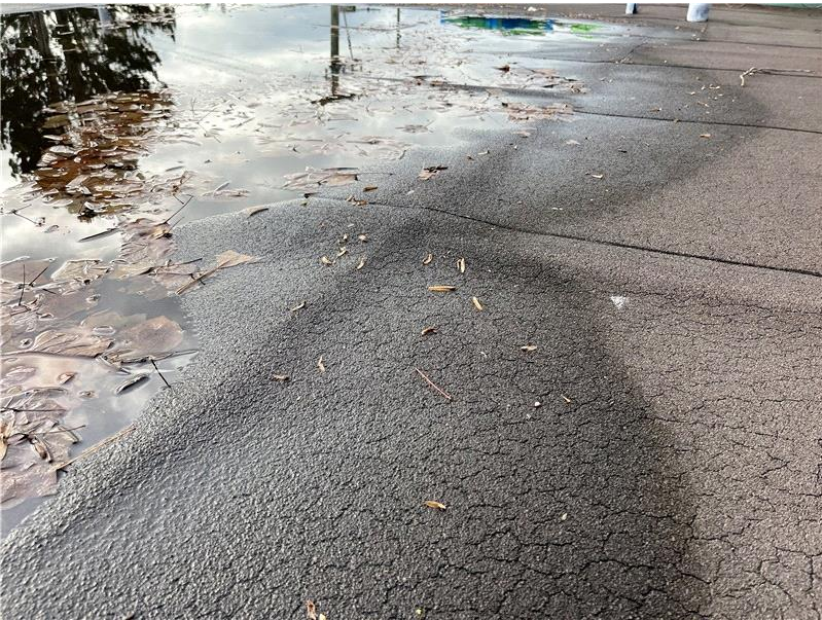
◆  
**Condition:** Blister 1  
**Severity:** High  
**Quantity:** 1

Another view of the large blisters noted on the roof level.

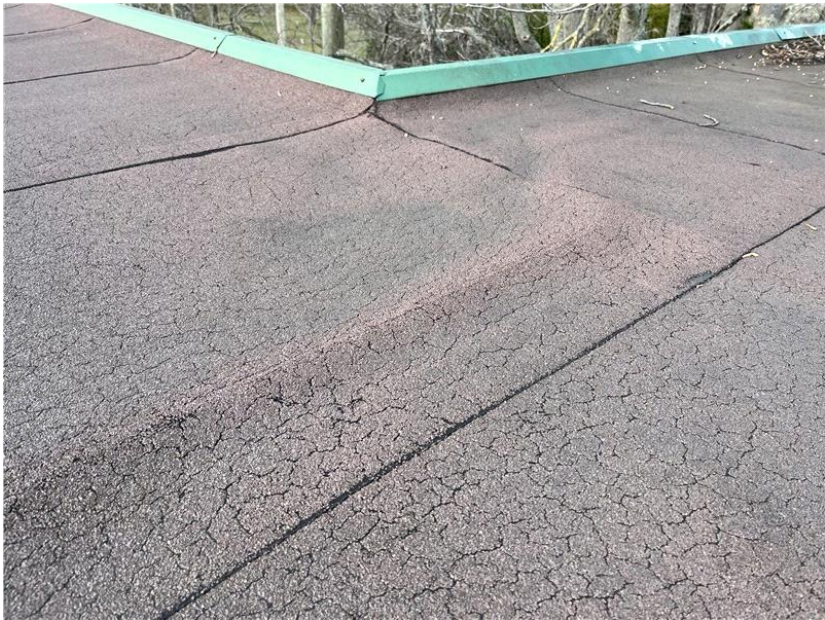
**Condition:** Blister 2  
**Severity:** High  
**Quantity:** 1

Another large blister noted on the roof level.

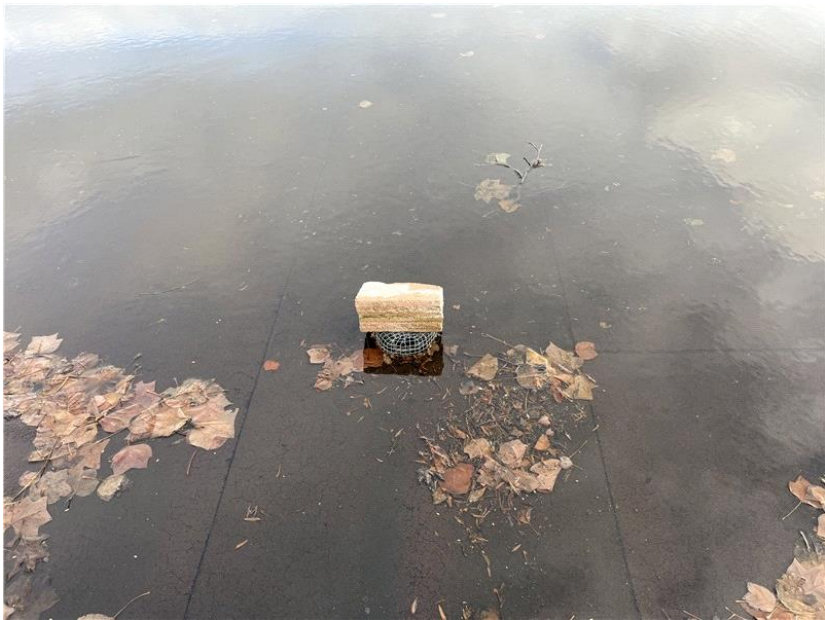
**Condition:** Drain- clogged  
**Severity:** High  
**Quantity:** 1

The drain pipe is clogged preventing proper drainage of the roof. A plumbing contractor should be contacted to clear the roof drain and ensure proper underside connections.

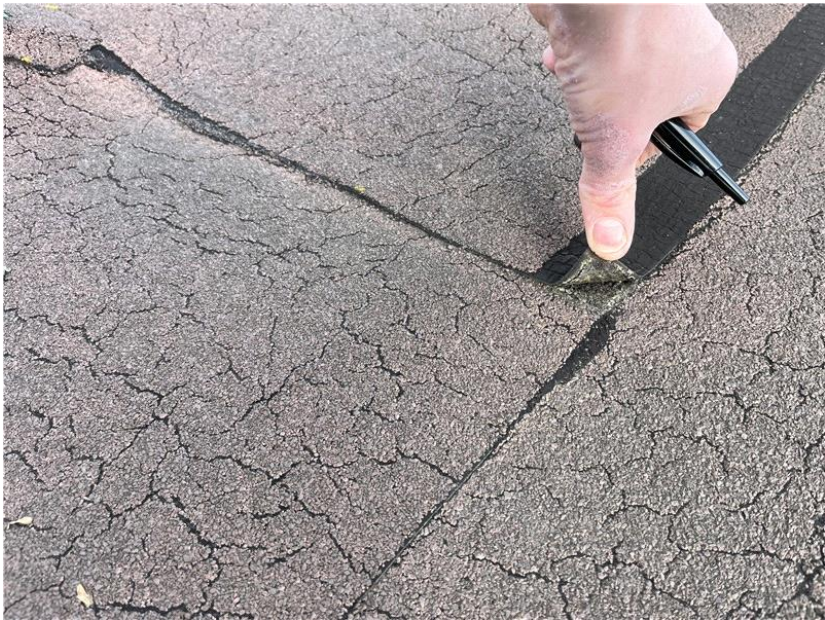
**Condition:** Open seam  
**Severity:** High  
**Quantity:** 1

Open field roofing membranes were noted on this roof level. This condition may be allowing water to enter the roofing assembly and/or building.

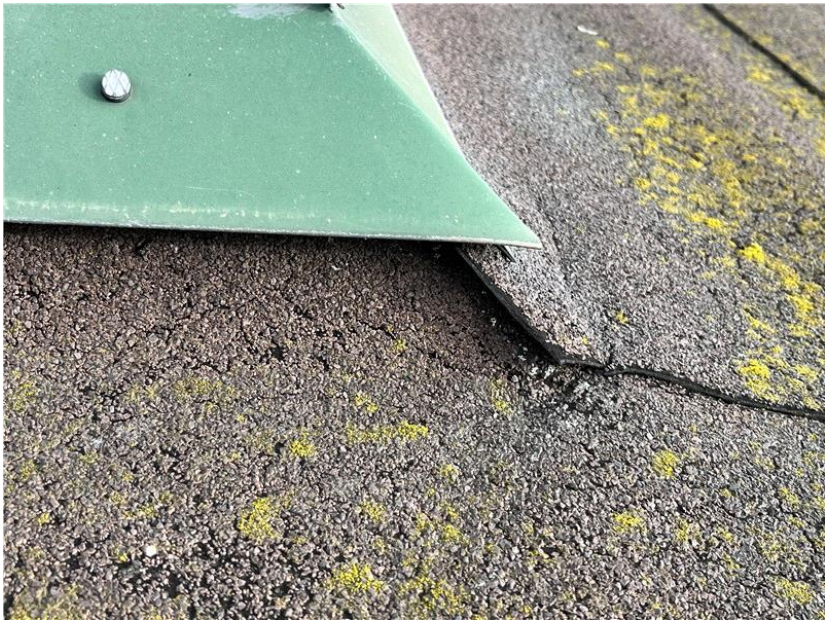
**Condition:** Open seam at base flashing  
**Severity:** High  
**Quantity:** 1

Open flashing membranes were noted around a unit curb on this roof level. This condition may be allowing water to enter the roofing assembly and/or building.

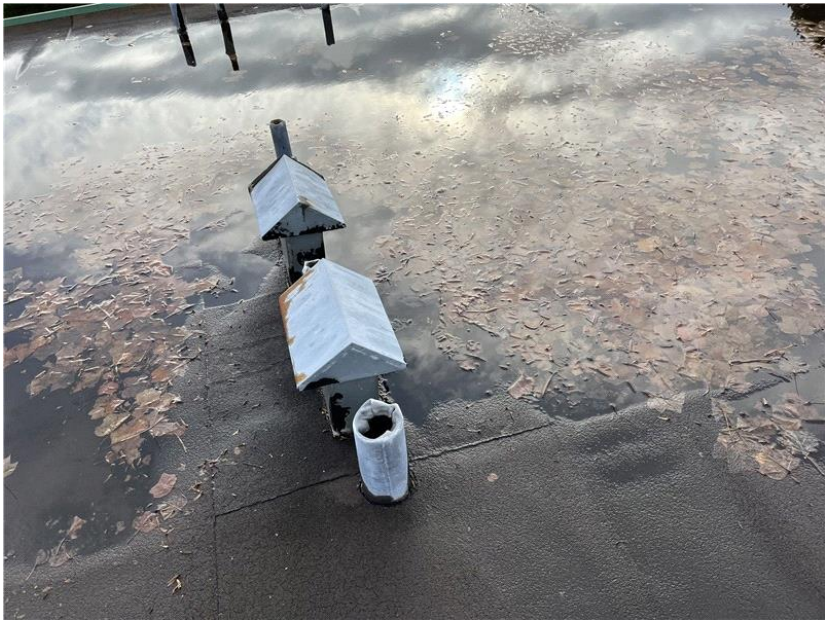
**Condition:** Corrosion  
**Severity:** Medium  
**Quantity:** 1

Minor corrosion was noted at the breather vents installed on this roof level.

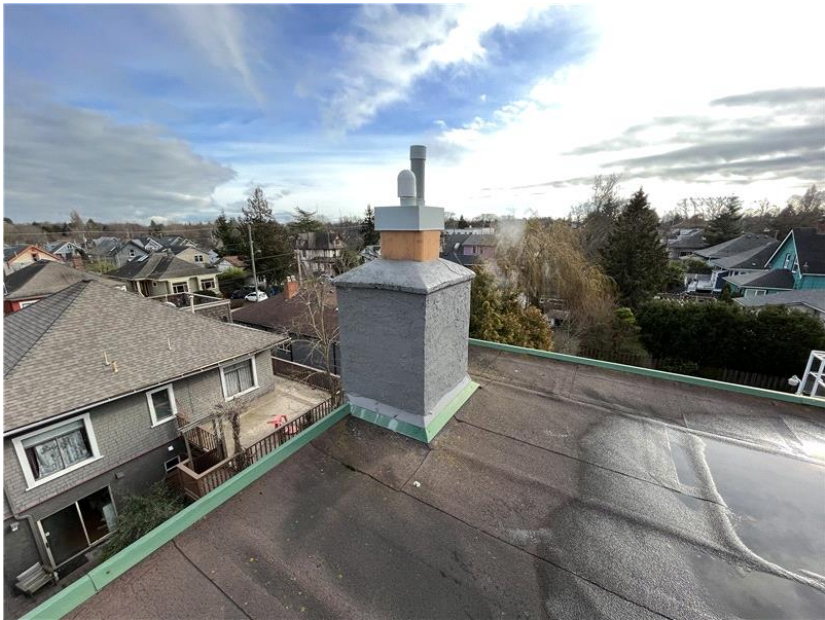
**Condition:** Deteriorated chimney  
**Severity:** Medium  
**Quantity:** 1

Cracks and deteriorated masonry was noted on the brick chimney.

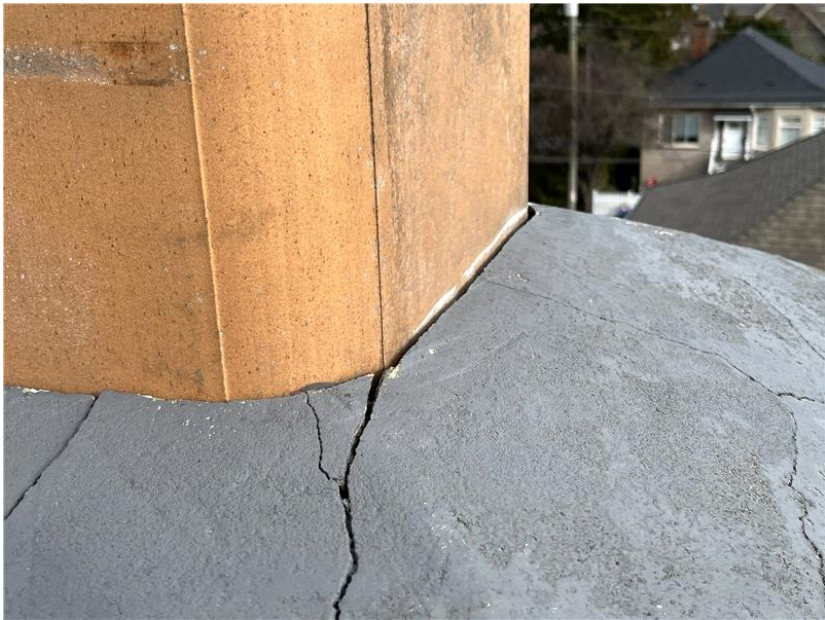
**Condition:** Deteriorated chimney 1  
**Severity:** Medium  
**Quantity:** 1

Close up of the cracks noted in the brick chimney.

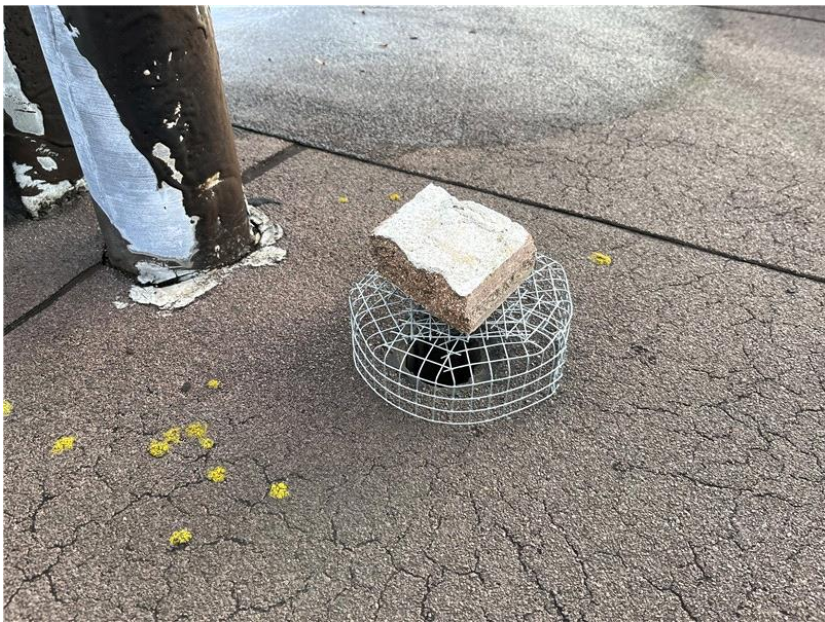
**Condition:** Drain- Strainer  
**Severity:** Medium  
**Quantity:** 1

View of improper drain strainer held in place by a brick. Without proper screen in place, roofing debris may be able to enter the drainage system and impede proper water flow.

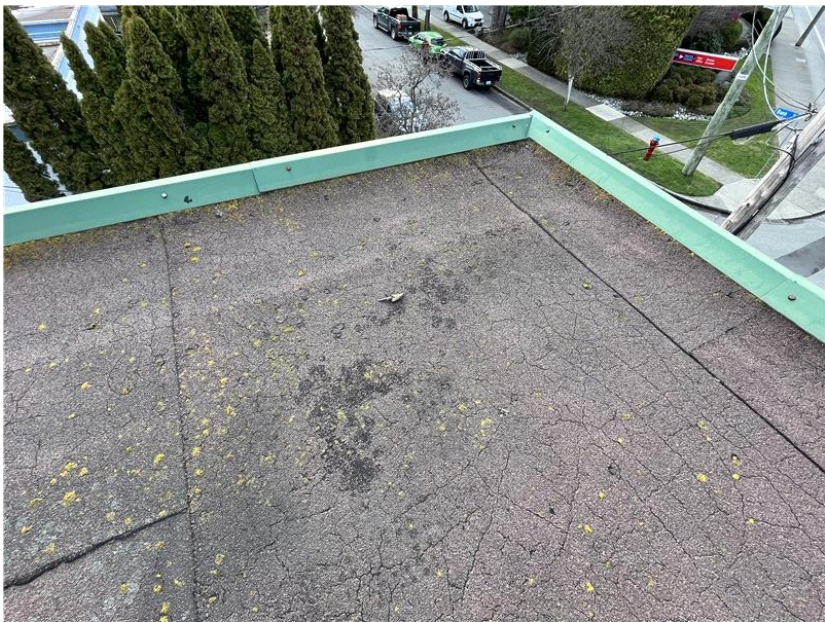
**Condition:** Loss of granules  
**Severity:** Medium  
**Quantity:** 1

The surfacing mineral granules have come off the cap sheet, exposing the underlying felt.

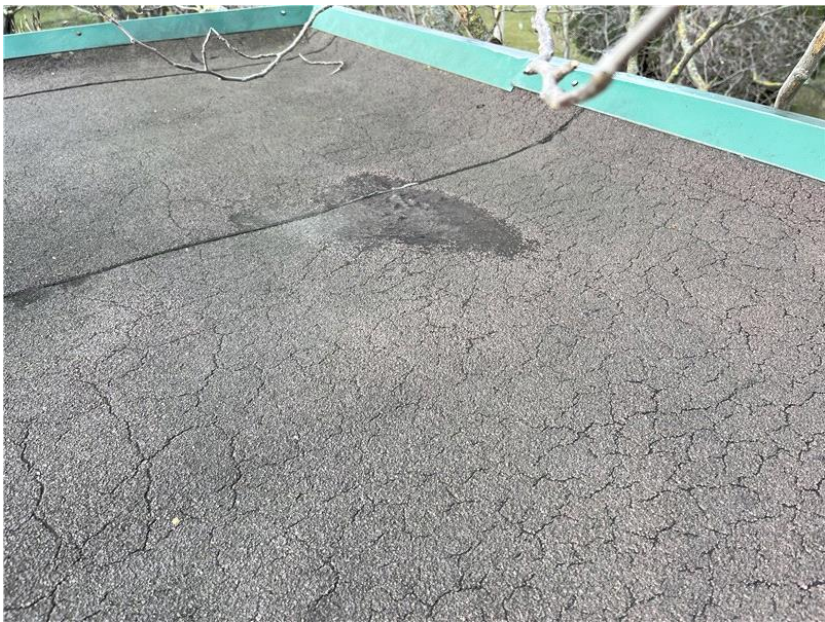
**Condition:** Loss of granules 1  
**Severity:** Medium  
**Quantity:** 1

Another view of the de-granulated cap sheet.

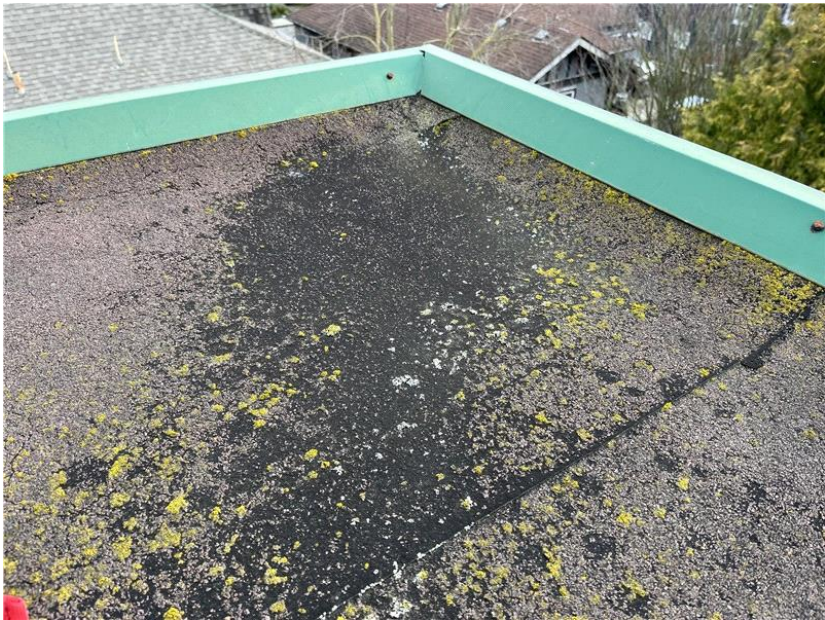
**Condition:** Loss of granules 2  
**Severity:** Medium  
**Quantity:** 1

Another area with de-granulated cap sheet.

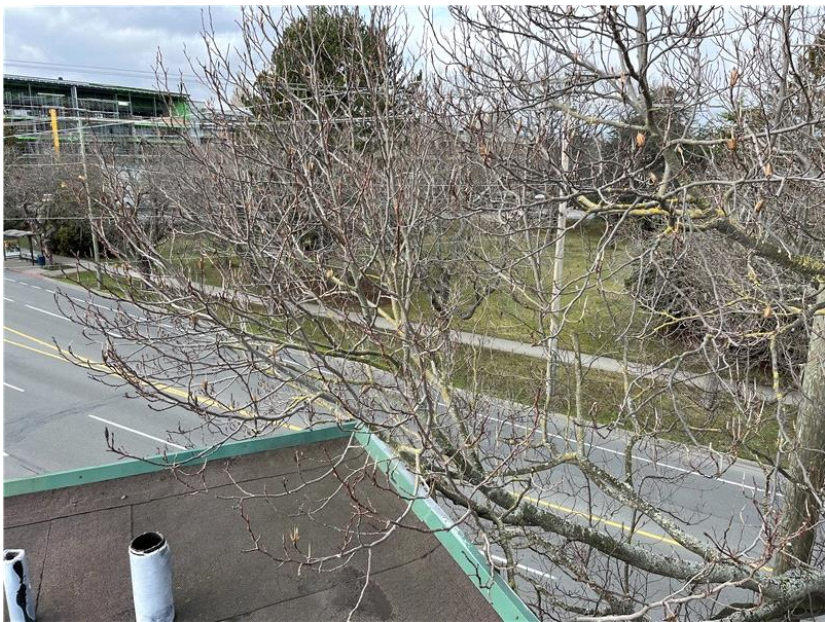
**Condition:** Overhanging Trees  
**Severity:** Medium  
**Quantity:** 1

Overhanging trees were noted along the perimeter of this roof level. The tree branches may scrape the roofing membranes and and deposit organic debris onto the surface of the roof, which will clog roof drains and impede drainage.

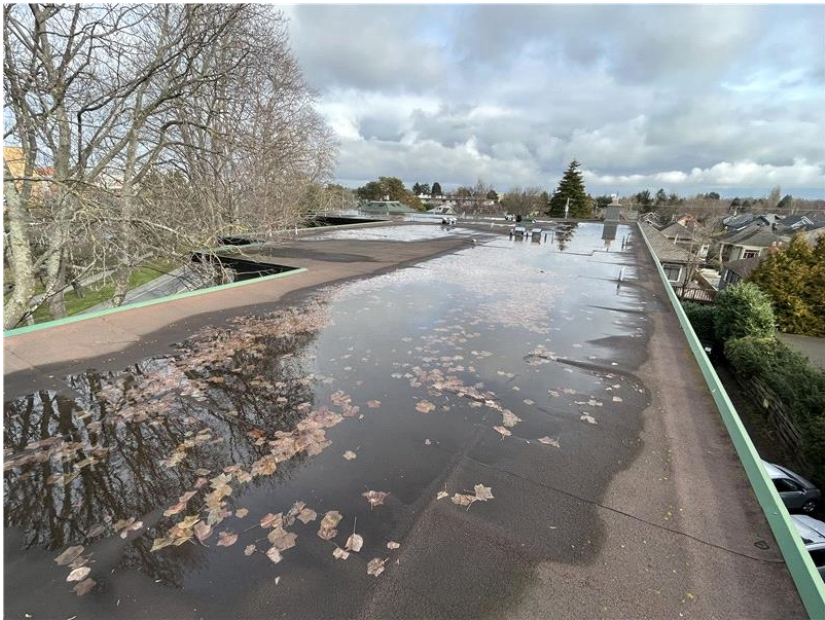
**Condition:** Ponding  
**Severity:** Medium  
**Quantity:** 1

Ponding water was observed throughout this roof level. It appears that the drains and/or control flow weirs may be clogged.

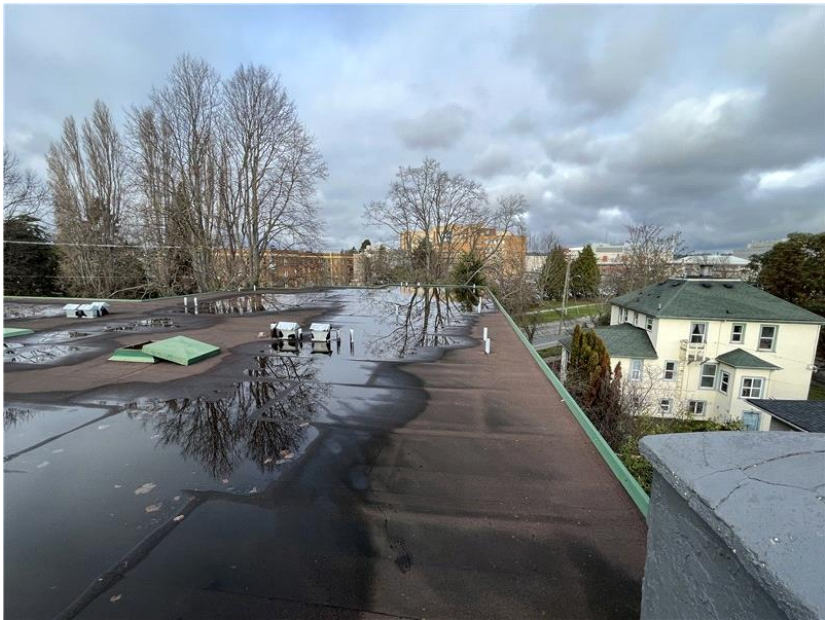
**Condition:** Ponding 1  
**Severity:** Medium  
**Quantity:** 1

Another view of the ponding water observed on this roof level.

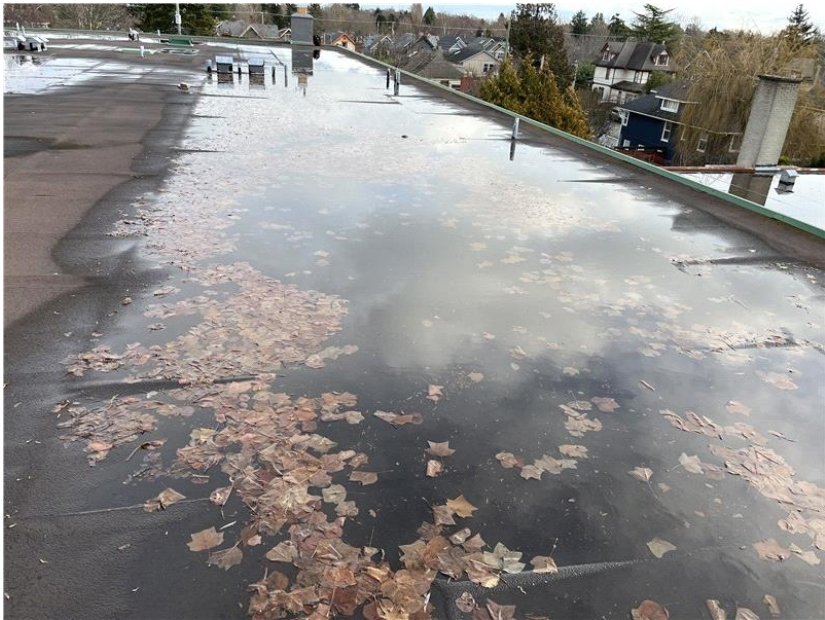
**Condition:** Ponding 2  
**Severity:** Medium  
**Quantity:** 1

More ponding water.

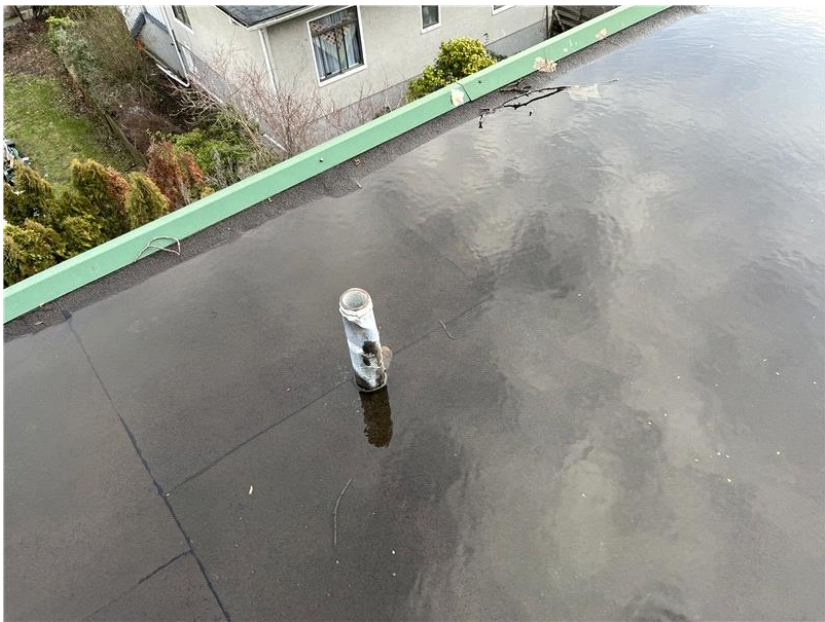
**Condition:** Ponding 3  
**Severity:** Medium  
**Quantity:** 1

More ponding water and a damaged soil stack.

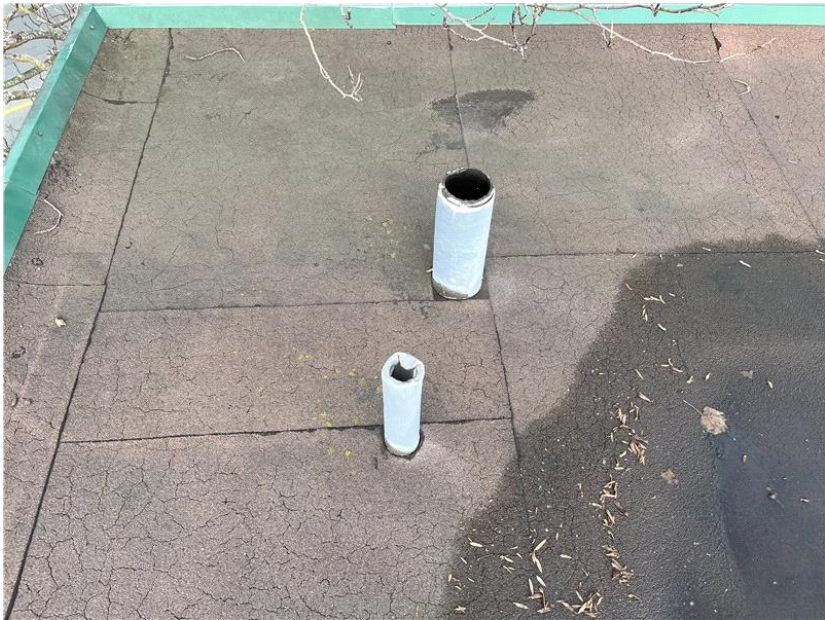
**Condition:** Sealant failure  
**Severity:** Medium  
**Quantity:** 1

The sealant around the soil stacks has deteriorated. This condition may be allowing water to enter the roofing assembly and/or building.

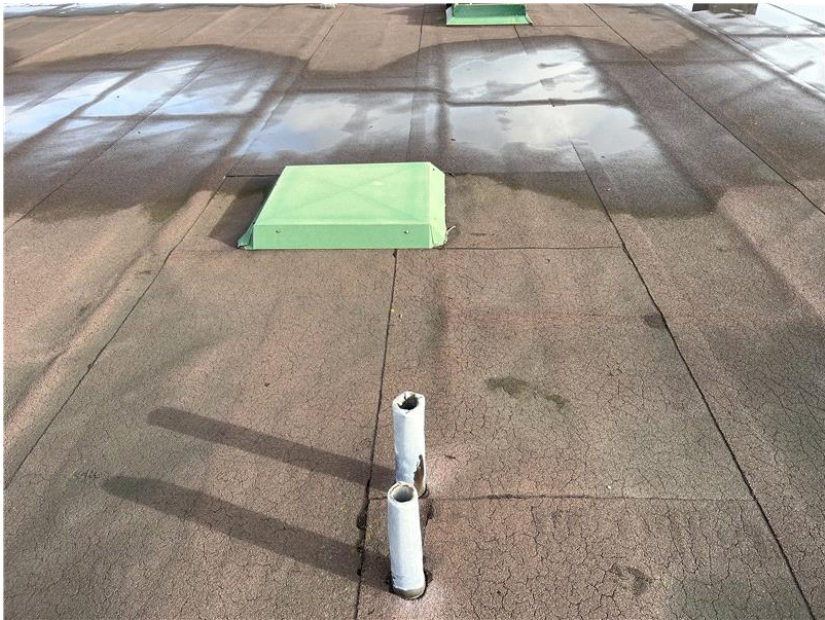
**Condition:** Alligatoring  
**Severity:** Low  
**Quantity:** 1

There is evidence of crazing of the top surface with hairline cracks (alligatoring).

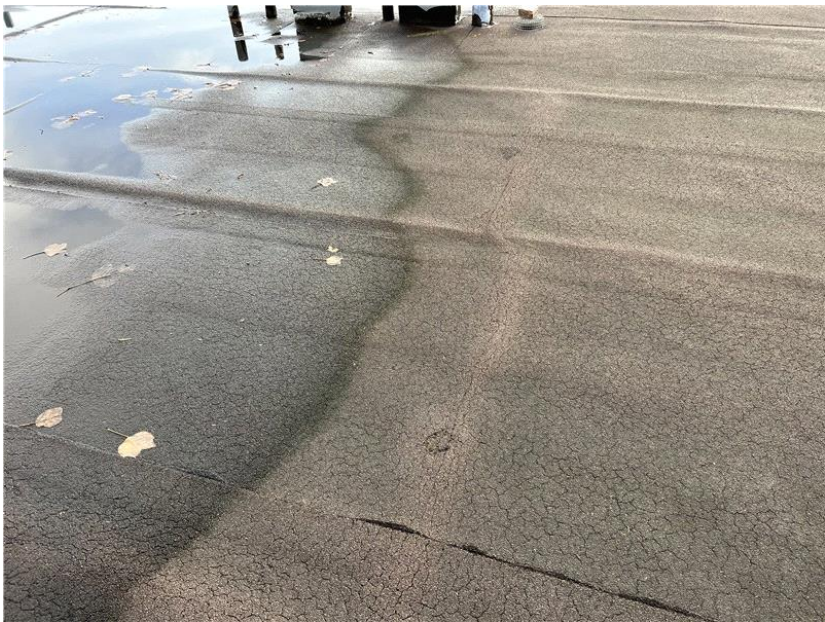
**Condition:** Alligatoring 1  
**Severity:** Low  
**Quantity:** 1

Another view of the alligatored roofing membrane.

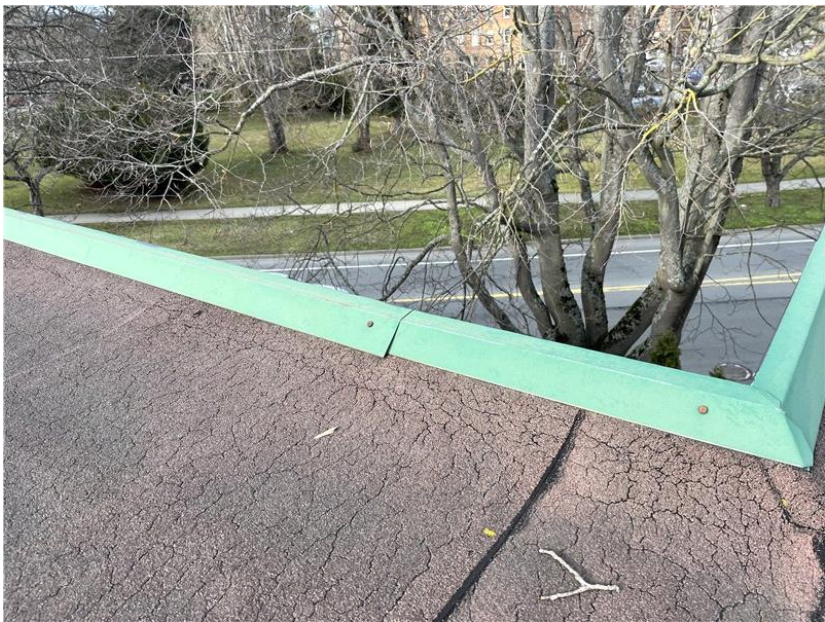
**Condition:** Fastener  
**Severity:** Low  
**Quantity:** 1

Metal cap flashings have been secured with standard roofing nails, which are also showing signs of corrosion. These sections are susceptible to leaks.

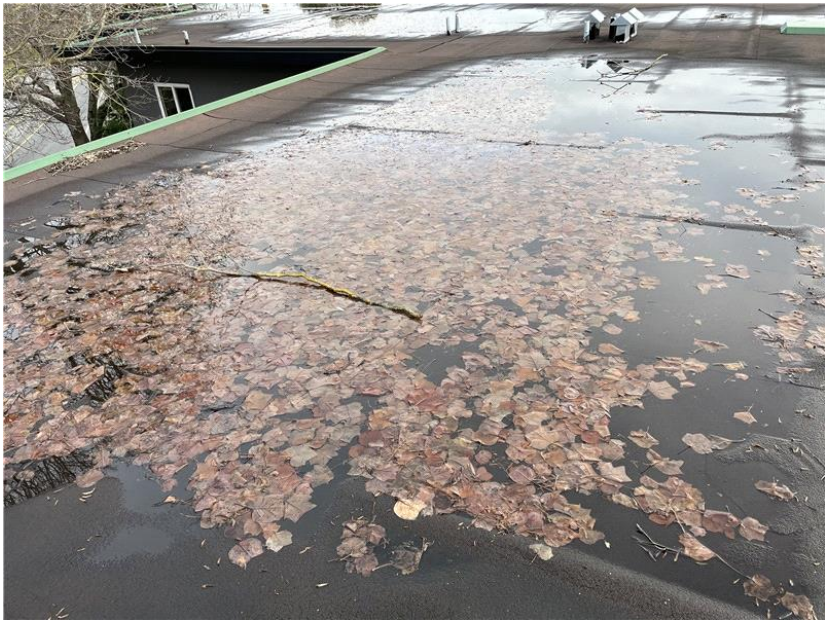
**Condition:** Organic debris  
**Severity:** Low  
**Quantity:** 1

Large accumulation of organic debris was noted on this roof level.

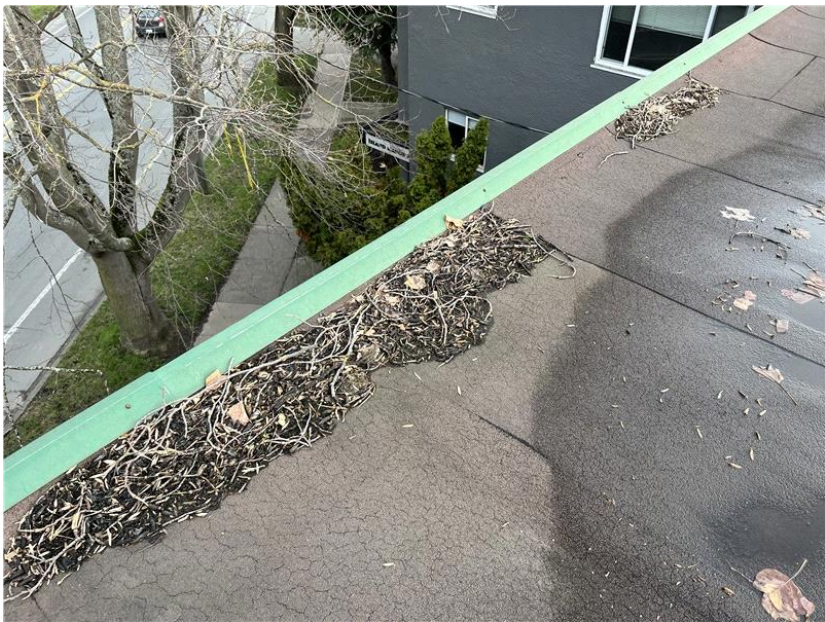
**Condition:** Organic debris 1  
**Severity:** Low  
**Quantity:** 1

More organic debris at the perimeter.

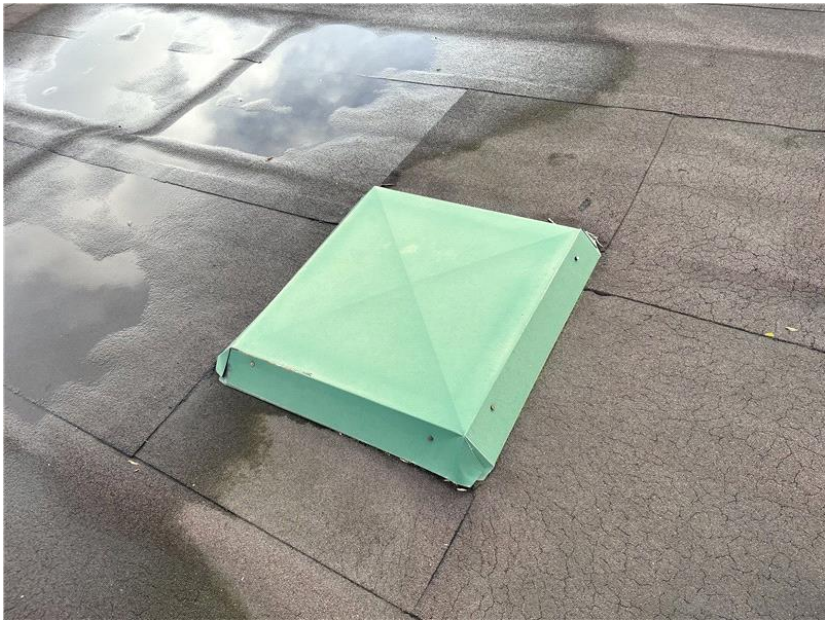
**Condition:** Redundant Curb  
**Severity:** Low  
**Quantity:** 0

This redundant curb has been completed with a height lesser than 8" with improper method of waterproofing. Section should be properly sealed with plywood, insulation, and membrane.
