## FIELD REVIEW REPORT No. 7

**Project:** Carlton Park Gardens,  
10851 – 10991 Mortfield Road,  
Richmond  
Exterior Siding Replacement  
**Project No.:** 23vR134A

**Date of Visit:** August 22, 2024  
**Weather:** Cloudy, 19°C  
**Time on Site:** 9:30am – 10:00am  
**Contractor:** Roma Building Restoration Ltd.  
**Workforce:** 2

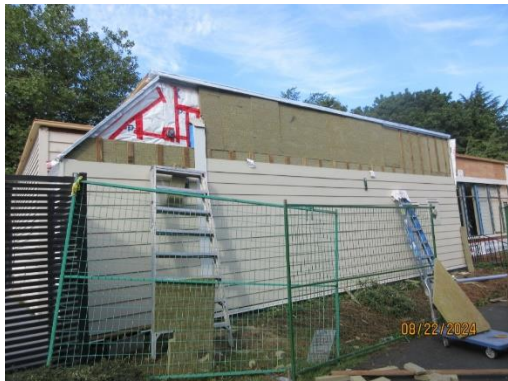
Photo 1): Ongoing siding installation on the east elevation.

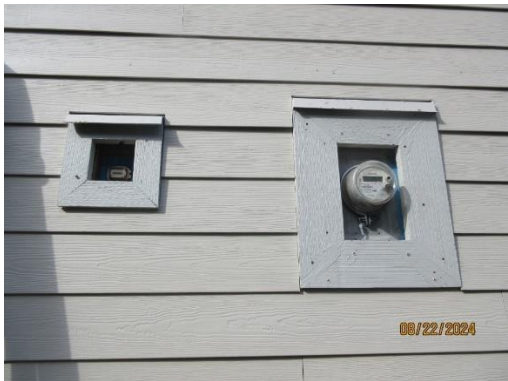
- Termination sealant was missing at the self-adhered membrane (SAM) where lapped onto the water monitoring device and light fixture. Roma agreed to install termination sealant, as specified.

- The SAM around the water monitoring device had two nail holes in it. Roma agreed to repair the holes before flashing is installed.
- SAM was not installed at the base of the northern section of wall. Roma advised SAM will be installed before base-of-wall flashing.

Photo 2): Trim and flashing at wall-mounted devices on the east elevation

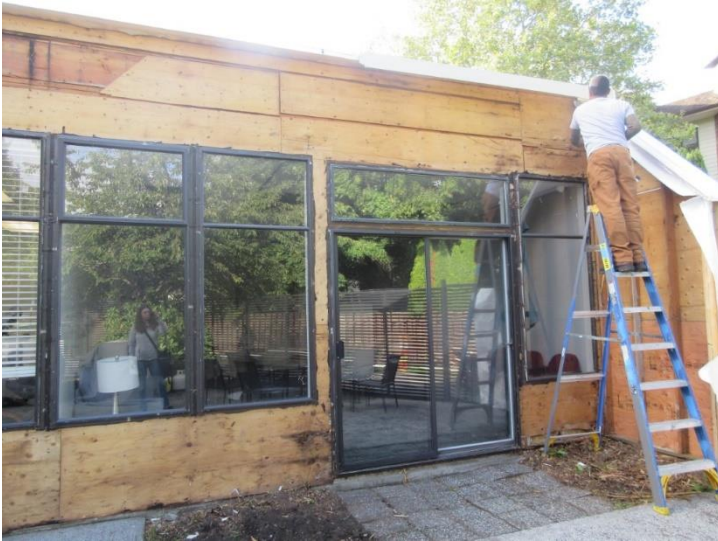
Photo 1): Demolition in progress on the north elevation.

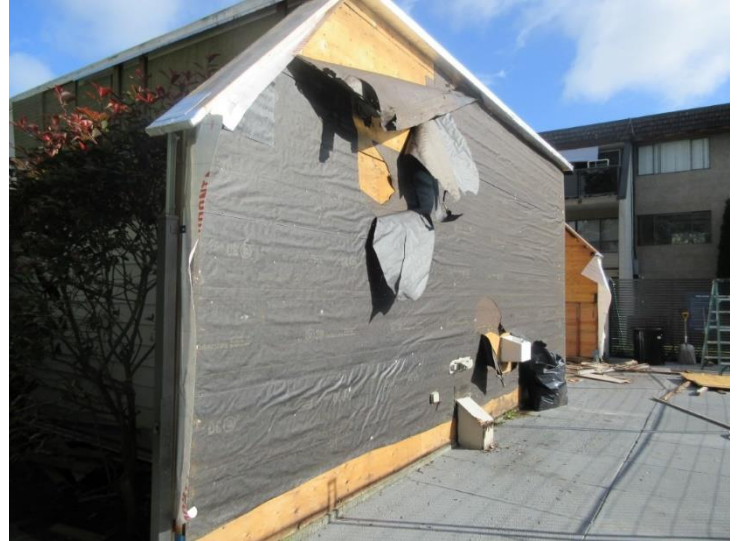
Photo 2): Demolition in progress on the south elevation.

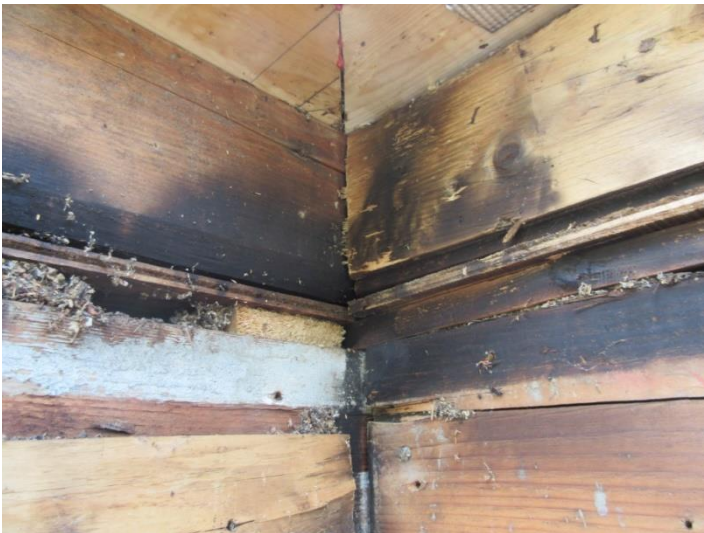
- There are burn marks on the wood framing above the swing door, likely from a past fire. The framing appears to be in good condition with only surface-level damage. Roma to lightly sand the damaged framing and treat with Boracol.
- The framing at one jamb of the swing door was rotten. Roma agreed to install a new full height studs.
- The joist above the main wall was sloped inwards. Roma agreed to install furring to ensure the wall is plumb.

Photo 3): Burn marks at framing on the north elevation.

| Date Recorded | Description | Action By | Due Date |
|---|---|---|---|
| | Sand burnt wood on north elevation and treat with Boracol | Roma | Ongoing |

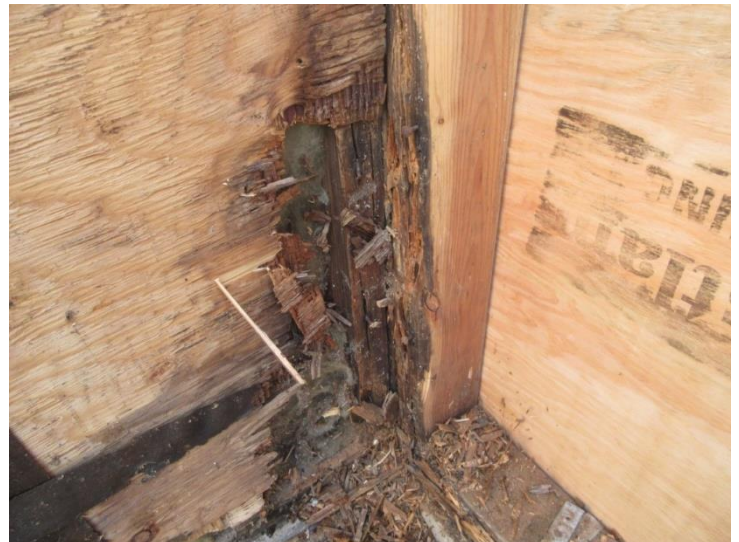
- Wood appears to be rotten in the following locations:
  - At the sill plate along the western section of the wall.
  - At one jamb of the swing door.
  - At the wing wall corner.Roma agreed to remove the sheathing at these locations and send Sense photos of the framing for review.
- Sense to discuss the water pipe at the base of the wall internally and advise.

Photo 4): Rotten framing on the south elevation.

| Date Recorded | Description | Action By | Due Date |
|---|---|---|---|
| | Remove sheathing where discussed on the south elevation and send Sense photos for review | Roma | 2024-09-20 |

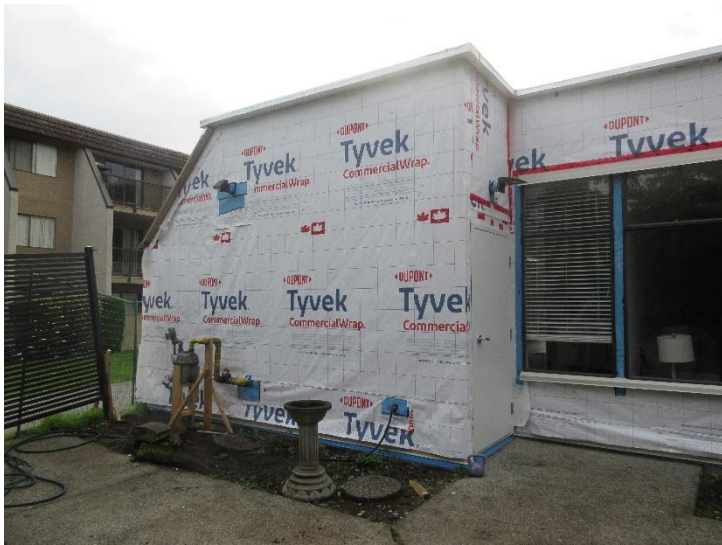
Photo 1): Siding installation in progress on the north elevation.

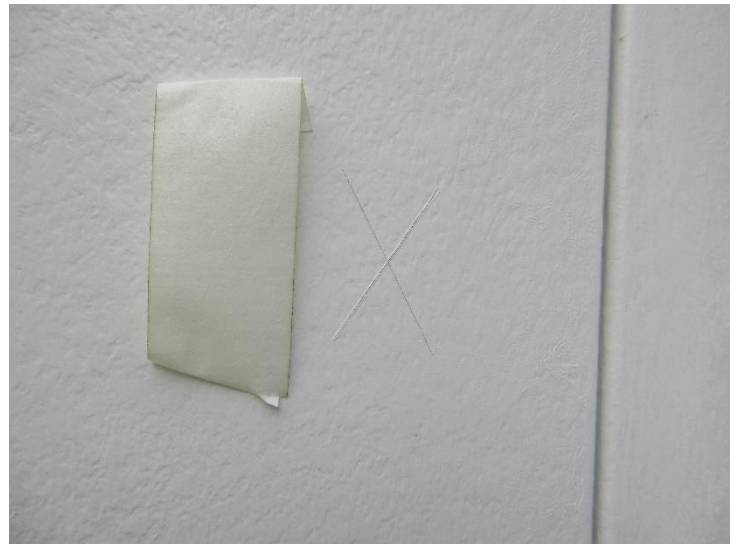
Photo 2): Passed paint adhesion test on the new north elevation door.

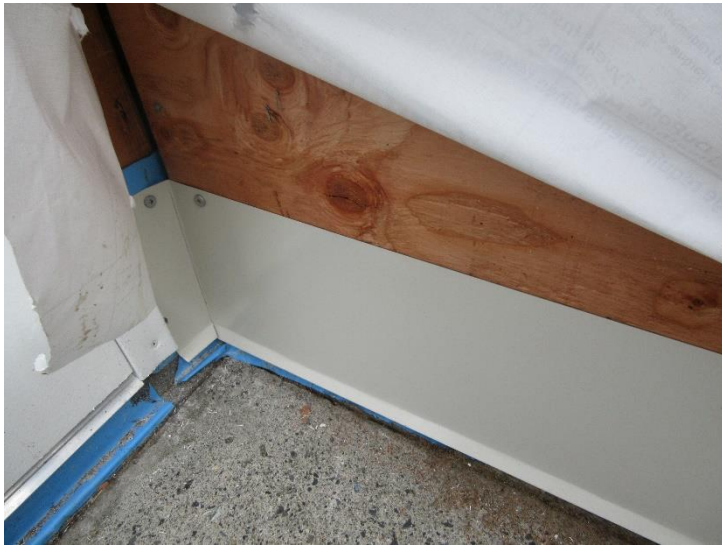
Photo 3): Self-adhered membrane not fully extended behind base of wall flashing.

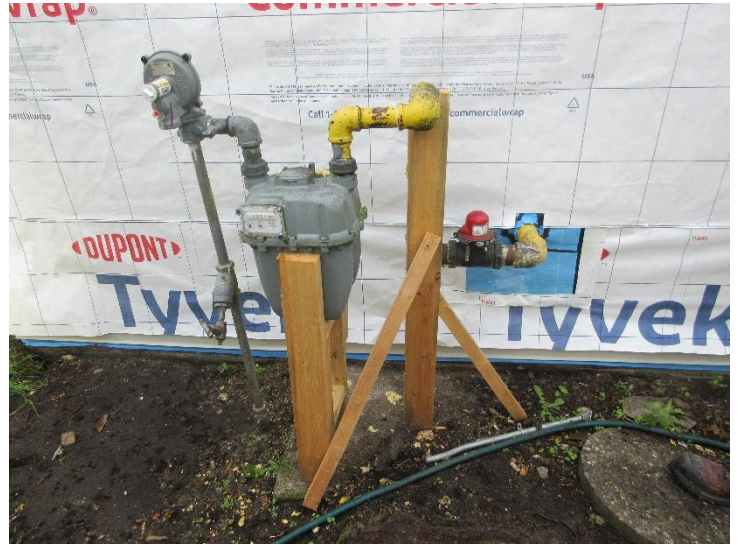
Photo 4): Blocking to be installed at gas meter brackets.
