## **BUILDING CONDITION ASSESSMENT**

### **CARLTON PARK GARDENS**

10851 / 10871 / 10891 / 10951 / 10971 /  
10991 MORTFIELD ROAD, RICHMOND

October 24, 2022

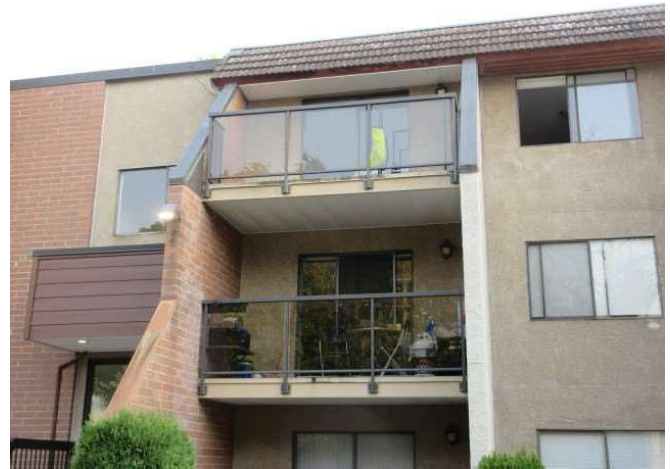
*Photo 7: Typical exterior walls.*

Other than the above, the exterior walls generally appeared to be performing well given their age, possibly due to the protection provided by the mansard roofs typically installed at the top of the exterior walls (see the *Roofs* section of this report for further discussion related to the mansard roofs). We assume that any local repairs to the exterior walls to address leaks, including local replacement of small areas of cladding can be carried out at costs below the report threshold throughout the report term.

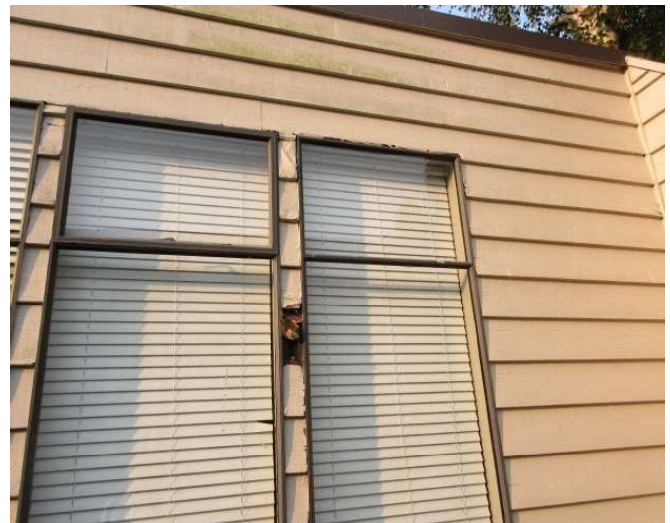
*Photo 8: Wood siding at the recreation centre.*

The wood siding at the recreation centre is rotted and there are likely concealed damages. We have budgeted for replacement of the siding and windows.

| Description | Classification | Present Cost | Timing (Year) | Cycle (Years) |
|---|---|---|---|---|
| Replace Cladding and Windows at the Recreation Centre | 3 | \$270,000 | 2024 | 40 |

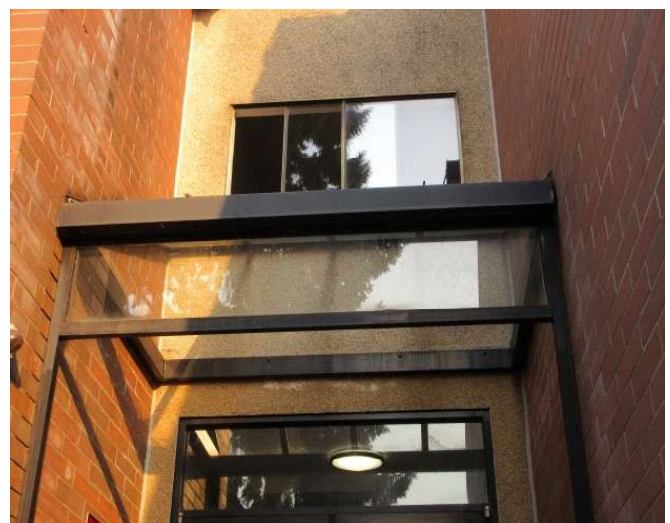
*Photo 9: Typical metal framed glass canopy of a front entrance.*

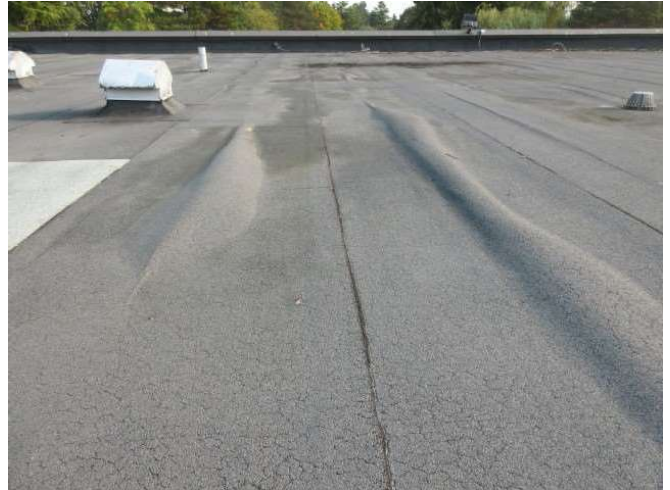
*Photo 13: Typical older modified bitumen roofing with blisters, ridges and cracked waterproofing.*

There are extensive blisters, ridges and cracks in the older modified bitumen roofs. There are also areas where water ponds and vegetation growth. Exposed modified bitumen roofs in the Lower Mainland climate tend to have a serviceable life of 20 years before they need to be replaced. This life expectancy assumes that proper materials were installed at the time of construction and proper application procedures were followed.

| Description | Classification | Present Cost | Timing (Year) | Cycle (Years) |
|---|---|---|---|---|
| Replace Roofs at the Regency Building | 3 | \$305,000 | 2025 | 20 |

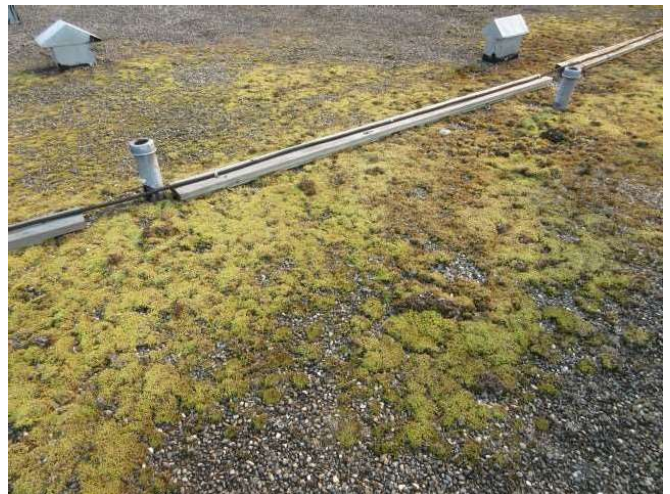
*Photo 14: Typical original roof with extensive vegetation.*

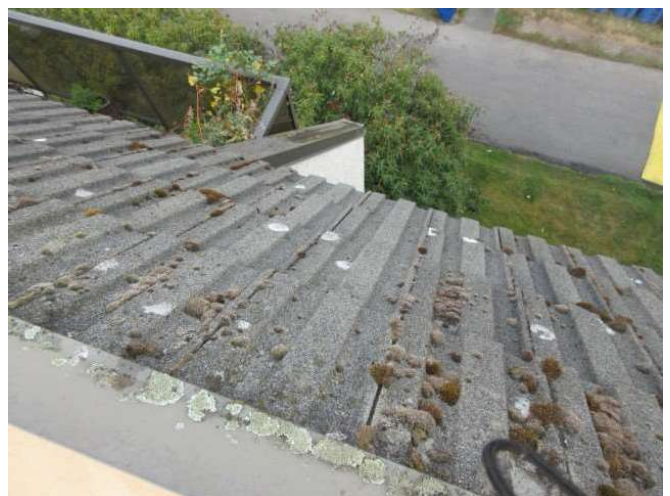
*Photo 15: Typical mansard roof with vegetation growth.*

The mansard roofs generally appeared to be in fair to good condition. The concrete tiles are cracked and broken at a few locations and there is some vegetation growth at the north elevations. We expect that the mansard roofs can be maintained beyond the report term.

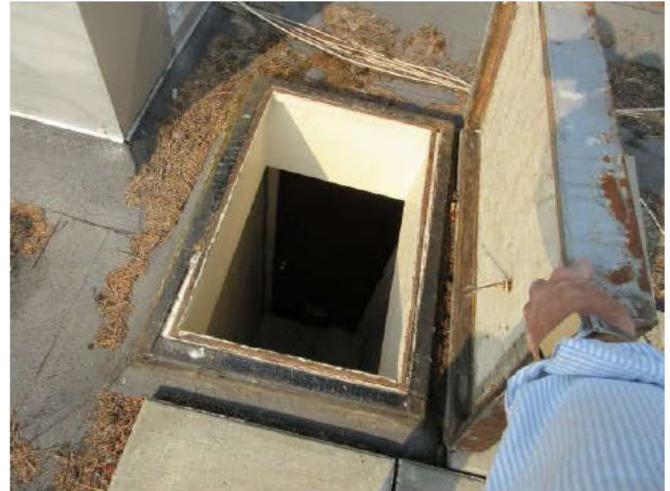
*Photo 16: Typical roof access hatch.*

The roof hatches are not hinged, they are heavy, difficult to open and close and should be replaced when the roofs are replaced.
