**FINAL**  
**Baseline Property**  
**Condition Assessment**  
8735 Selkirk Street, Vancouver,  
British Columbia

March 9, 2021

Pinchin File: 289294

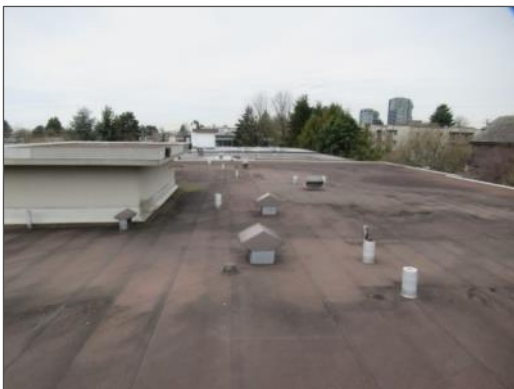
General view of the north modified bitumen roof system.

As previously mentioned, the roof systems atop the Site Building were reportedly installed in 2000 (i.e., ~ 21 years old). Due to the current age of the roof systems, Pinchin has carried allowances for replacement within the mid portion of the term of the analysis. Pinchin also recommends that the above noted minor deficiencies are addressed and that regular annual maintenance be performed on the roof systems throughout the term of the analysis.

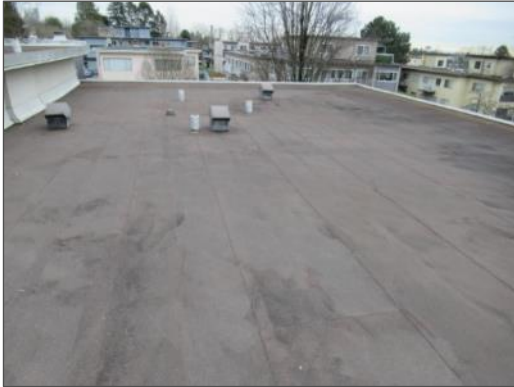
General view of the south modified bitumen roof system.

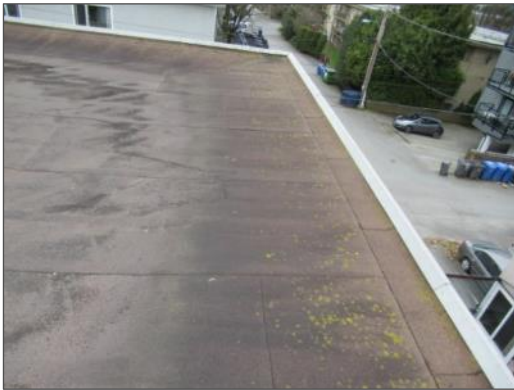
View of typical staining and organic growth atop the roof systems.

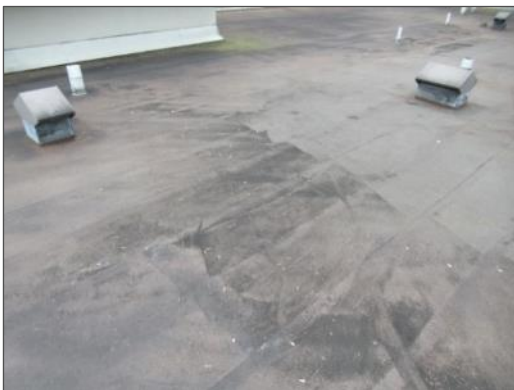
View of evidence of ponding water atop the north roof system.

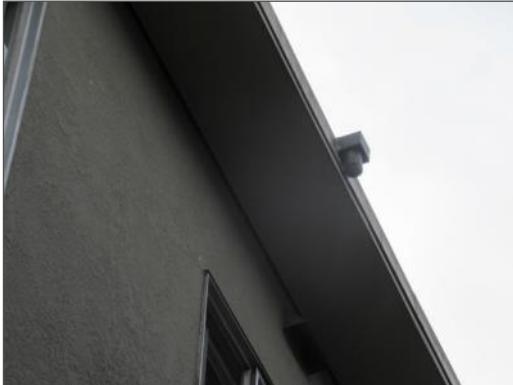
View of a missing downspout at a scupper drain on the west perimeter of the roof.

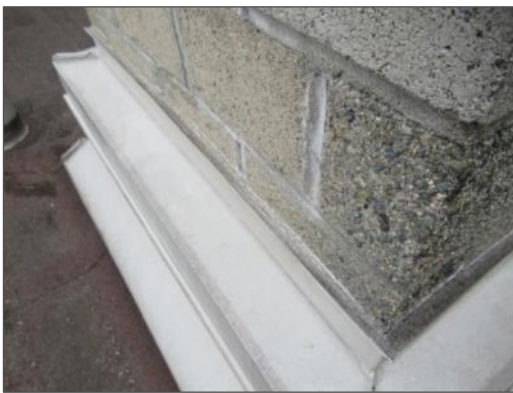
<ul style="list-style-type: none"> <li>Deteriorated sealants were noted at a portion of the flashing around the roof penetrations.</li> </ul>	<ul style="list-style-type: none"> <li>Replace the affected sealants.</li> </ul>

View of deteriorated sealant around the flashing at the chimney.

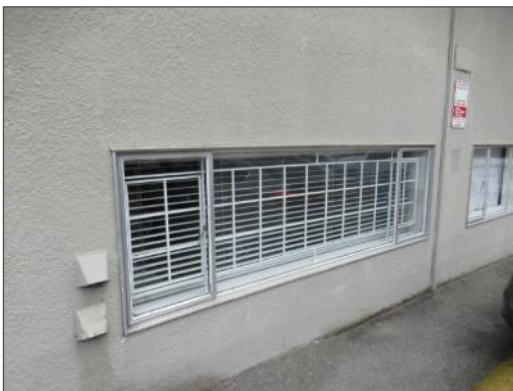
View of a typical SG window system at the Site Building.

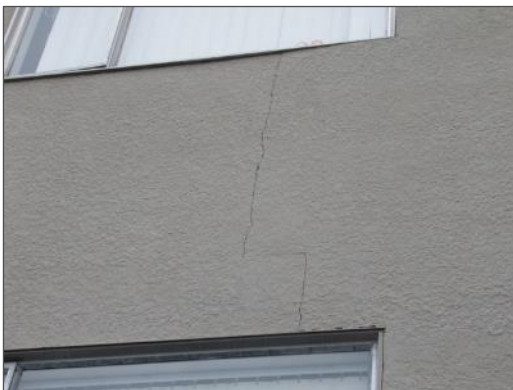
View of cracking in the stucco on the south elevation of the Site Building.

It has been Pinchin's experience that stucco is prone to micro cracking which may permit water infiltration over time. Pinchin recommends that the stucco be monitored throughout the term of the analysis and if deficiencies are observed that they be repaired.

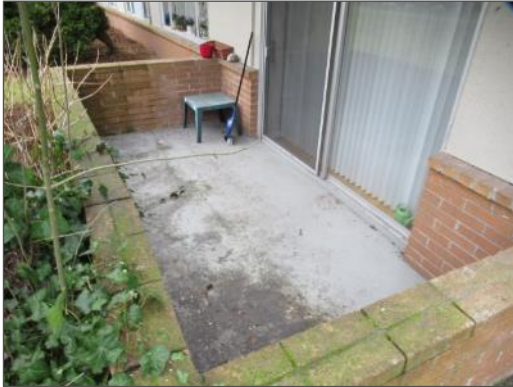
View of a grade level patio on the north elevation of the Site Building.

Note: The brick masonry retaining wall is bowed.

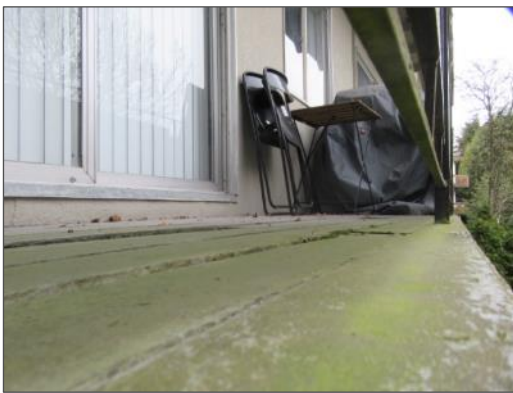
View of water staining and organic growth on the wood deck boards serving a balcony system.

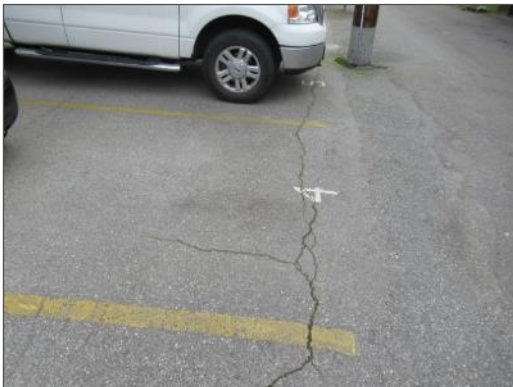
View of cracking in the asphalt paved parking lot.

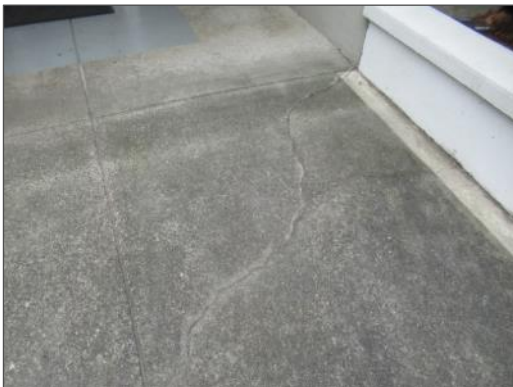
View of cracking in the concrete walkway adjacent to the main entrance on the east elevation.

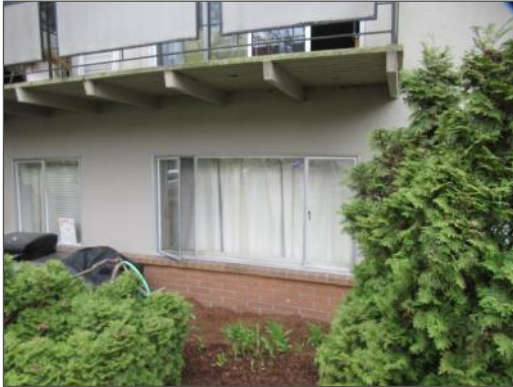
View of mulch which has been installed against the brick masonry on the north elevation of the Site Building.

The Site features appear to be in satisfactory condition with the exception of the above noted minor deficiencies. Pinchin has carried an allowance to re-landscape the mulch which has been installed against the brick veneer masonry on the north elevation of the Site Building. Pinchin also recommends that repairs/crack sealing be completed to the asphalt pavements, cast-in-place concrete walkway and retaining wall; however, allowances have not been carried as repairs are expected to fall below the threshold of reporting. Pinchin also recommends that regular annual maintenance of the Site features be performed throughout the term of the analysis. Assessment of or comment upon concealed deficiencies and any buried/concealed utilities or components are outside the scope of work.

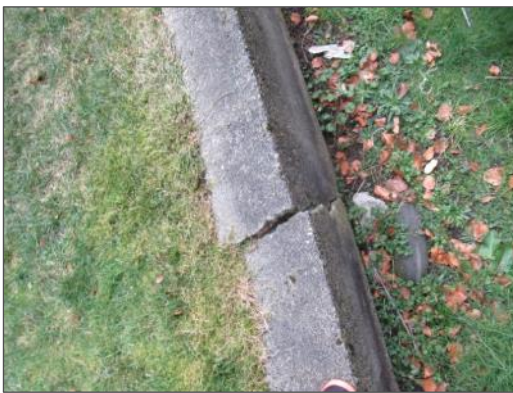
<ul style="list-style-type: none"> <li>Cracking was observed in the concrete retaining wall along the west perimeter of the Site.</li> </ul>	<ul style="list-style-type: none"> <li>Repair the cracked retaining wall.</li> </ul>

View of cracking in the concrete retaining wall along the west perimeter of the Site.

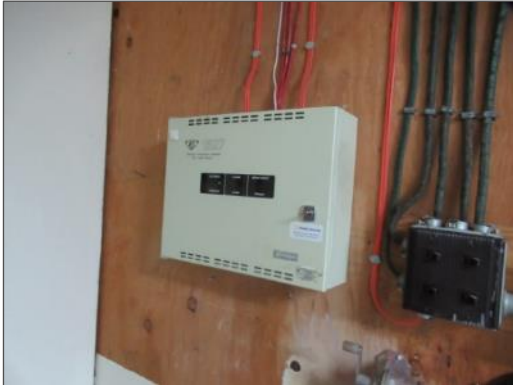
View of the “Edwards” fire alarm panel.

Upon inspection the electrical and life safety systems were noted to be in satisfactory condition with the exception of the aged fire alarm panel which has reached its PUL. Pinchin has carried an allowance to replace the fire alarm panel within the early portion of the term of the analysis. It should be noted that allowances do not include associated fire alarm components such as wiring, pull stations, heat detectors, etc.
