## The Impala

### Condition Assessment Report

8735 Selkirk Street  
Vancouver, BC

January 12, 2021  
RJC No. VAN.040210.0020

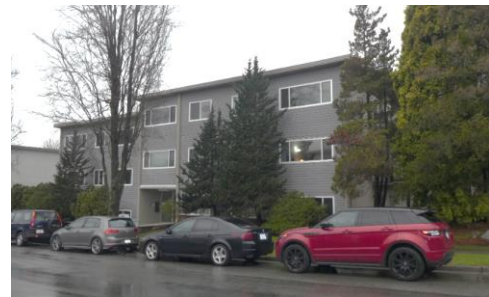
**Figure 1 - Overview of building**
