NON-DESTRUCTIVE TESTING – CORROSION INVESTIGATION

Xradar Project # XBC-VAN-9793

Project Site: 12184, 224 Street, Maple Ridge, BC

Client: Evoke Buildings Engineering Ltd.

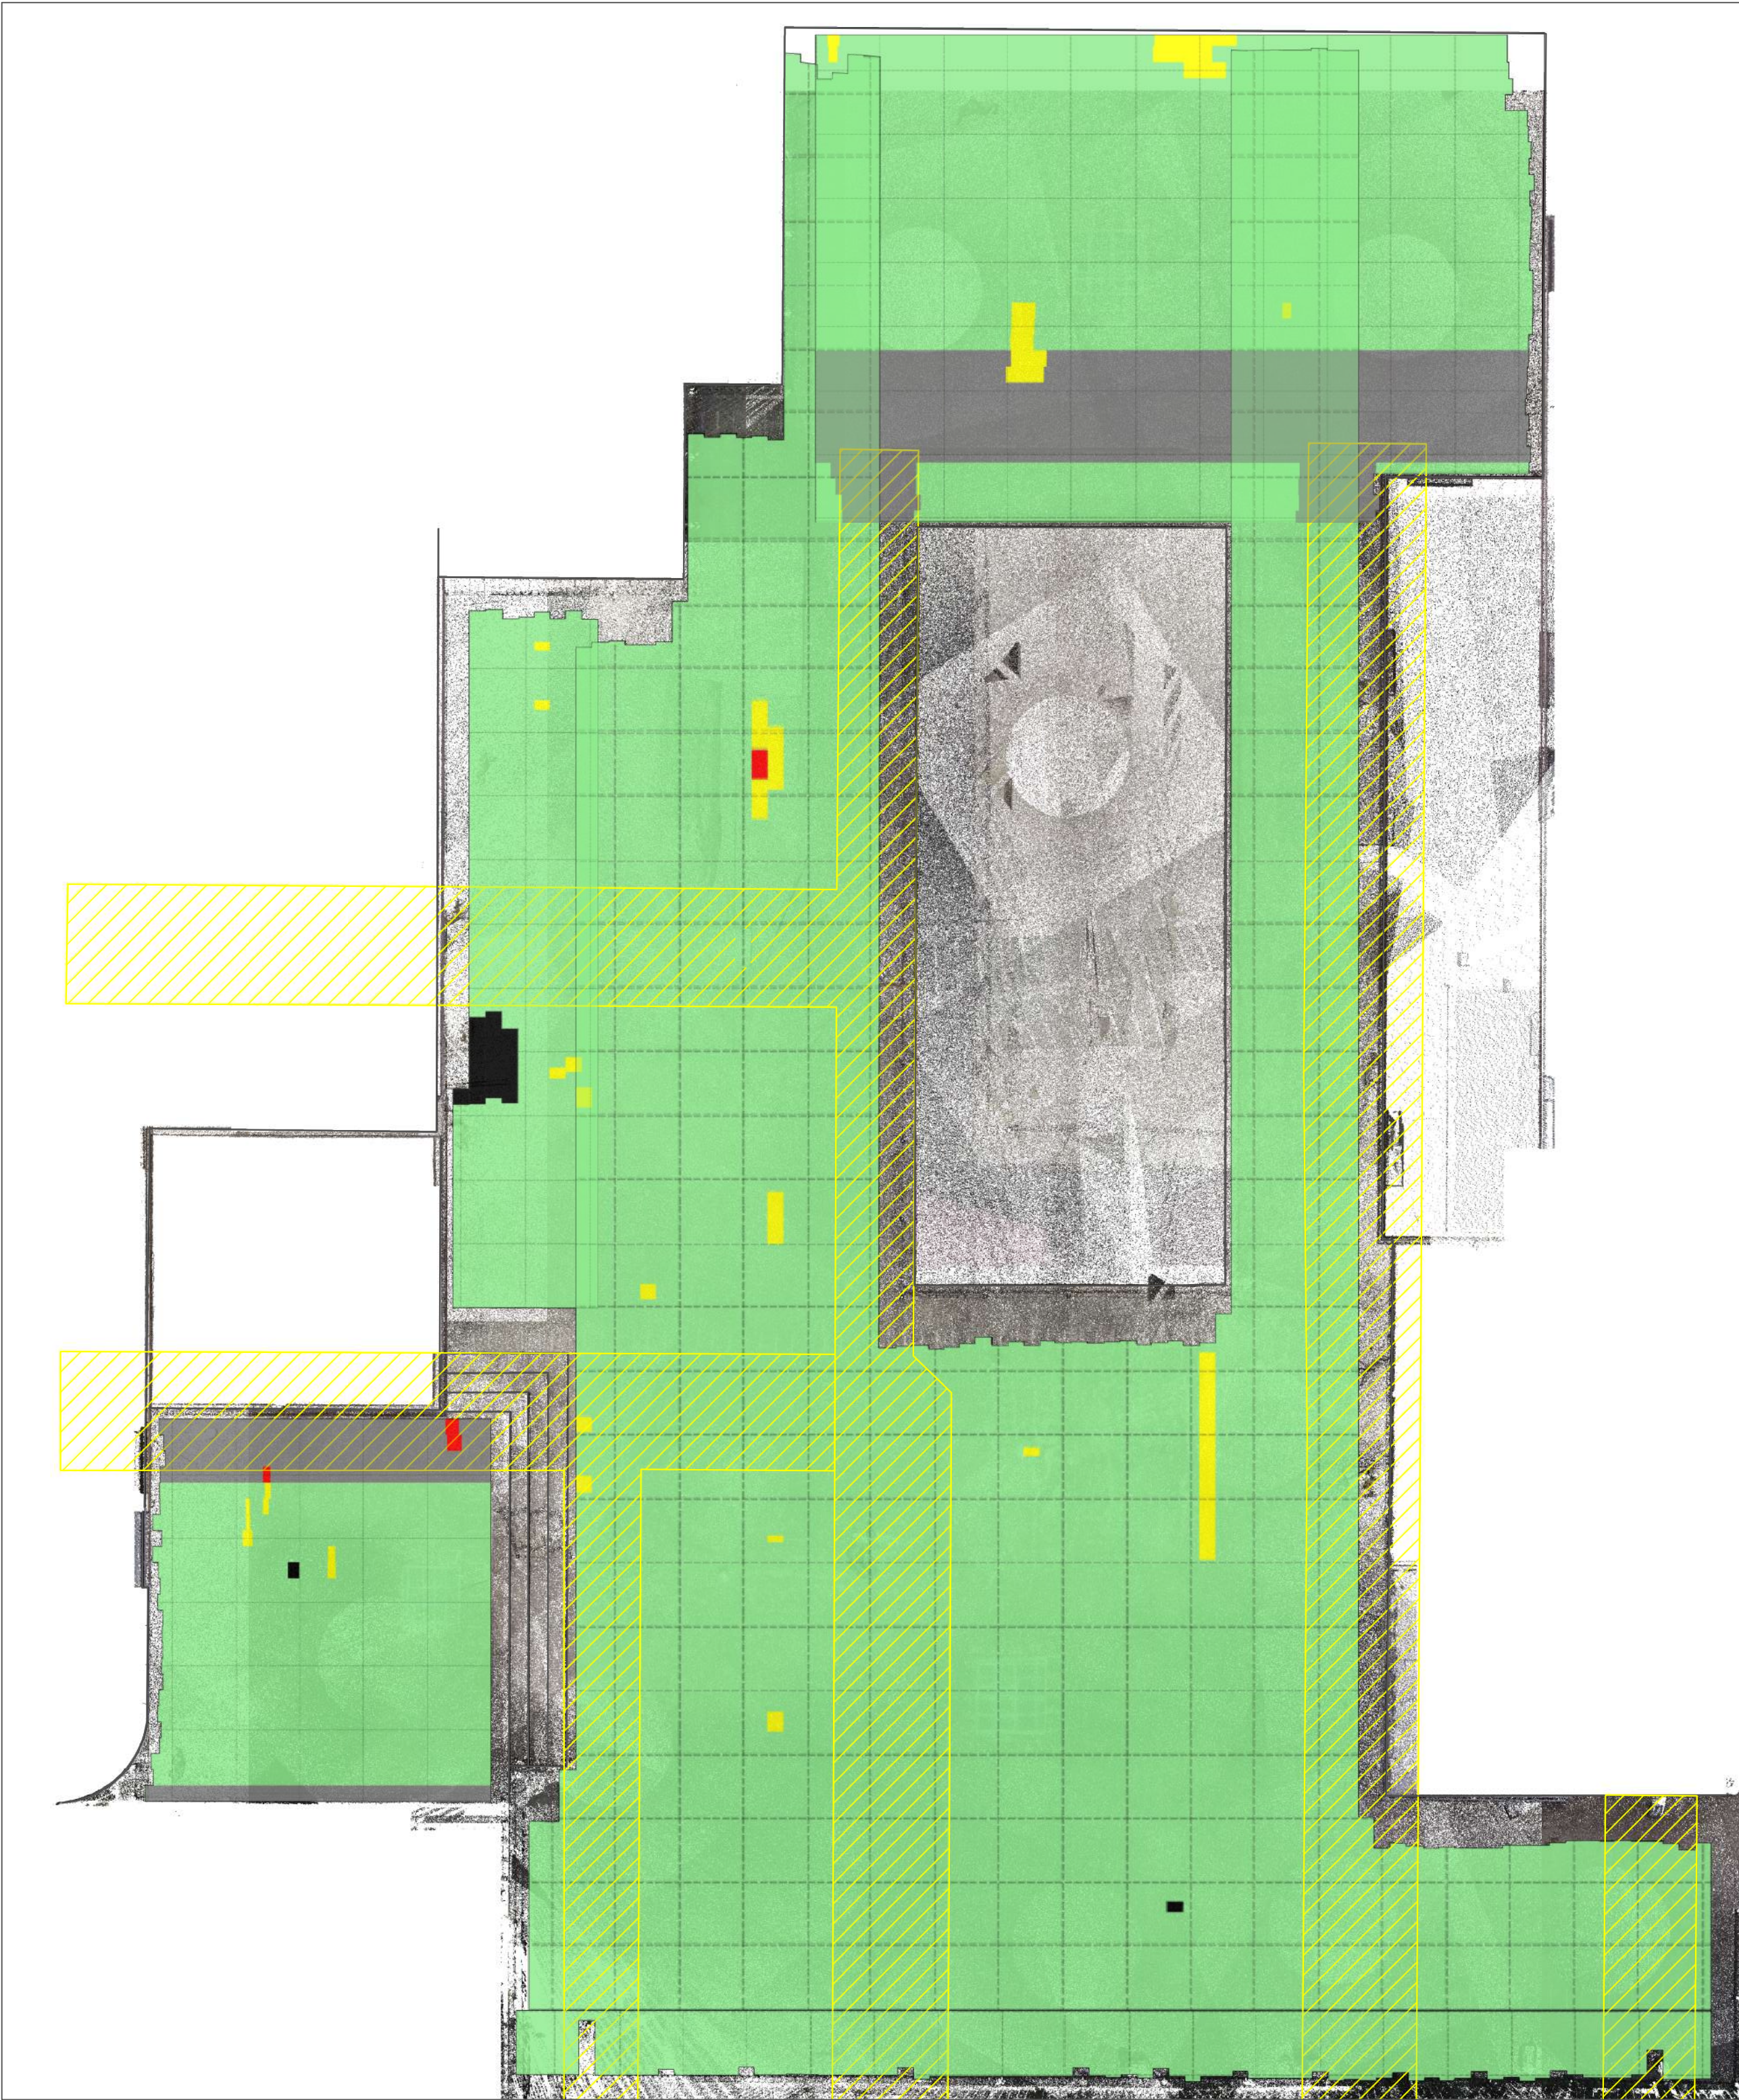
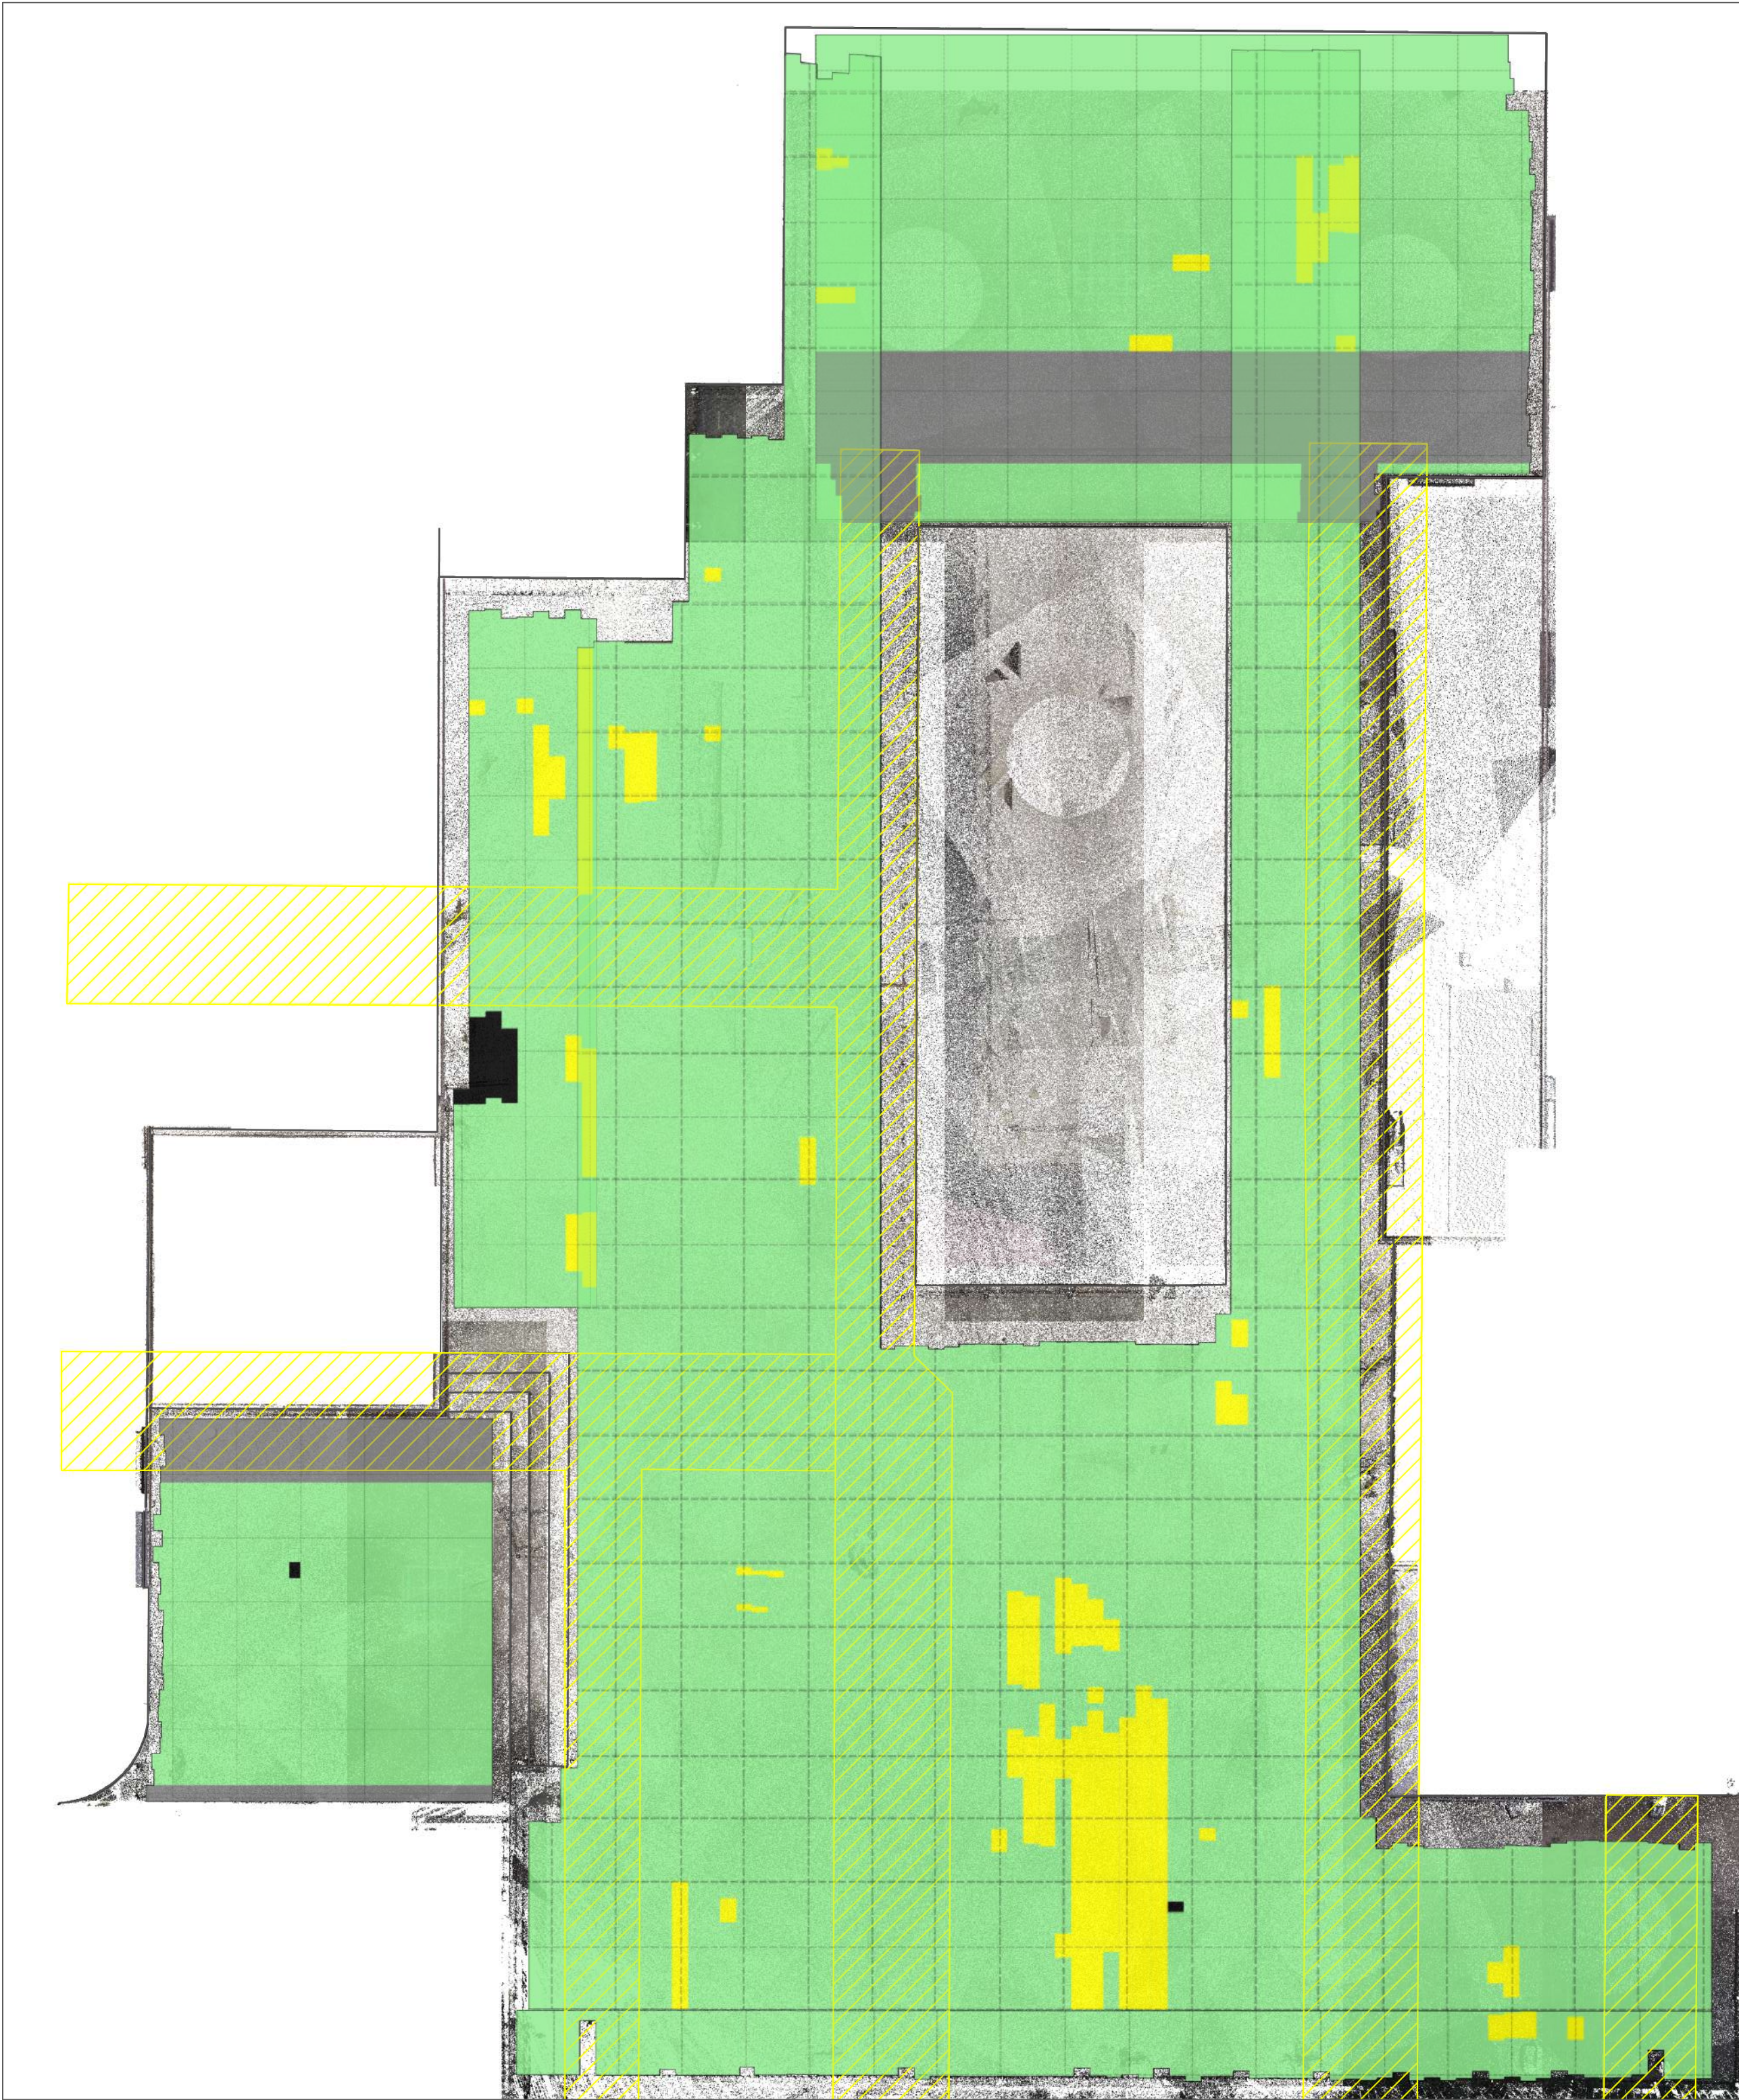
AREA 1 - GPR CORROSION RESULTS- TOP REBAR MAT
SCALE: 1:80

Both moderate and severe corrosion were found across the survey areas. Area 1 contained lots of small localized sections on both the upper and lower reinforcement mat. A much more condensed area of

moderate corrosion exists in the central southern area of Area 1, on the bottom rebar mat. Additionally visual signs of corrosion were abundant on the underside of the slab in this southern area. Cracking was present on the topside and underside of the slab most notably in the north west corner of area 1. Some cracking was also present on the underside of the south-central zone of area 1.

It is recommended a structural engineer is approached to determine structural condition and provide and assessment of the rebar condition.

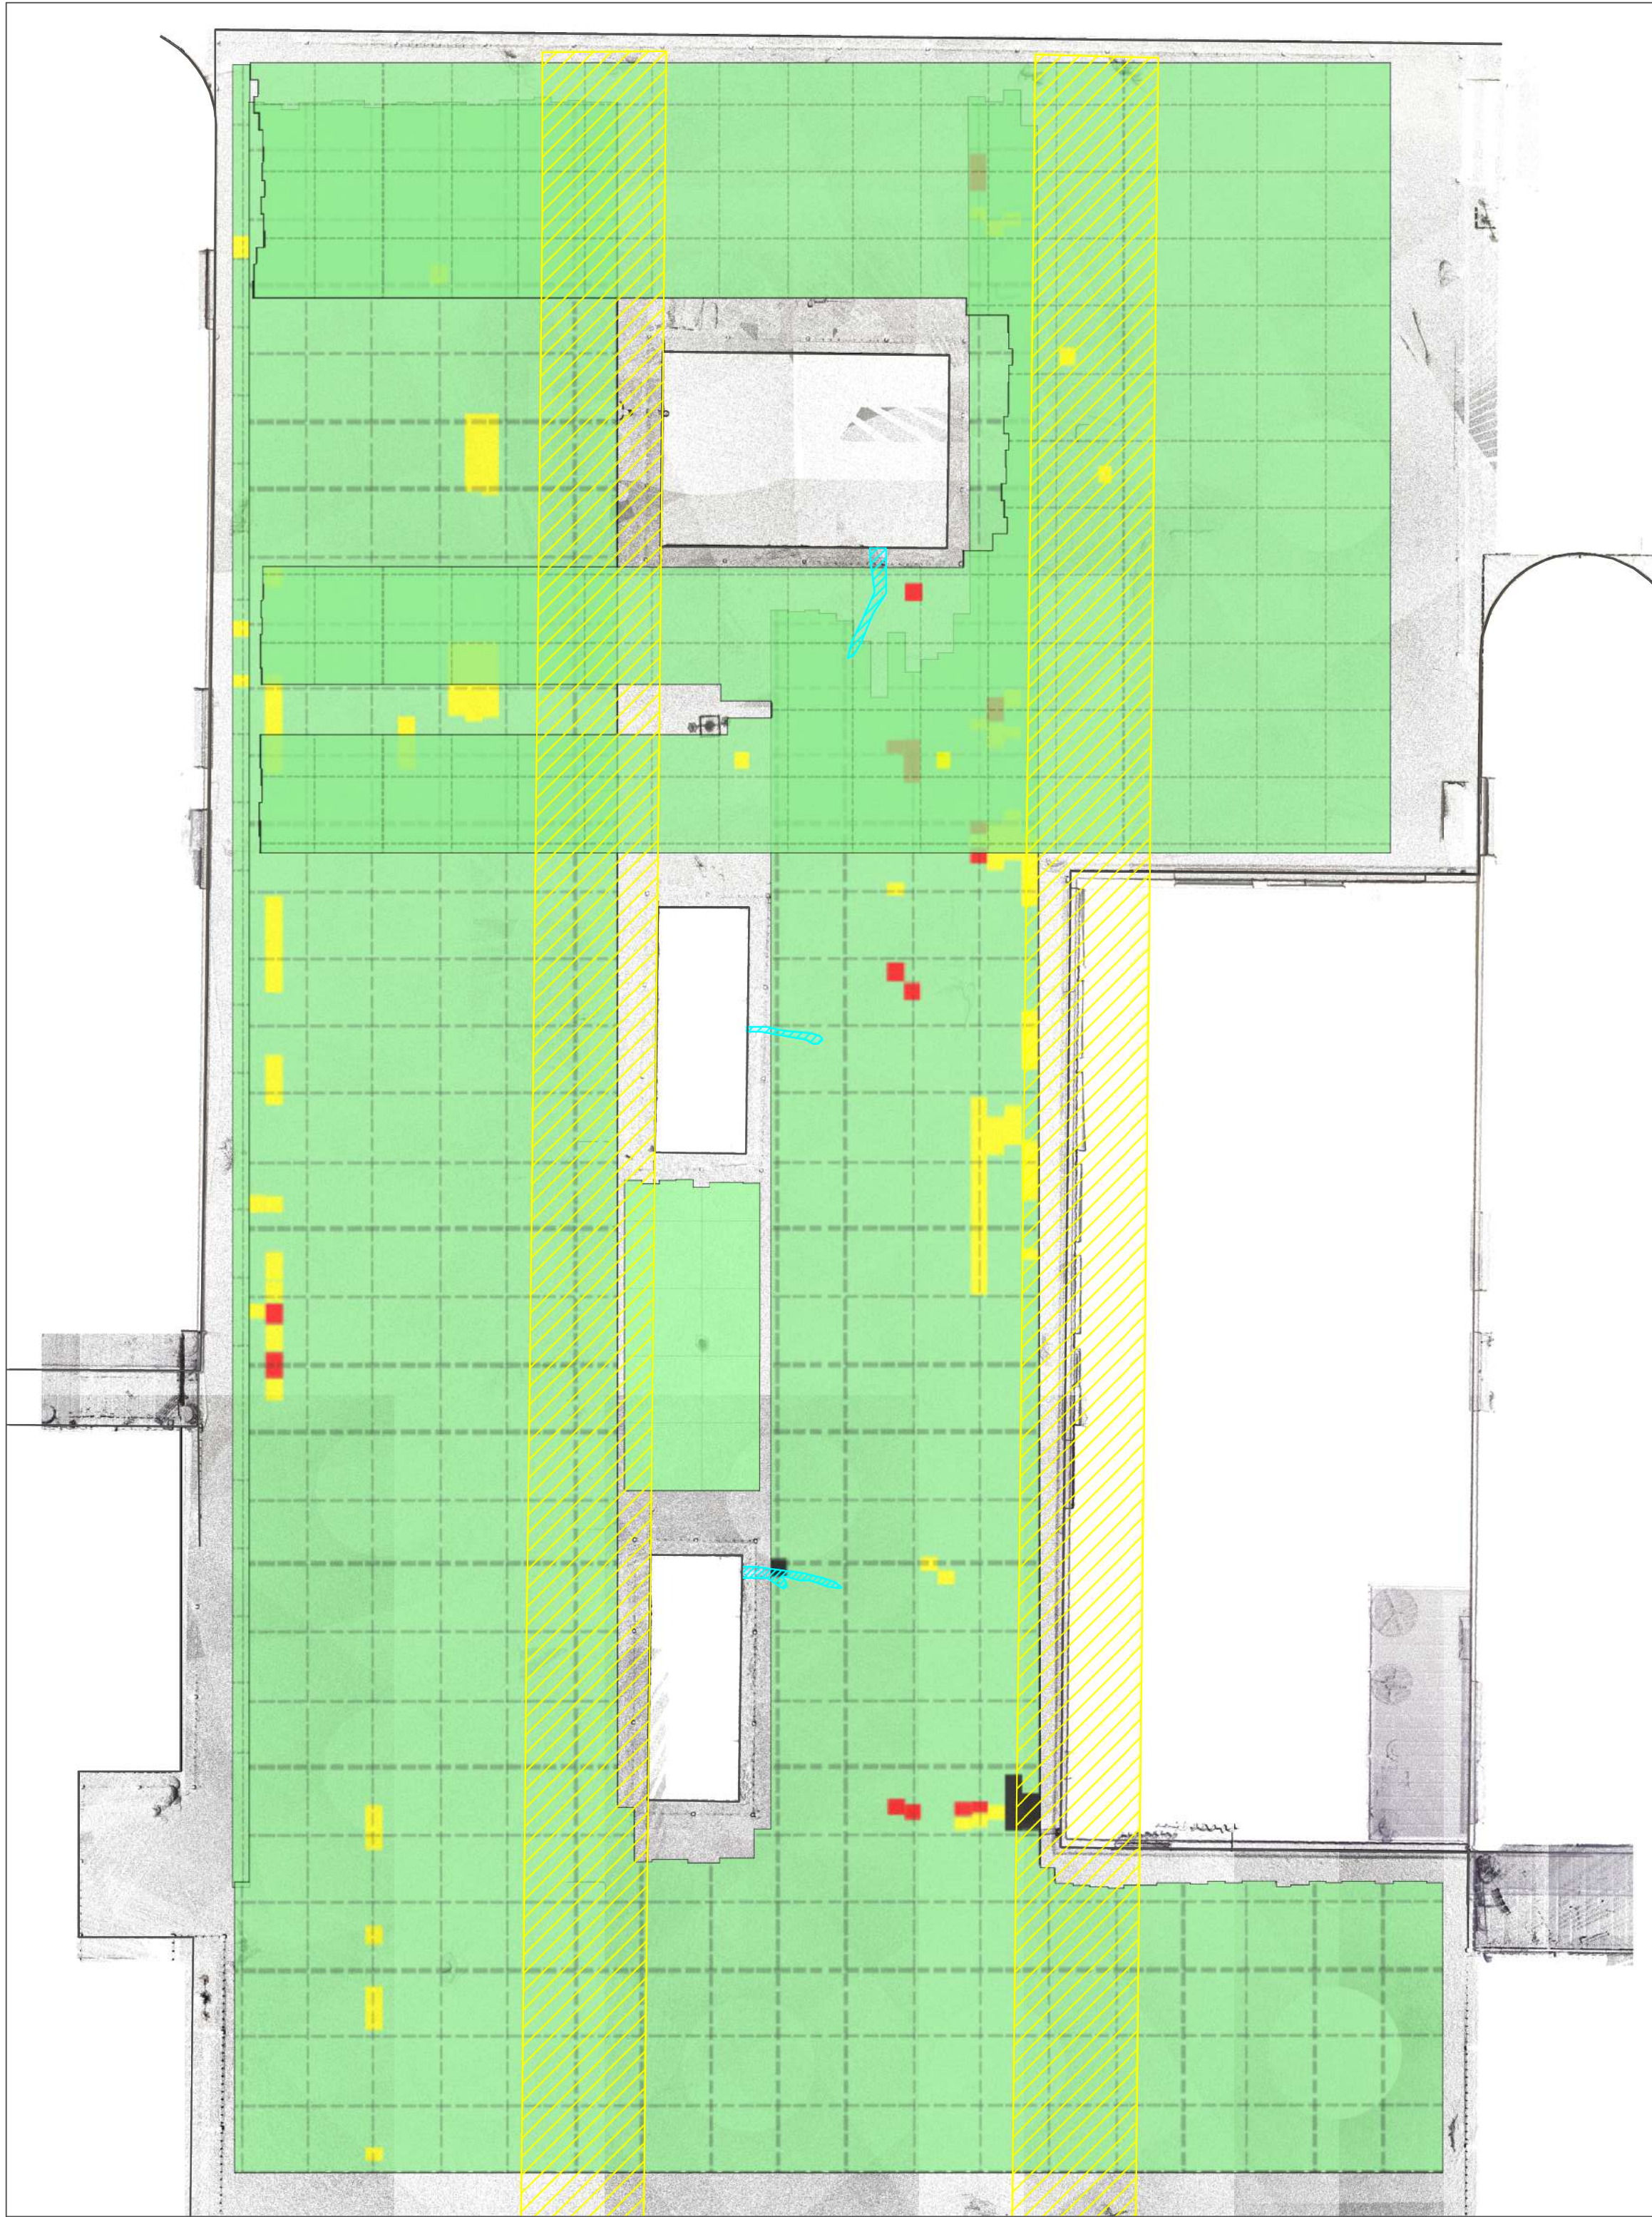
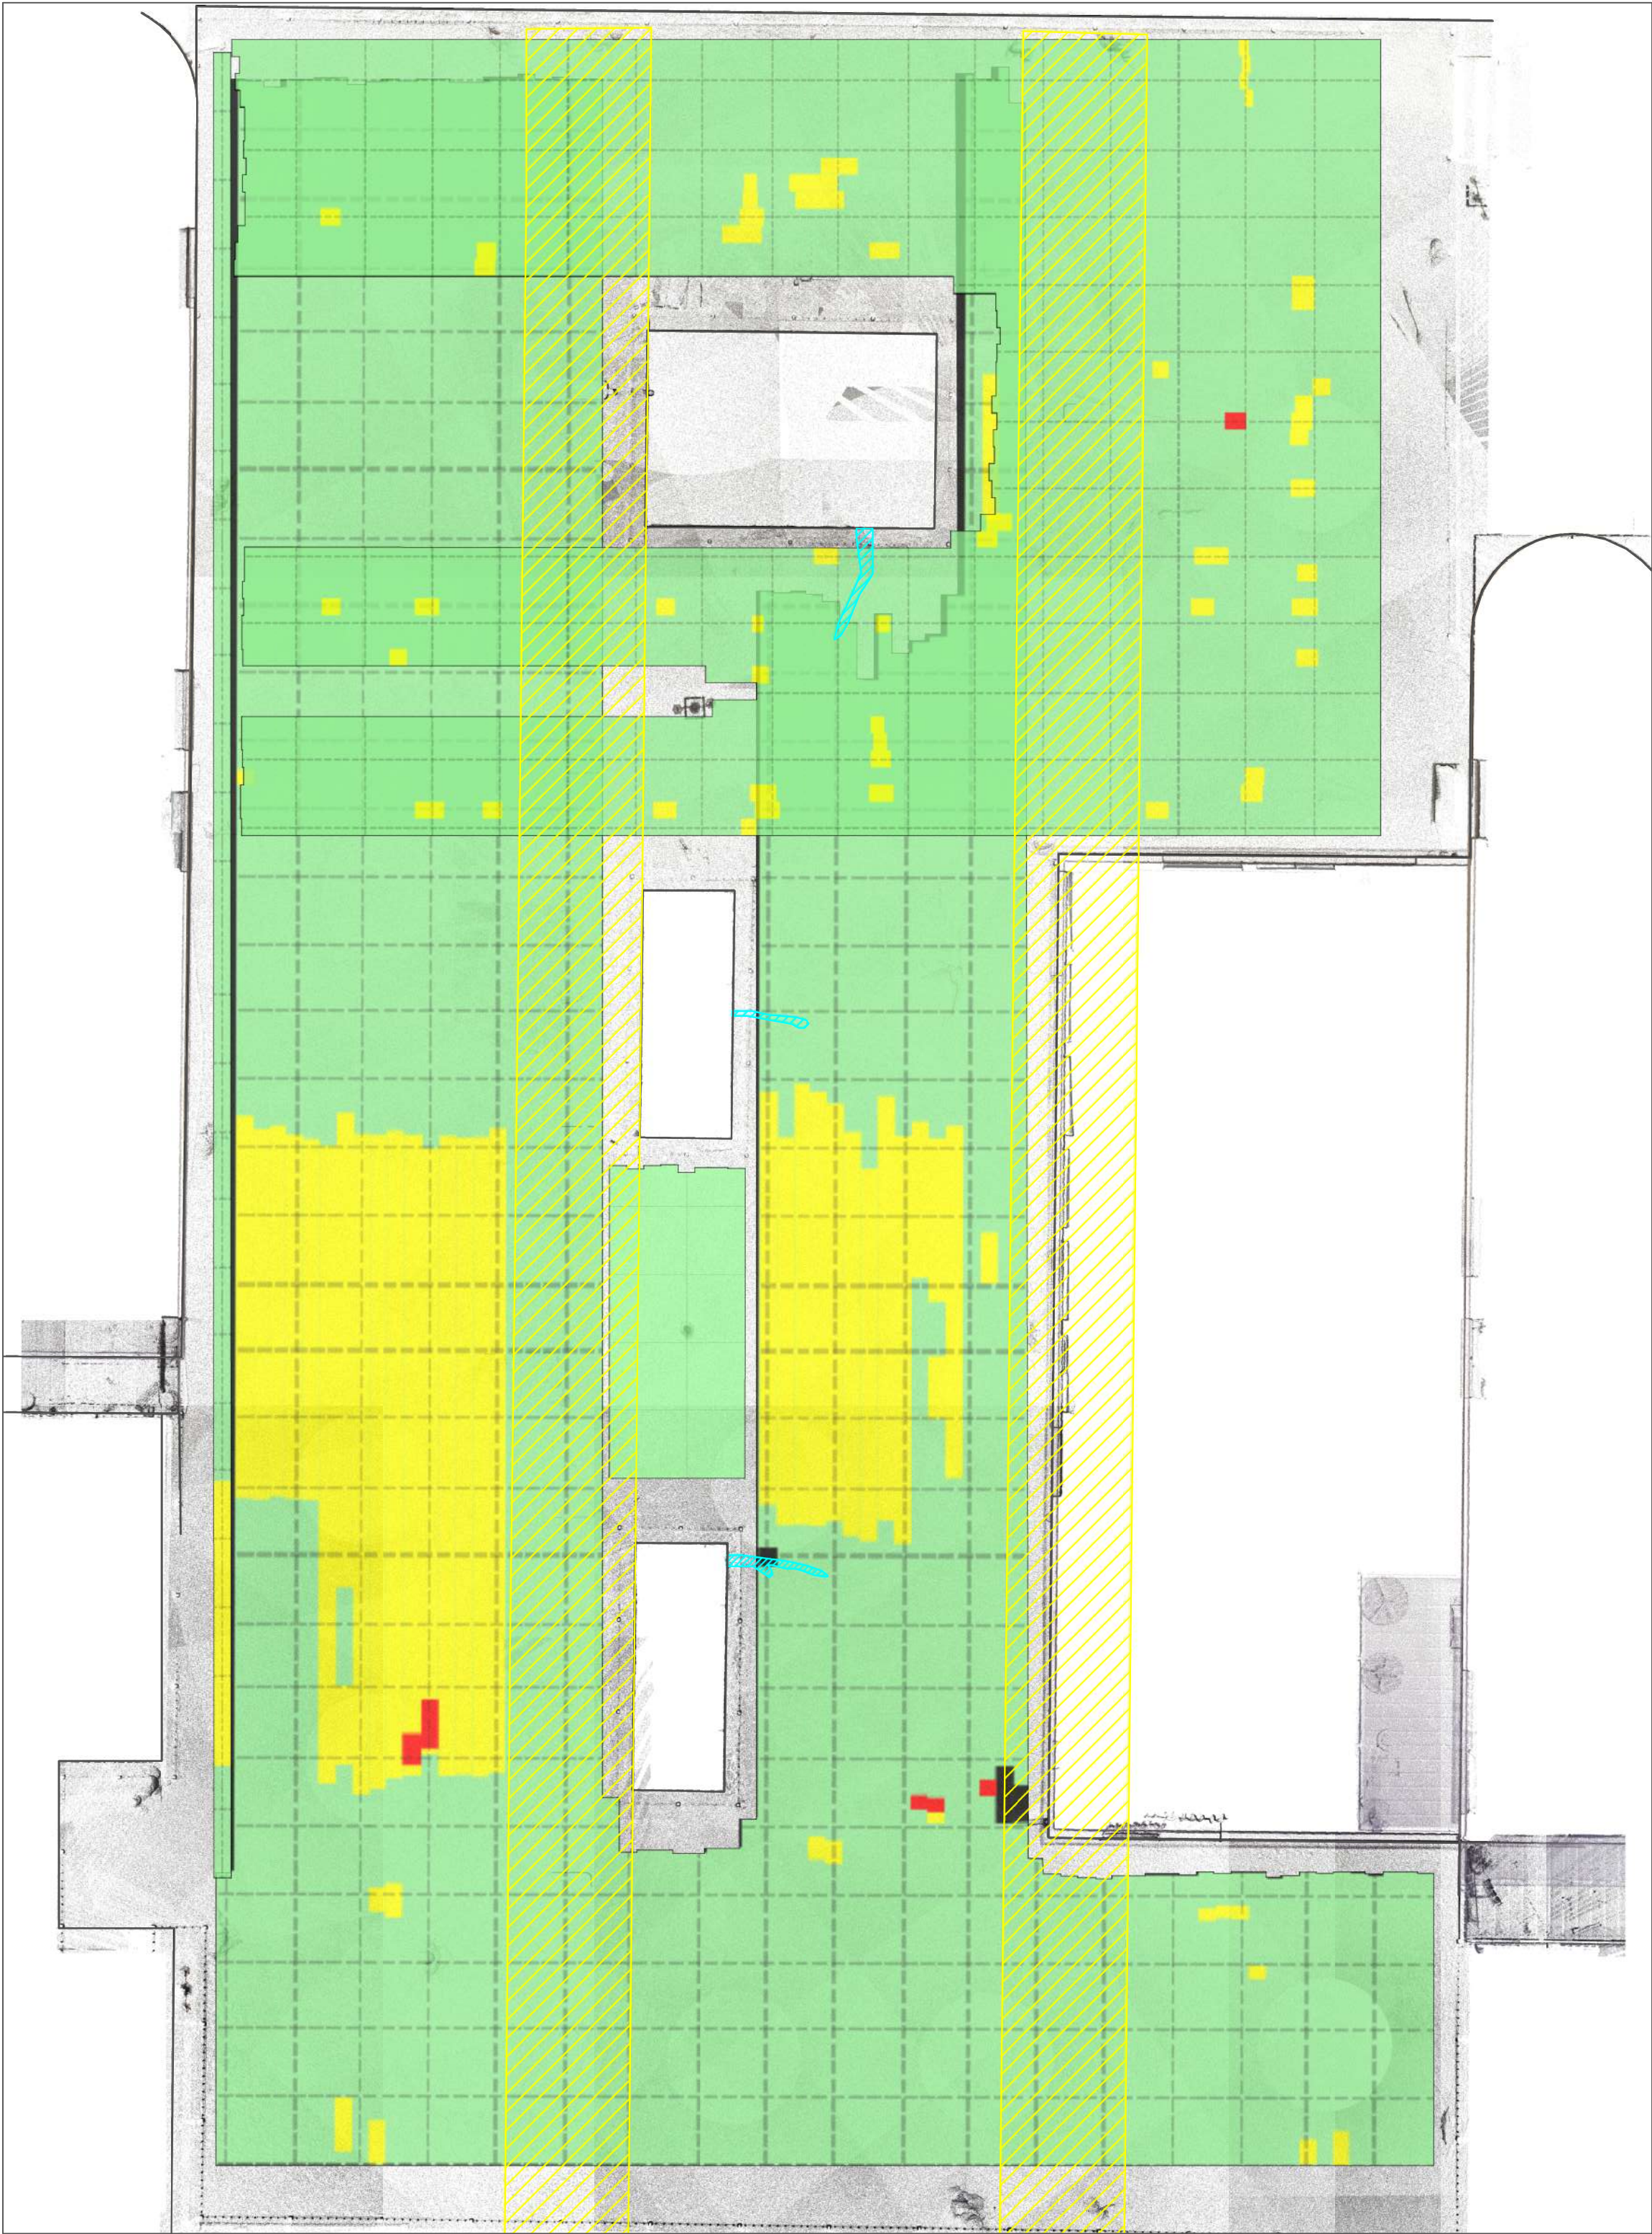
AREA 2 - GPR CORROSION RESULTS- TOP REBAR MAT
SCALE: 1:80

Area 2 was similar containing multiple isolated areas of moderate corrosion and some severe, and a condensed area in the south-central part of Area 2. There were multiple areas of visual corrosion notably the north east and south west of the area. Cracking was abundant on the underside of area 2 with some sporadic cracks on the topside of the slab. Areas of exposed bars existed on the underside of some of the beams in area 2 also. It is worth noting the underside of beams were not scanned using GPR. Depth penetration from the top of the slab did not reach to the bottom of the beams.

Both moderate and severe corrosion were identified across the survey areas. This predominantly existed in isolated pockets. With some notable areas being more widespread. The eastern area of concentrated moderate corrosion on area 2 correlates with the location of previously pooling water. Saturation of the concrete surface can cause a change in the dielectric of the surface concrete and therefore make the reinforcement appear more corroded. This could be possible in this area. However, the opposite could be true and the pooling water is in fact a cause of the corrosion in this area. Delamination, spalling and exposed rebar was present on the bottom of the slab in places. In the areas where visual corrosion exists but GPR corrosion does not it is suspected corrosion of the exposed bars is limited to those bars running in that direction. When corroded rebar is isolated to specific bars as opposed to more spread it is best identified when running perpendicular to the bar with antenna. Grid collection direction varied so therefore there is a chance for some bars to be missed.
