NON-DESTRUCTIVE TESTING – CORROSION INVESTIGATION

Xradar Project # XBC-VAN-9793

Project Site: 12184, 224 Street, Maple Ridge, BC

Client: Evoke Buildings Engineering Ltd.

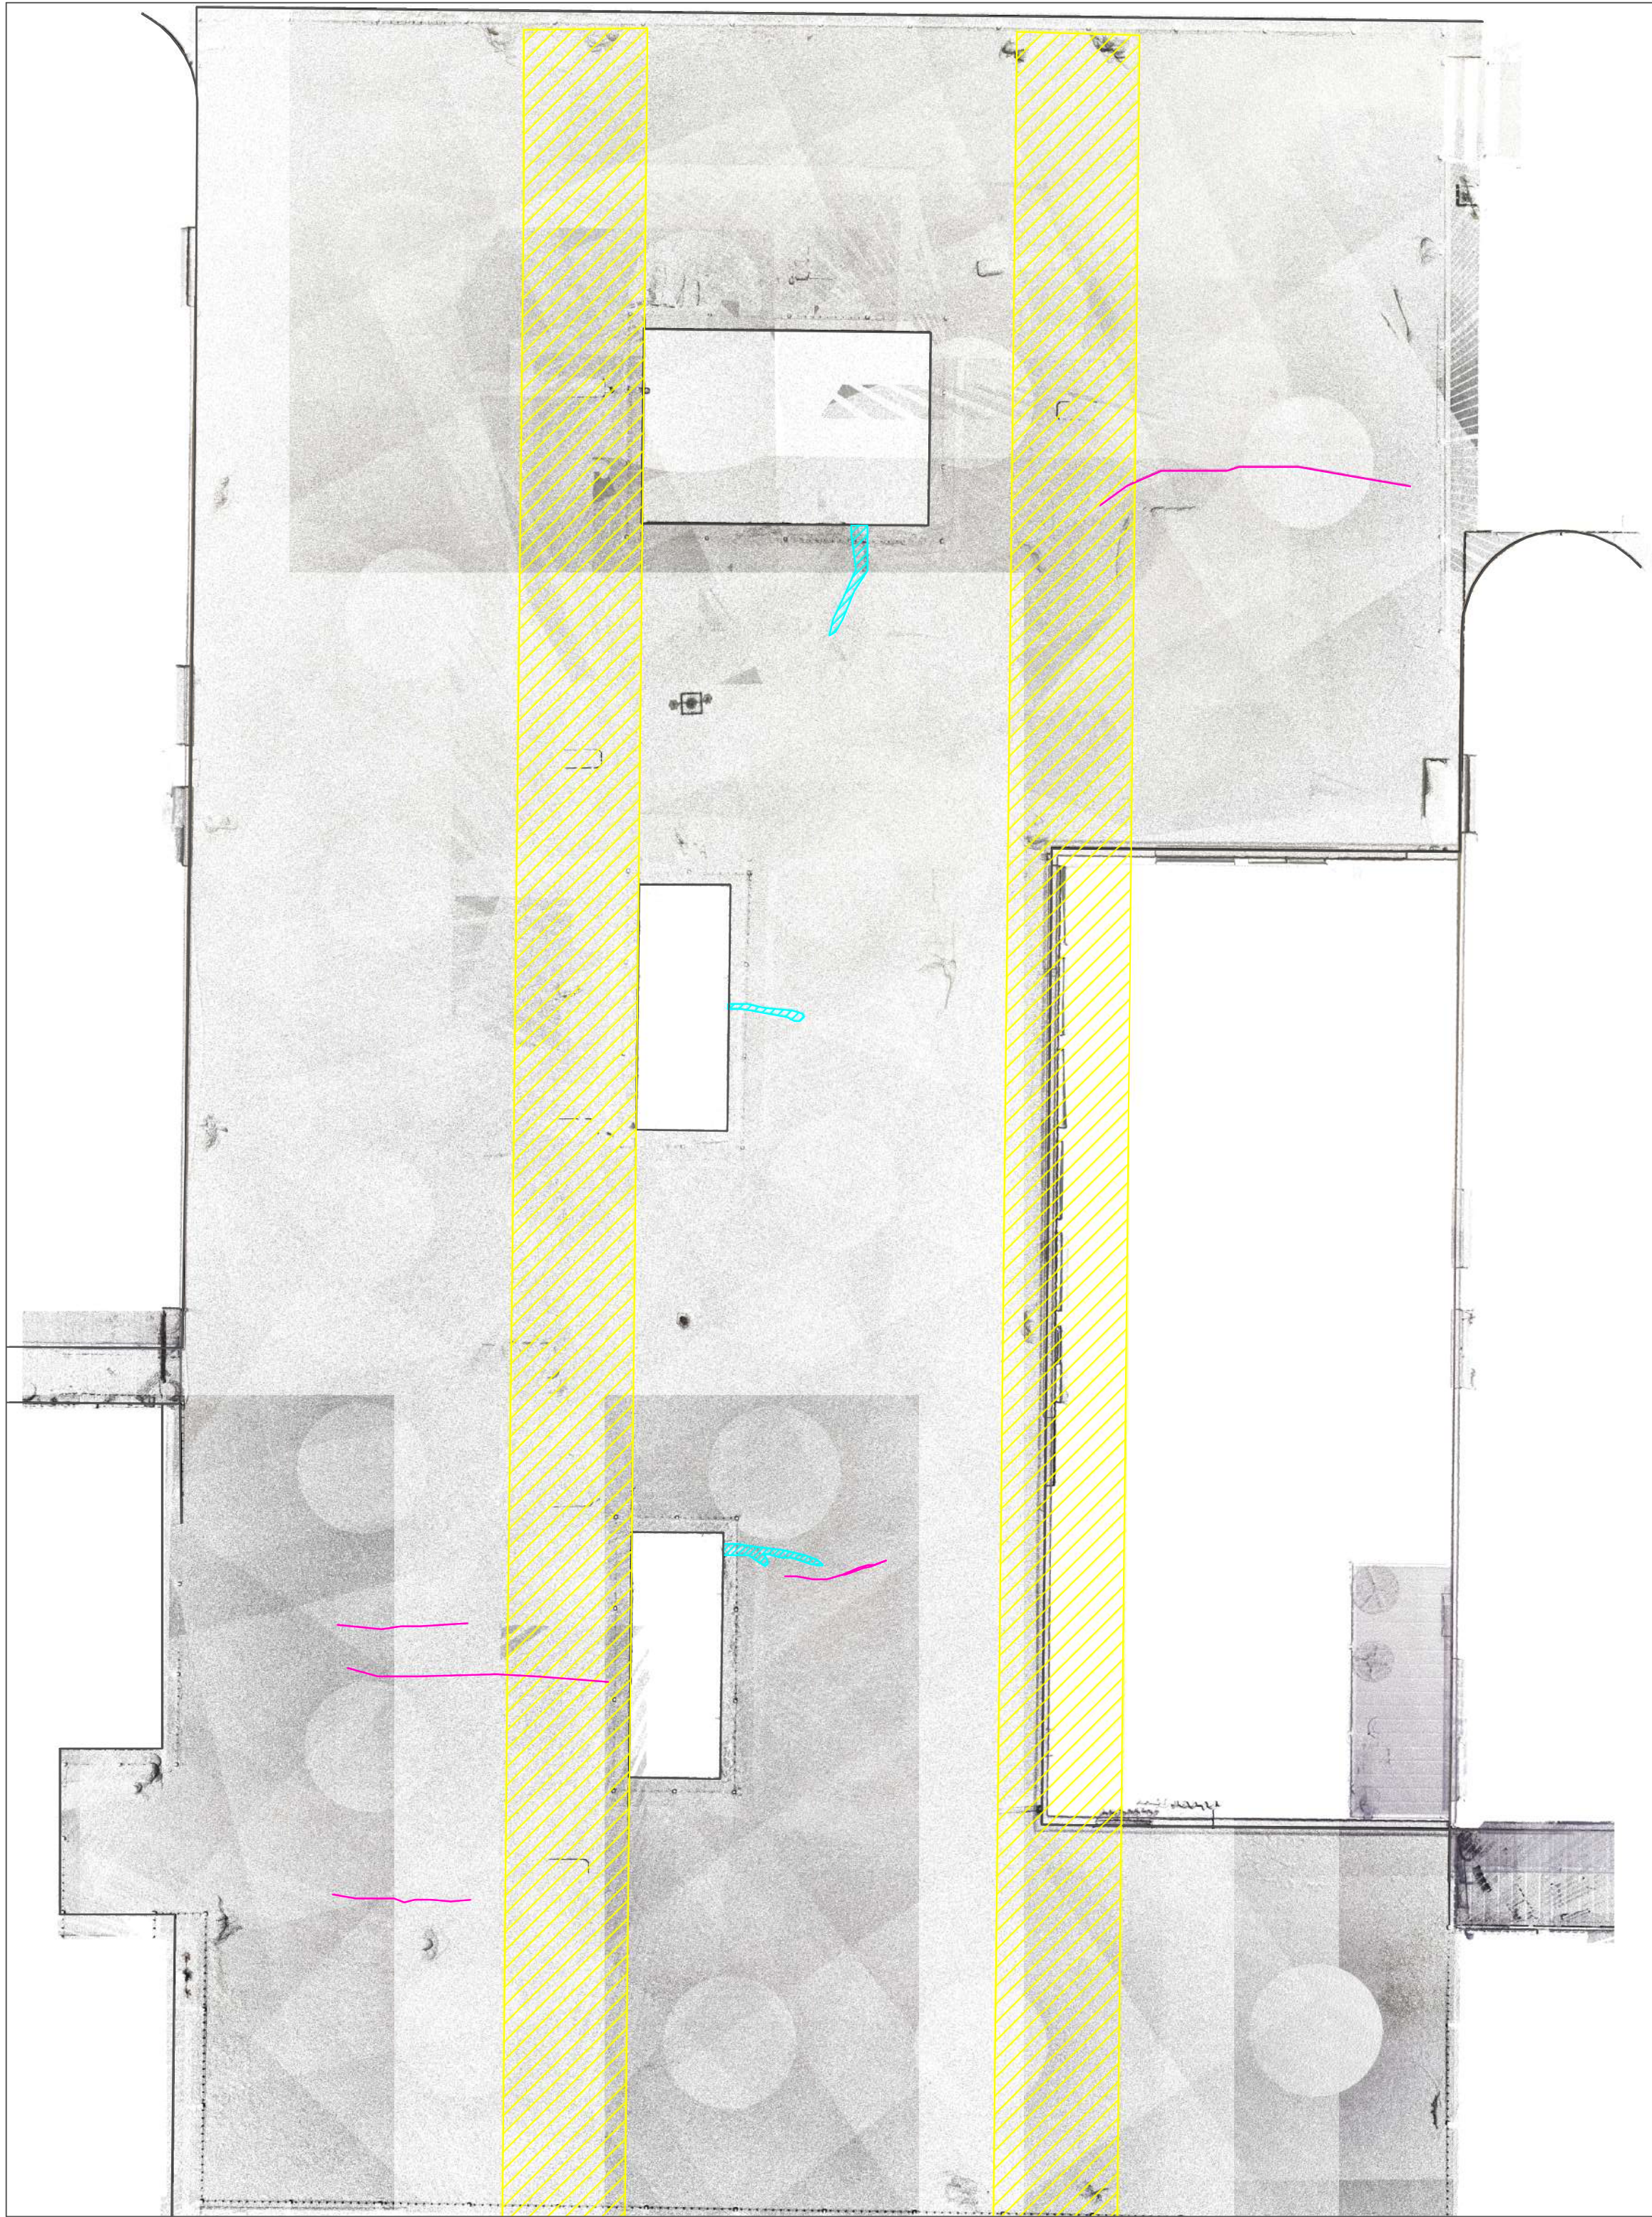
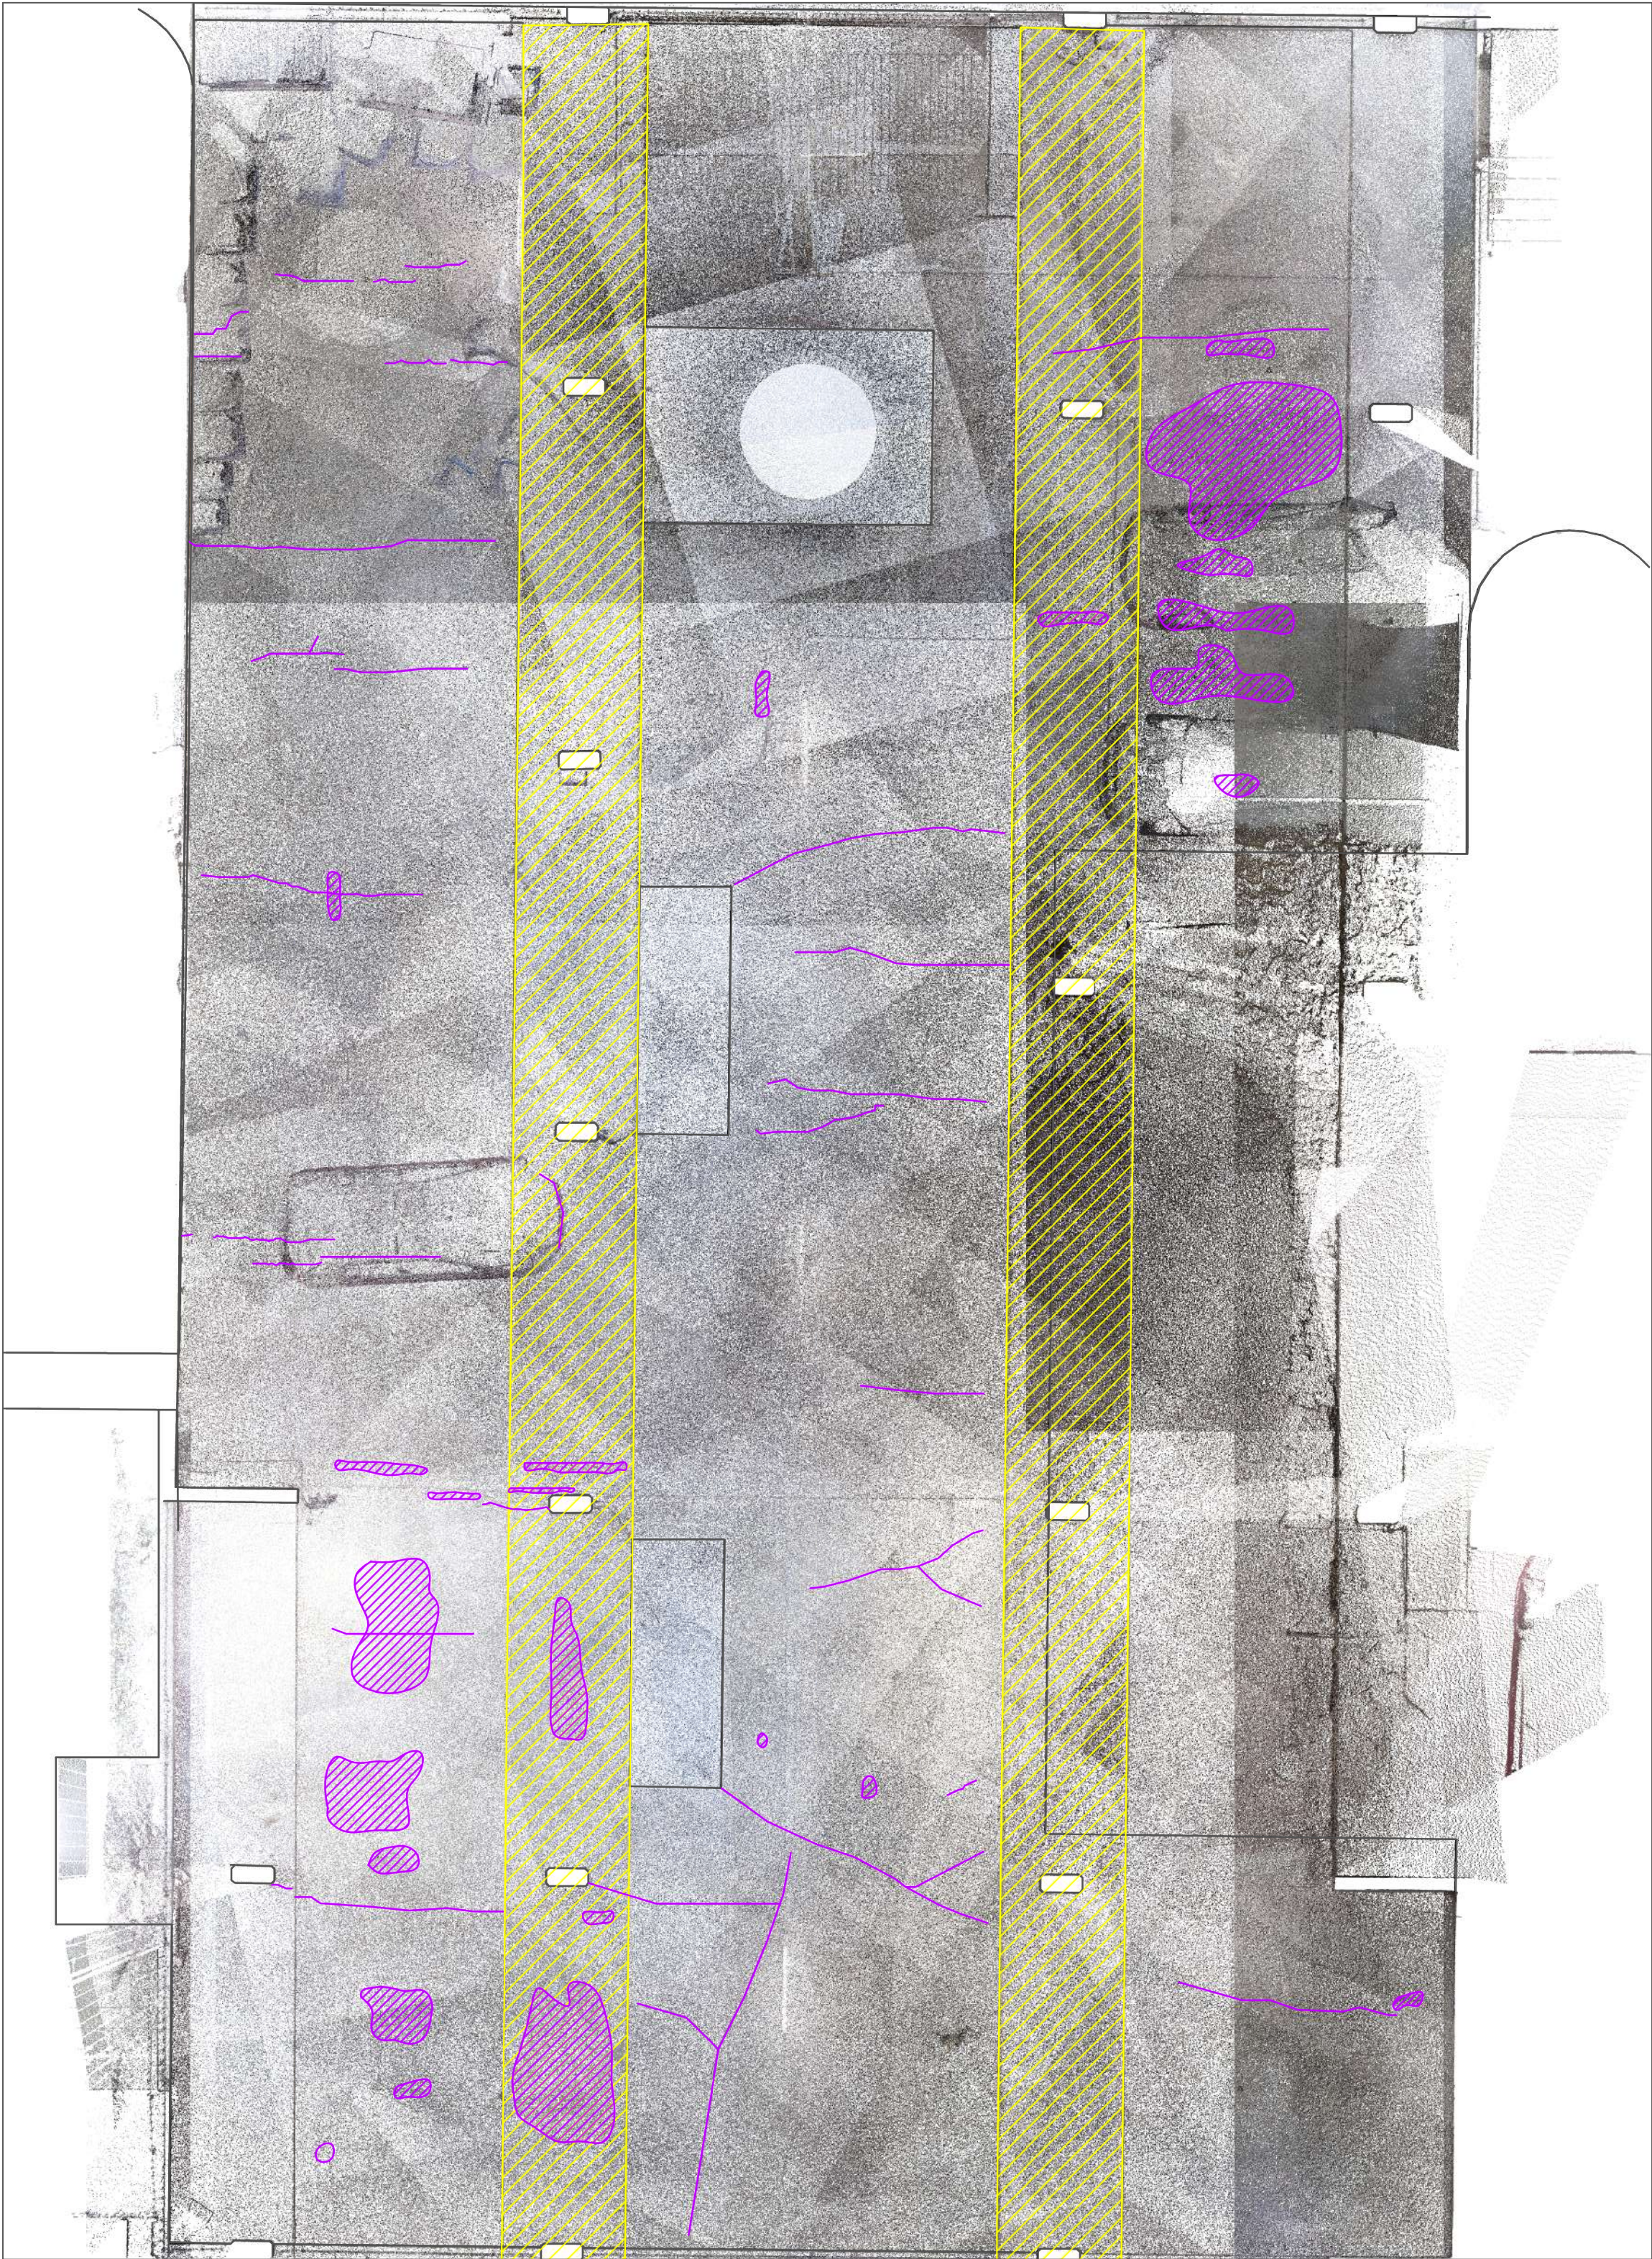
AREA 2 - VISUAL CORROSION - TOPSIDE
SCALE: 1:80

Area 2 was similar containing multiple isolated areas of moderate corrosion and some severe, and a condensed area in the south-central part of Area 2. There were multiple areas of visual corrosion notably the north east and south west of the area. Cracking was abundant on the underside of area 2 with some sporadic cracks on the topside of the slab. Areas of exposed bars existed on the underside of some of the beams in area 2 also. It is worth noting the underside of beams were not scanned using GPR. Depth penetration from the top of the slab did not reach to the bottom of the beams.

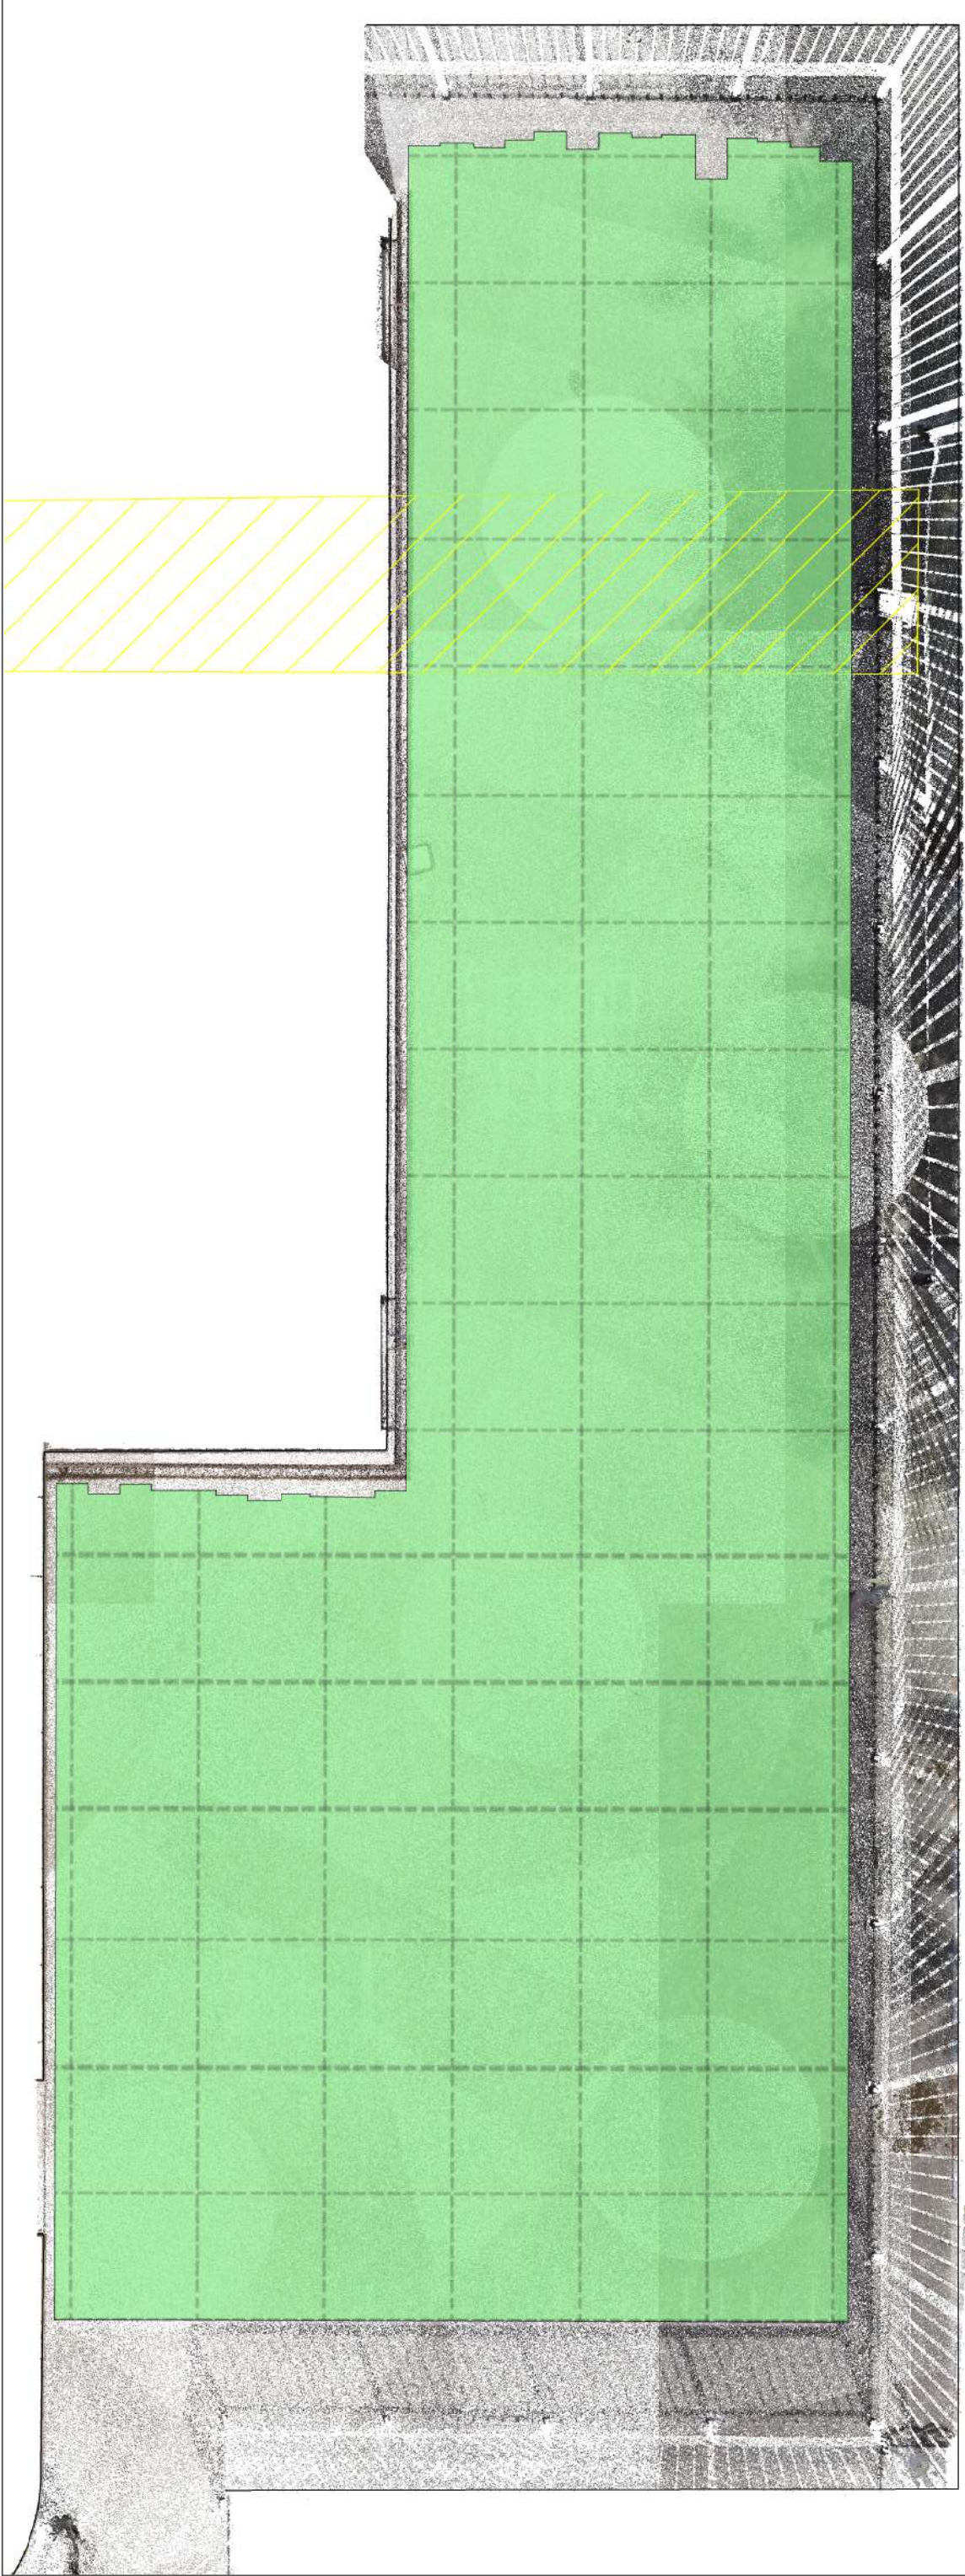
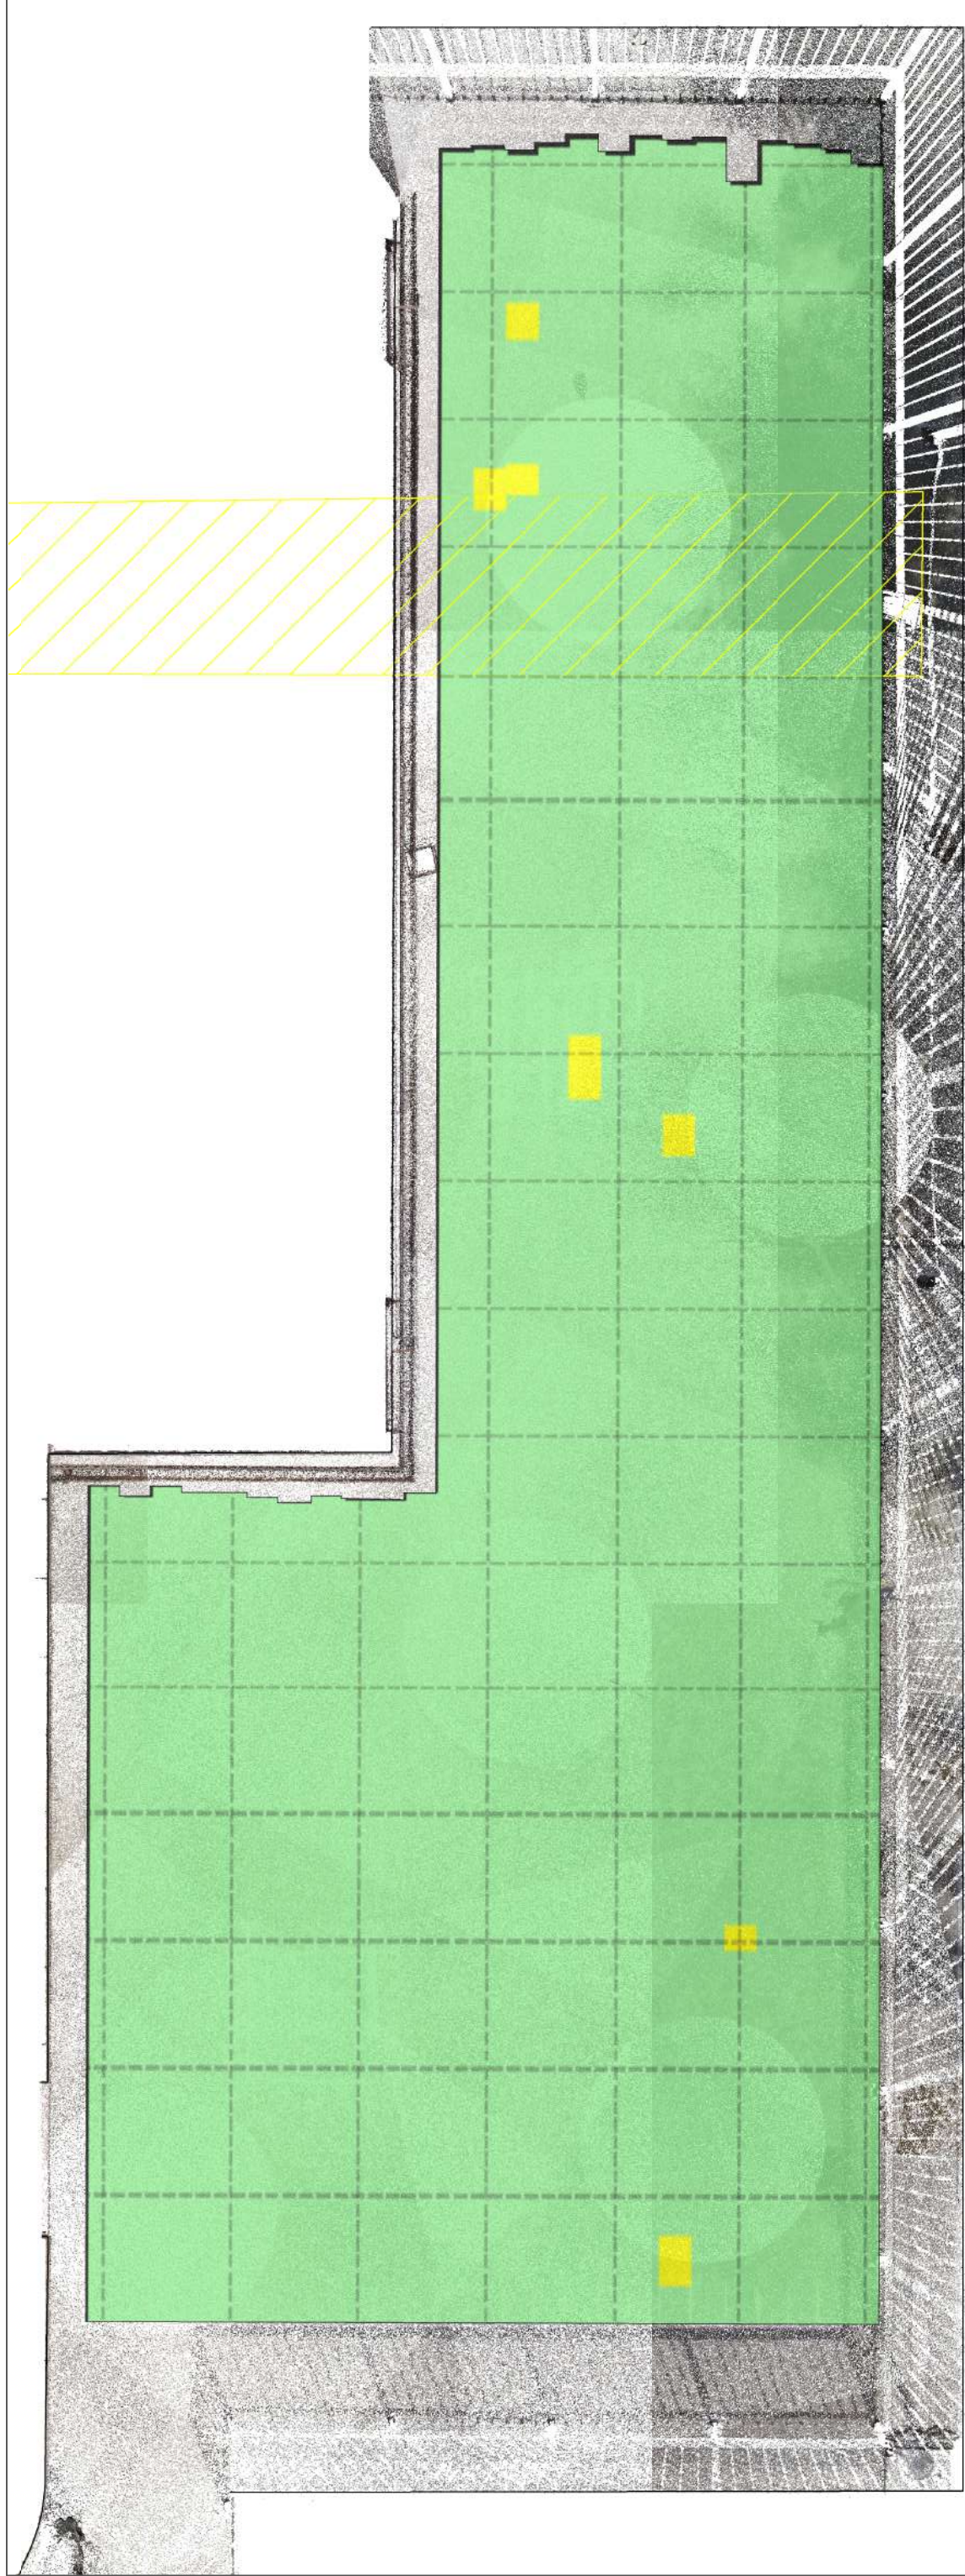
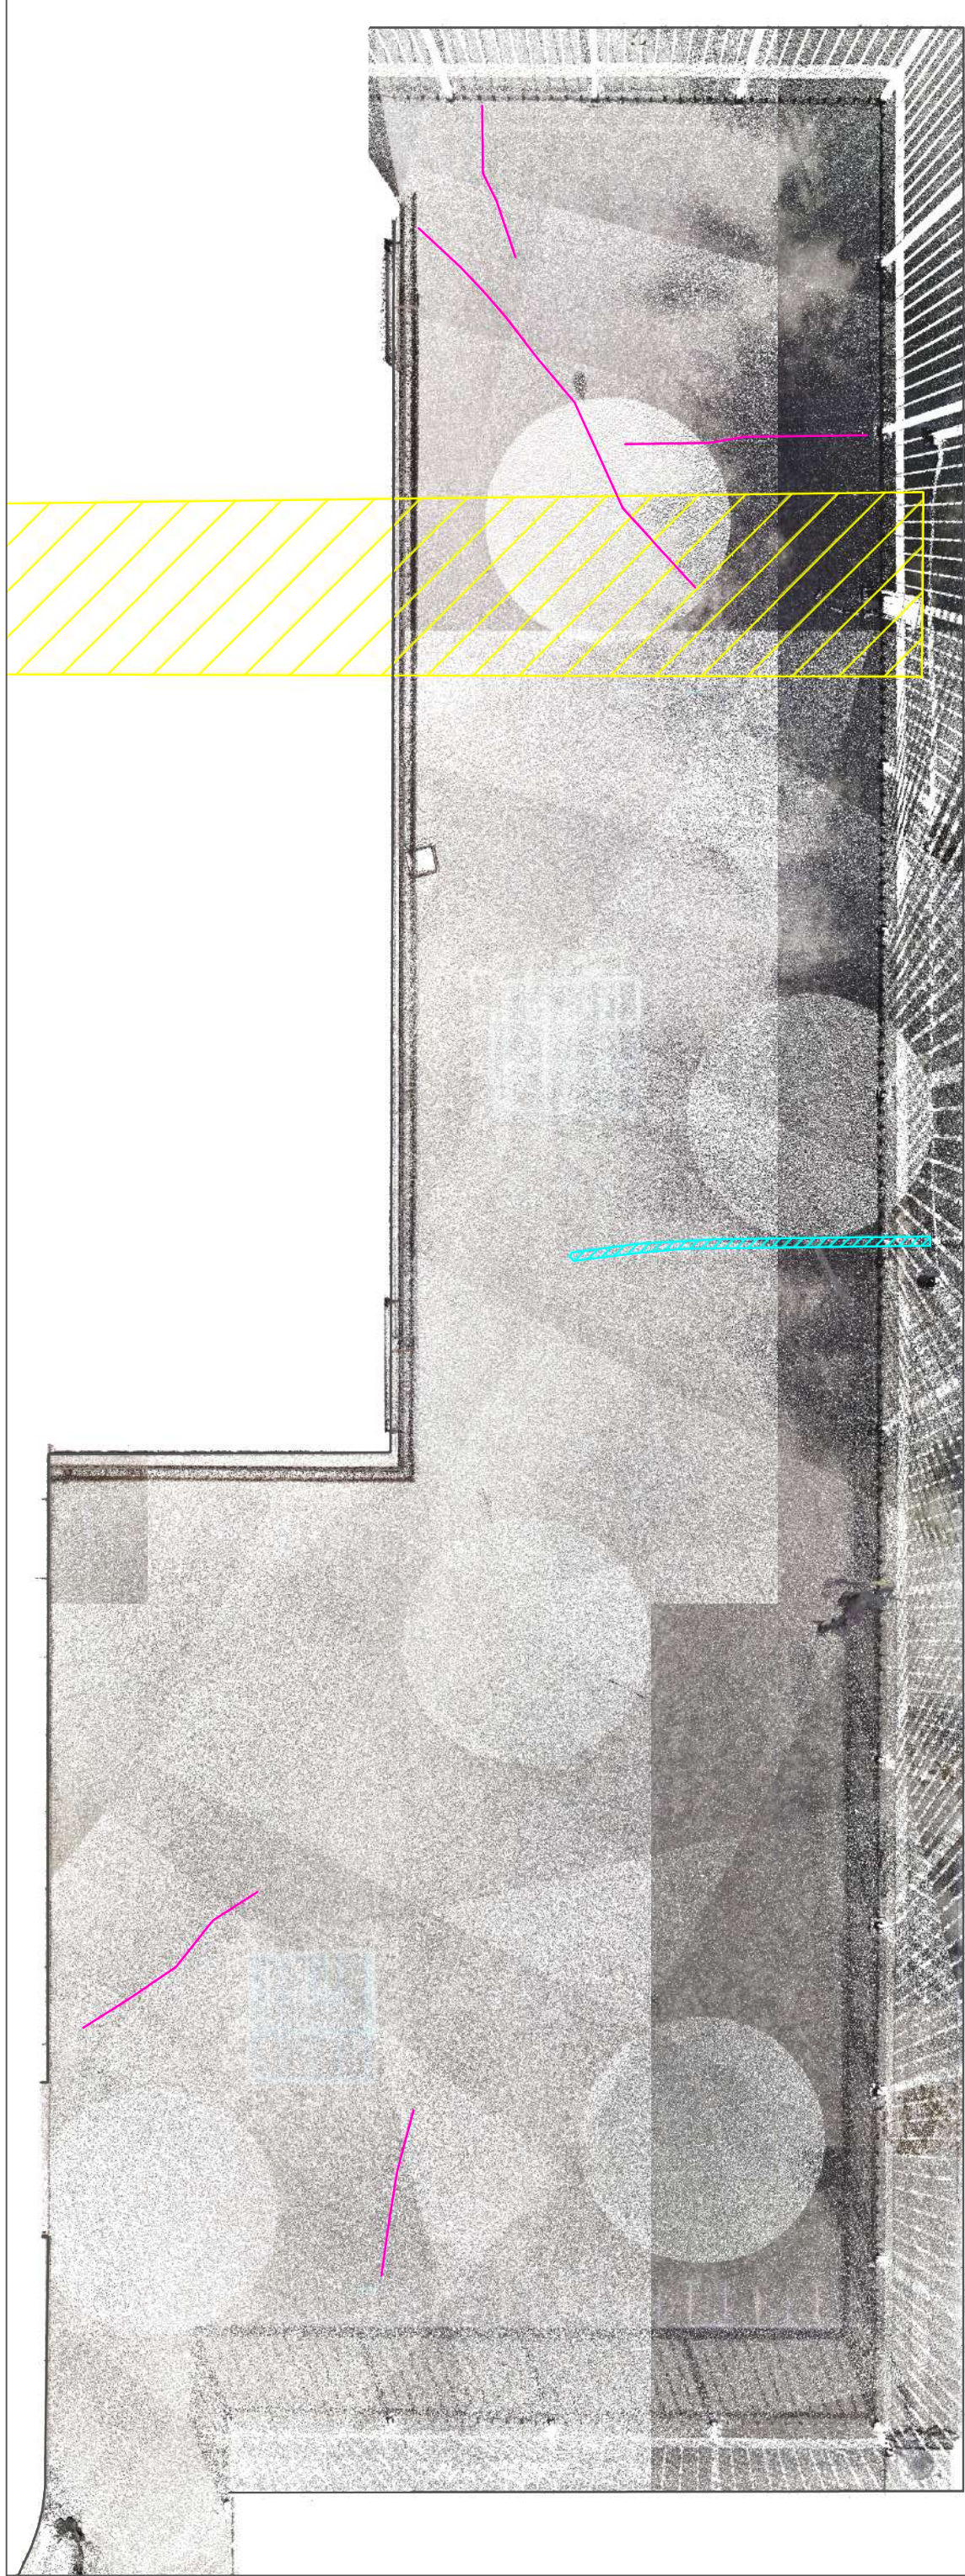
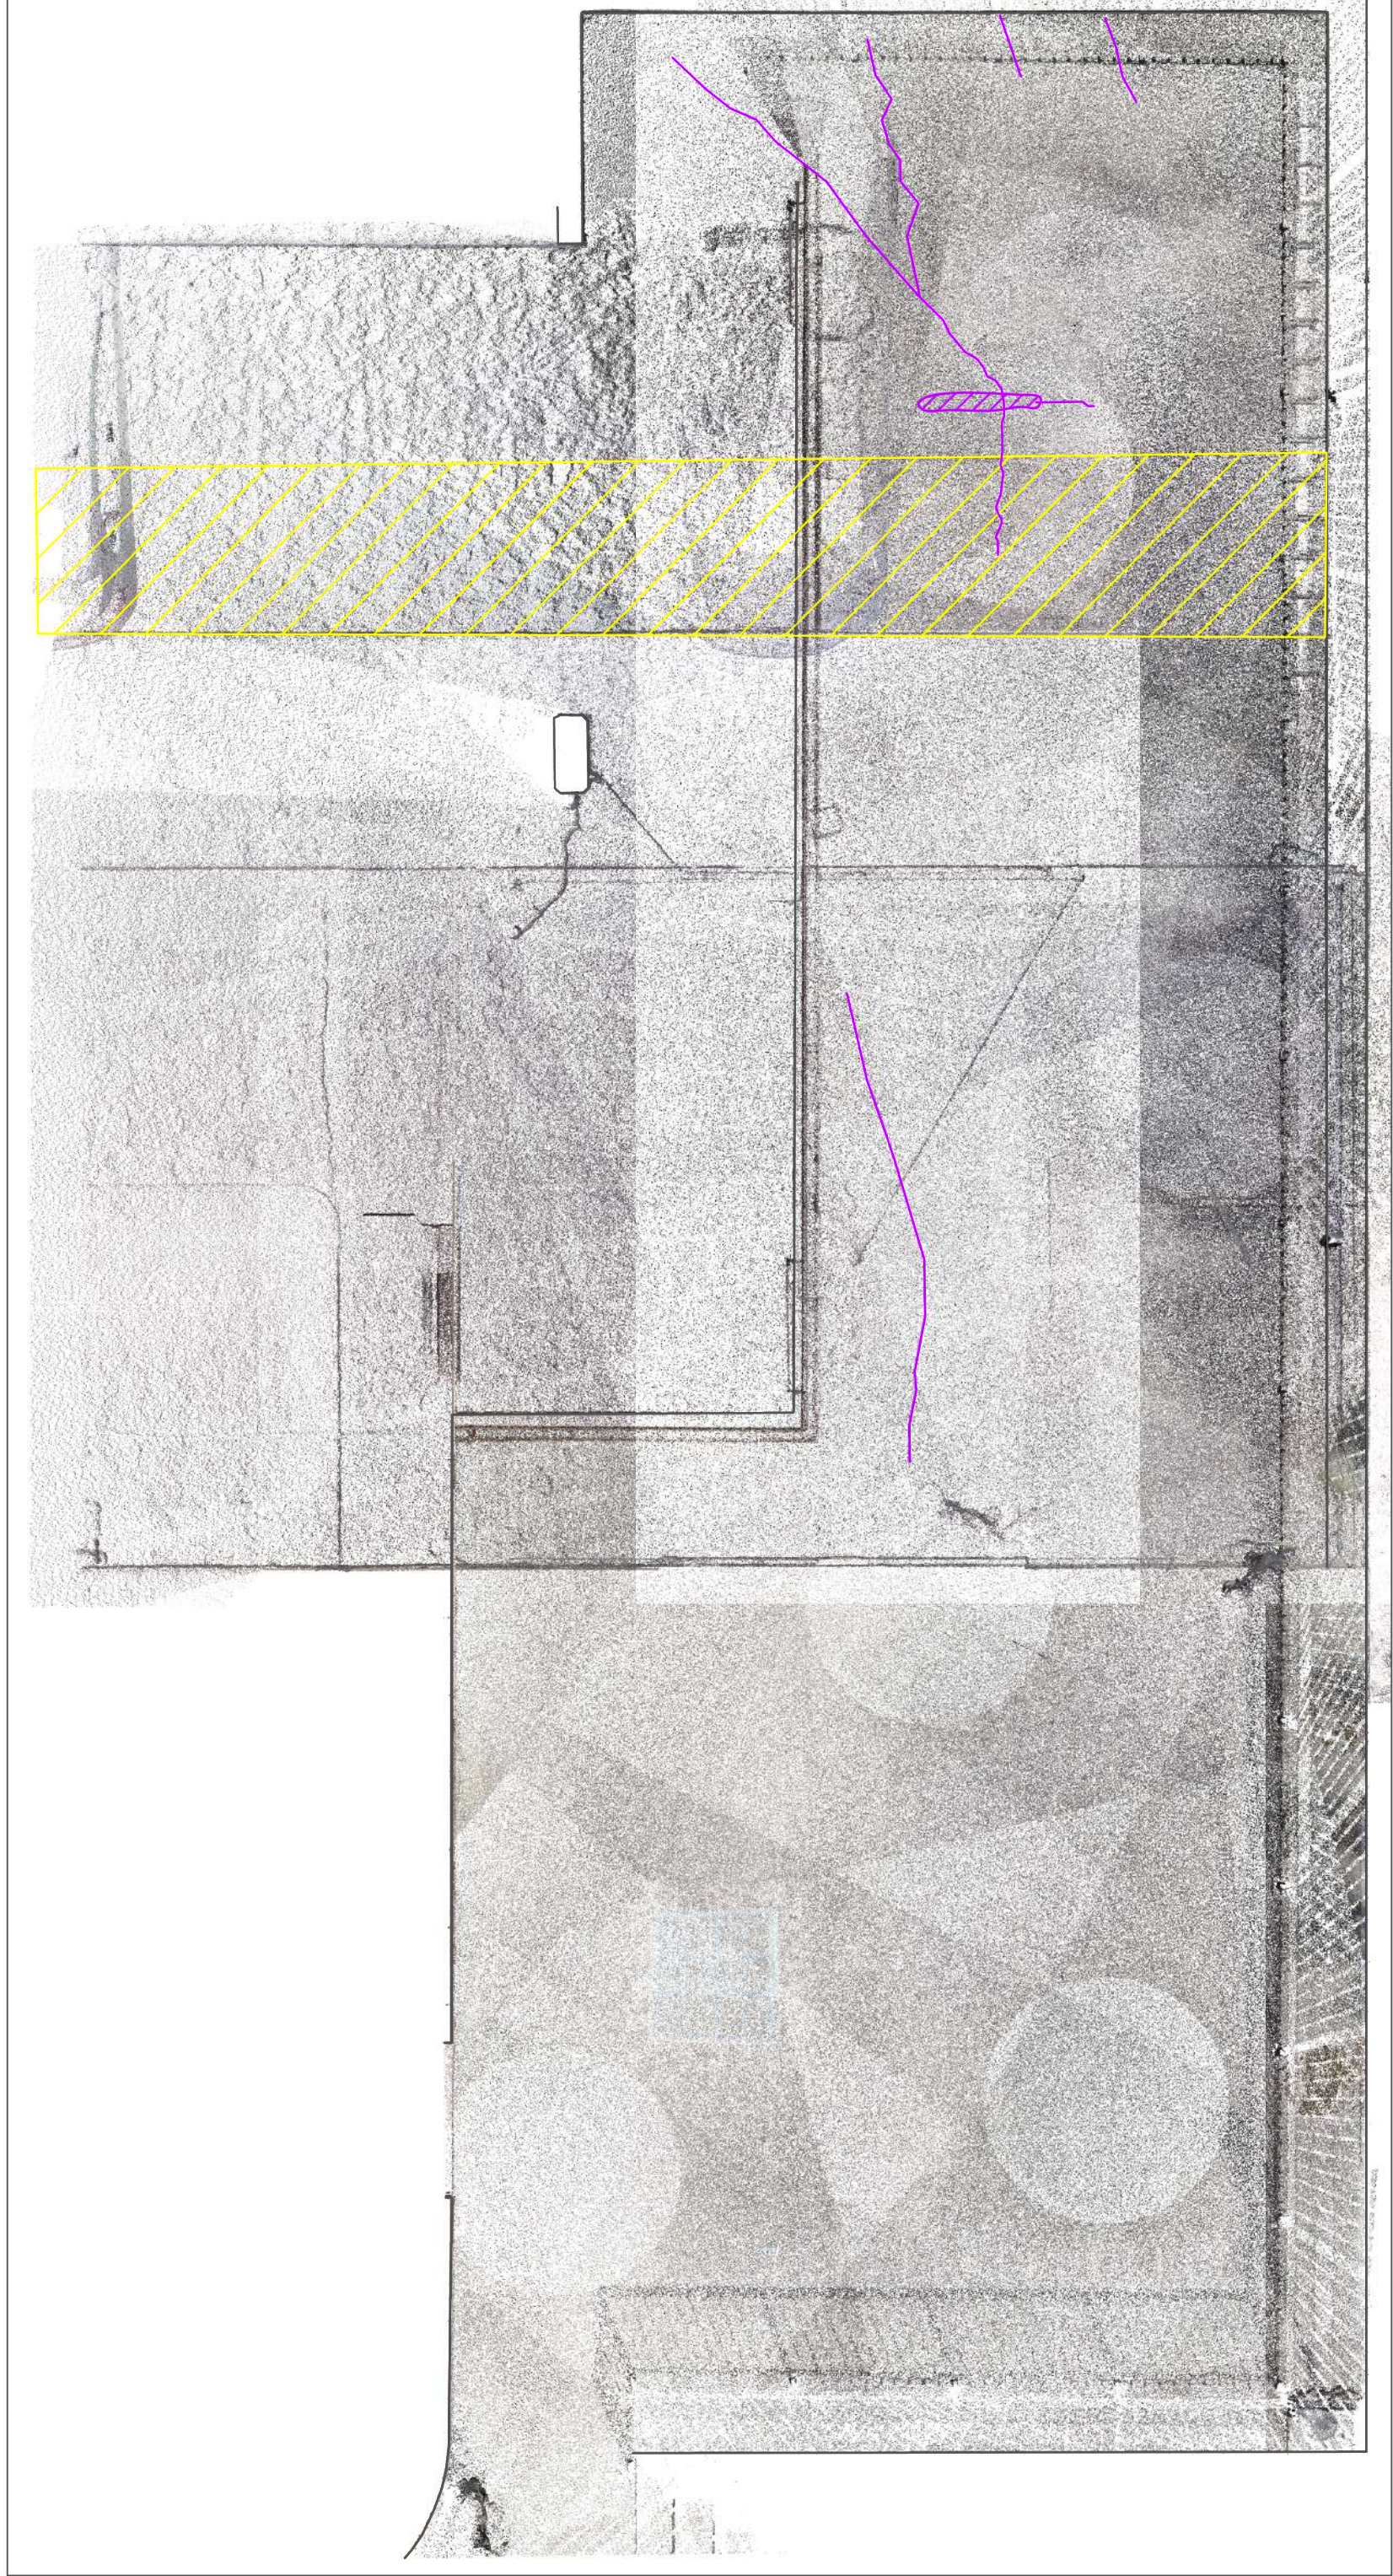
SHEET 12 - AREA 3- GPR CORROSION AND VISUAL RESULTS

Area 3 contained some small sporadic areas of moderate corrosion, no severe corrosion. Additionally, some cracking was observed on the topside and underside, with one area of exposed rebar on the underside. It is worth mentioning the presence of manmade trenches for draining water, on Areas 2 and 3. These are clearly retaining water.

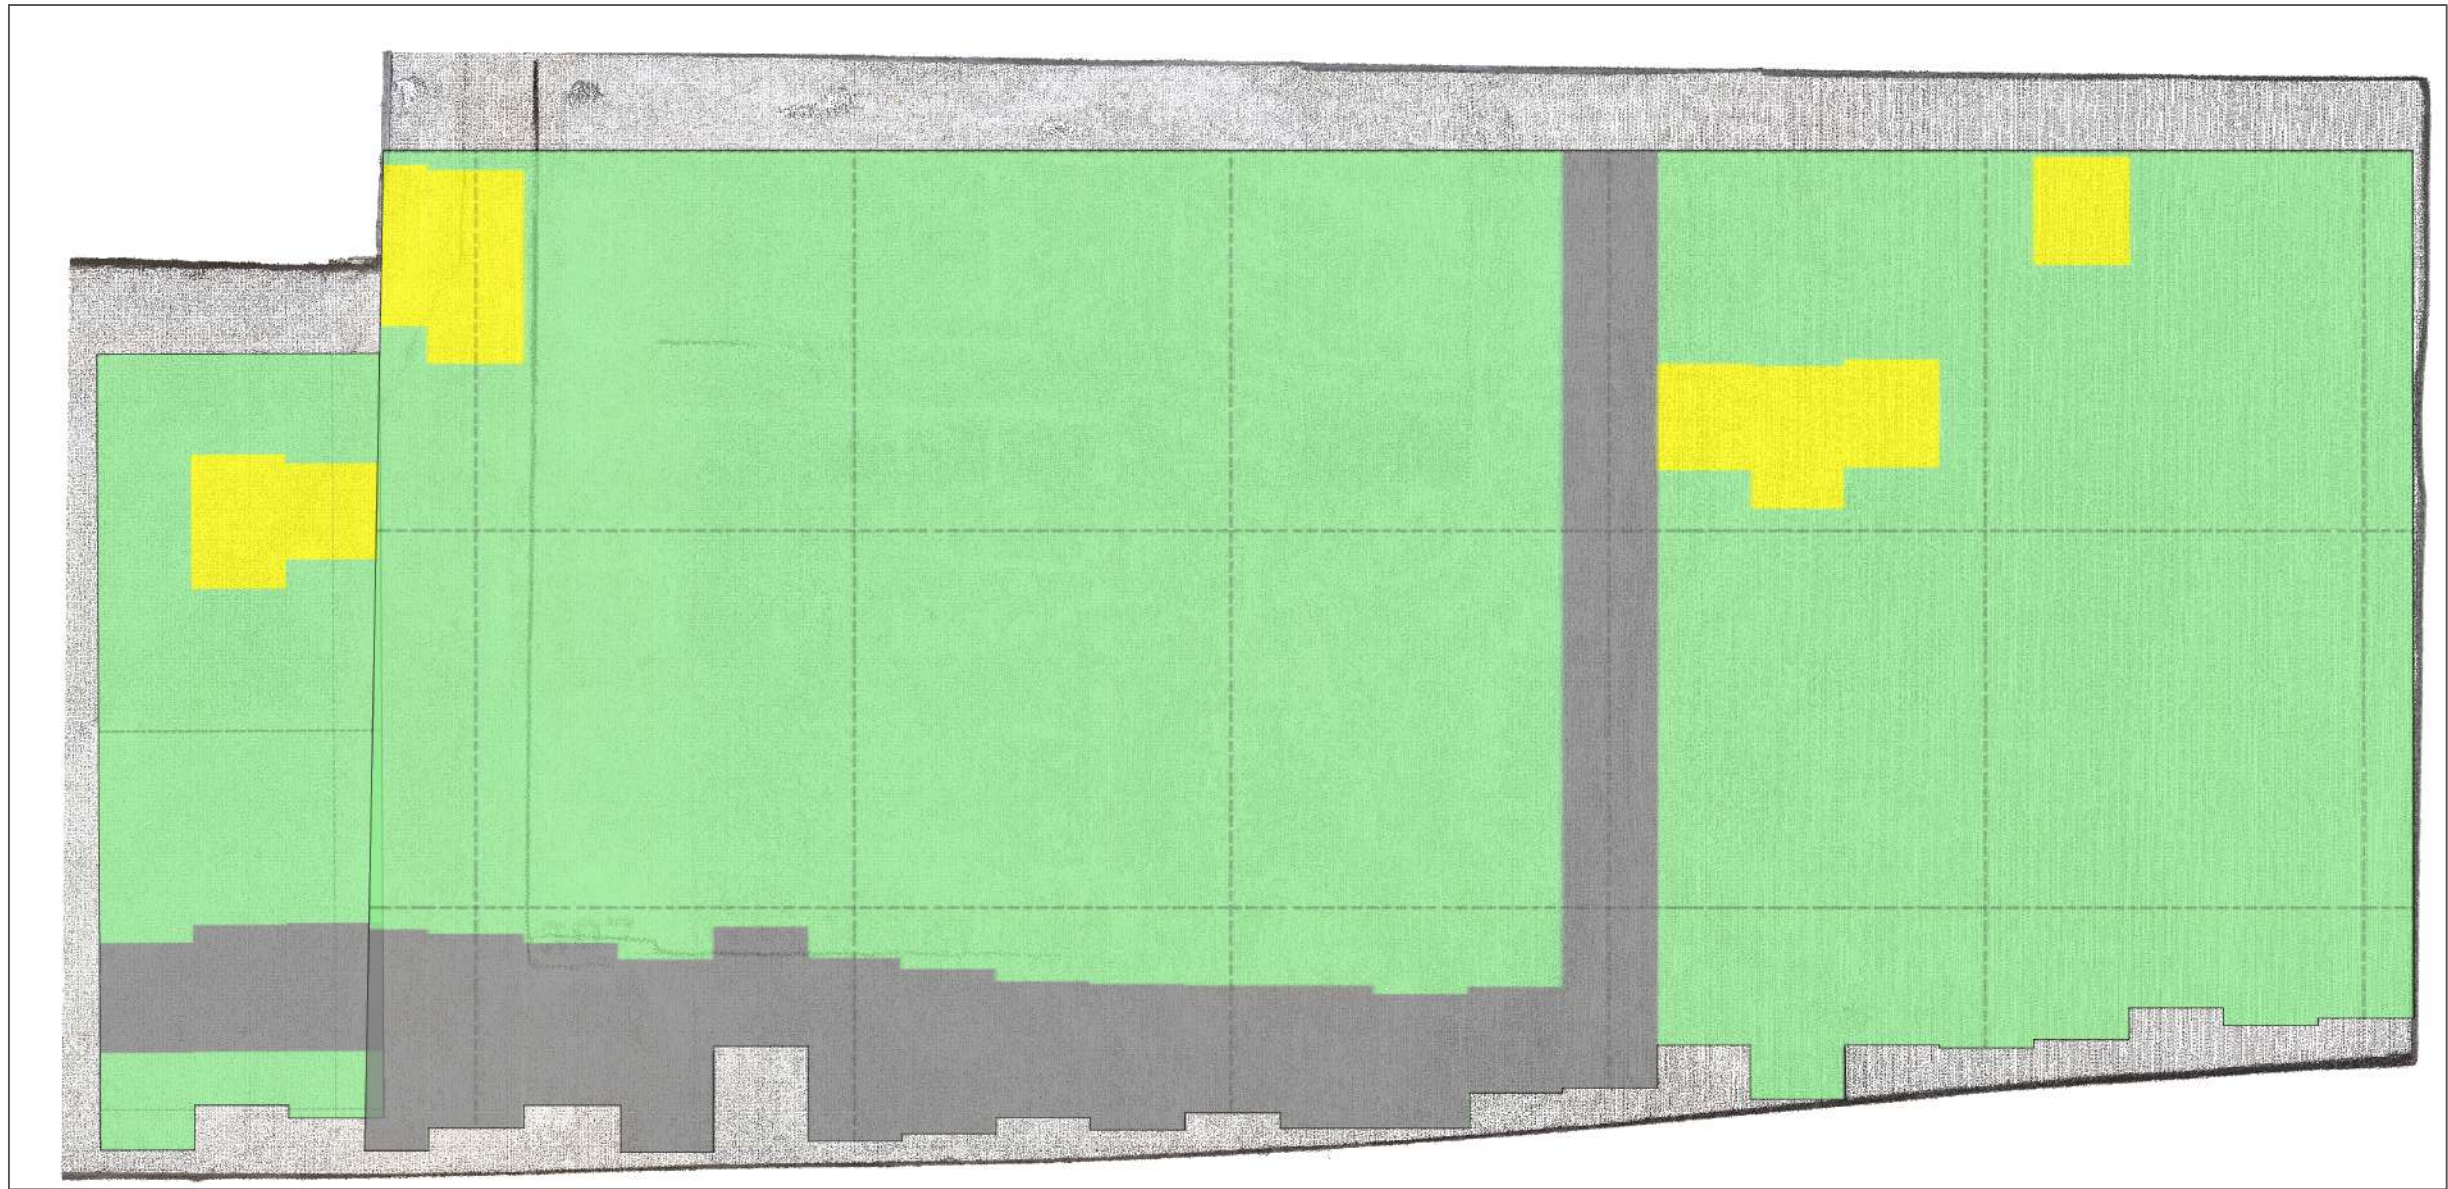
AREA 1 WALL - SOUTH FACE - CORROSION RESULTS
SCALE: 1:20

Both wall 1 and wall 2 contained some isolated suspected moderate corrosion. Wall 2 did contain two small areas of exposed rebar. The wall was very rough in places missing some chunks of concrete so data collection was limited to areas the antenna could roll over.
