RE: Balcony Investigation

RJC No. VAN.103256.0015

Bellevue Tower West

195 21st Street, West Vancouver, BC V7V 4A4

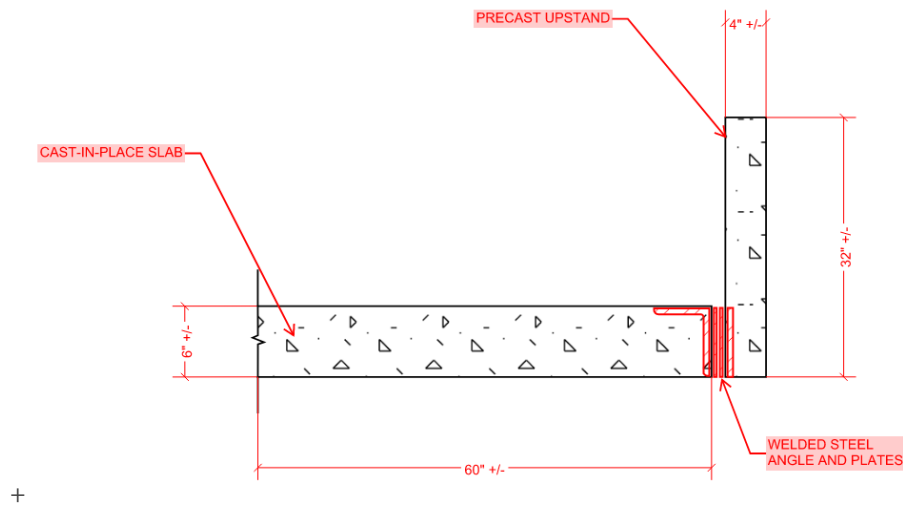
available to RJC for review. The connections are observed to be constructed of embedded steel plates and angles connected through welds. See Figure 3.

Figure 3: Observed upstand/slab connection detail

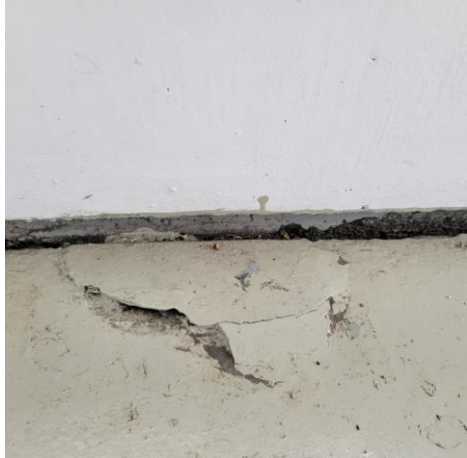
Table 1: Top Surface Connection Deterioration	
Observations	Photograph
<p>At localized connections, the topping has spalled partially or completely as noted in Photos 1 and 2, respectively. Where this condition was noted, the steel connection plates presented significant surface rust and potential cross-section loss, see Photo 2.</p> <p>Many locations were observed to have previous topping repairs at the upstand walls/slab.</p> <p>During our review we noted a consistent hollow sound around the connections indicating either a poor topping repair application or steel plate deterioration.</p>

<p>Photo 1: Spalled concrete at upstand wall/slab connection</p>

A typical minor repair would include a concrete repair around the connection: chipping the loose concrete around the connections, wire brushing and cleaning the steel plates and welds to remove surface rust, and patching with new concrete. This is for connections where the plates and welds present minor or negligible surface rust only and minor concrete deterioration.

When the concrete deterioration is more significant and the weld at the connection plates has been compromised, a major repair would be necessary. In addition to the minor repair requirements, a major connection repair would include new welding between the embedded steel plates to retrofit the connection and a greater extent of concrete repair.

When the connection is observed to have significant cross-section loss in the embedded plates, and reduction in the structural capacity of the existing welds, a full connection replacement would be warranted. In this condition, the connection plates and welds would be replaced and reinstalled and a significant area of concrete repairs would be carried out.

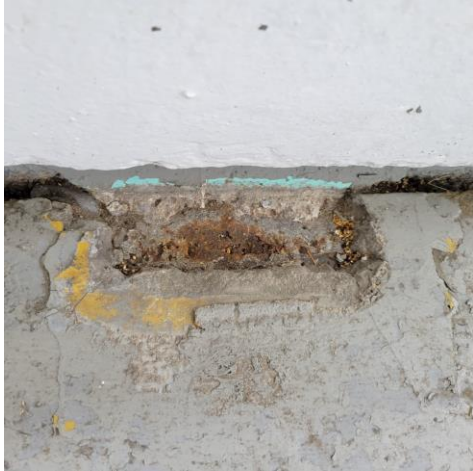
<p>Photo 2: Exposed steel plate connection with visible signs of major surface rust and cross-section loss</p>

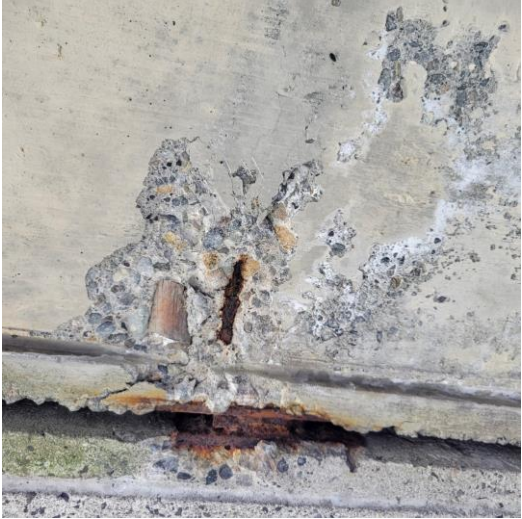
Table 2: Soffit Connection Deterioration	
Observations	Photograph
<p>Concrete spalling was observed at the soffit of concrete slabs and underneath the embedded steel connections. In general, the majority of steel plates and observed welds presented significant surface rust.</p> <p>At localized connections, the large extent of rebar and steel plate connection deterioration has resulted in a significant loss of concrete leading to a poor embedment of the steel plate connections, see Photo 3. The welds connecting the steel plates presented visible signs of cross-section loss.</p>

<p>Photo 3: Spalled concrete at upstand wall/slab connection. Slab soffit presents reinforcement with visible cross-section loss</p>

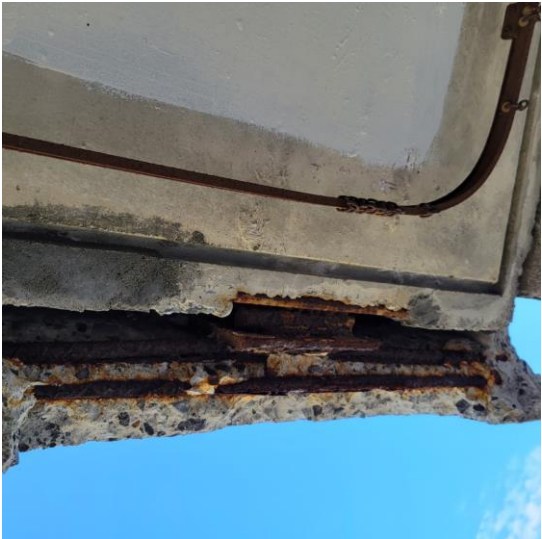
<p>Photo 4: Poor steel plate embedment due to major spalled concrete</p>

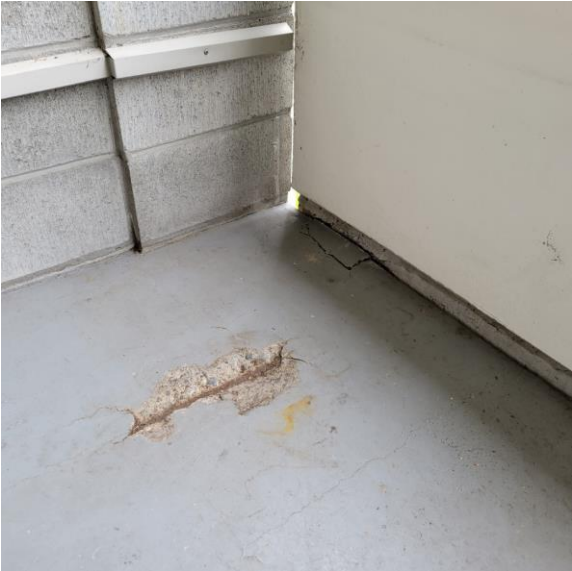
Table 3: Slabs And Walls Concrete Deterioration Observations	
Description	Photograph
<p>Localized top surface delamination was observed during our hammer sounding review. Spalled concrete due to rebar corrosion was observed as noted in Photo 5.</p> <p>The concrete survey at the precast upstand walls showed that the walls are generally in good condition with only minor vertical concrete delaminations.</p>

<p>Photo 5: Spalled concrete at balcony top surface</p>

- Complete localized concrete repairs to the balcony slabs.
- All concrete upstand walls and slab soffits should be scaled to remove any loose or spalled concrete.
- Undertake a repair project to the existing upstands and their connections or replace the existing upstand walls with new guardrails. **We recommend that this work be commenced within the next year.** If new guardrails are selected as the option to move forward, this work may require a development permit and the involvement of an architect.
- Tenants should be advised that heavy objects should not lean or rest on the precast concrete upstand walls.
- Consider restricting the number of people who can be on the balcony at any time.

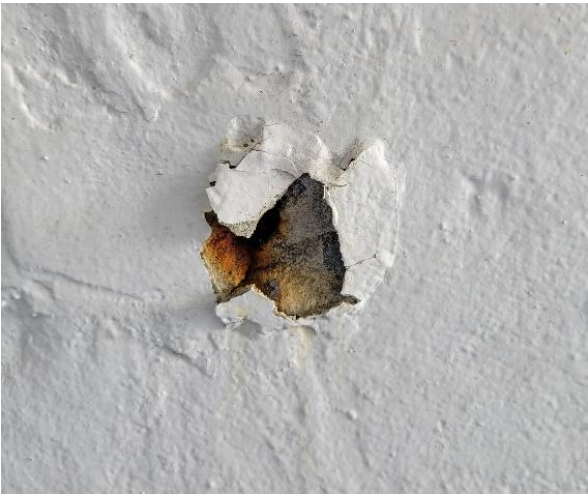
<p>Photo 6: Minor vertical delamination at upstand wall</p>
