Re: 1021 4<sup>th</sup> Avenue  
New Westminster, British Columbia  
Balcony Repairs  
Change Order 2 - CO#2  
Our Reference No: CCC-224718-22

**August 29<sup>th</sup>, 2023**

**Site Address:** 1021 Fourth Avenue, New Westminster, British Columbia

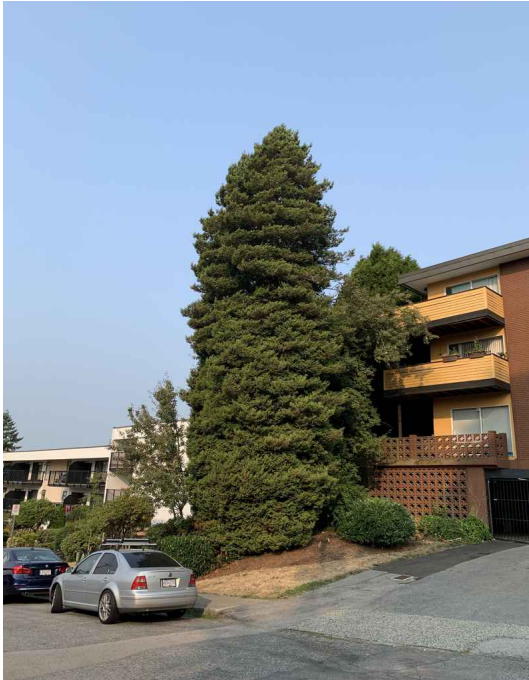
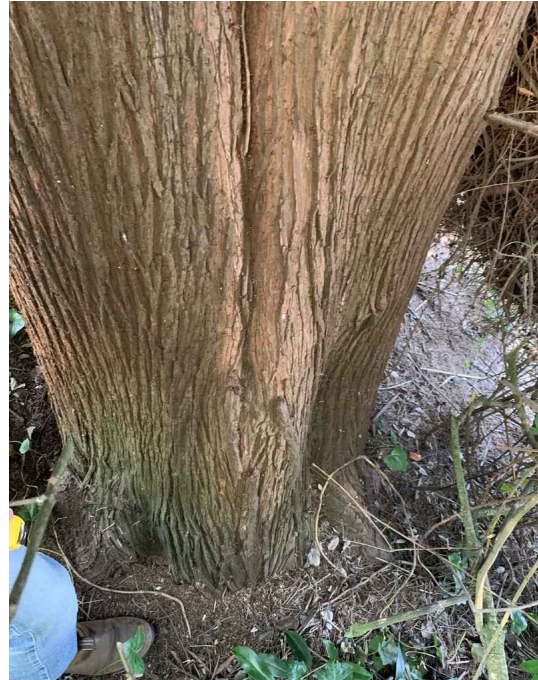
**Tree #27** is a sawara cypress (*Chamaecyparis pisifera*) tree located on the southwest corner of the subject property. The tree has a co-dominant stem structure. Both stems are measured as approximately 36 centimetres DBH, which makes the total DBH 51 centimetres. The tree has a crown spread of approximately 4 metres. TPB size is determined by the DBH and should be 3.3 metres or 11 feet, if retained. The tree is located over 2 metres away from the edge of the podium, which is also the edge of the balconies above the podium. As per the site plan, new posts will be installed at the corner of these balconies. The posts will be situated on the podium level. No excavation will be required at the grade of the tree. Replacement of the existing guardrails on the balconies will require the installation of a metal scaffold on the south side of the balconies. The metal scaffold will likely be 3 feet (approximately 1 metre) wide. The posts of the metal scaffold should avoid contacting any surface roots. A 1 inch thick layer of plywood should be laid on grade, within the TPB area, to reduce soil disturbances from foot traffic. Arborist inclusion is required for metal scaffold installation, foot access corridor installation, final landscaping, and any entry into the formal TPB area. **Arborist inclusion required. (Refer to Arborist inclusion outline & the TPB and Tree Impact Summary table.) NO activities within the formal TPB areas without Arborist inclusion.**

**Tree #27 – Co-dominant stems with bark inclusion**

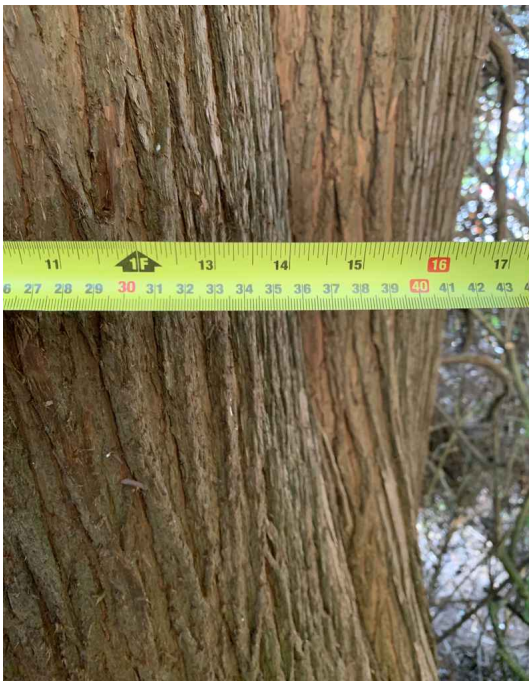
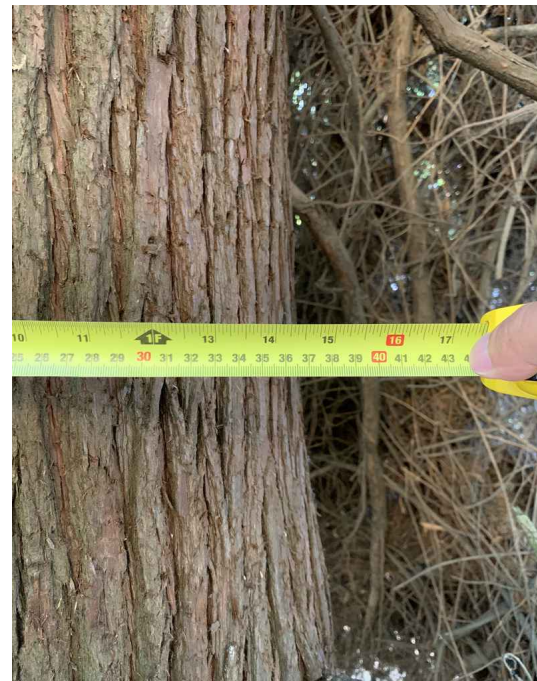
**Tree #27 – DBH of the stems are ~36 cm.**

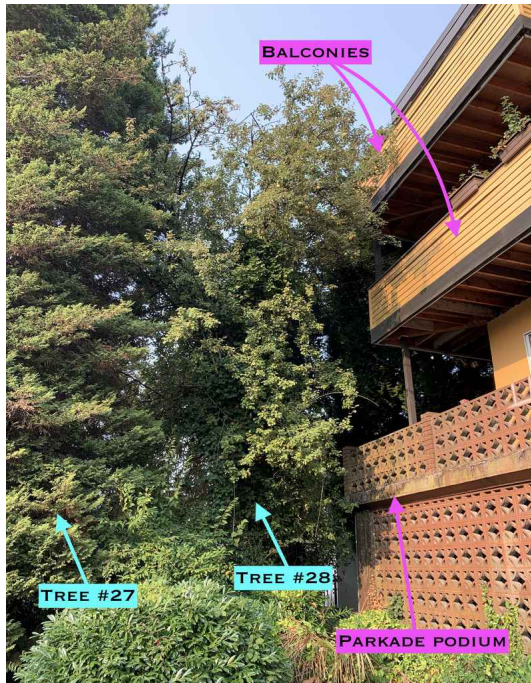
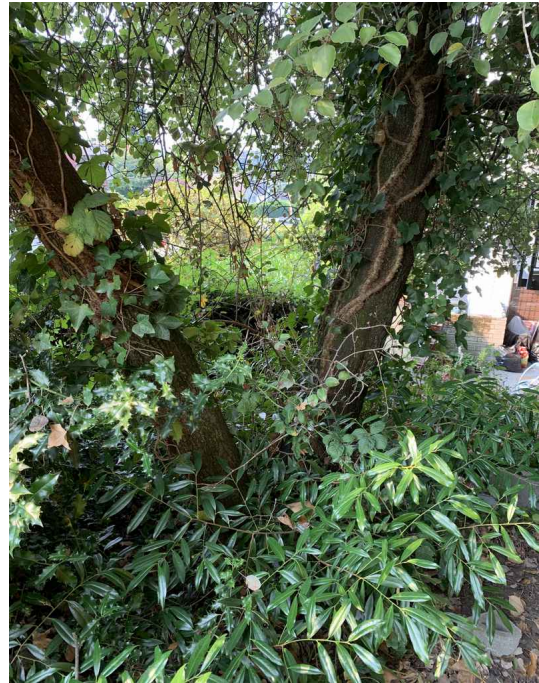
**Tree #28** is a pear (*Pyrus* sp.) tree located on the southwest corner of the subject property. The tree has a co-dominant stem structure. The total DBH of the tree is 36 centimetres. The tree has a crown spread of approximately 4 metres. TPB size is determined by the crown spread and should be 3 metres or 10 feet, radial span, if retained. The tree is located west of the podium. The extent of the metal scaffolds is anticipated to be located outside the podium on the south side and on top of the podium on the west side. It is unlikely that the installation of the metal scaffold will impact this tree. The majority of the crown of this tree is located on the west side. Minor pruning may be required to provide clearance from the balconies. The posts of the metal scaffold should avoid contacting any surface roots. A 1 inch thick layer of plywood should be laid on grade, within the TPB area, to reduce soil disturbances from foot traffic. Arborist inclusion is required for metal scaffold installation, foot access corridor installation, pruning, final landscaping, and any entry into the formal TPB area. **Arborist inclusion required. (Refer to Arborist inclusion outline & the TPB and Tree Impact Summary table.) NO activities within the formal TPB areas without Arborist inclusion.**

### Tree #28 – Co-dominant stems

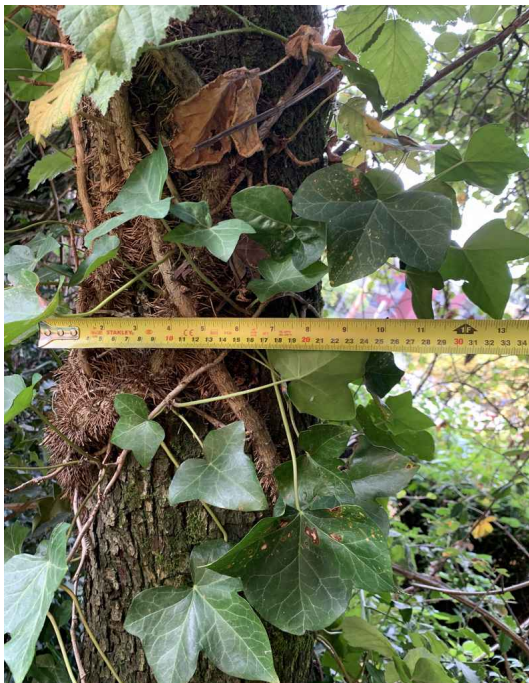
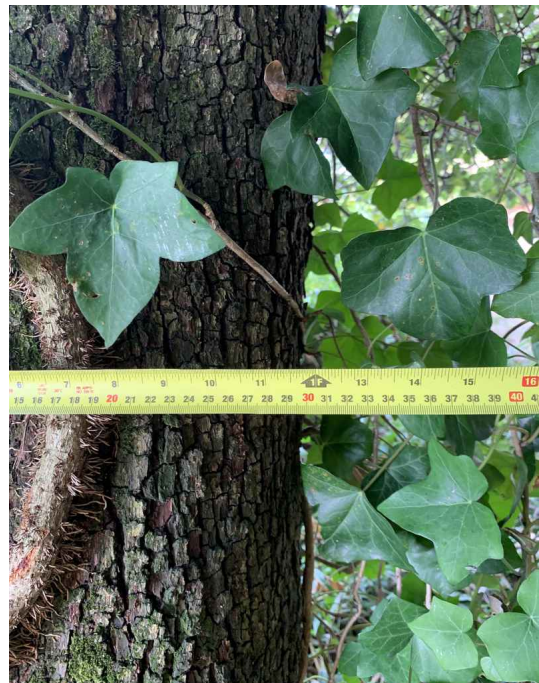
### Tree #28 – DBHs are ~30 & 20 cm.

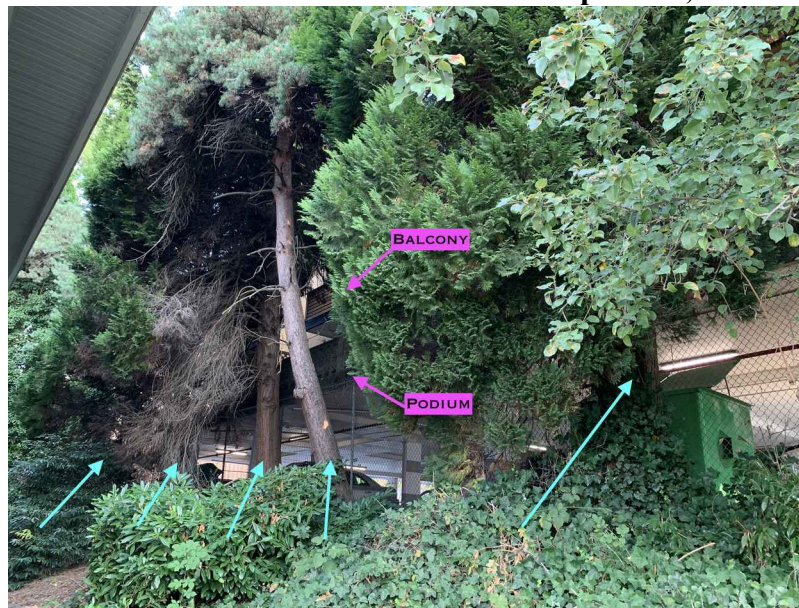
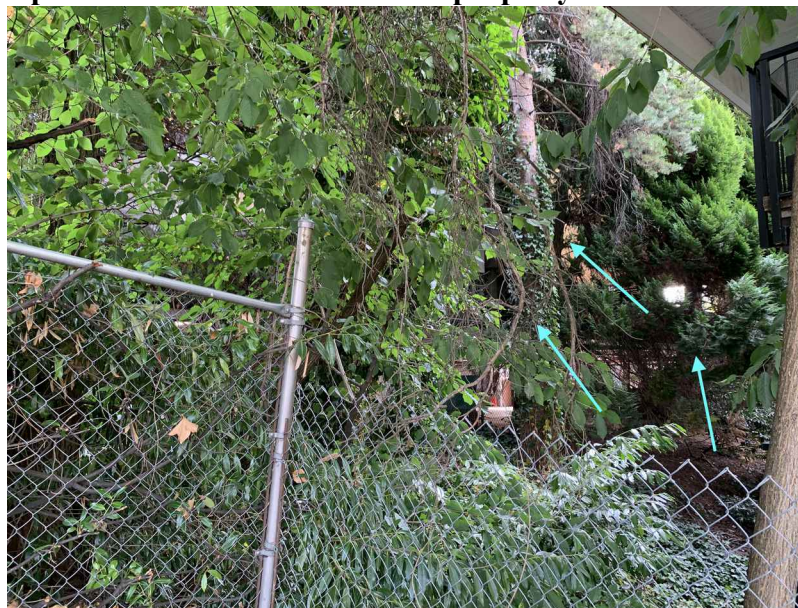
**Tree #29** is a row of 5 trees located along the west property line, midspan. It is constituted of 3 cypress (*Cupressus* sp.) trees and 2 pine (*Pinus* sp.) trees. The trees are located in a densely vegetated area and cannot be accessed from the subject property. The approximate DBHs of these trees are 30 – 40 centimetres. Most trees have an asymmetrical crown and a small crown spread due to the proximity to the podium. The crown spread of the trees is approximately 4 metres. TPB size is determined by the crown spread and should be 3 metres or 10 feet, radial span, if retained. Since all proposed works will be on the podium on this side of the property, it is unlikely that there will be any impact to the rooting area of this tree row. TPB should be omitted for this tree row. Minor pruning may be required to provide clearance from the balconies. Arborist inclusion is required for pruning, final landscaping, and any entry into the formal TPB area. **Arborist inclusion required. (Refer to Arborist inclusion outline & the TPB and Tree Impact Summary table.) NO activities within the formal TPB areas without Arborist inclusion.**

**Tree row #29 – below the podium, next to the parkade area. West side of the property.**

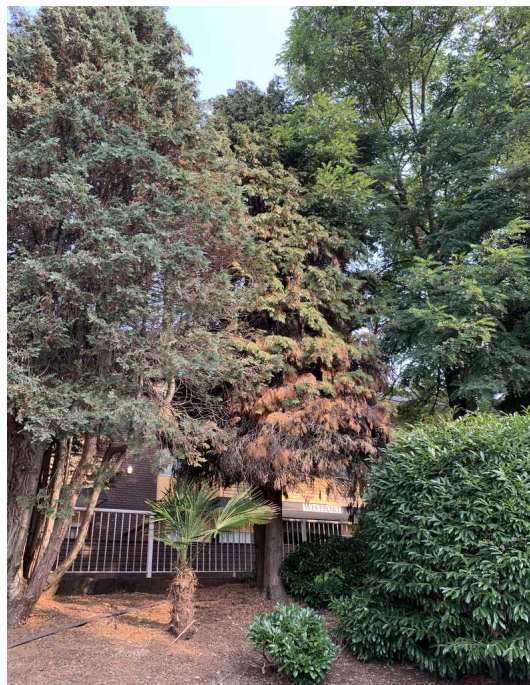
| Tree Species | Tree ID # | DBH | Crown Spread | Tree Location | TPB | Tree Vigour - General Observations | Bldg Envlpe | Action |
|---|---|---|---|---|---|---|---|---|
| Cypress | #31 | 41 cm DBH | 3 m | SW quadrant | RQD<br>2.7 m or 9 ft | LOW VIGOUR<br>Co-dominant stems, chlorotic foliage, large portion of the crown is wilted | NO | RETAIN |

**Tree #31** is a cypress (*Chamaecyparis* sp.) tree located in the southwest quadrant of the subject property. The tree is measured as 41 centimetres DBH and has a crown spread of approximately 3 metres. TPB size is determined by the DBH and should be 2.7 metres or 9 feet, if retained. The tree is located outside the podium area and is not close to any existing balcony. TPB should be erected up to the edge of the podium or any walkway. There are no anticipated development influences at this time of reporting. Arborist inclusion is not required. No development activities are permitted within the tree protection area without arborist inclusion.

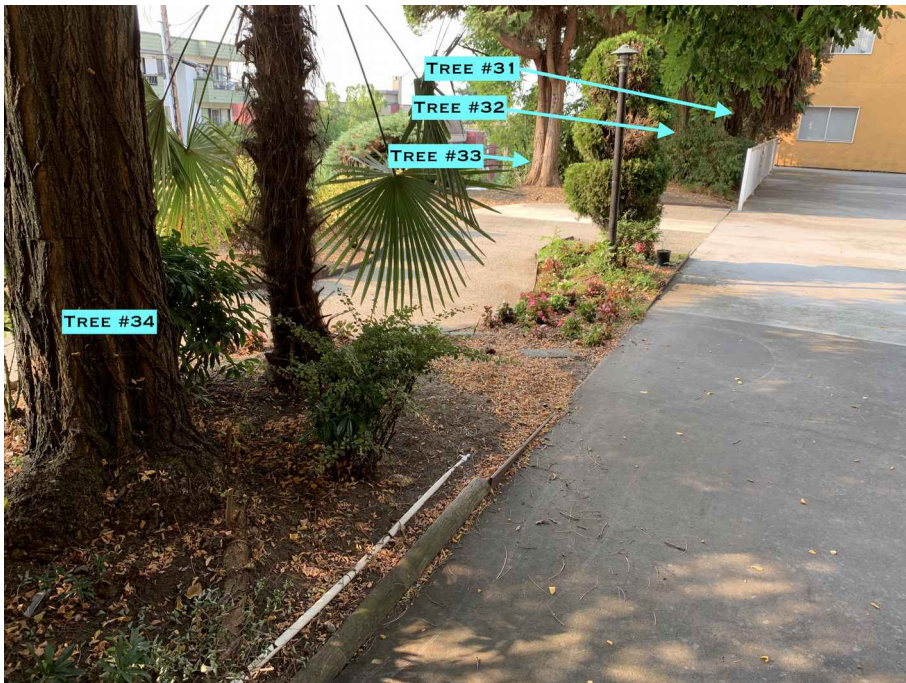
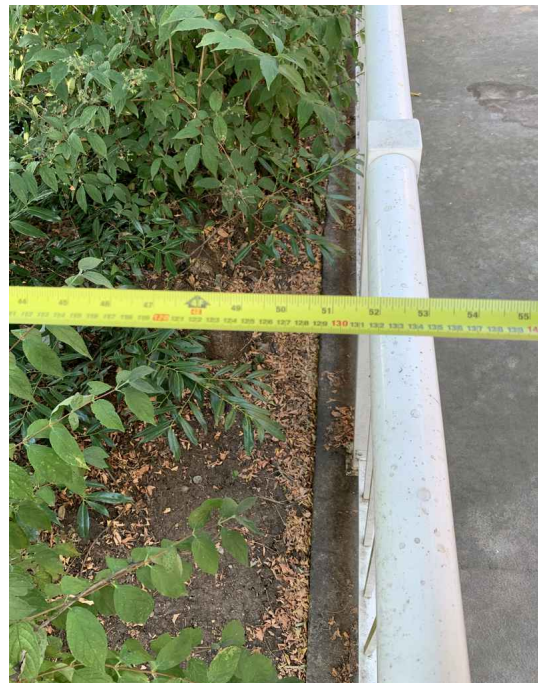
**Trees #30 - #34 are ~1.3m outside the podium area**

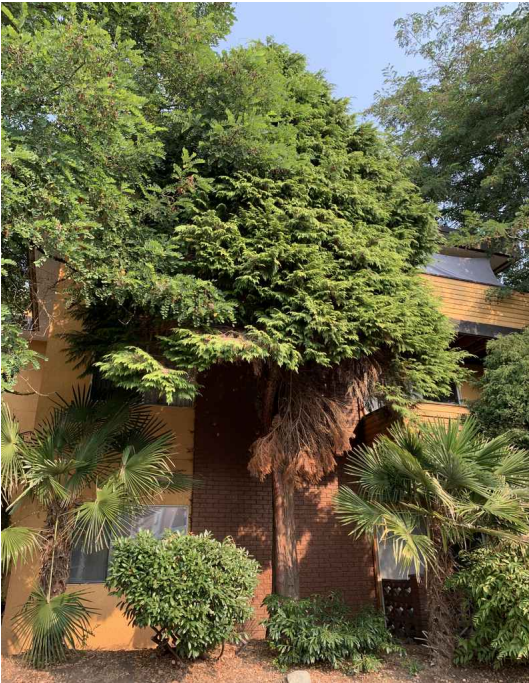
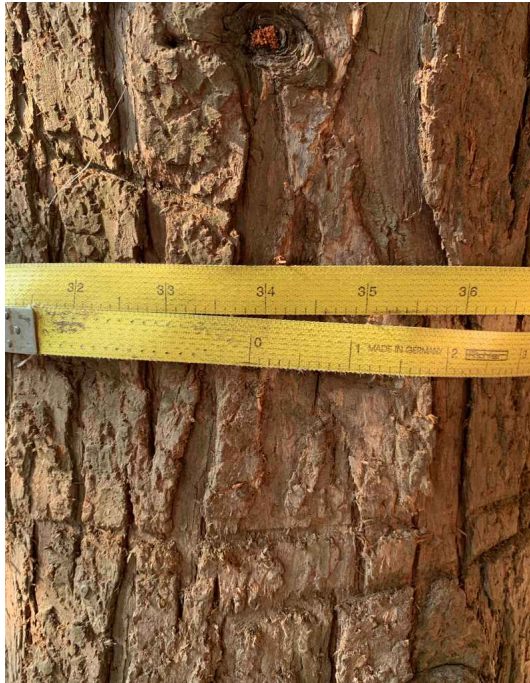
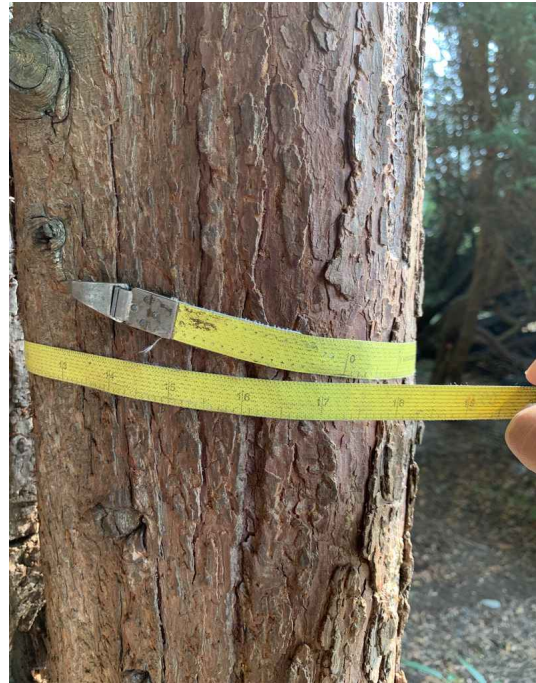
**Tree #35** is a cypress (*Chamaecyparis* sp.) tree located in the southeast quadrant of the subject property. The tree has 2 stems and the measured DBH is 38 centimetres. The crown spread of the tree is approximately 4 metres. TPB size is determined by the crown spread and should be 3 metres or 10 feet, radial span, if retained. The tree has been crown raised in the past to achieve the current LCR of 50%. The tree is approximately 7 feet (2.13 metres) away from the balconies located on the southeast corner of the building. Replacement of the existing guardrails on the balconies will require the installation of a metal scaffold around the balconies. The posts of the metal scaffold should avoid contacting any surface roots. A 1 inch thick layer of plywood should be laid on grade, within the TPB area, to reduce soil disturbance from foot traffic. Pruning will be required to provide clearance from the balconies and for the installation of the metal scaffolds. Arborist inclusion is required for metal scaffold installation, foot access corridor installation, pruning, final landscaping, and any entry into the formal TPB area. **Arborist inclusion required. (Refer to Arborist inclusion outline & the TPB and Tree Impact Summary table.) NO activities within the formal TPB areas without Arborist inclusion.**

**Tree #35 – DBHs are 34 and 17 cm.**

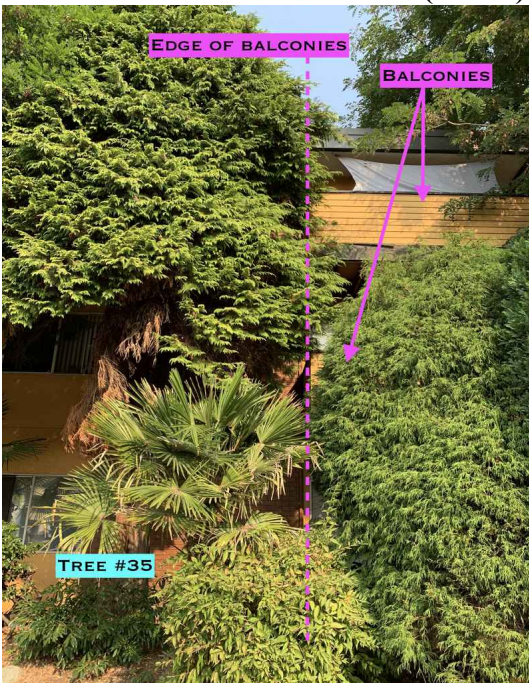
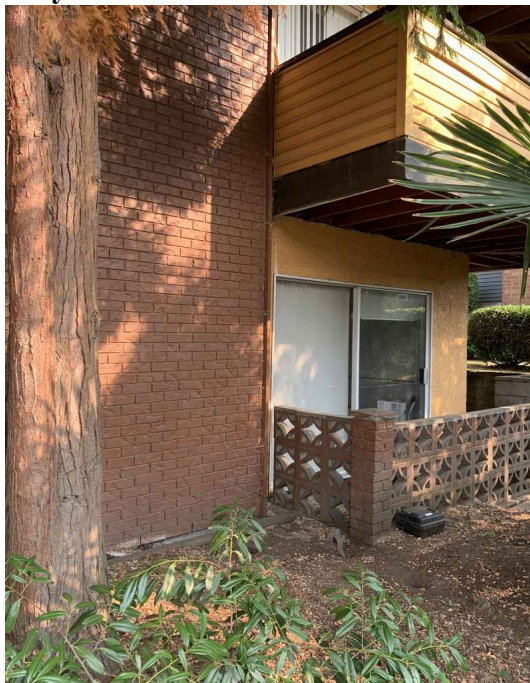
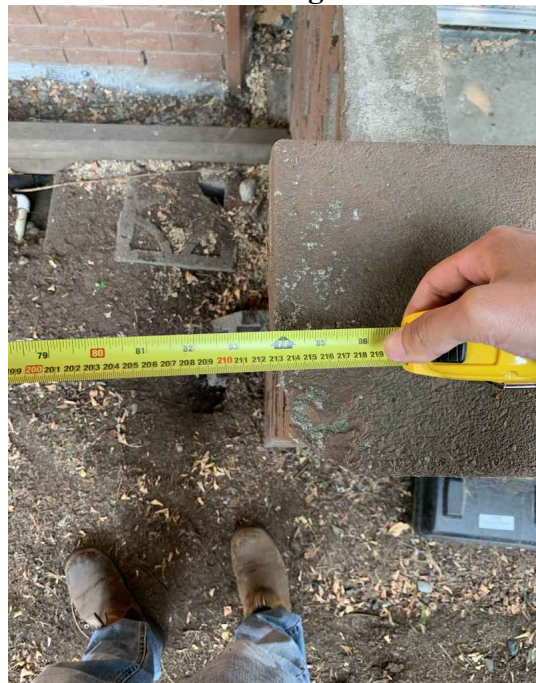
**Tree #35 is ~7' (2.13m) away from the balconies on the southeast corner of the building**

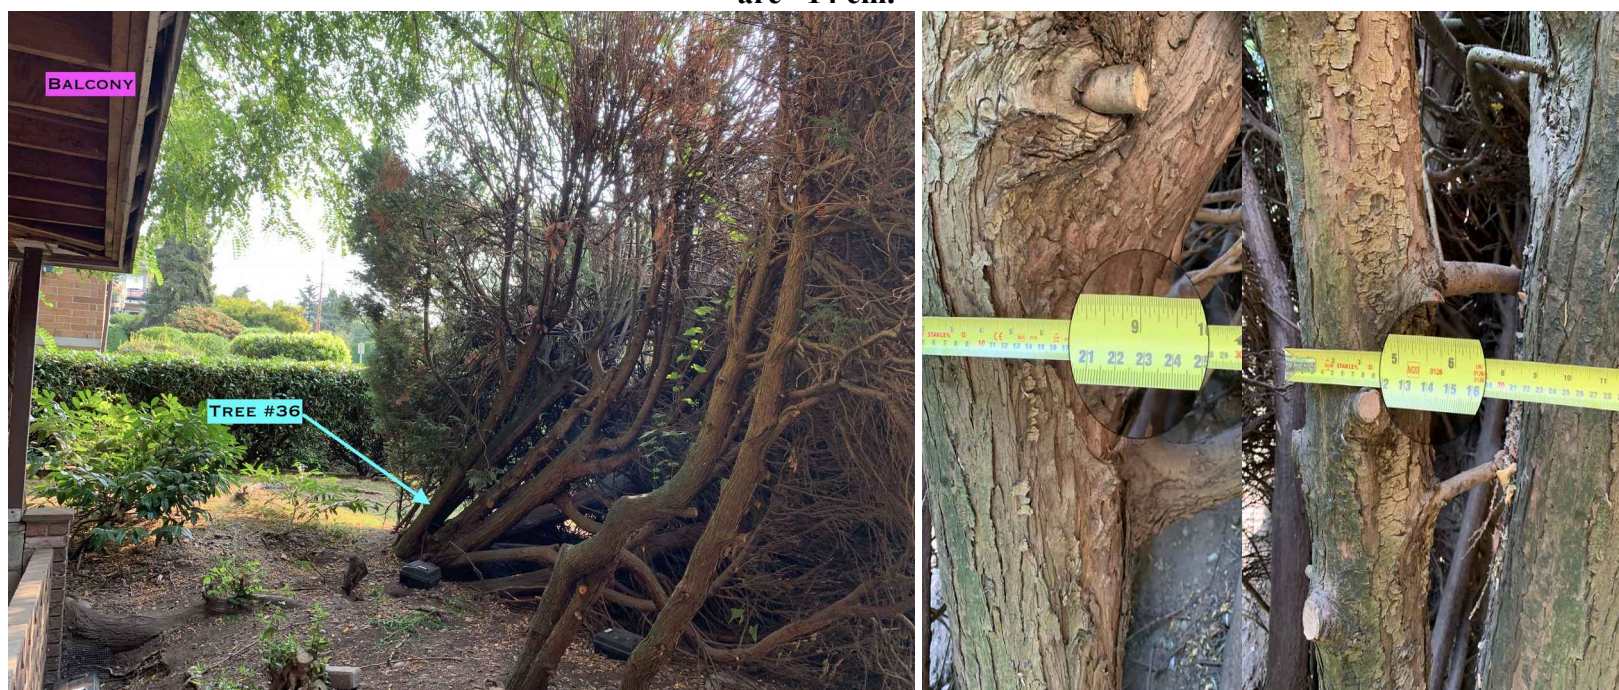
**Tree #36** is a cypress (*Chamaecyparis* sp.) shrub located in the southeast quadrant of the subject property. The shrub is approximately 4 metres tall, with a multiple stem structure that all the stems are growing at an angle toward south, and no foliage on the north side. The largest stem is measured as 25 centimetres DBH and the rest of the stems are approximately 14 centimetres DBH. The total DBH of this shrub is estimated to be 35 centimetres. The shrub has a crown spread of approximately 4 metres. TPB size is determined by the crown spread and should be 3 metres or 10 feet, radial span, if retained. The base of this shrub is over 2 metres away from the edge of the balcony. Since the crown is absent on the north side of the tree, there is no need to prune this shrub for the proposed repair work. A 1 inch thick layer of plywood should be laid on grade, within the TPB area, to reduce soil disturbance from foot traffic. Arborist inclusion is required for metal scaffold installation, foot access corridor installation, final landscaping, and any entry into the formal TPB area. **Arborist inclusion required. (Refer to Arborist inclusion outline & the TPB and Tree Impact Summary table.) NO activities within the formal TPB areas without Arborist inclusion.**

**Tree #36 – Multi-stemmed, asymmetrical crown. DBH of largest stem is ~23 cm. Smaller stems are ~14 cm.**

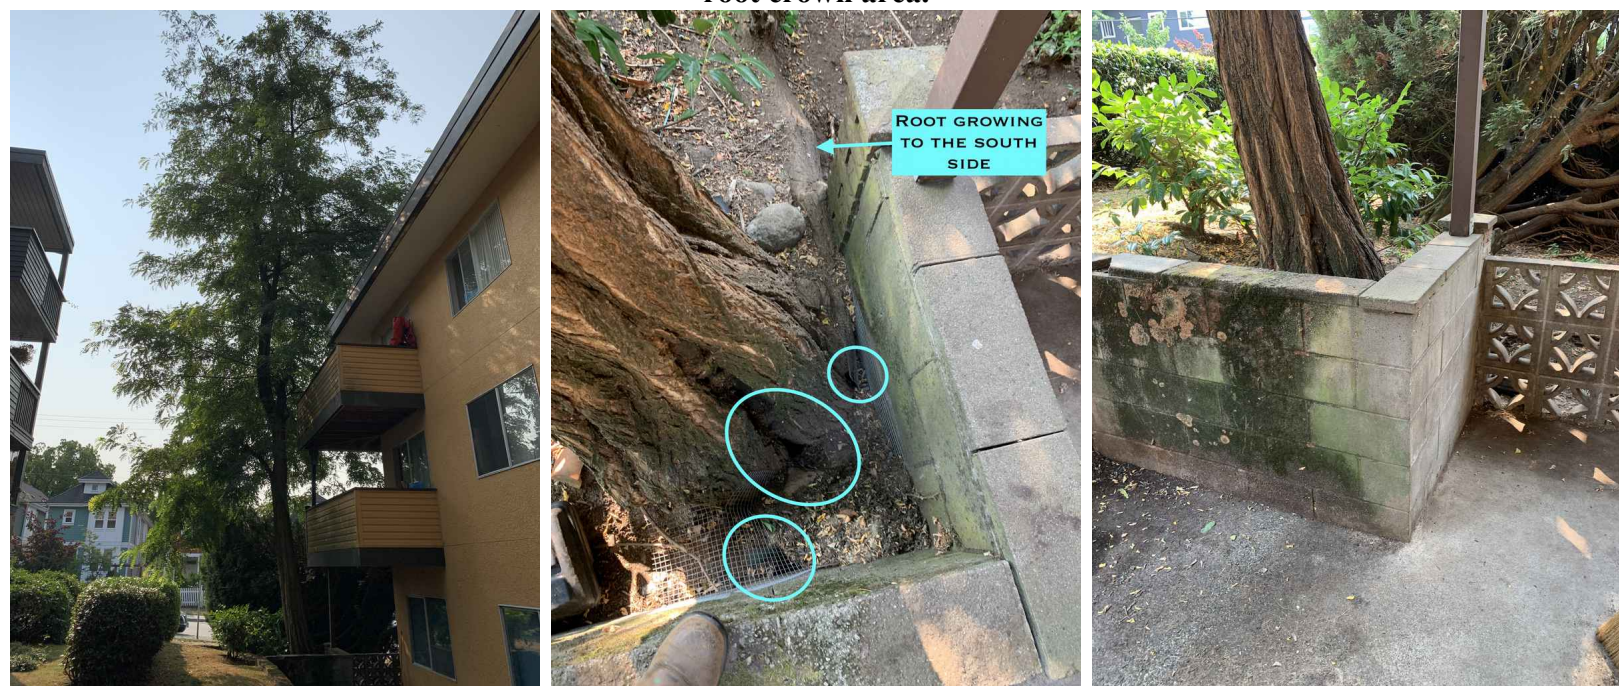
| Tree Species | Tree ID # | DBH | Crown Spread | Tree Location | TPB | Tree Vigour - General Observations | Bldg Envlpe | Action |
|---|---|---|---|---|---|---|---|---|
| Black locust | #37 | 40 cm DBH | 4 m | SE corner | RQD<br>3 m or 10 ft | NORMAL VIGOUR<br>In proximity to existing retaining wall, crooked stem, voids at trunk base | NO | RETAIN |

**Tree #37 – North and west rooting area restricted by a retaining wall. Gaps can be found at the root crown area.**

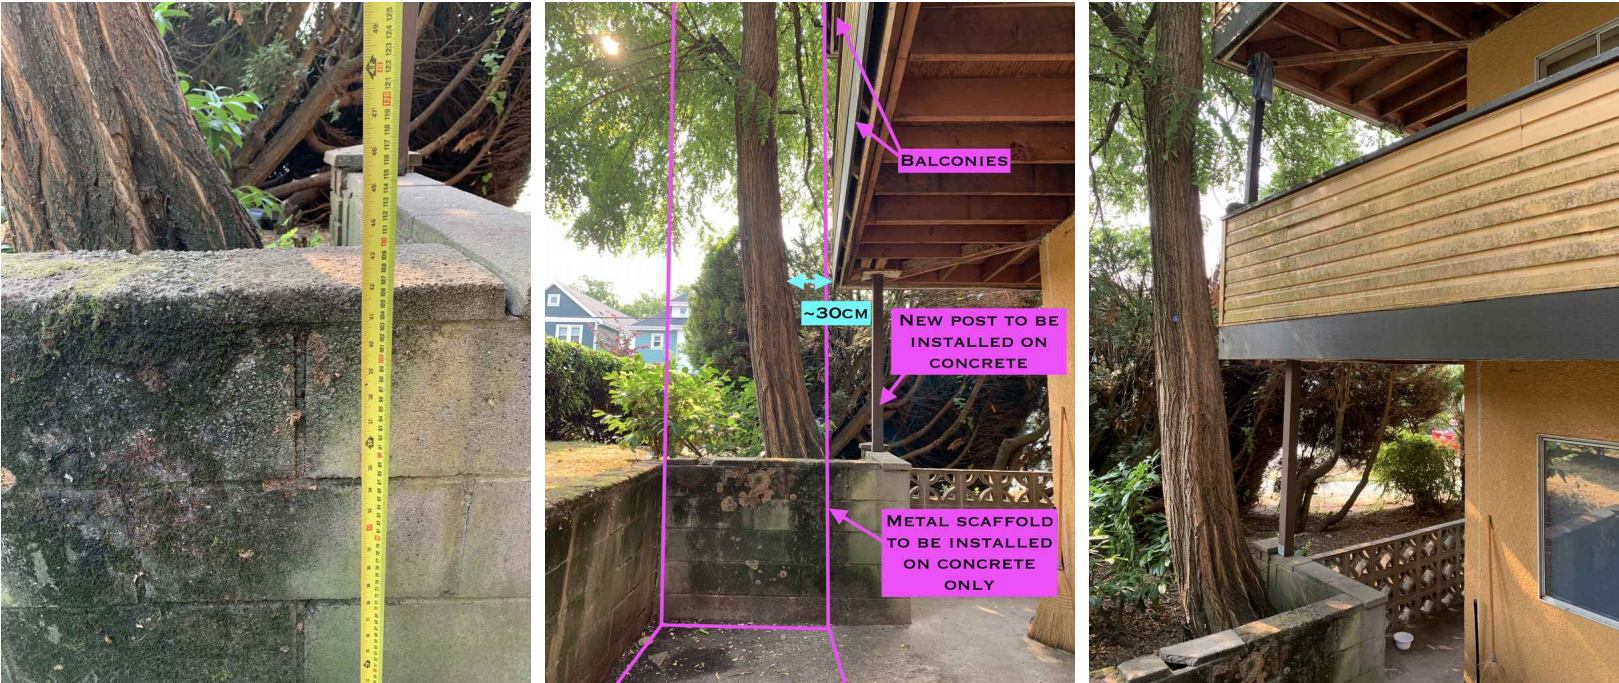
**Tree #37** is a black locust (*Robinia pseudoacacia*) tree located on the southeast corner of the subject property. The tree is measured as 40 centimetres DBH and has a crown spread of approximately 4 metres. TPB size is determined by the crown spread and should be 3 metres or 10 feet, radial span, if retained. The tree is located on the east side of the balconies, above a 1 metre tall retaining wall. The rooting area is restricted on the north and west sides because of the wall. Buttress root development can be seen on the northwest side of the root collar; however, given the restricted root plate on the north and west sides, it is uncertain if the roots have grown under the wall. One surface root was found originating from the west side of the trunk, but growing along the retaining wall towards to the south. Several gaps can be seen in between the buttresses on the northwest side of the root collar. The gaps were covered with a metal mesh and could not be assessed. It is uncertain whether decay is present in these gaps. The main stem appears to be growing at an angle towards the southeast, away from the building, for phototropic reasons. The trunk is approximately 30 centimetres away from the edge of the balconies. The metal scaffolds for replacing the guardrails can be installed on the east side of the balconies, below the retaining wall, to avoid impacting the rooting area of the tree. The new posts will be situated on the existing concrete. No excavation will be required at the grade of the tree. It is likely that the tree will not be impacted by the proposed repair work. The tree can be retained under the proposed scope of work. However, it is recommended that a further inspection be carried out to assess the feasibility of long-term tree retention, outside this permit application. Arborist inclusion is required for metal scaffold installation, foot access corridor installation, pruning, final landscaping, and any

**Tree #37 – Retaining wall is ~1 m tall. Tree is ~30 cm away from existing balconies. New post and metal scaffolds are to be installed on concrete.**

entry into the formal TPB area. **Arborist inclusion required. (Refer to Arborist inclusion outline & the TPB and Tree Impact Summary table.) NO activities within the formal TPB areas without Arborist inclusion.**

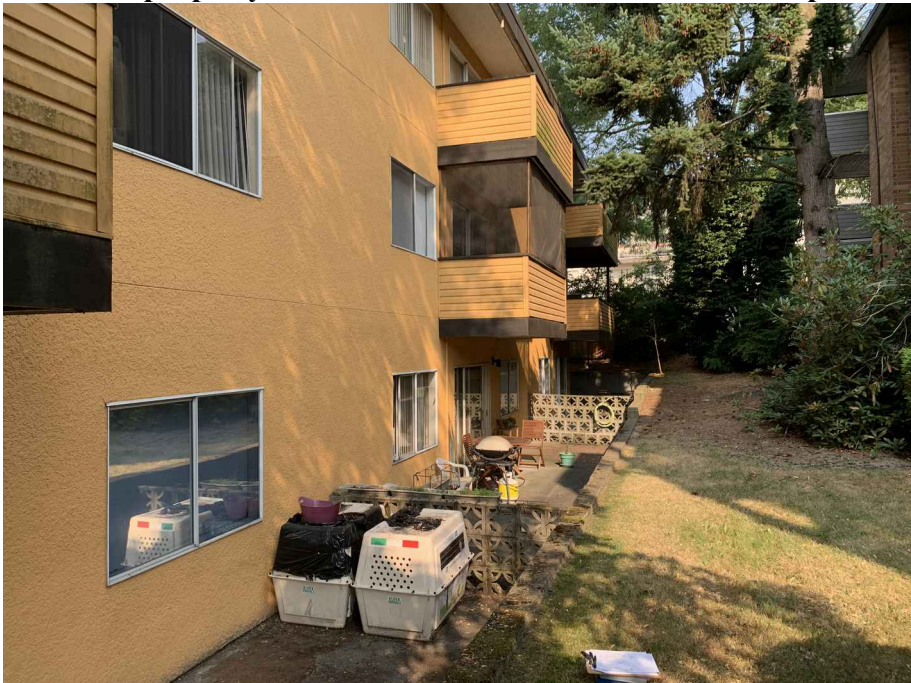
**East side of the property. Trees A – D are all located outside the podium wall.**

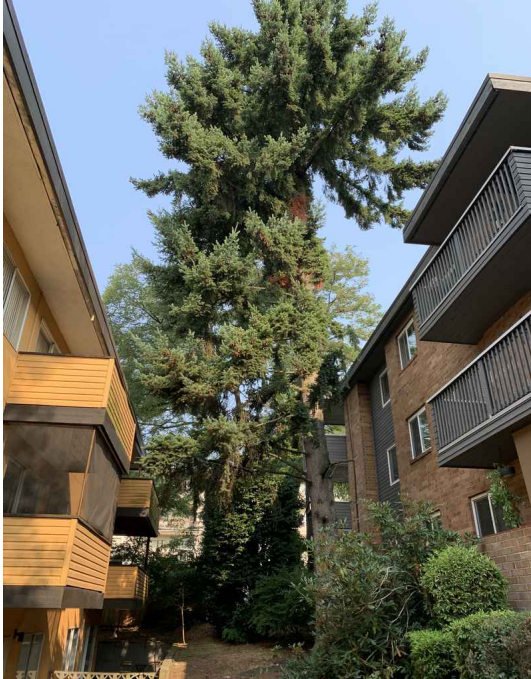
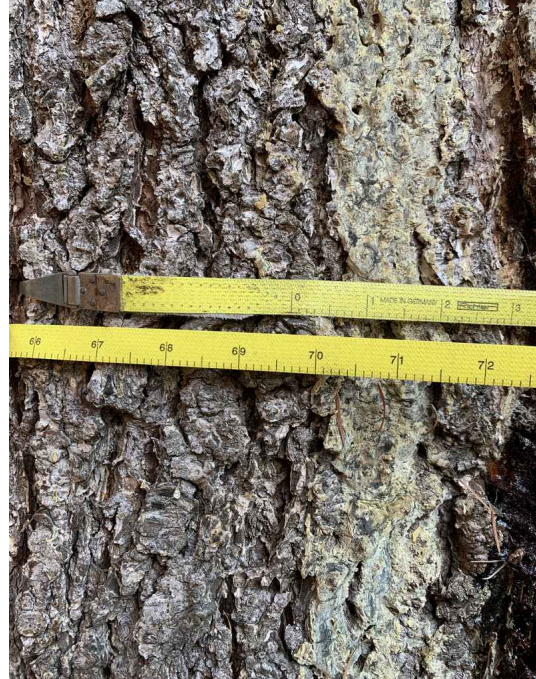
**Tree A – DBH is 70 cm.**

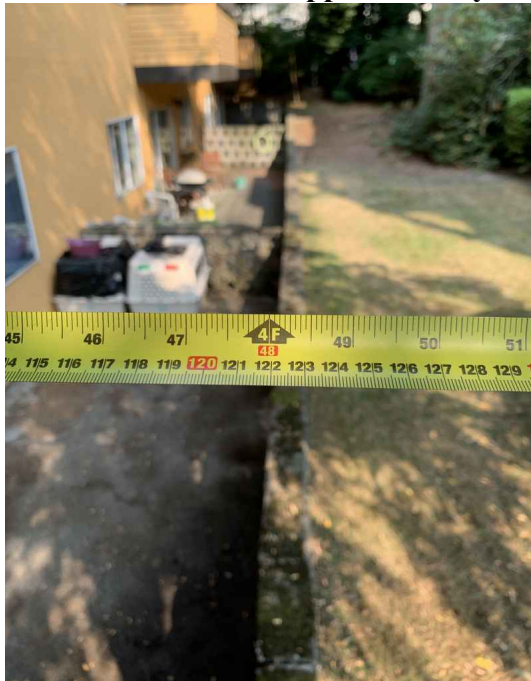
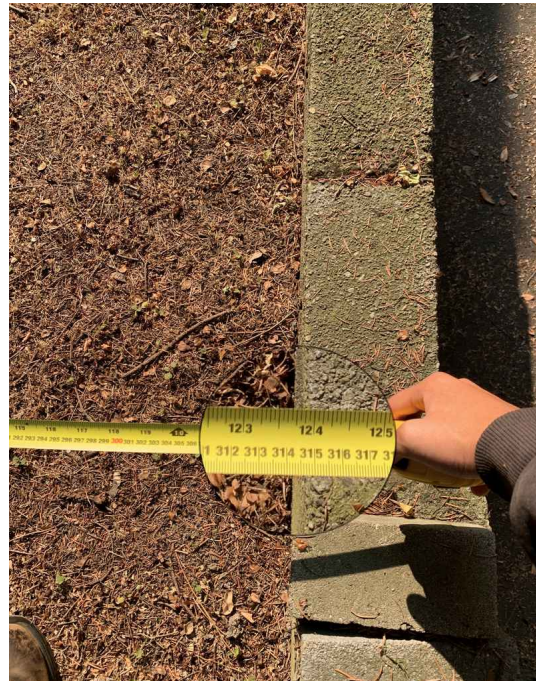
**Tree A – Podium wall is approximately 4 feet (1.2 metres) east of the balconies and approximately 3.1 metres west of the tree.**

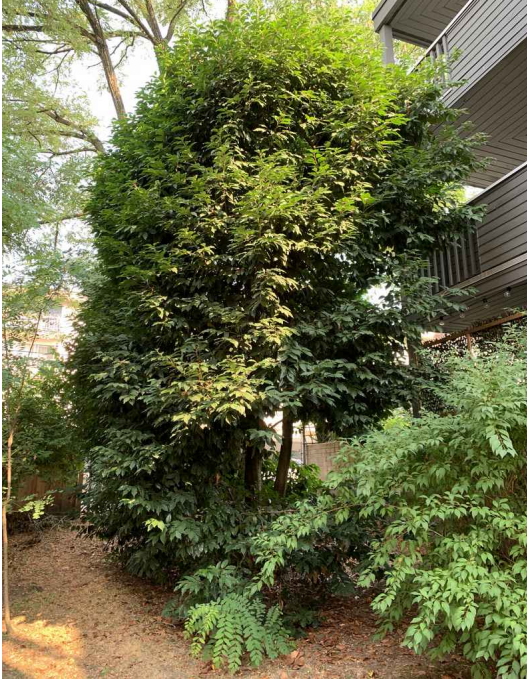
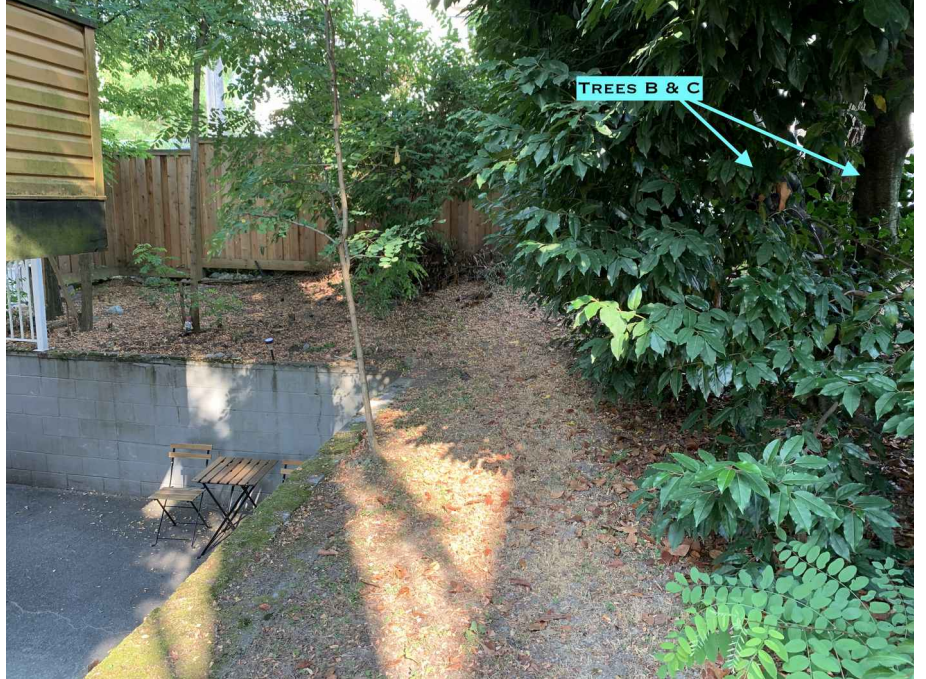
**Trees B & C – Away from the podium wall and balconies.**
