RR Roof Rider Ltd

8 May 2024 | 60 Photos

855 Vancouver St

Your Apartment building. This is a brief photo summary of my visit to quote the roof for replacement.

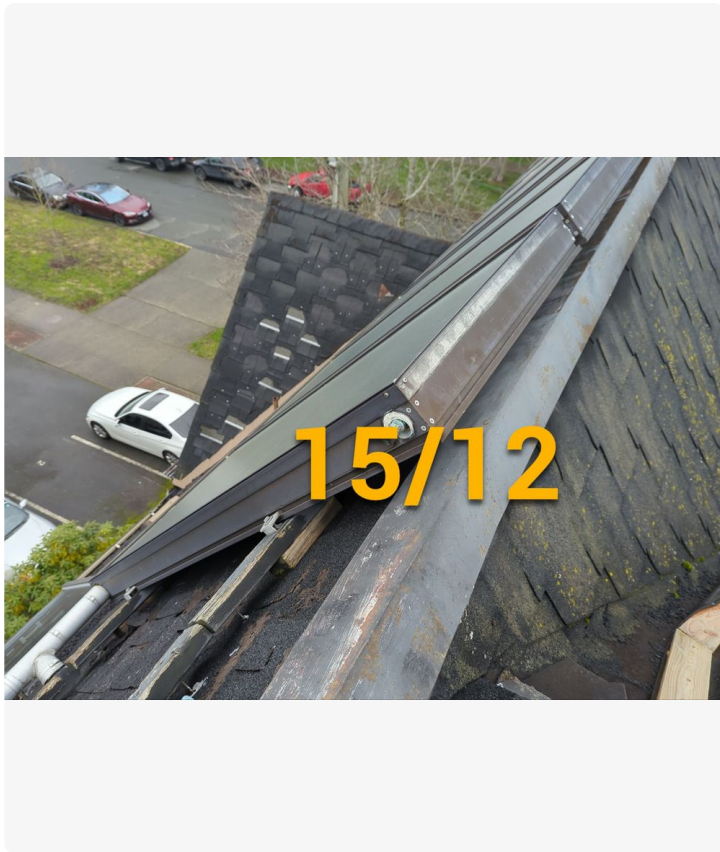
This is a steep and challenging roofing project. The quote is based on the passive solar water heaters being taken off before the project begins (As discussed with Bruce on site).

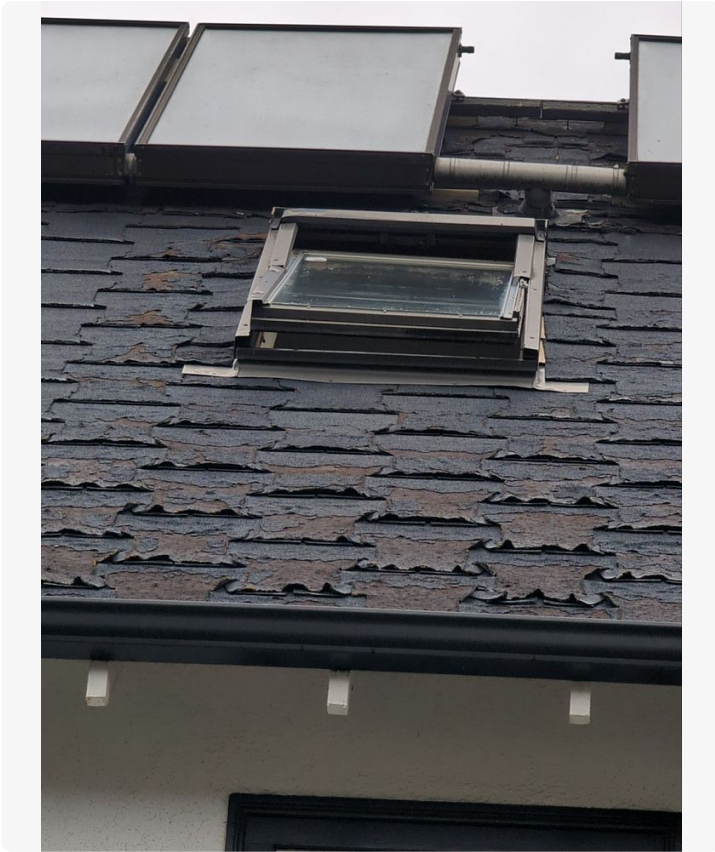
I didn't quote for a new skylight in this location. Let me know if you would like a quote on a replacement.

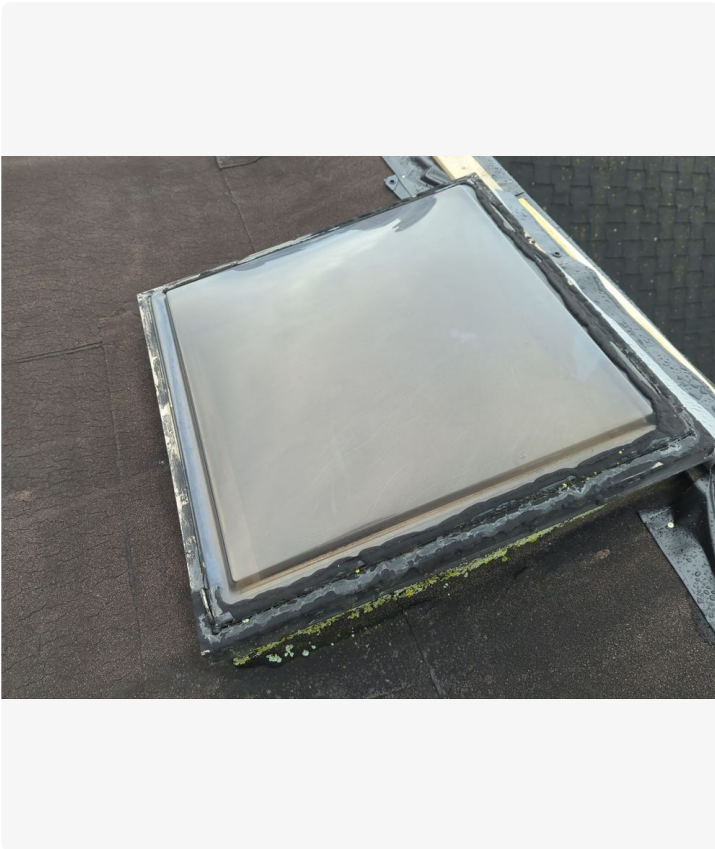
I quoted on replacing this skylight with a Velux low E skylight.

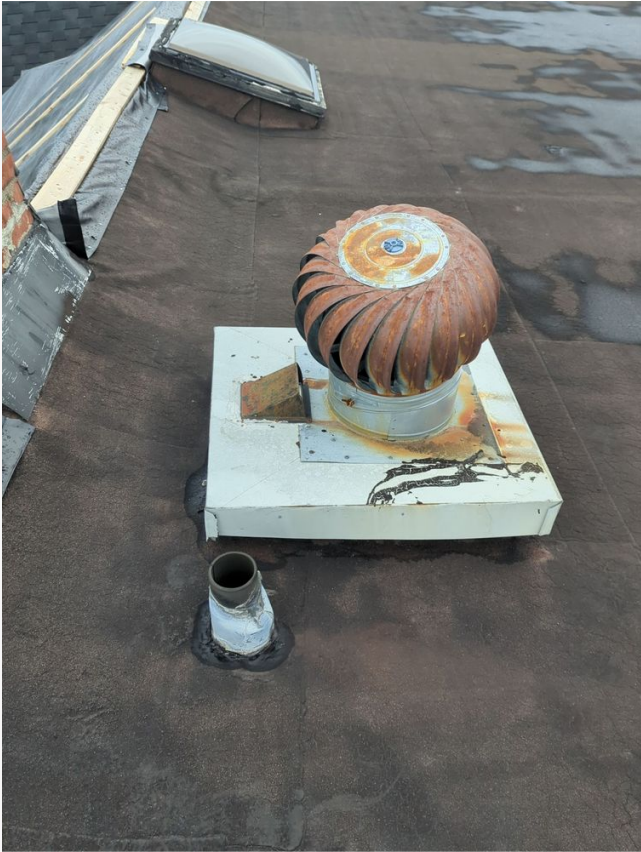
We will replace this cap and Whirly Bird.

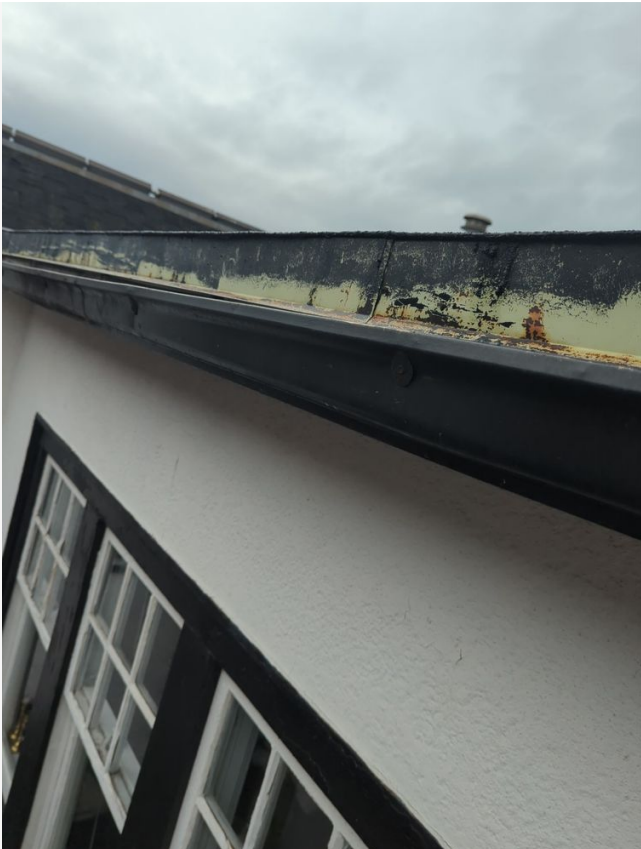
We will replace this rusty flashing system.

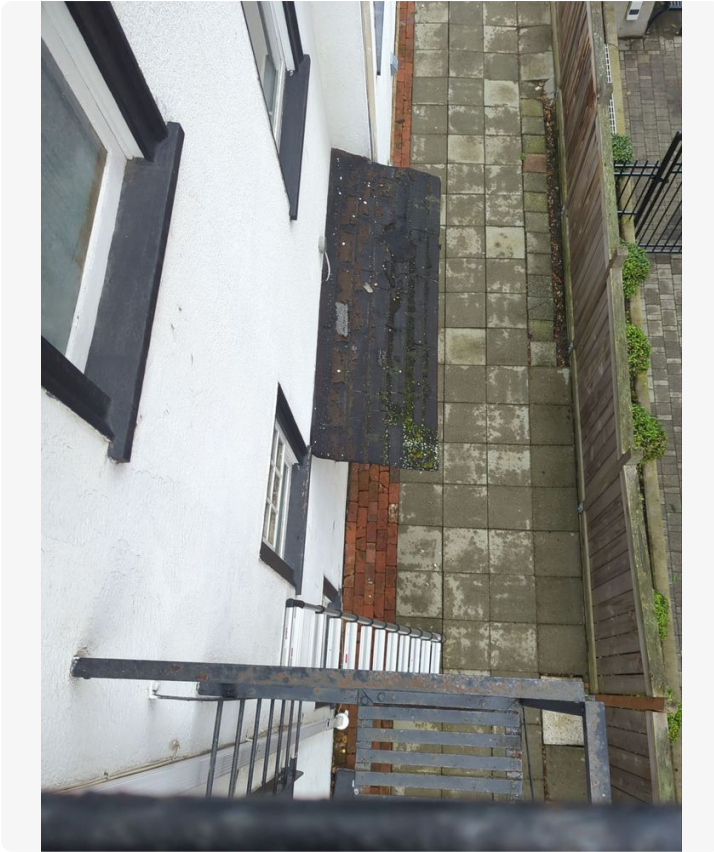
We will remove this sub roof to erect scaffolding but we will rebuild afterwards with new sheathing, fascia and shingles.

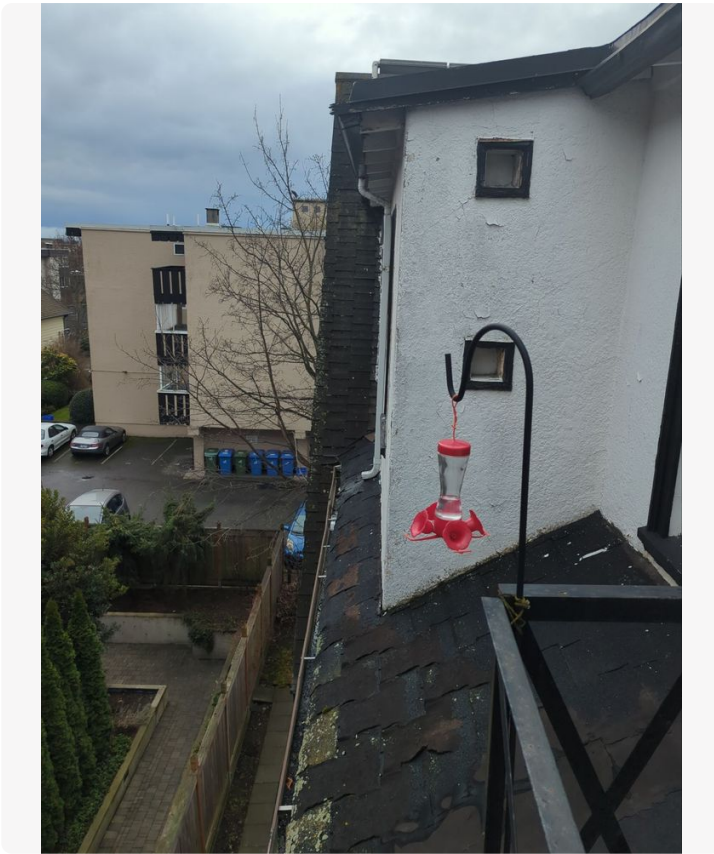
This area is a fairly rough, multiple layers so it will require some attention. Possibly some rotten planking and ideally stucco work.

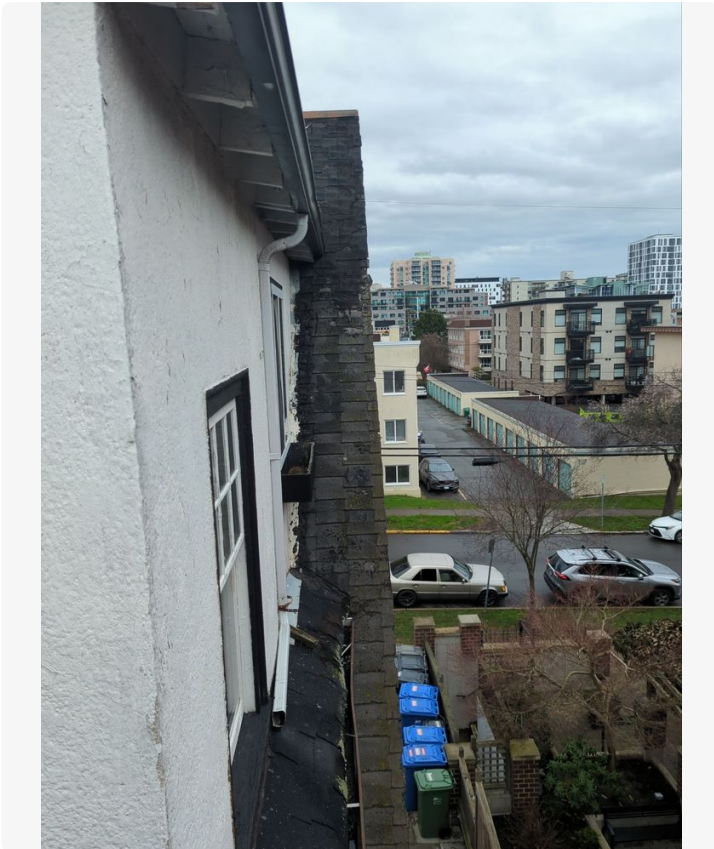
There is no real safe way to work on these skirts so I have quoted supplying scaffolding on the back of the bulding. This will be erected on one gable (closest to Burdett) and then moved to the other gable on the back side.

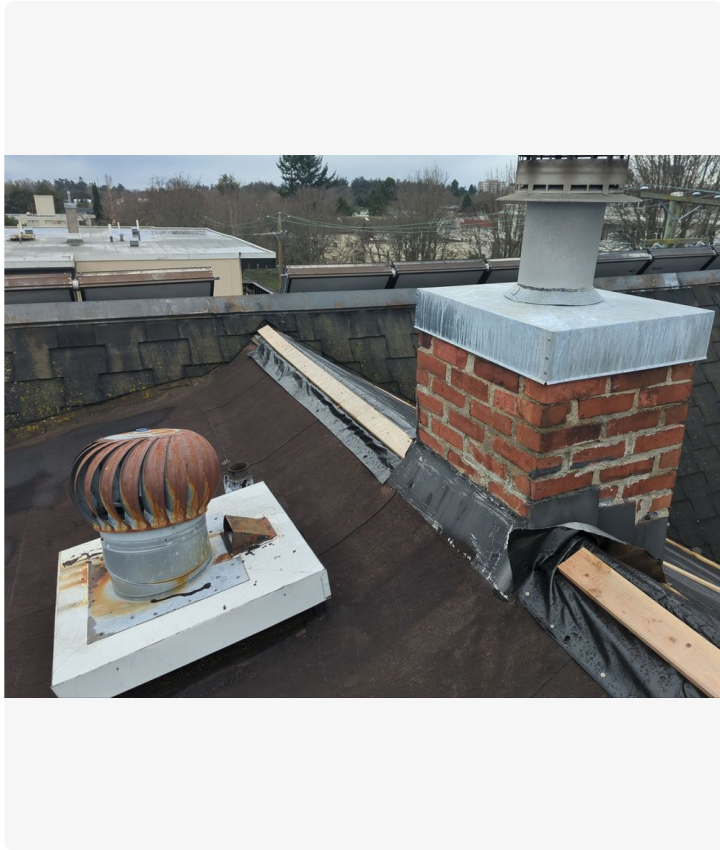
The chimney is in good condition.

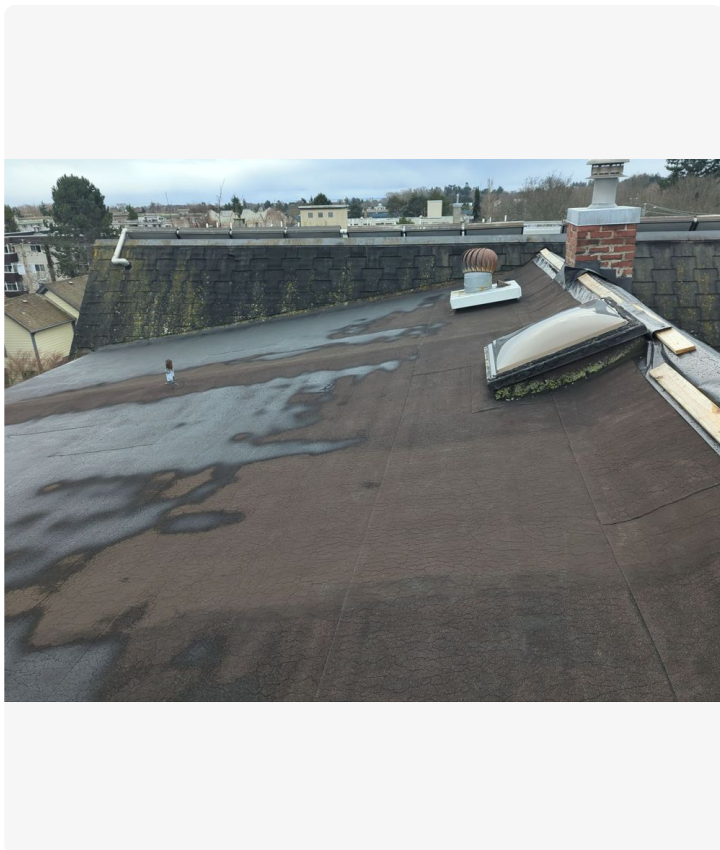
The flat roof is ready for replacement. I have quoted it based on a 1 layer tear off. We will need to take a core sample to confirm if this is accurate.

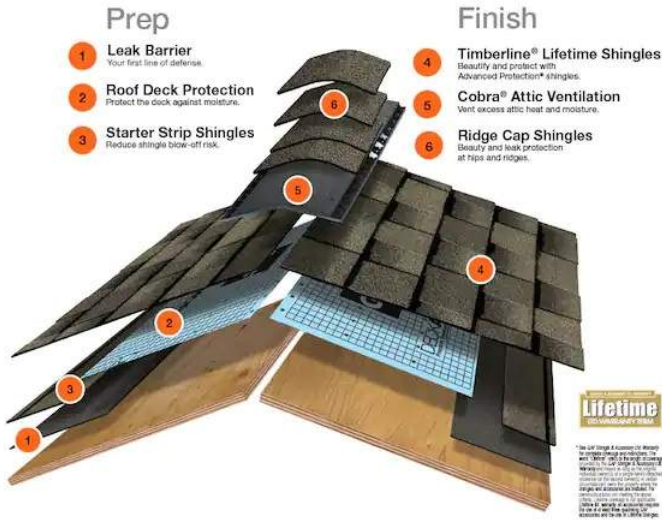
This is the roofing system we install: The Golden Pledge Roofing System.

Not shown in this picture is that we install metal drip edge on all leading edges (gables and eaves) plus starter strip on all leading edges (gables and eaves). This gives you an unlimited wind warranty.

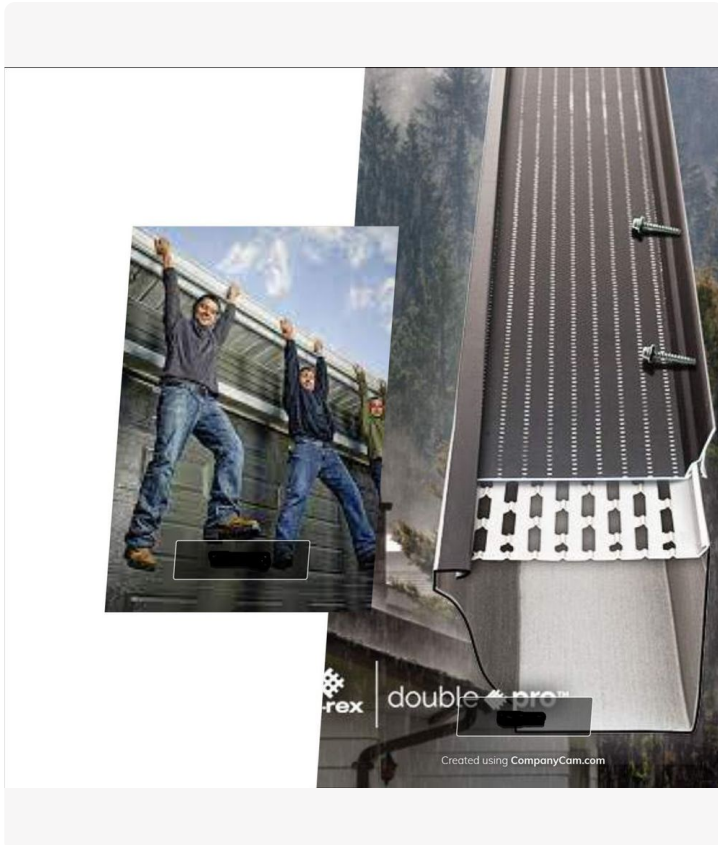
I have included in the quote new gutters in all areas the currently have gutters + included this gutter guard for minimal maintenance. This gutter guard is actually a continuous hanger so it makes the gutter extremely strong and resistant to damage.

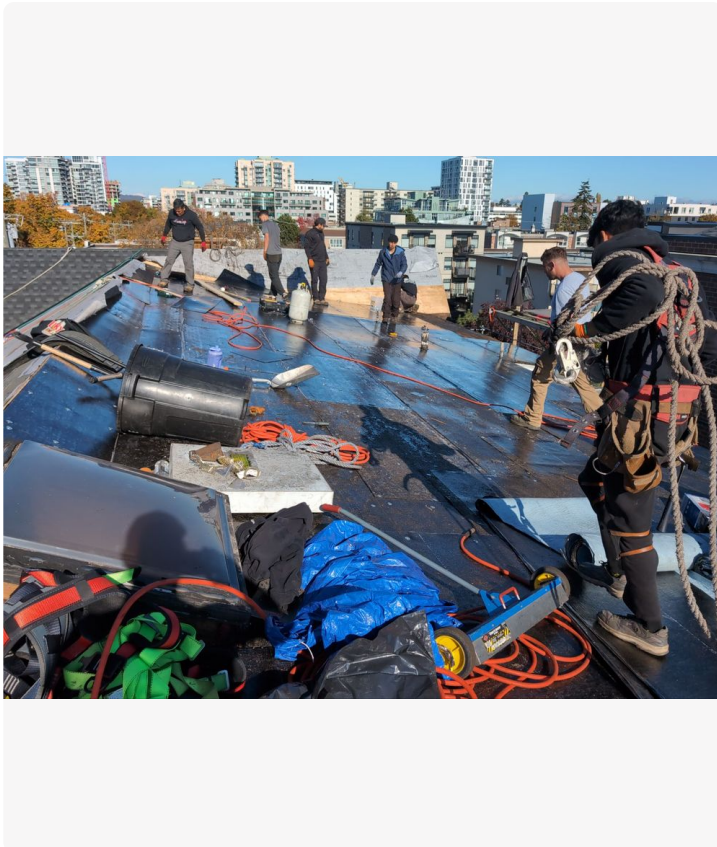
The flat roof had to have a Recovery board installed over the uneven planking it was built with.

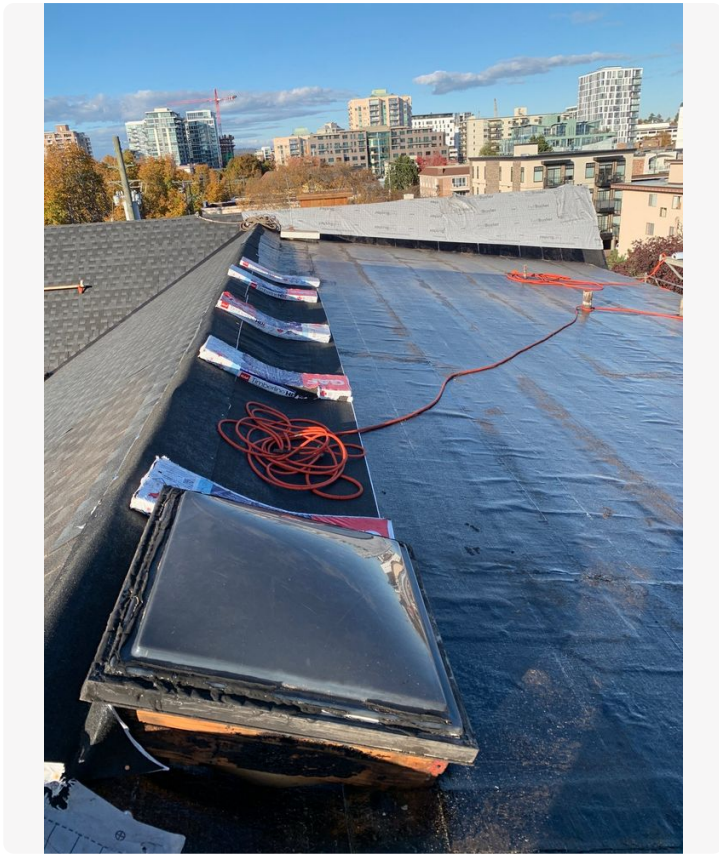
Flat roof base applied over the recovery board.

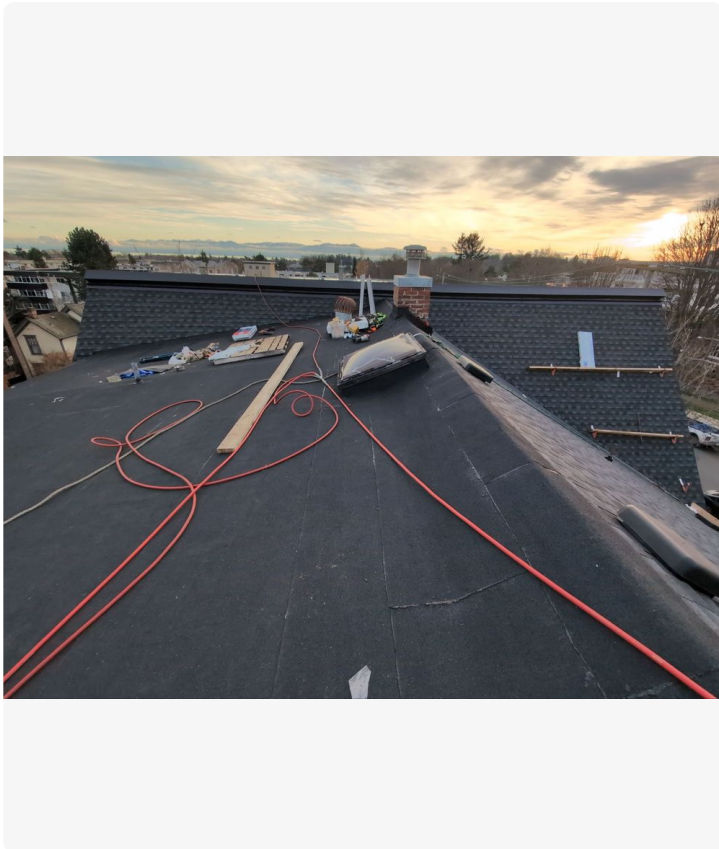
Flat roof completed, except for the transition flashings.

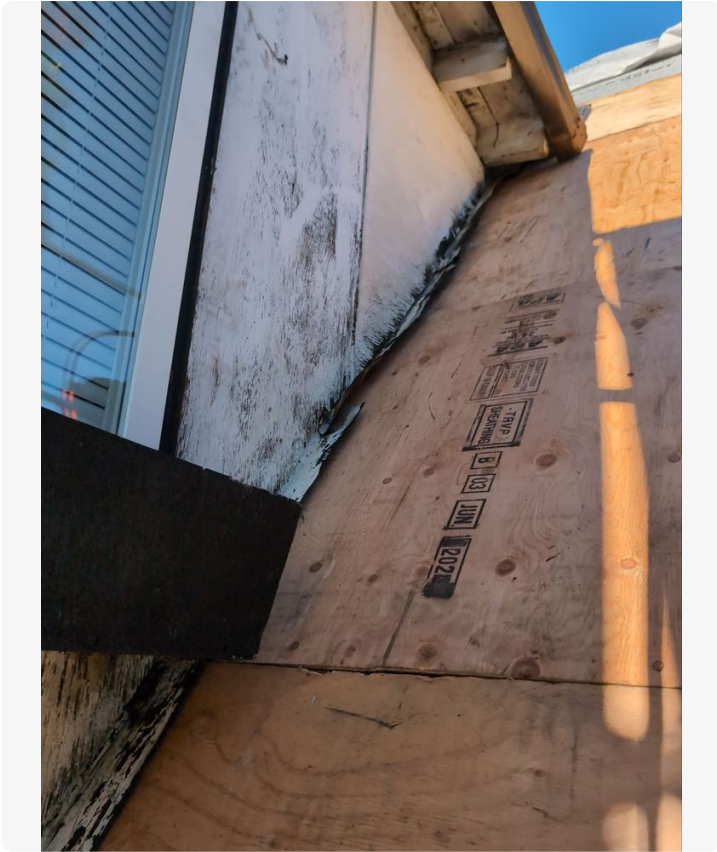
Stripping the steep slope roofing. We had to install all new wall counter flashings, the ones from the install were in poor condition.

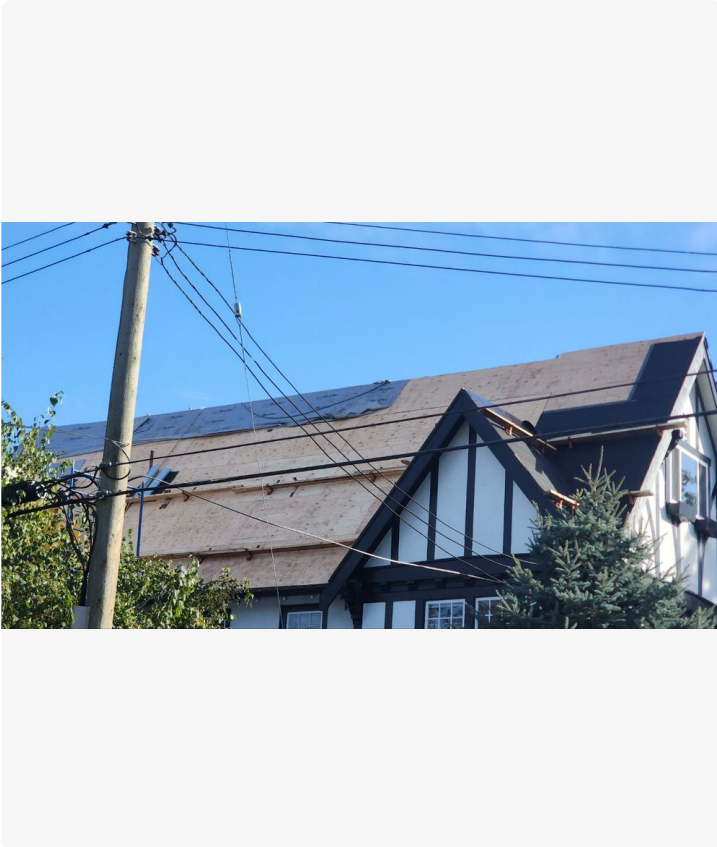
Re-sheeted the building.

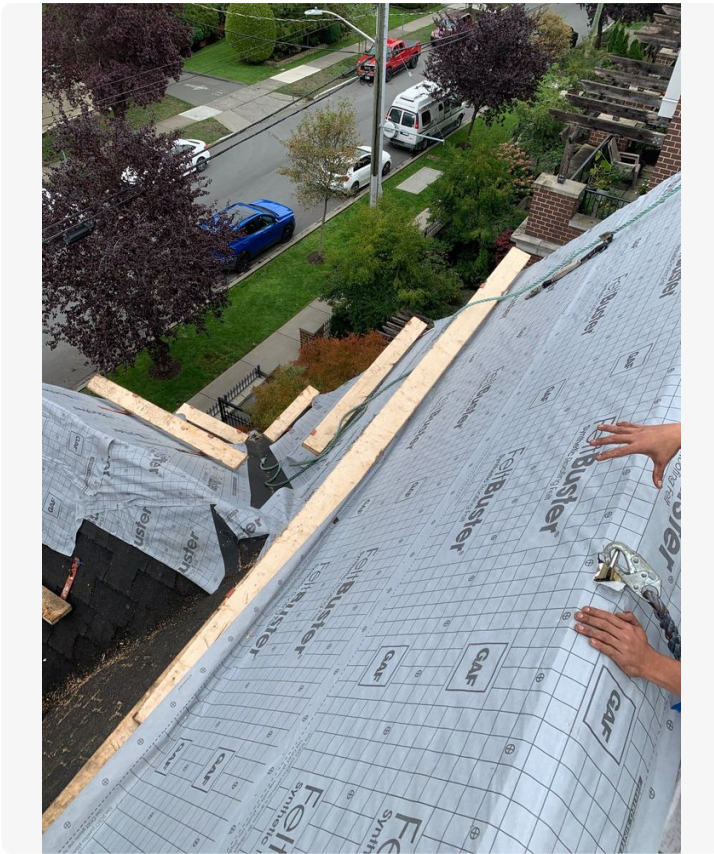
Bitumen underlayment in the valleys, leading edges and penetrations and the gray synthetic underlayment on the rest of the building.

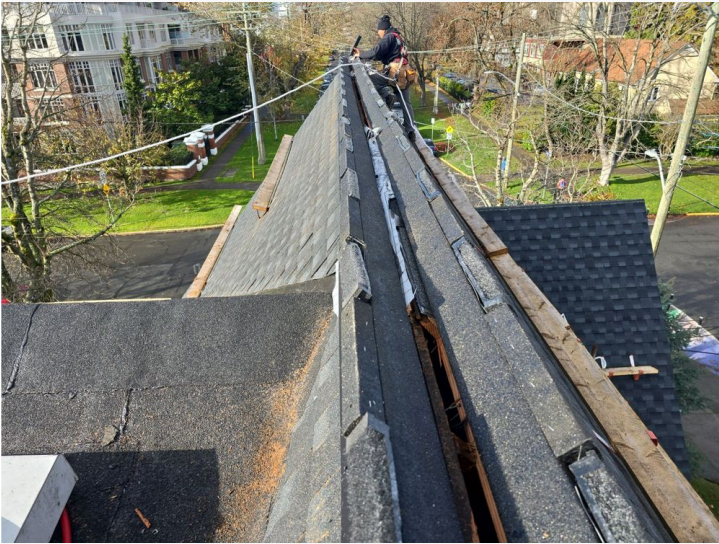
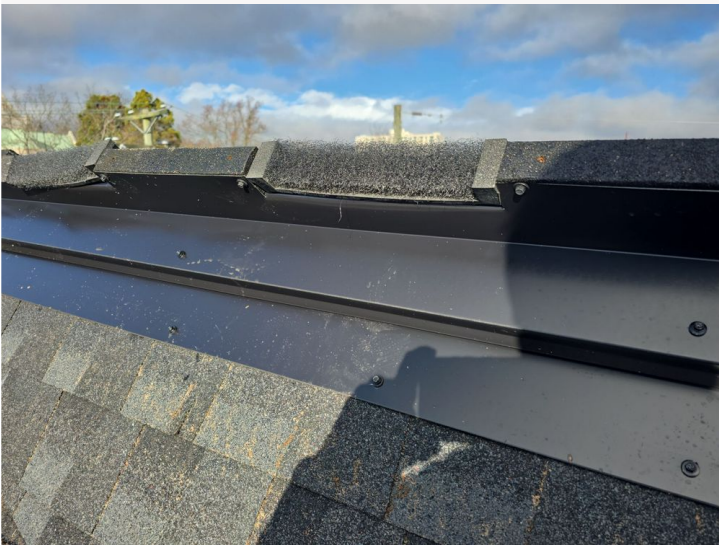
Setting up to install the Continuous Ridge Venting.

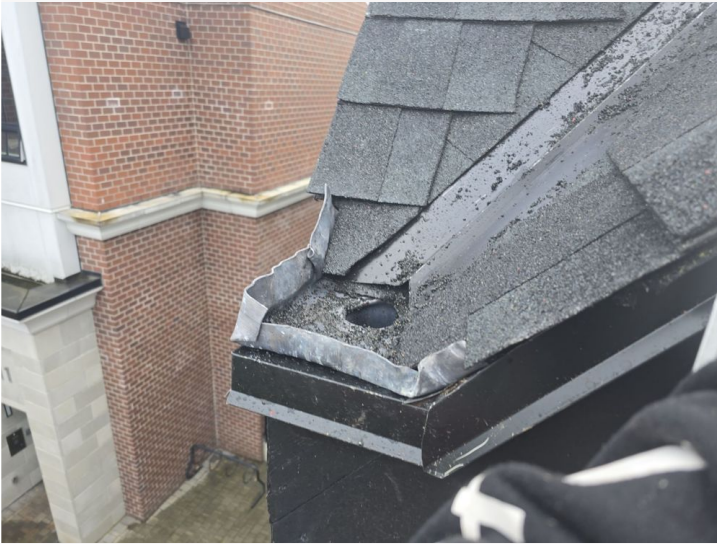
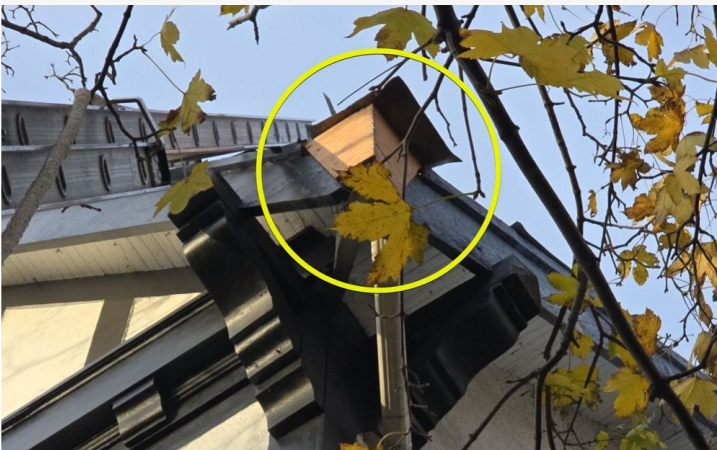
We had to rebuild several of these corners since they had rotted from moisture over run.

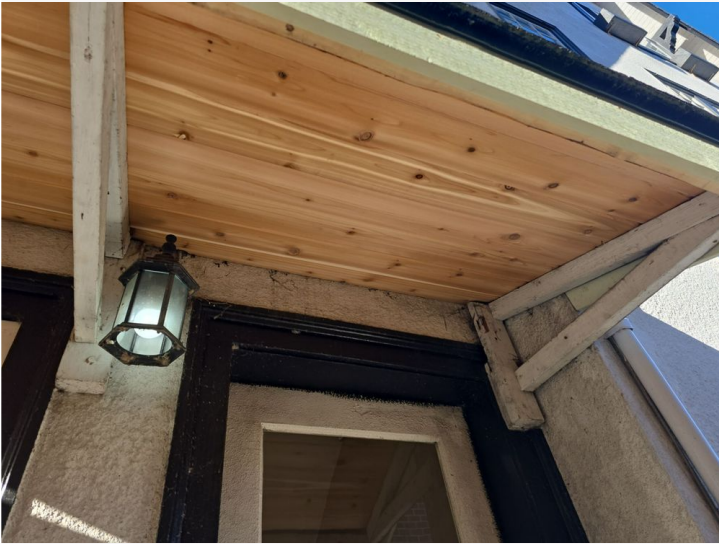
The rebuilt awning.

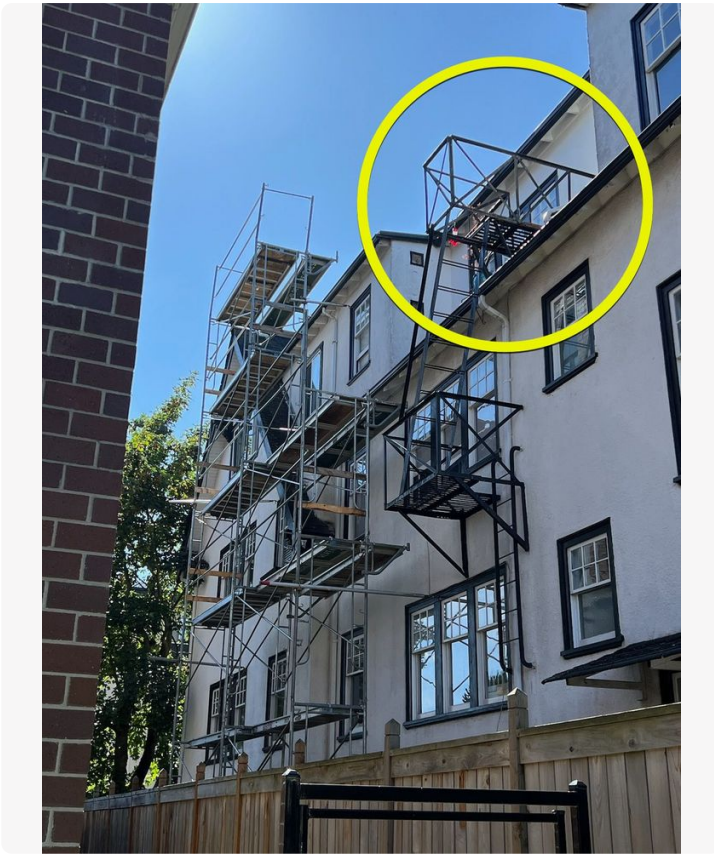
Unfortunately I don't have pictures of how that platform was attached to the roof but it was a mess, multiple layers and the previous roofers had just left it with the old roofing and just left it like that.

It became apparent that to re-roof it properly we would have to come up with a better solution.

We decided to enclose the base after we ensured that it was well attached to the building.

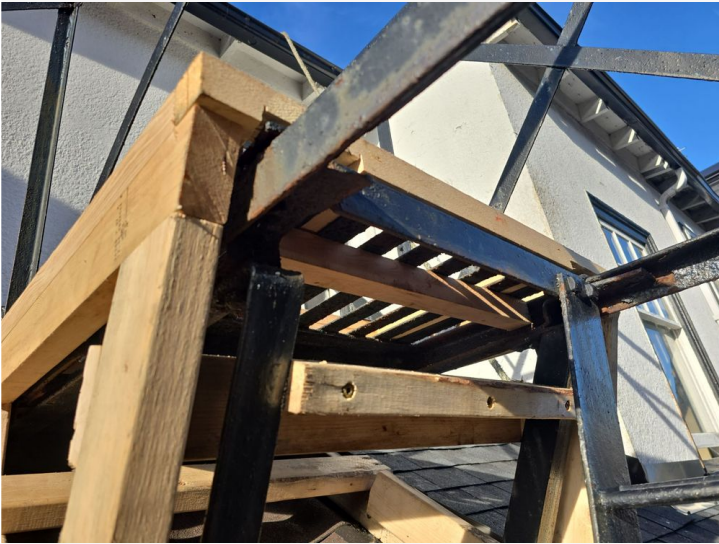
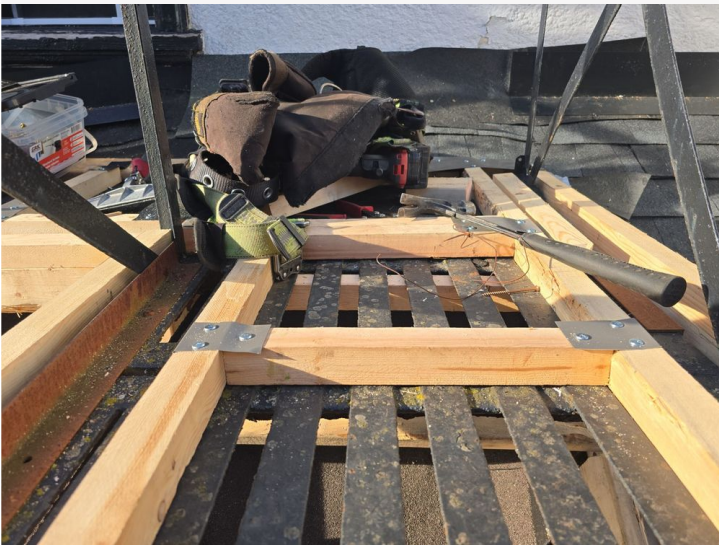
This is us framing the escape.

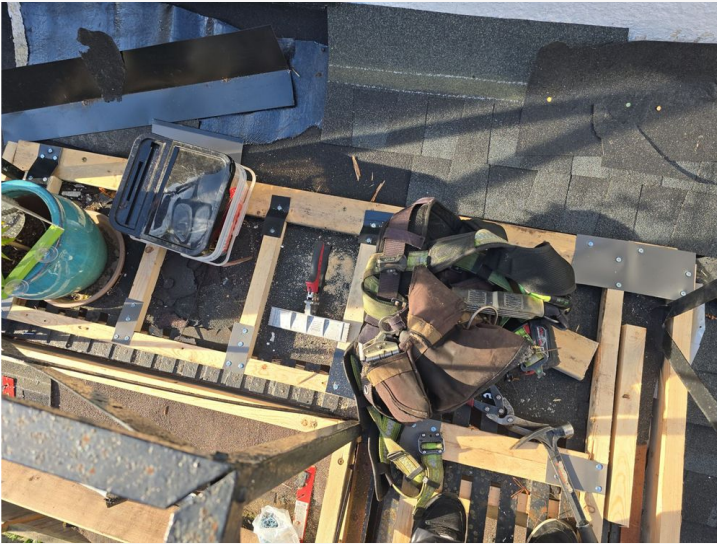
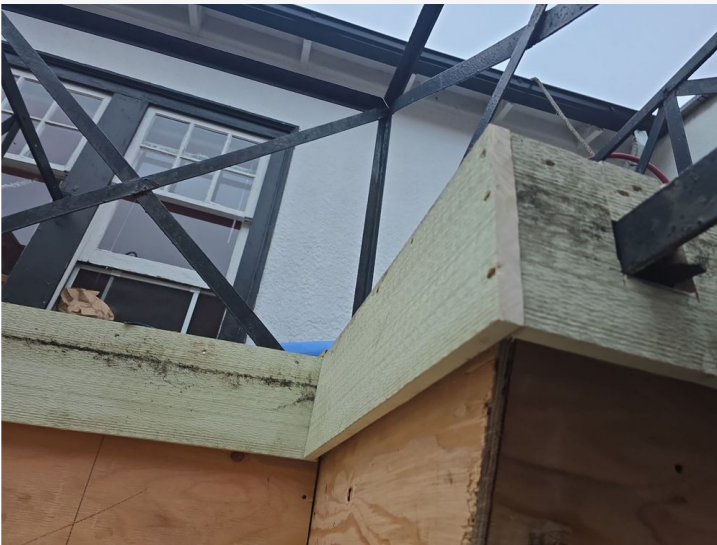
We ran many structural screws into the buildings framing.
