TRI-TECH PINNACLE

Roof Condition Report - Sansar Apartments - 1140 Hillside Avenue, Victoria, BC

Inspection Date:

11/9/2022

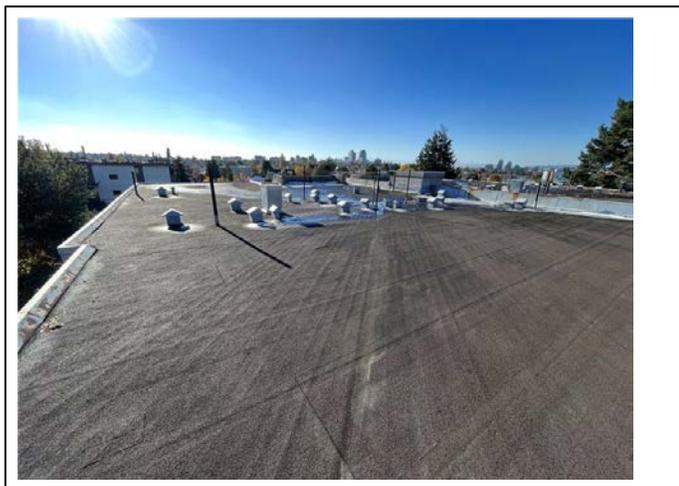
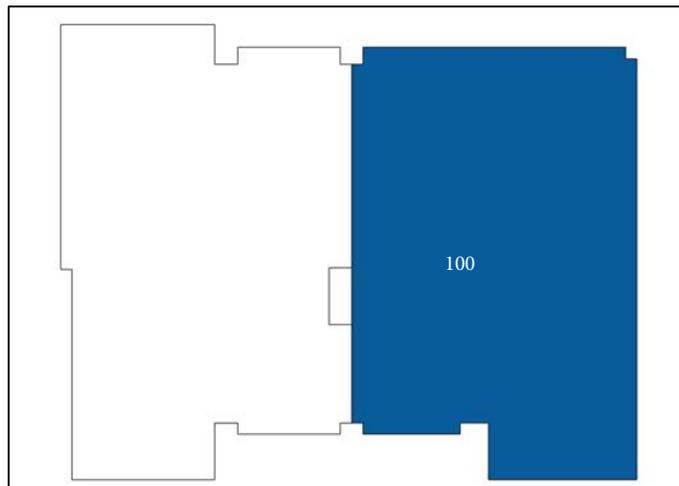
Roof: 100

Roof System: Modified Bitumen
Estimated Install Date: 2002
Condition Index: Poor
Roof Access: Roof Hatch
Approx. Roof Sq. Ft.: 3,600
Height: 40'

Assessment: This roof level is approximately 20+ years old. Signs of deterioration and some serious roofing deficiencies were noted. Roof replacement should be scheduled within the next 1-2 years.

Due to the age and condition of the installed roofing assembly, roof replacement is recommended within the next 1-2 years.

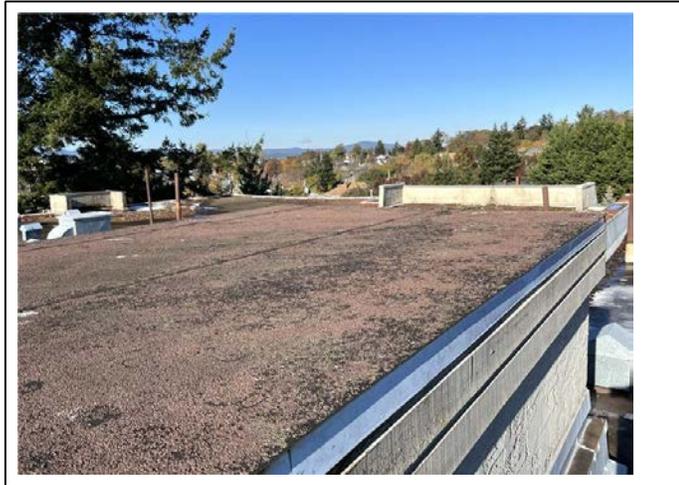
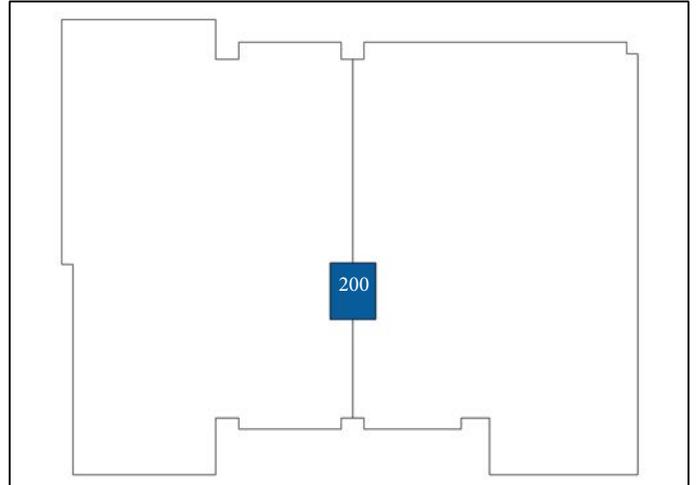
Roof: 200

Roof System: Modified Bitumen
Estimated Install Date: 2002
Condition Index: Poor
Roof Access: Exterior
Approx. Roof Sq. Ft.: 80
Height: 44'

Assessment: This roof level is approximately 20+ years old. Signs of deterioration and some serious roofing deficiencies were noted. Roof replacement should be scheduled within the next 1-2 years or at the same time as the main roof level to ensure preferred pricing.

Due to the age and condition of the installed roofing assembly, roof replacement is recommended within the next 1-2 years or at the same time as the main roof levels to ensure preferred pricing.

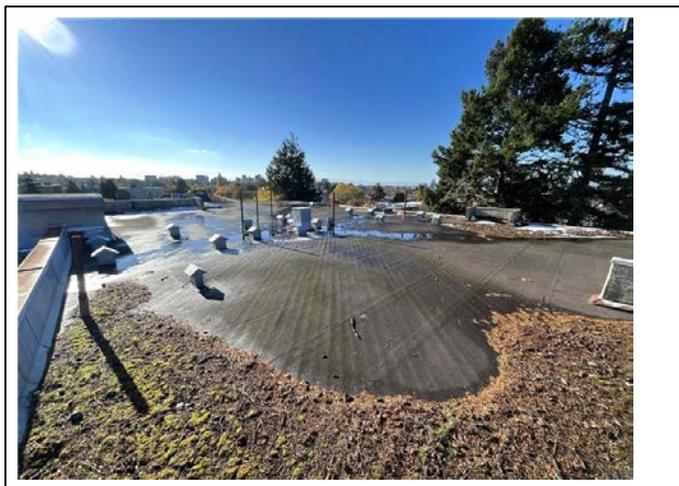
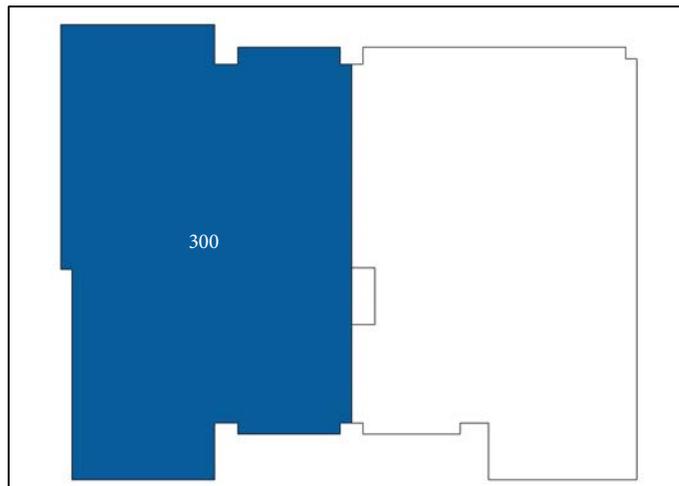
Roof: 300

Roof System: Modified Bitumen
Estimated Install Date: 2002
Condition Index: Poor
Roof Access: Roof Hatch
Approx. Roof Sq. Ft.: 3,600
Height: 40'

Assessment: This roof level is approximately 20+ years old. Signs of deterioration and some serious roofing deficiencies were noted. Roof replacement should be scheduled within the next 1-2 years.
