## Roof Condition Report - Terraces on Tenth, New Westminster

**Pinnacle Group Inc.**

5/22/2018

28-484

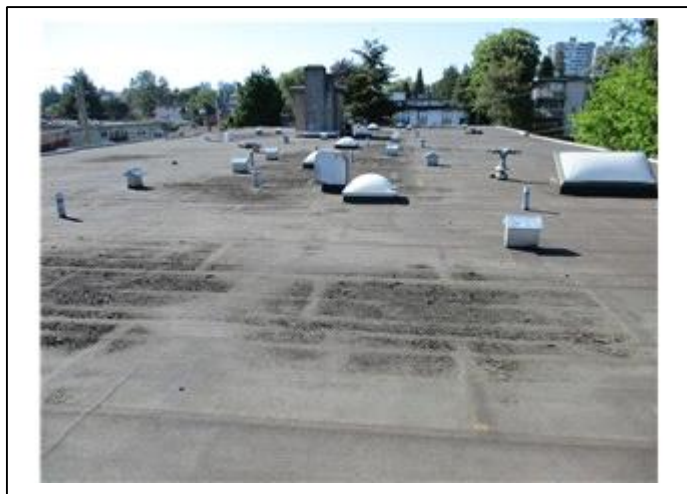
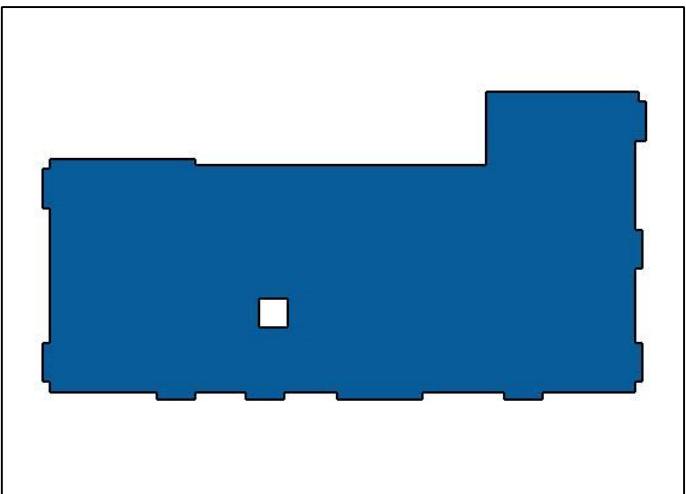
Roof: 100	Building: Terraces on Tenth
-----------	-----------------------------

Roof System:	Mod.Bit.
Estimated Install Date:	1998
Condition Index:	Very Poor
Interior Sensitivity:	Normal
Roof Sq. Ft.:	11,698
Height:	40'
Roof Access:	Roof Hatch

Assessment: The west half of this roof level is approximately 20 years old, while the east half was replaced approximately 14 years ago. Signs of deterioration and some serious roofing deficiencies were noted. This roof level should last its full serviceable life expectancy, but complete roof replacement should be scheduled within the next 4-5 years.

Due to the age and deteriorated state of this roof level, we recommend it is scheduled for replacement within the next 4-5 years.

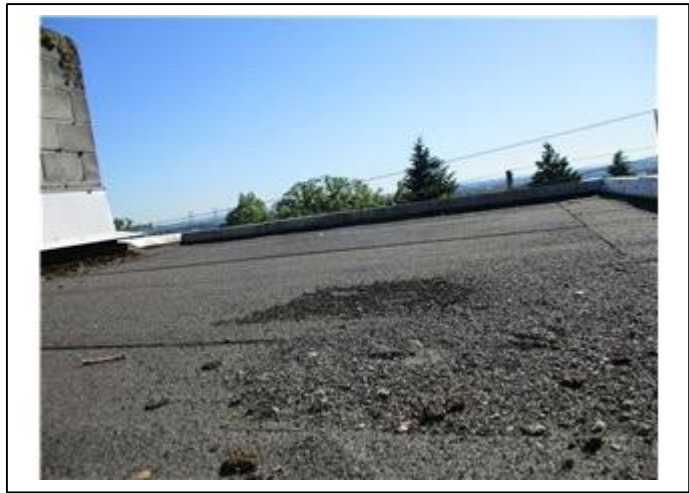
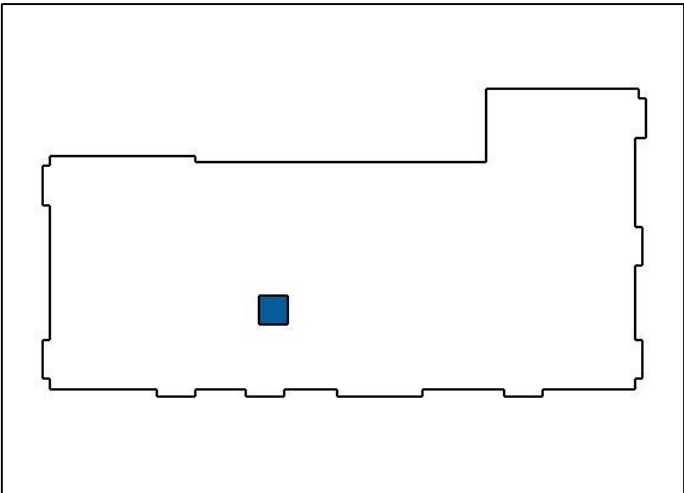
Roof: 200

Roof System:	Mod. Bit.
Estimated Install Date:	2004
Condition Index:	Fair
Interior Sensitivity:	Normal
Roof Sq. Ft.:	64
Height:	50'
Roof Access:	Ladder Required

Assessment: This roof level appears to be approximately 14 years old. With continued maintenance and annual inspections, this roof level should reach its full serviceable life expectancy.
