## Roof Condition Report - Carlton Park Gardens - 10851 Mortfield Road, Richmond, BC

**Inspection Date:**

7/20/2022

221073

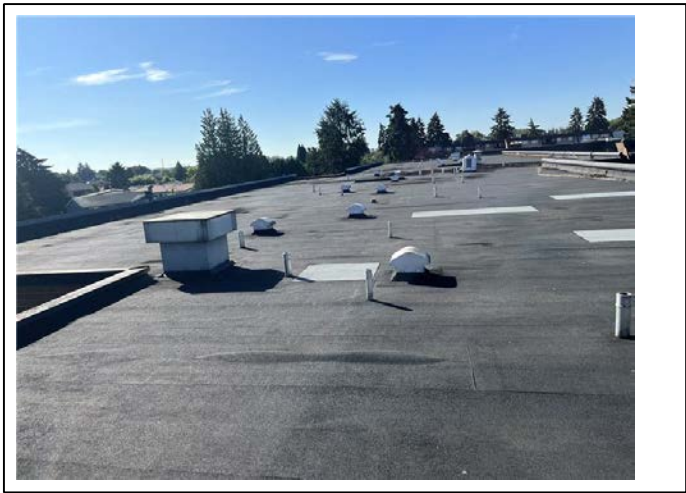
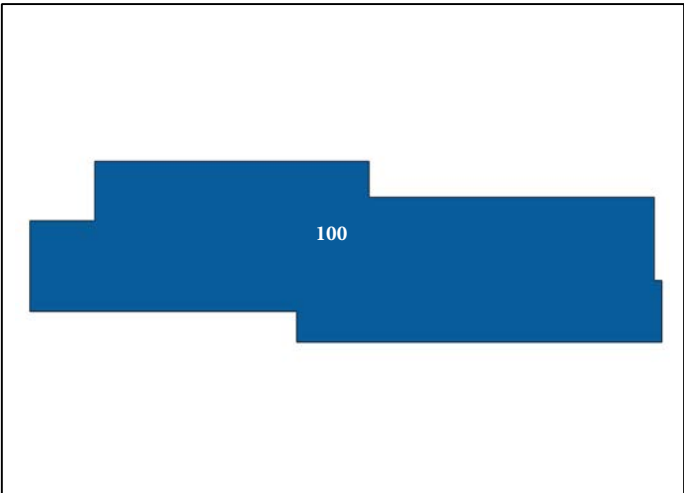
Roof: 100

Assessment: This roof level appears to be approximately 16 years old and appears in very poor condition. Roof replacement is recommended as soon as budgeting allows.
