## Roof Condition Report - Hartnell House - 1204 Yates Street, Victoria, BC

**Inspection Date:**

11/9/2022

221234

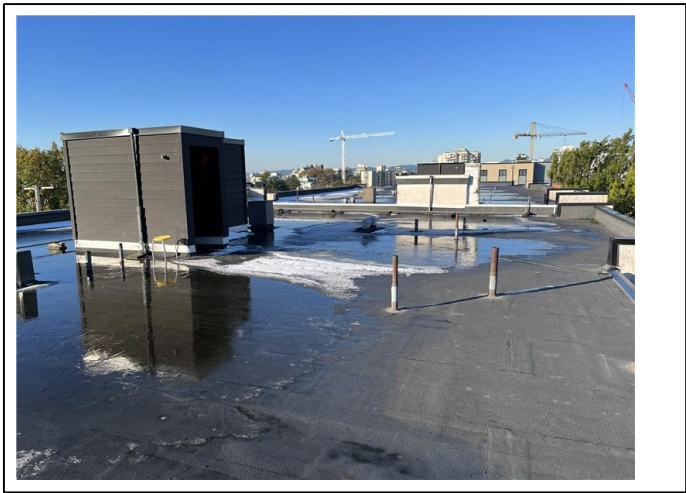
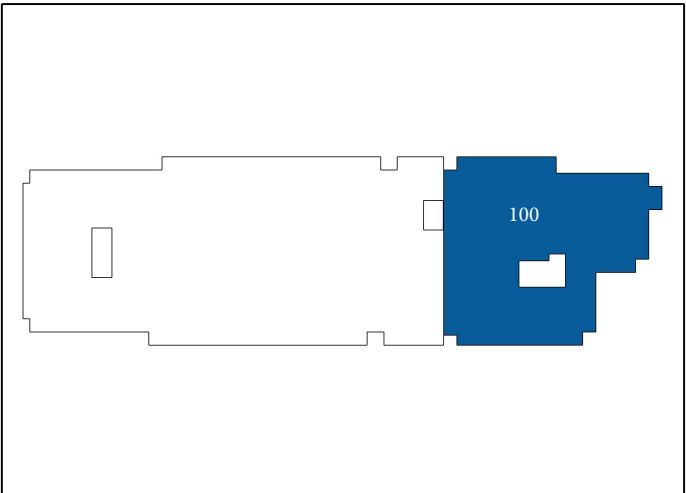
Roof: 100

Roof System: Modified Bitumen  
Estimated Install Date: 2005  
Condition Index: Poor  
Roof Access: Roof Hatch  
Approx. Roof Sq. Ft.: 2,888  
Height: 40'

Assessment: This roof level is approximately 15-20 years old. Signs of deterioration and some serious roofing deficiencies were noted. Roof replacement should be scheduled within the next 1-2 years.

Due to the age and condition of the installed roofing assembly, roof replacement should be scheduled in the next 1-2 years.

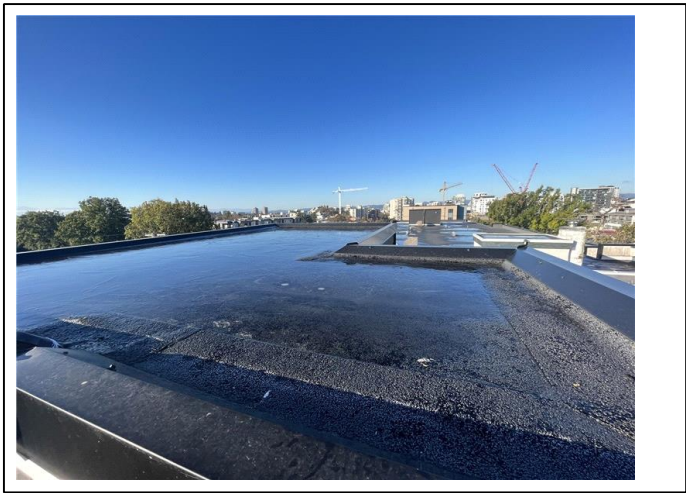
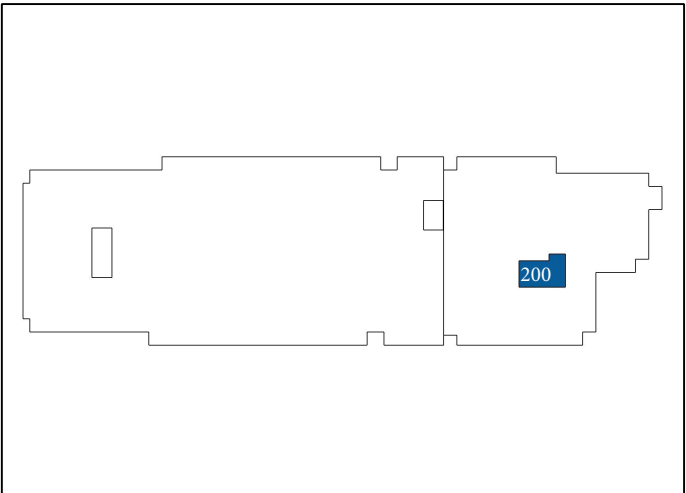
Roof: 200

Roof System: Modified Bitumen  
Estimated Install Date: 2005  
Condition Index: Poor  
Roof Access: Exterior  
Approx. Roof Sq. Ft.: 122  
Height: 47'

Assessment: This roof level is approximately 15-20 years old. Roof replacement should be scheduled within the next 1-2 years or at the same time as roof level 100.

Due to the age and condition of the installed roofing assembly, roof replacement should be scheduled in the next 1-2 years or at the same time as the main roof level to ensure preferred pricing.

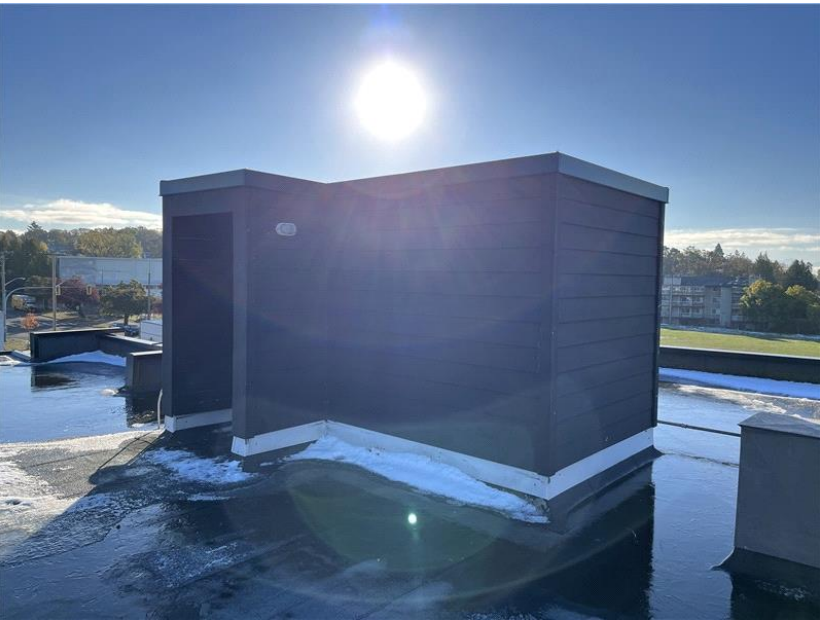
**Condition:** Deteriorated membrane  
**Severity:** High  
**Quantity:** 1

The roofing membrane is deteriorated with several under water blisters also noted.

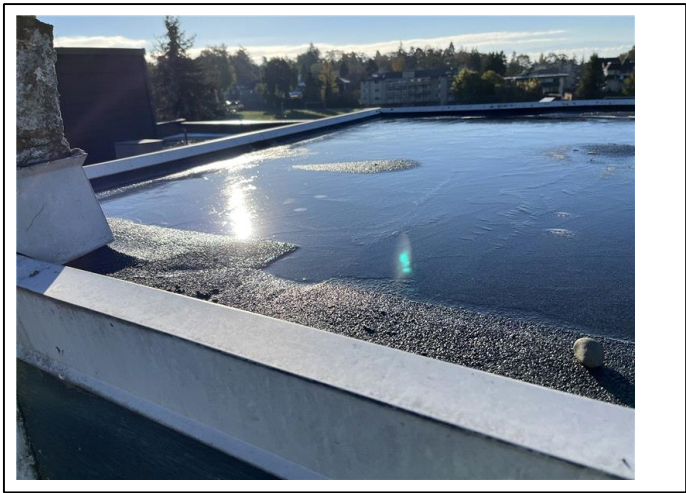
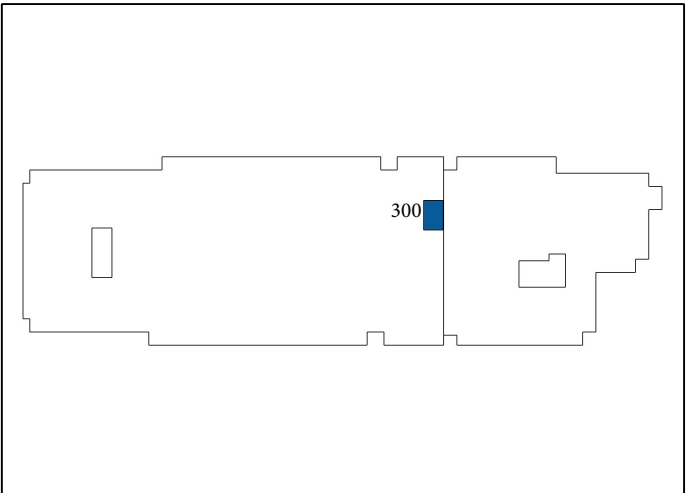
Roof: 300

Roof System: Modified Bitumen  
Estimated Install Date: 2005  
Condition Index: Poor  
Roof Access: Exterior  
Approx. Roof Sq. Ft.: 54  
Height: 45'

Assessment: This roof level is approximately 15-20 years old. Roof replacement should be scheduled within the next 1-2 years or at the same time as the main roof levels.

Due to the age and condition of the installed roofing assembly, roof replacement should be scheduled in the next 1-2 years or at the same time as the main roof level to ensure preferred pricing.

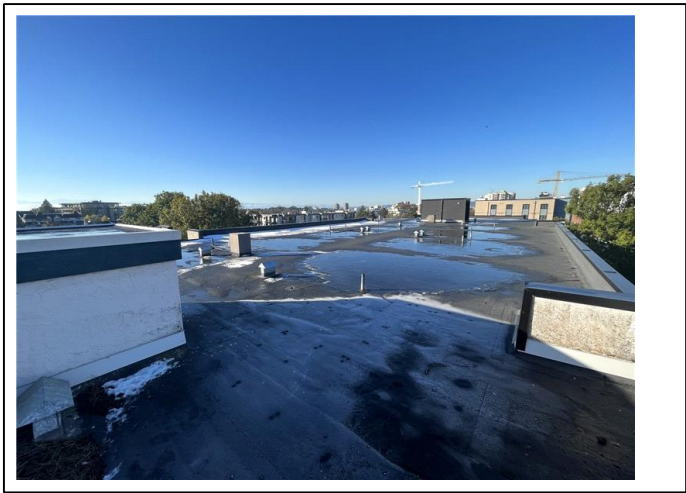
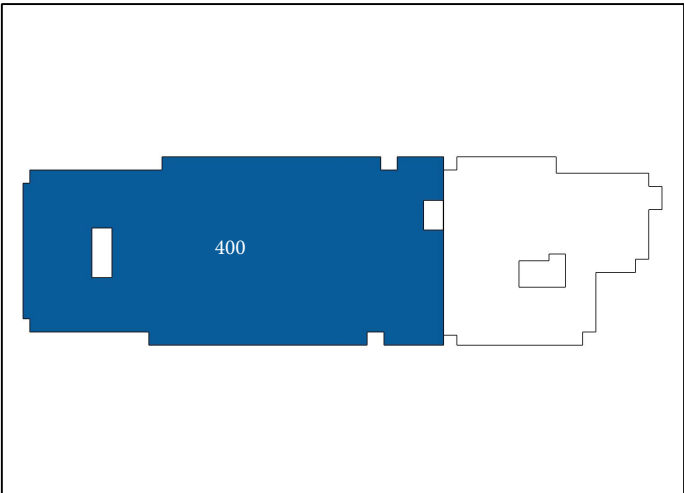
Roof: 400

Roof System: Modified Bitumen  
Estimated Install Date: 2005  
Condition Index: Poor  
Roof Access: Roof Hatch  
Approx. Roof Sq. Ft.: 6,719  
Height: 40'

Assessment: This roof level is approximately 15-20 years old. Signs of deterioration and some serious roofing deficiencies were noted. Roof replacement should be scheduled within the next 1-2 years.

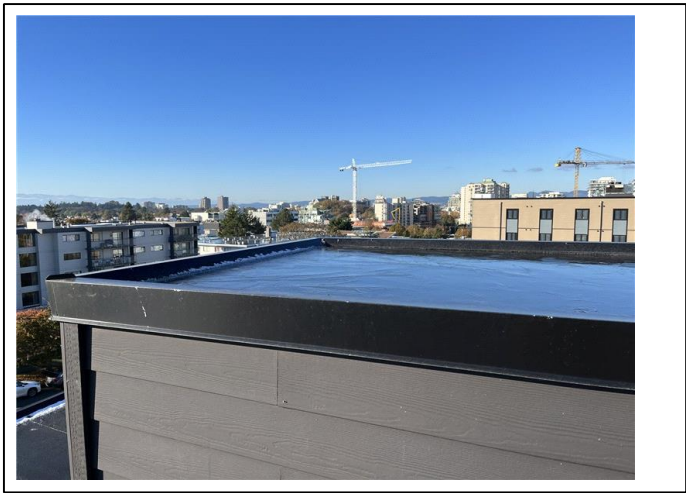
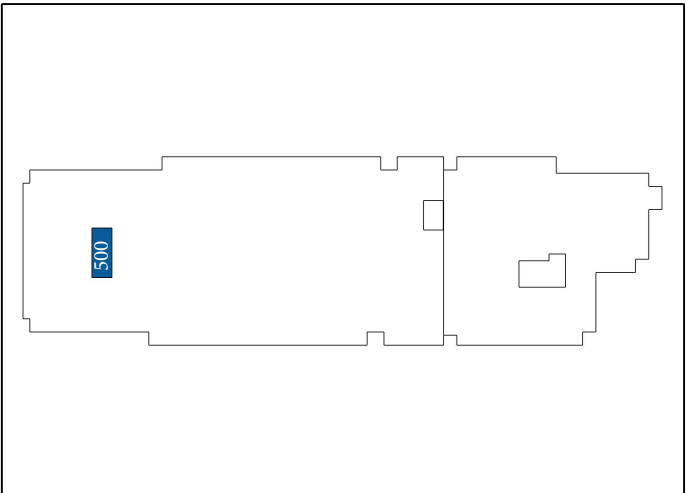
Roof: 500

Roof System: Modified Bitumen  
Estimated Install Date: 2005  
Condition Index: Poor  
Roof Access: Exterior  
Approx. Roof Sq. Ft.: 90  
Height: 47'

Assessment: This roof level is approximately 20+ years old. Roof replacement should be scheduled within the next 1-2 years or at the same time as the main roof levels.

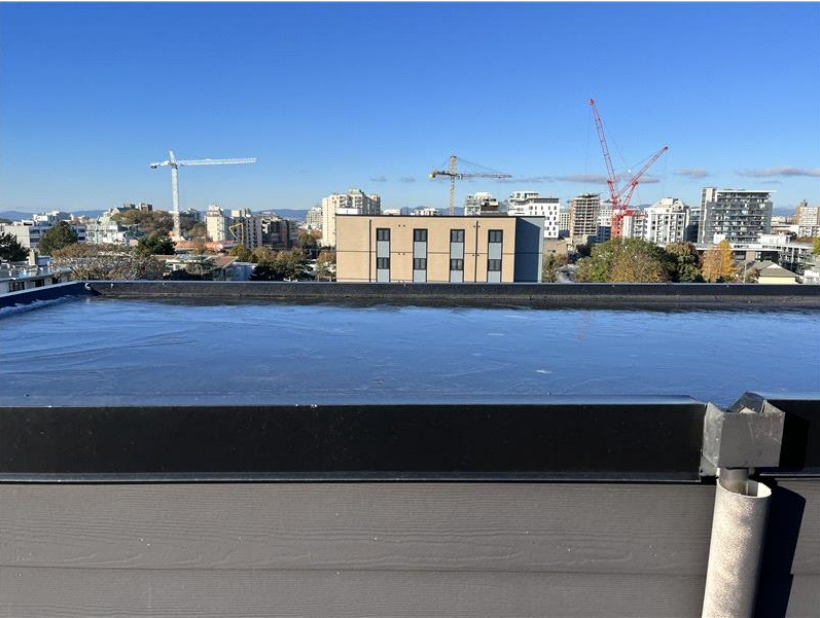
↑  
**Condition:** Overview  
**Quantity:** 1

Another view of the roof level.

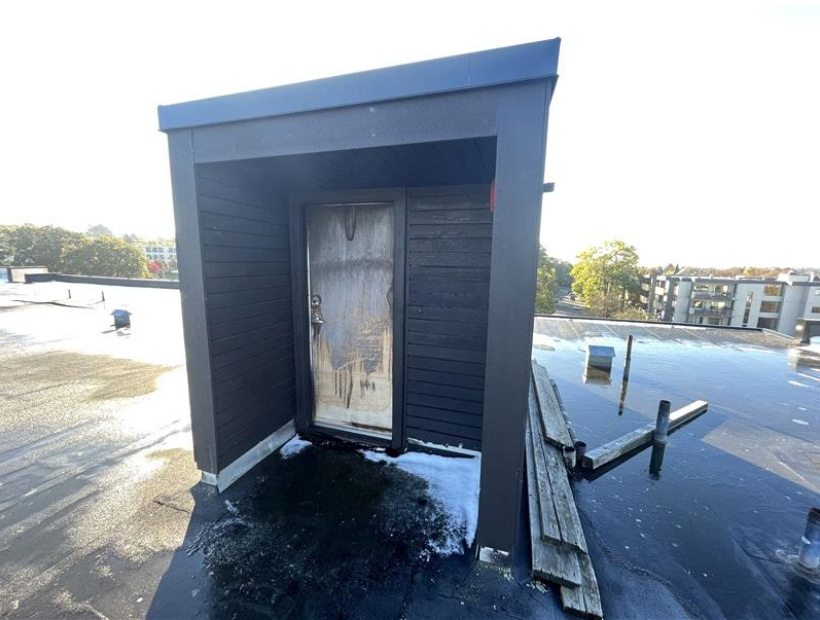
↓  
**Condition:** Overview1  
**Quantity:** 1

Another view of the elevator penthouse roof.
