Roof Condition Report - Queen Anne Apartments - 12188 224 Street, Maple Ridge, BC

Tri-Tech Pinnacle Group Inc.

9/20/2022

221246

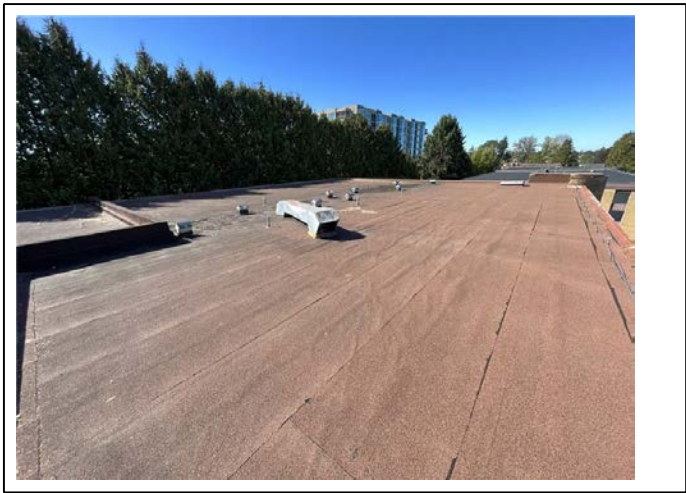
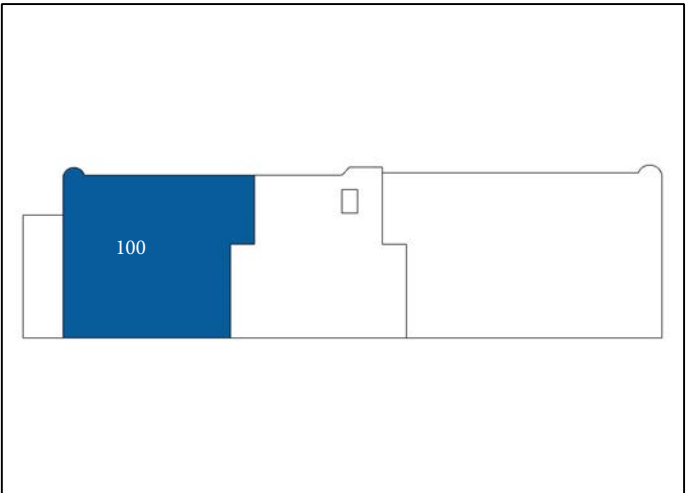
Roof: 100

Roof System: Modified Bitumen
Estimated Install Date: 2003
Condition Index: Poor
Roof Access: Roof Hatch
Approx. Roof Sq. Ft.: 4,100
Height: 40'

Assessment: This roof level is approximately 20+ years old. Signs of deterioration and some serious roofing deficiencies were noted. Roof replacement should be scheduled as soon as budgeting permits.

Due to the age and condition of the installed roofing assembly, roof replacement should be scheduled as soon as budgeting permits.

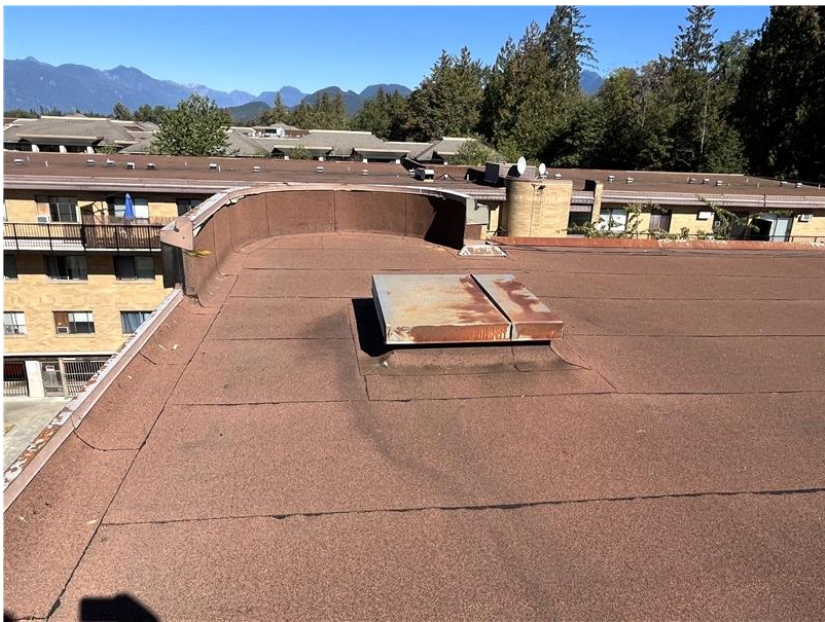
Condition: Roof Hatch
Quantity: 1

View of the roof hatch.

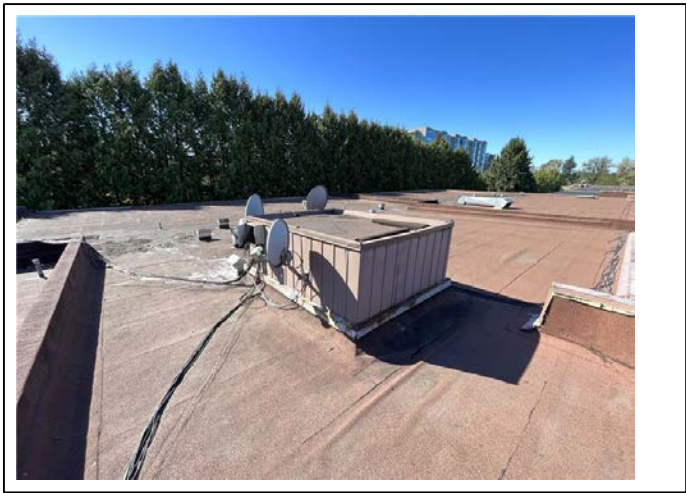
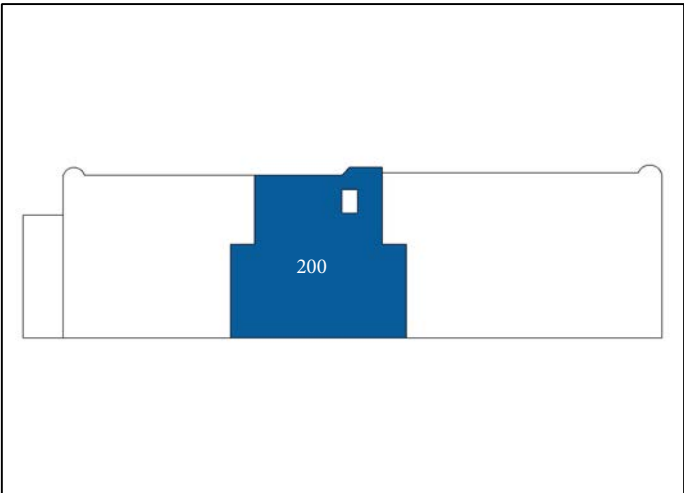
Roof: 200

Roof System: Modified Bitumen
Estimated Install Date: 2003
Condition Index: Poor
Roof Access: Roof Hatch
Approx. Roof Sq. Ft.: 3,550
Height: 40'

Assessment: This roof level is approximately 20+ years old. Signs of deterioration and some serious roofing deficiencies were noted. Roof replacement should be scheduled as soon as budgeting permits.

Due to the age and condition of the installed roofing assembly, roof replacement should be scheduled as soon as budgeting permits.

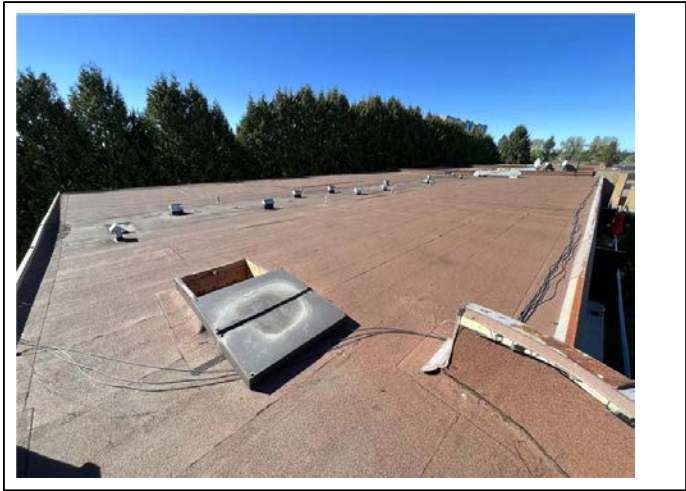
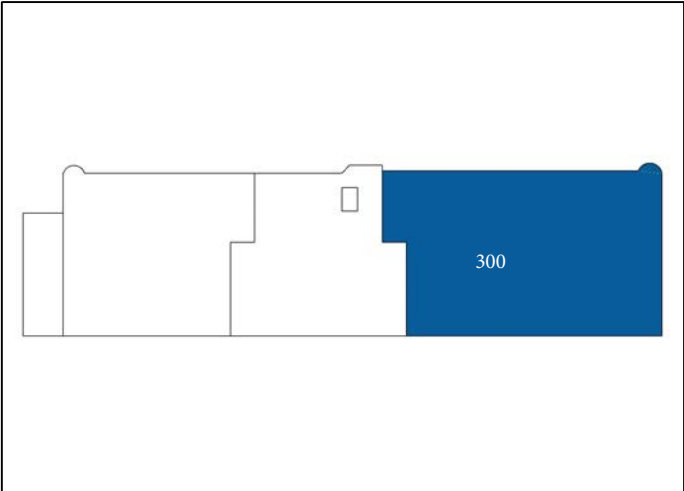
Roof: 300

Roof System: Modified Bitumen
Estimated Install Date: 2003
Condition Index: Poor
Roof Access: Roof Hatch
Approx. Roof Sq. Ft.: 6,215
Height: 40'

Assessment: This roof level is approximately 20+ years old. Signs of deterioration and some serious roofing deficiencies were noted. Roof replacement should be scheduled as soon as budgeting permits.

Due to the age and condition of the installed roofing assembly, roof replacement should be scheduled as soon as budgeting permits.

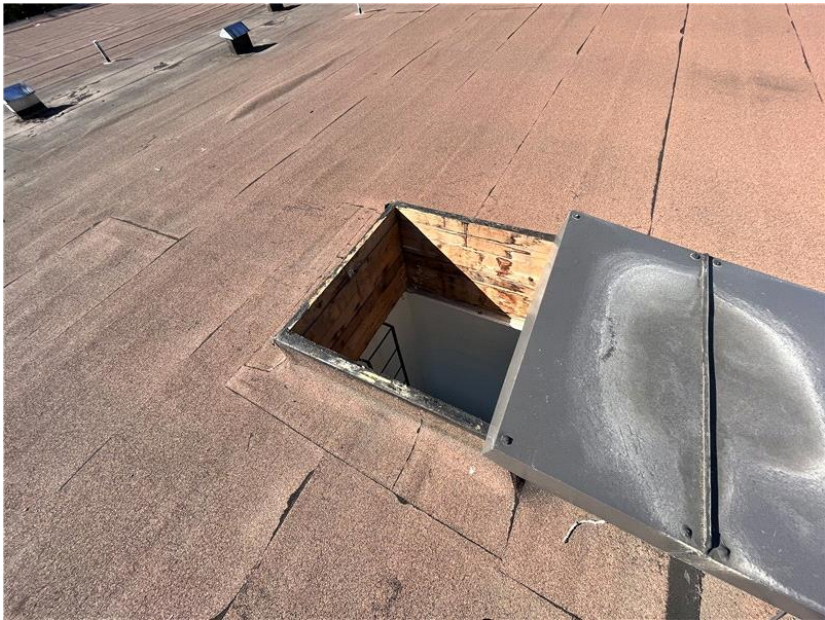
Condition: Roof Hatch
Quantity: 1

View of the roof hatch.

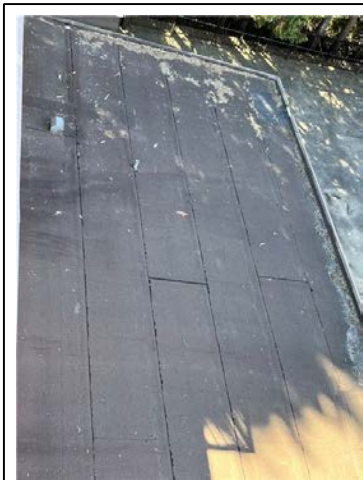
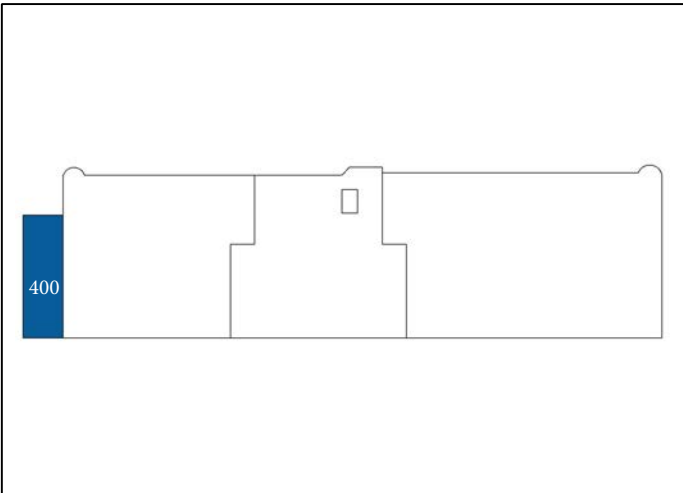
Roof: 400

Roof System: Modified Bitumen
Estimated Install Date: 2003
Condition Index: Poor
Roof Access: Exterior
Approx. Roof Sq. Ft.: 690
Height: 12'

Assessment: This roof level is approximately 20+ years old. Signs of deterioration and some serious roofing deficiencies were noted. Roof replacement should be scheduled as soon as budgeting permits.

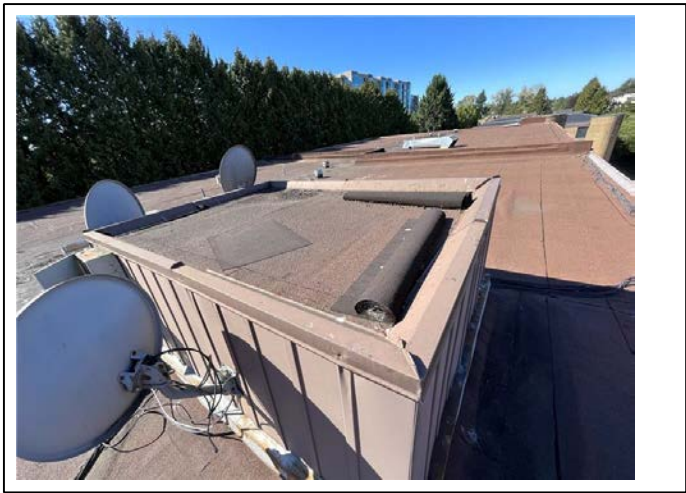
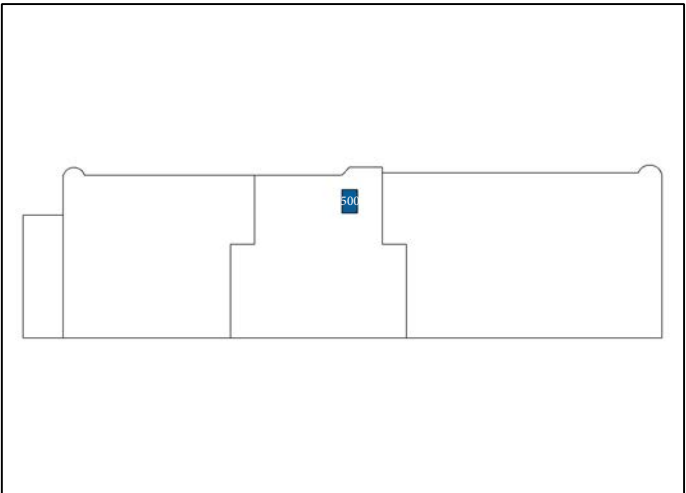
Roof: 500

Roof System: Modified Bitumen
Estimated Install Date: 2003
Condition Index: Poor
Roof Access: Exterior
Approx. Roof Sq. Ft.: 54
Height: 43'

Assessment: This small elevator shaft roof is approximately 20+ years old and should be scheduled for replacement at the same time as the main roof levels.
