NON-DESTRUCTIVE TESTING – CORROSION INVESTIGATION

Xradar Project # XBC-VAN-9793

Project Site: 12184, 224 Street, Maple Ridge, BC

Client: Evoke Buildings Engineering Ltd.

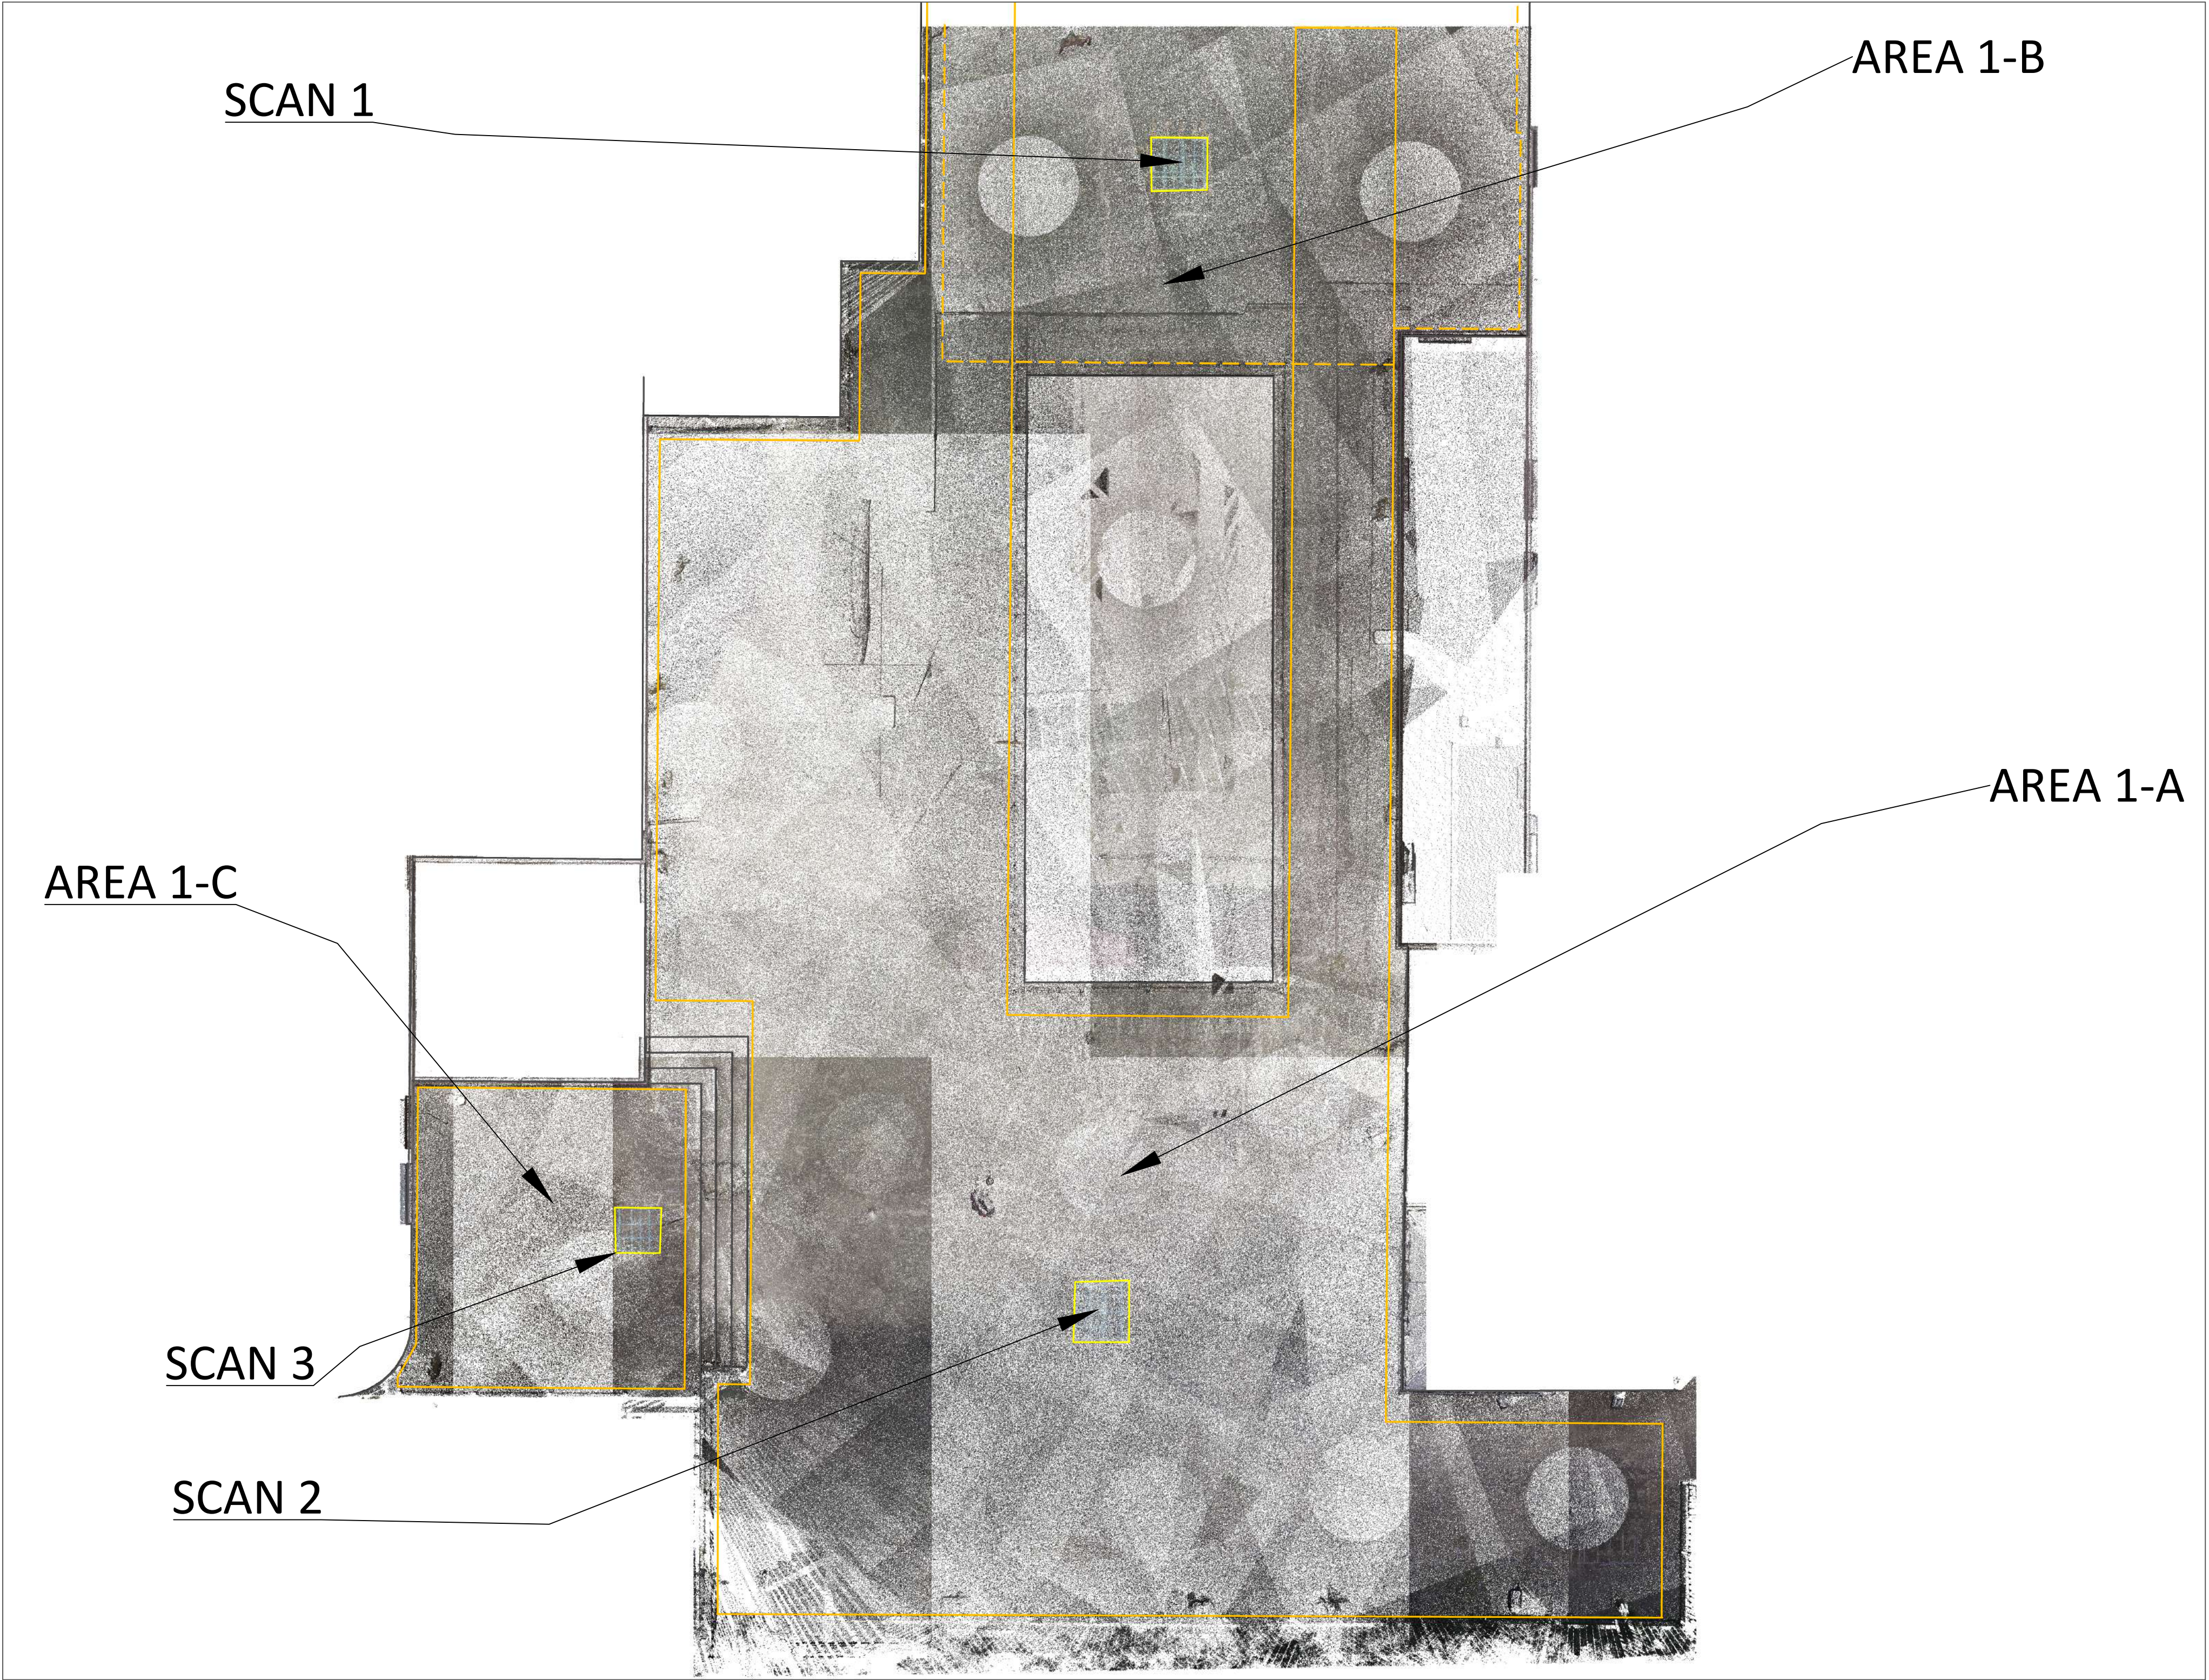
AREA 1 - SURVEY GRID BOUNDARIES
SCALE: 1:80

moderate corrosion exists in the central southern area of Area 1, on the bottom rebar mat. Additionally visual signs of corrosion were abundant on the underside of the slab in this southern area. Cracking was present on the topside and underside of the slab most notably in the north west corner of area 1. Some cracking was also present on the underside of the south-central zone of area 1.

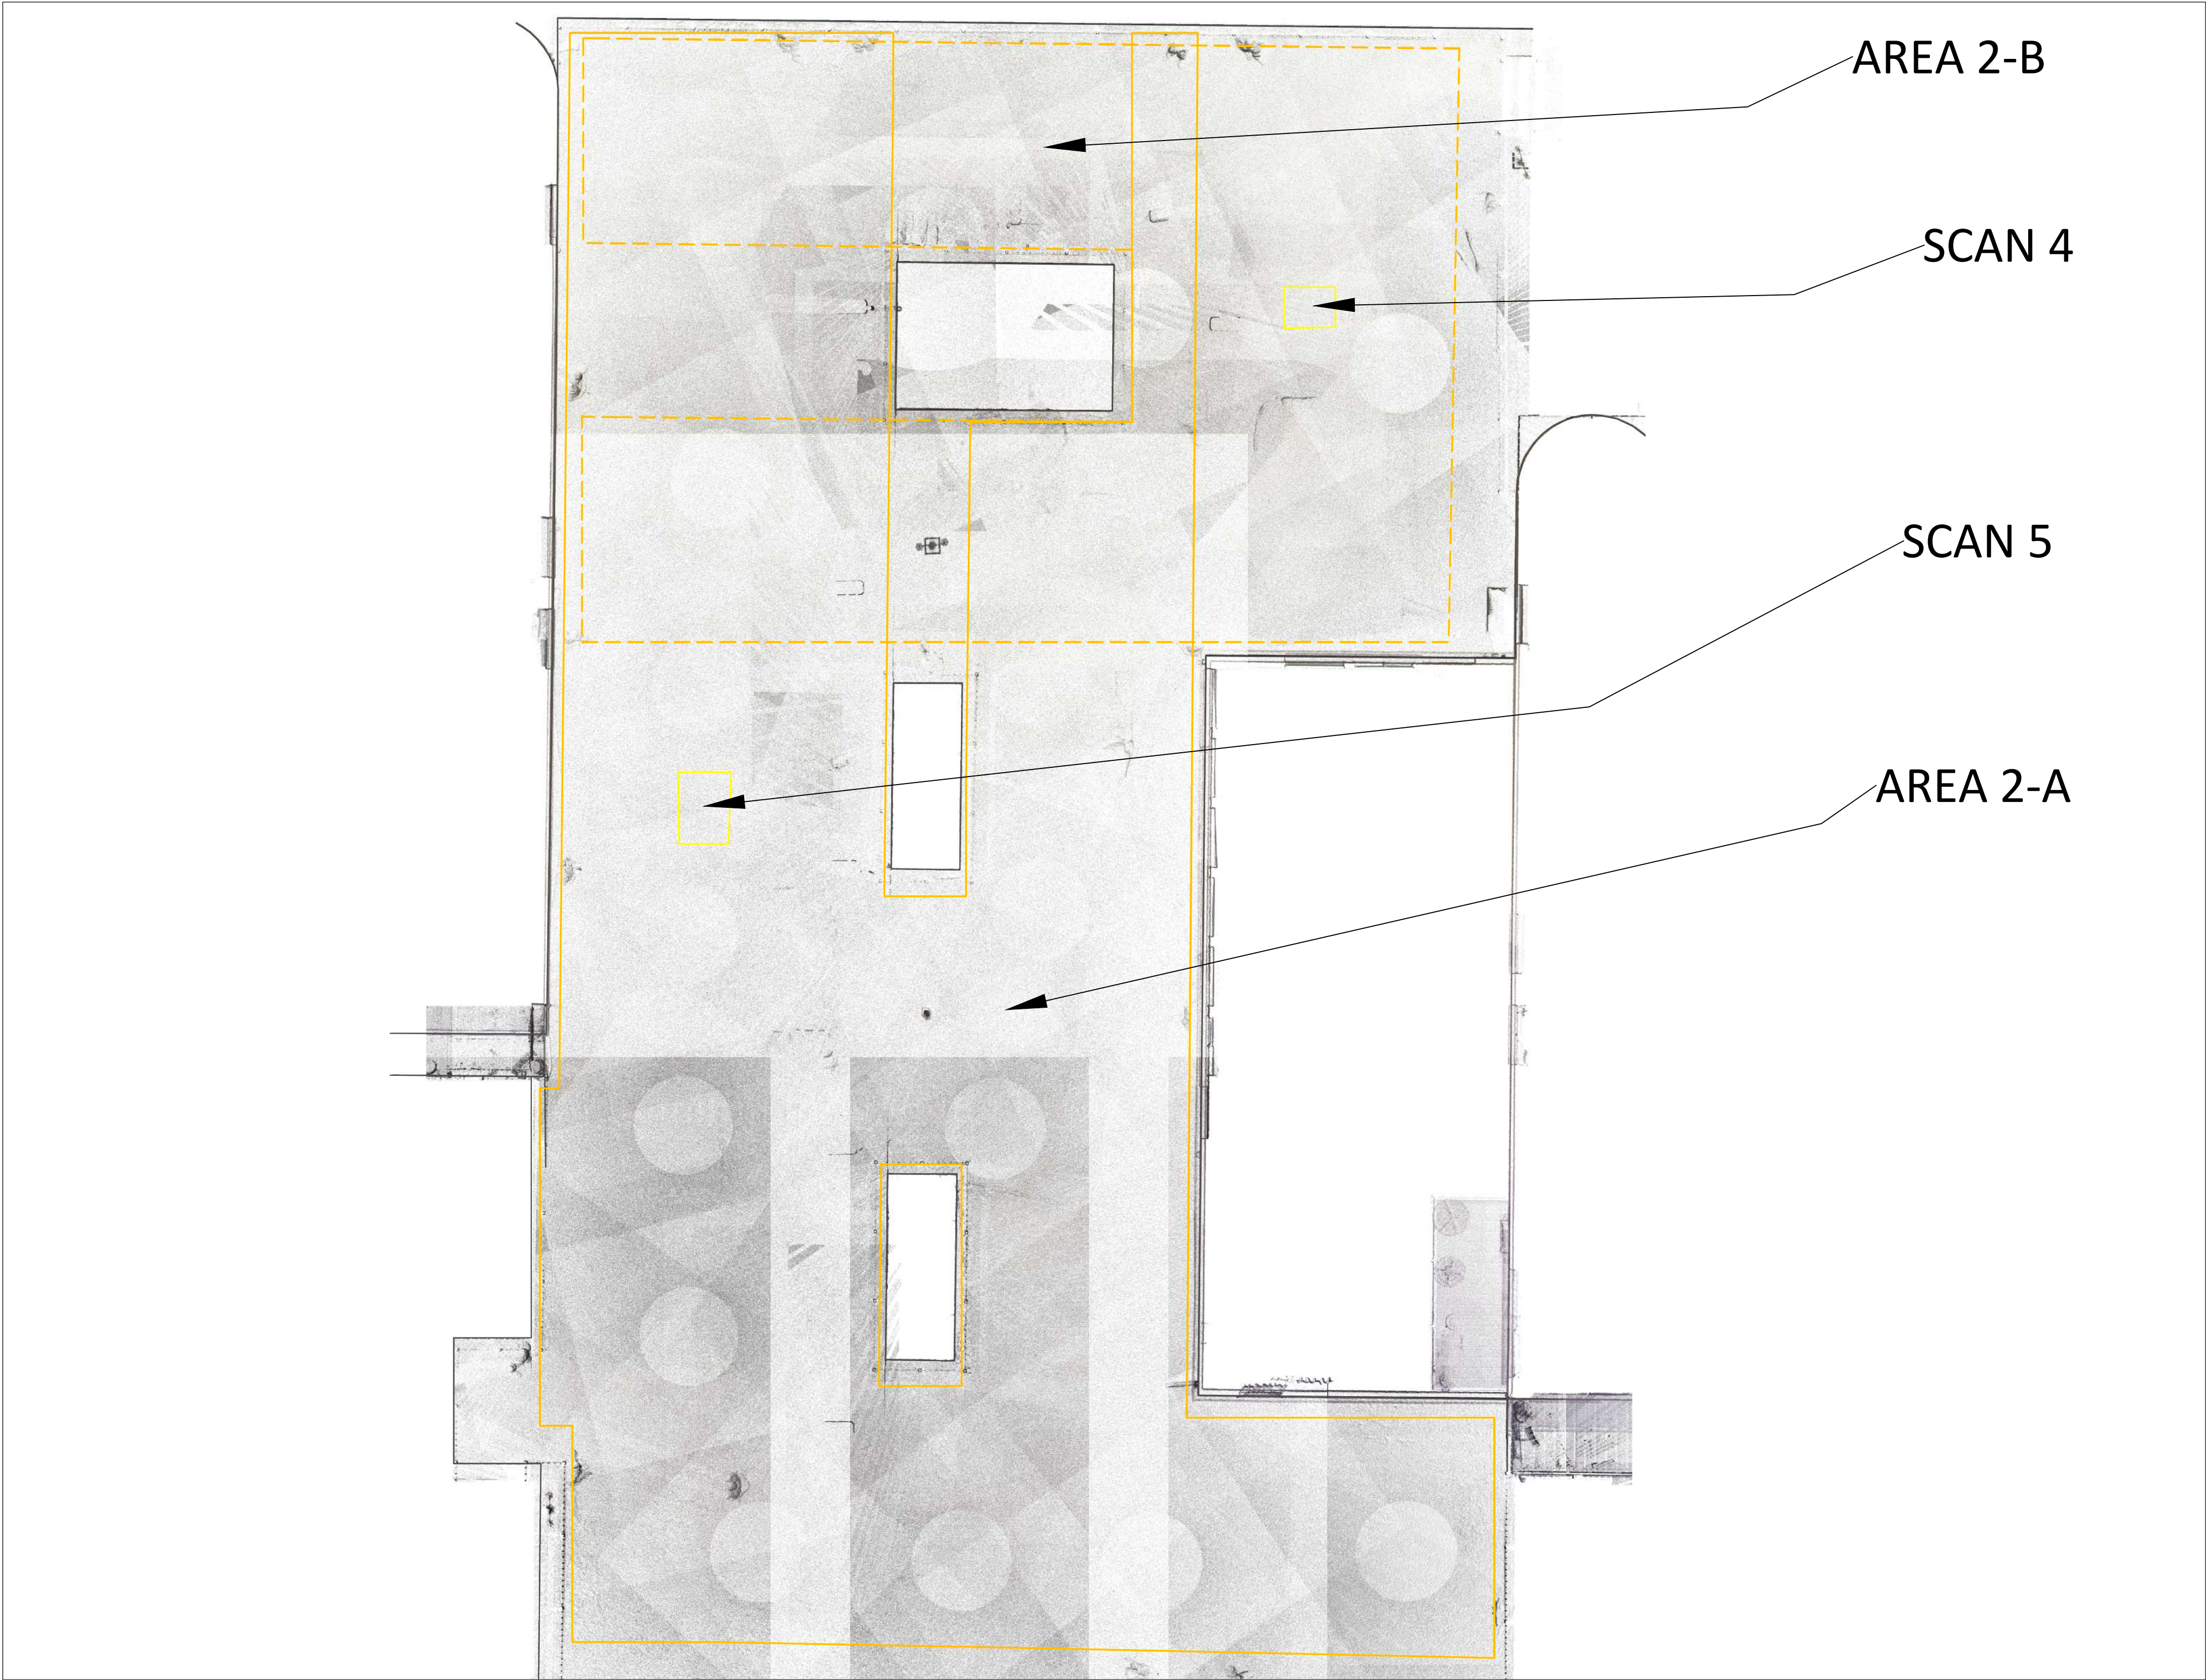
AREA 2 - SURVEY GRID BOUNDARIES
SCALE: 1:80

Area 2 was similar containing multiple isolated areas of moderate corrosion and some severe, and a condensed area in the south-central part of Area 2. There were multiple areas of visual corrosion notably the north east and south west of the area. Cracking was abundant on the underside of area 2 with some sporadic cracks on the topside of the slab. Areas of exposed bars existed on the underside of some of the beams in area 2 also. It is worth noting the underside of beams were not scanned using GPR. Depth penetration from the top of the slab did not reach to the bottom of the beams.

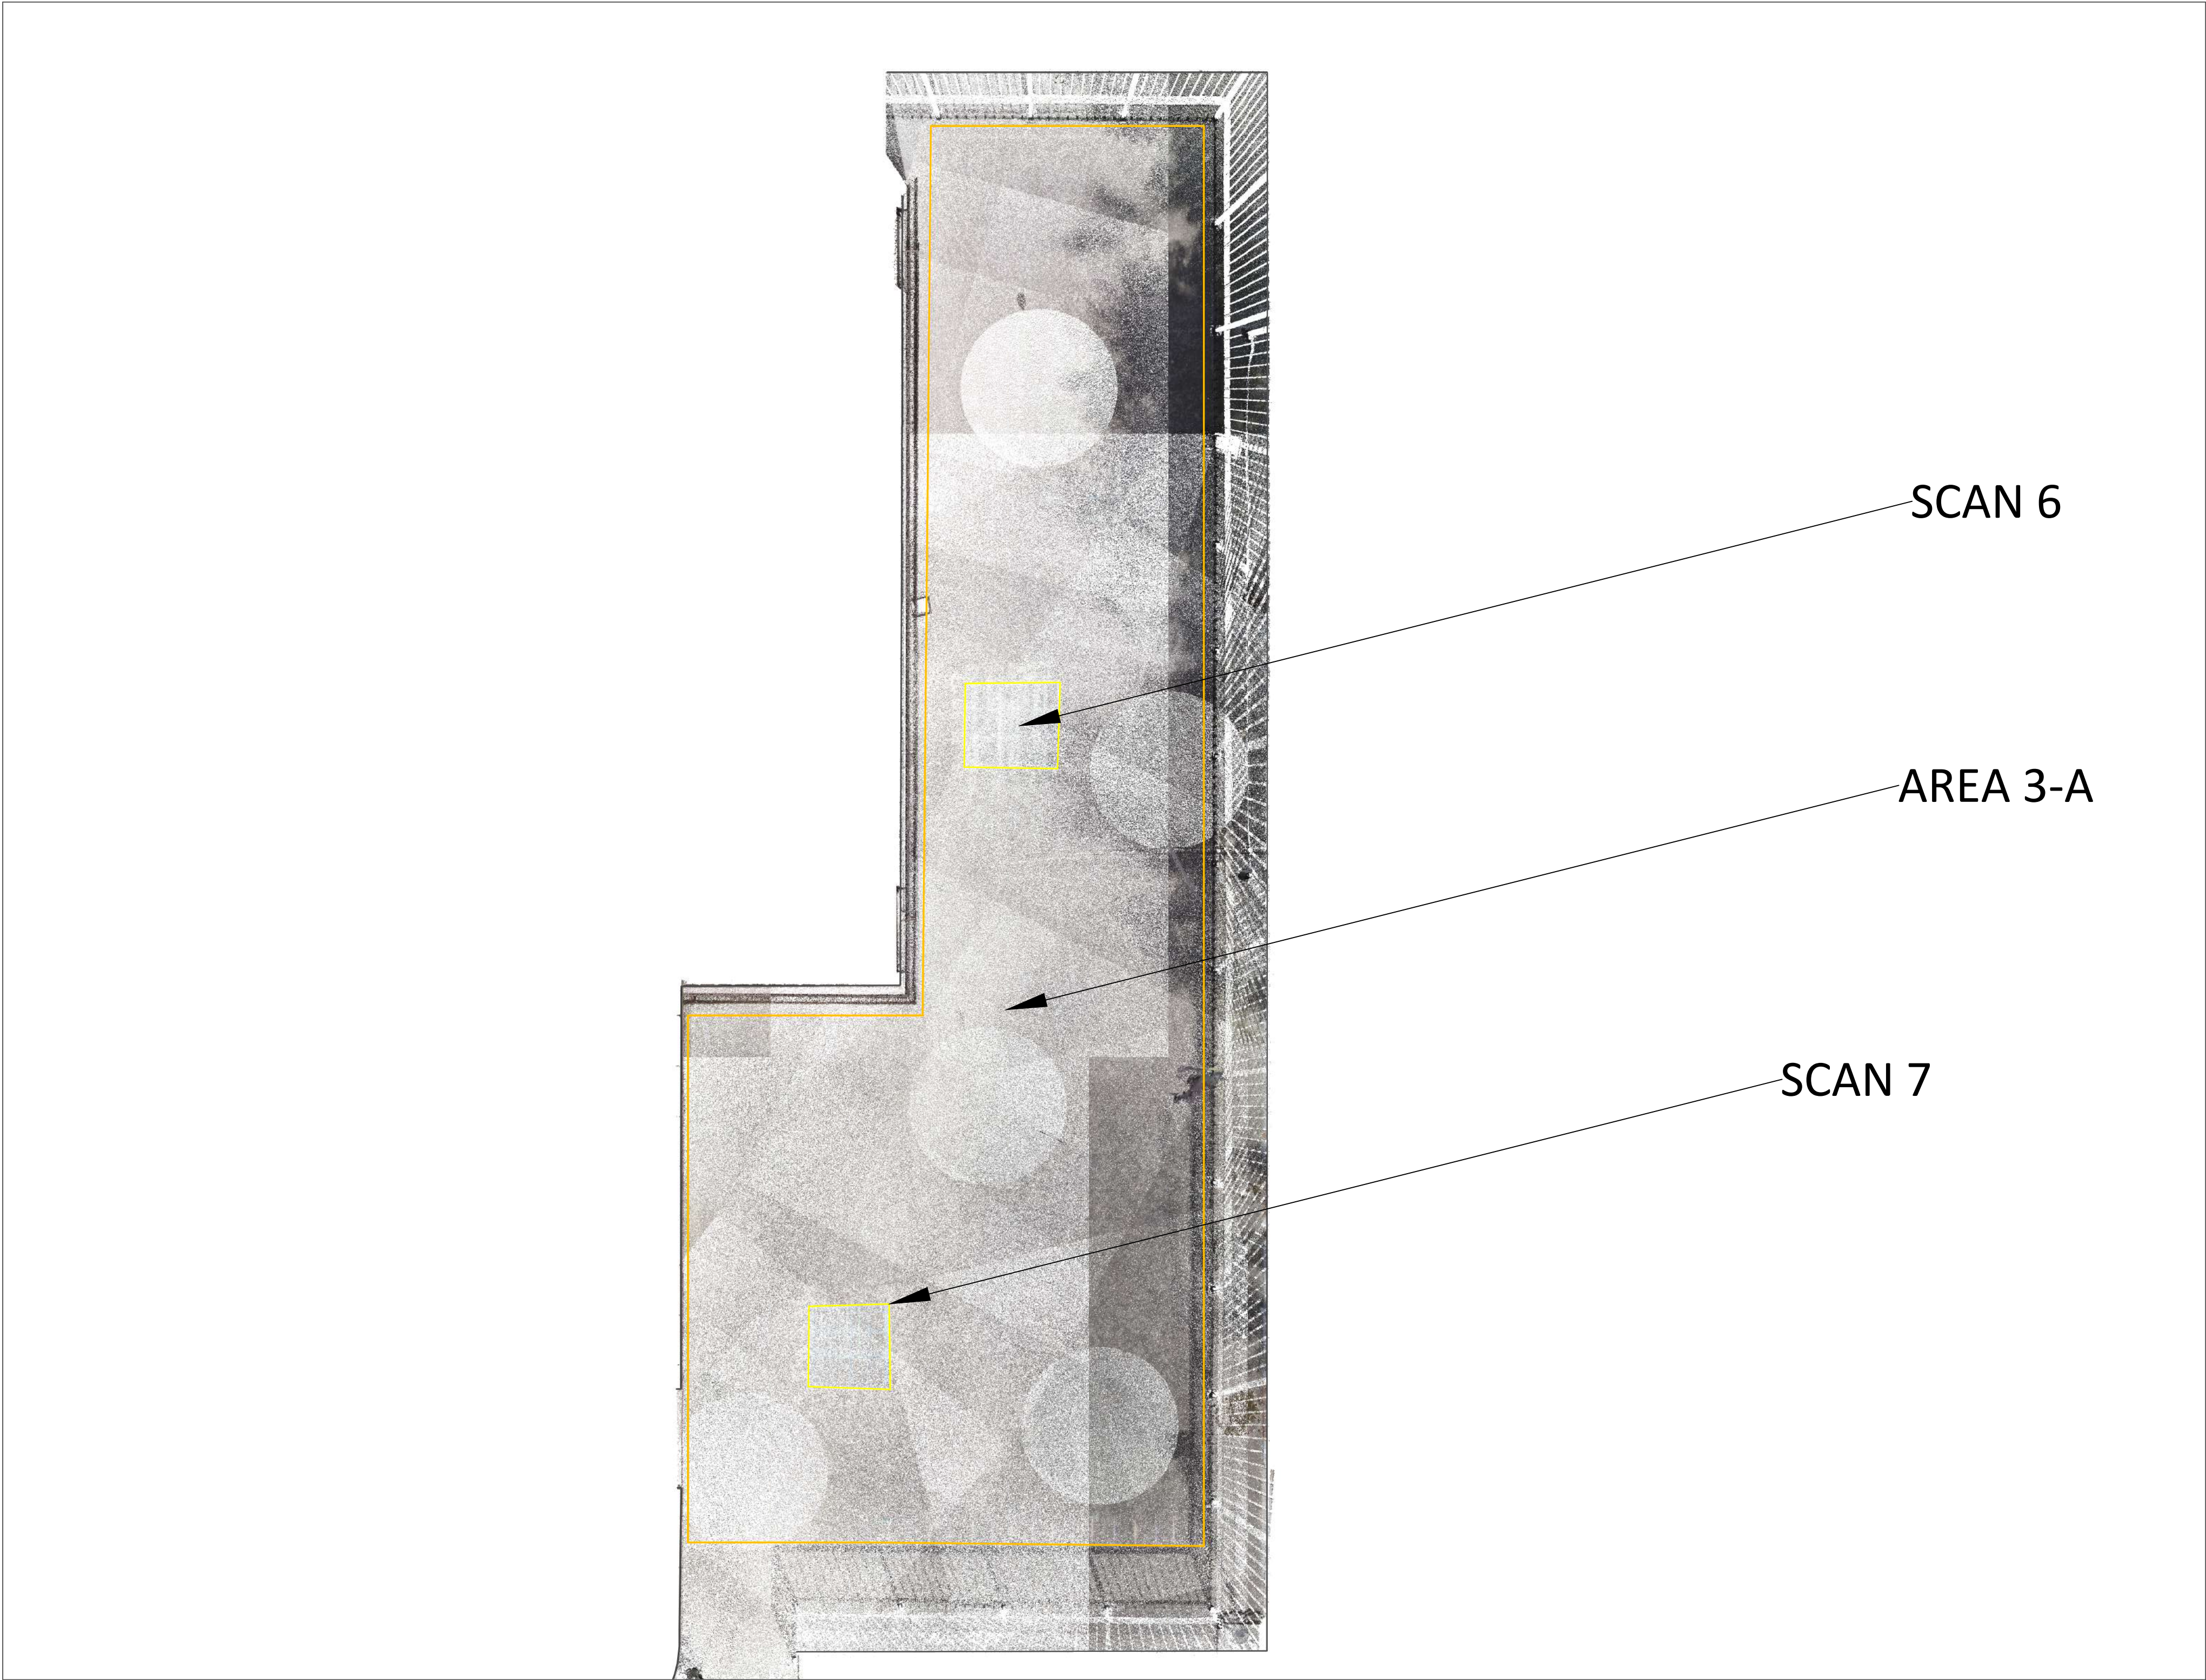
AREA 3 - SURVEY GRID BOUNDARY
SCALE: 1:50

Area 3 contained some small sporadic areas of moderate corrosion, no severe corrosion. Additionally, some cracking was observed on the topside and underside, with one area of exposed rebar on the underside. It is worth mentioning the presence of manmade trenches for draining water, on Areas 2 and 3. These are clearly retaining water.

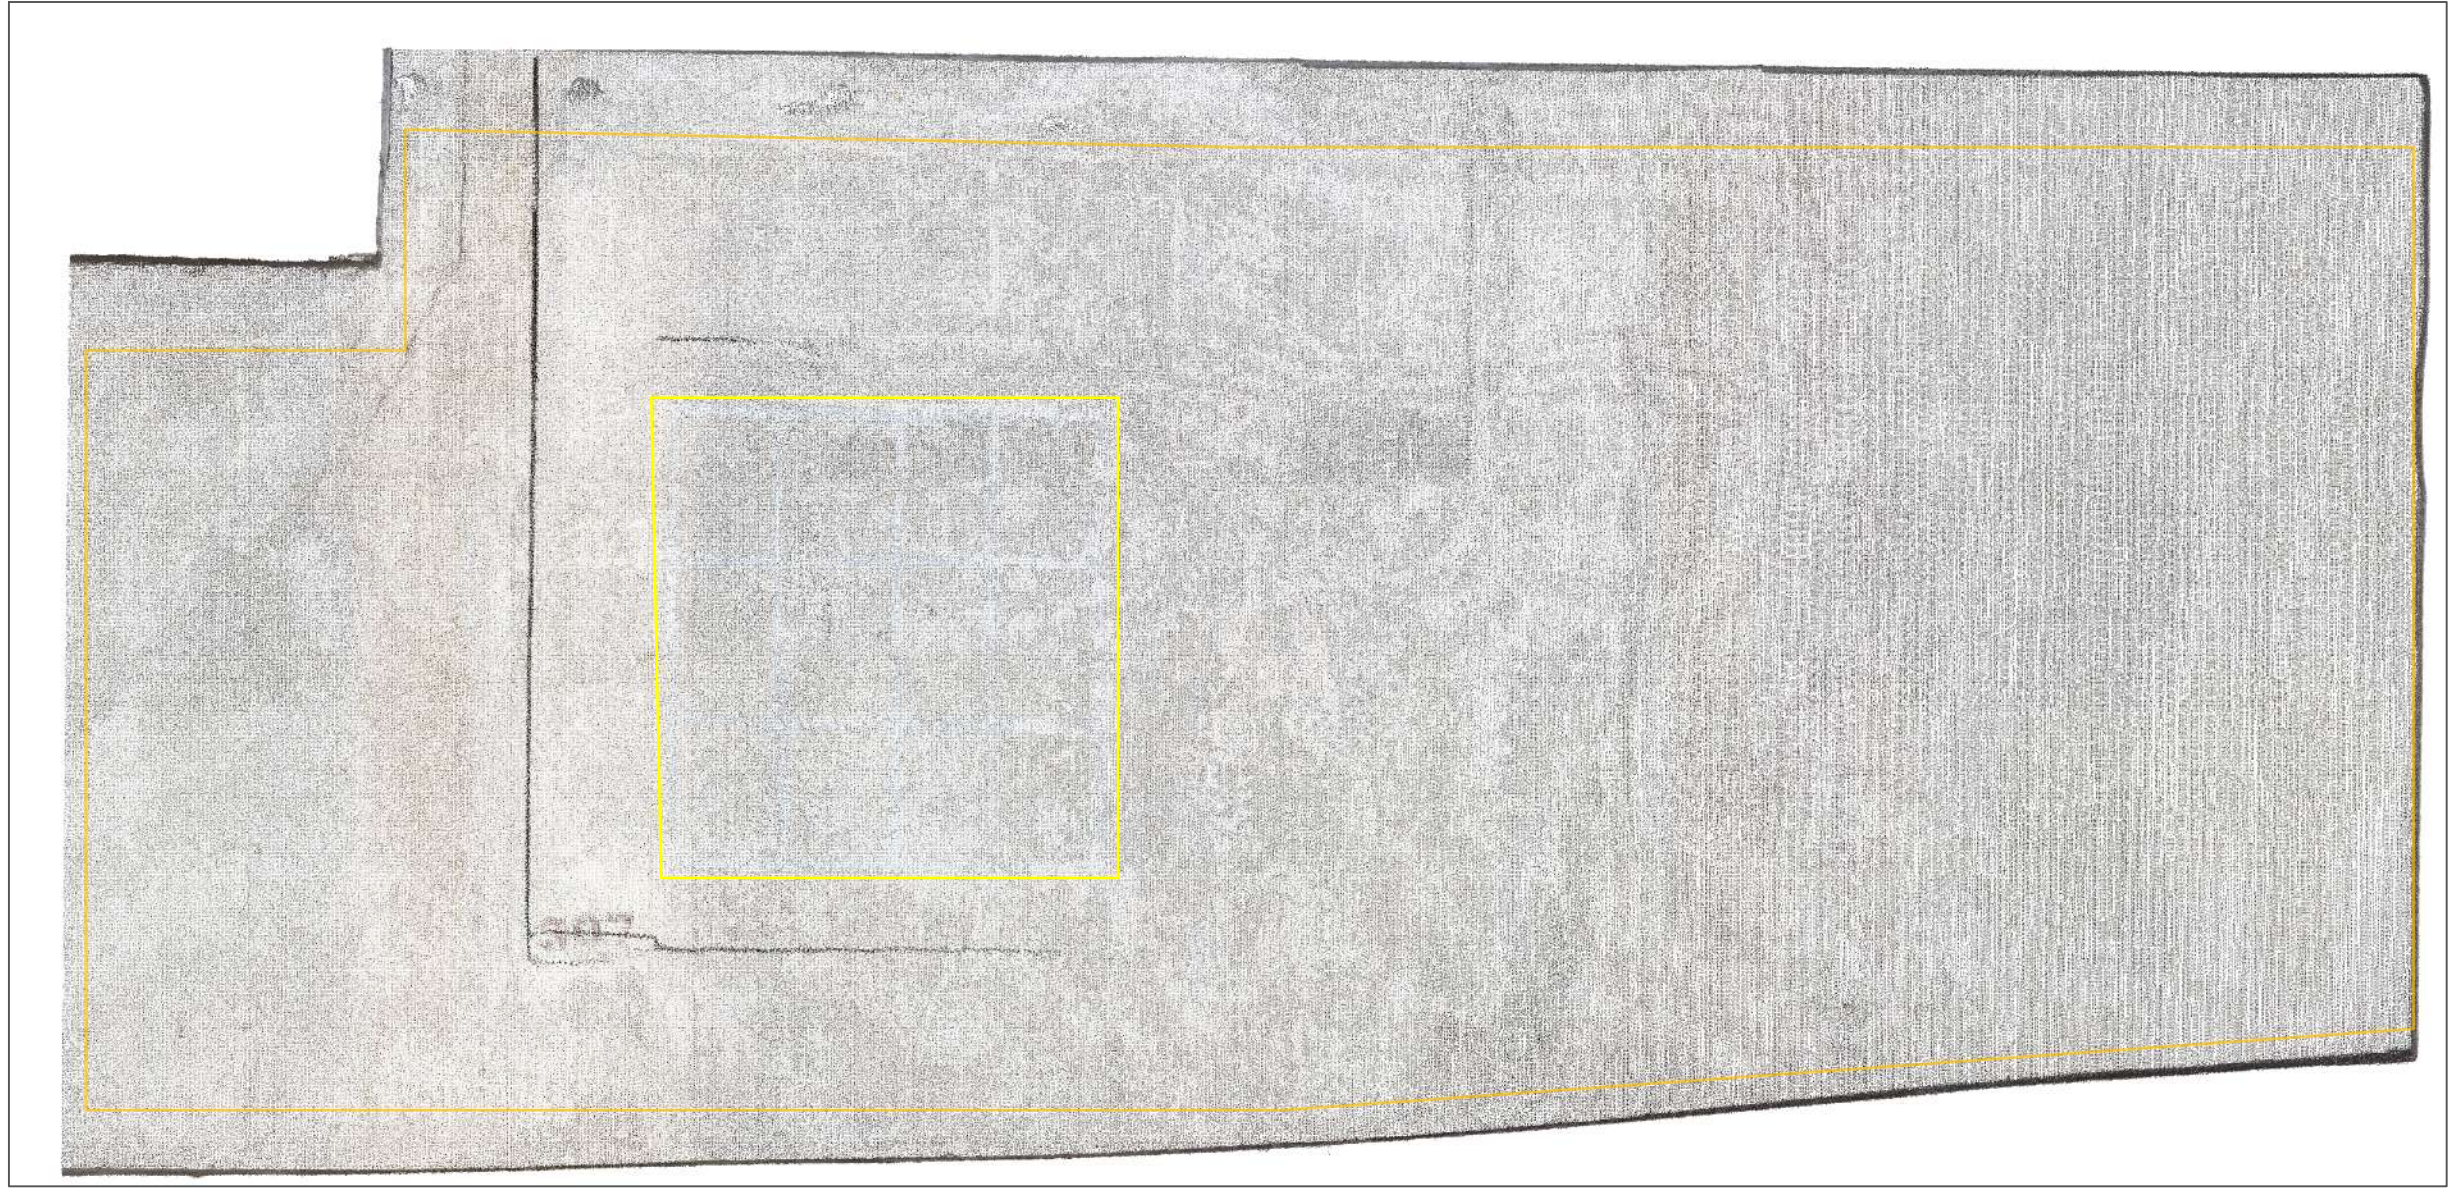
AREA 1 WALL - SOUTH FACE
SCALE: 1:20

Both wall 1 and wall 2 contained some isolated suspected moderate corrosion. Wall 2 did contain two small areas of exposed rebar. The wall was very rough in places missing some chunks of concrete so data collection was limited to areas the antenna could roll over.
