RE: Balcony Investigation

RJC No. VAN.103256.0015

Bellevue Tower West

195 21st Street, West Vancouver, BC V7V 4A4

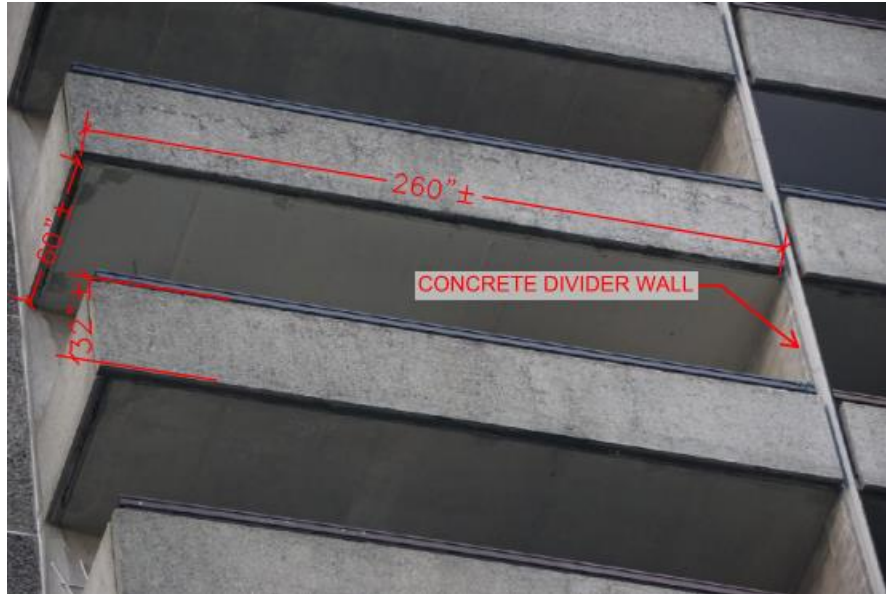
Figure 2: Overview of balcony dimensions

The balconies' guards are constructed on two sides with independent precast upstand concrete walls connected to the slab. The third side of each balcony is constrained by a full-height concrete divider wall. The approximate plan dimensions of the cantilevered balcony slab are 5'-0" x 19'-0". The precast upstand walls are 4 in +/- thick and 32 in +/- tall. An aluminum railing connected to the upper portion of the upstand forms the remaining height of the guard. Refer to Figure 2 for an overview of the balcony dimensions.
