Re: 1021 4<sup>th</sup> Avenue  
New Westminster, British Columbia  
Balcony Repairs  
Change Order 1 - CO#1 **PO 8502340**  
Our Reference No: CCC-224718-22

Please see the attached bid form and detail drawings which represents a change in the scope of work for balcony repairs at 8 corner balconies and 2 concrete balconies at 1021 4<sup>th</sup> Avenue, New Westminster, BC.

| REV | DATE | DESCRIPTION | APP |
|---|---|---|---|
| <b>BUILDING ENVELOPE REPAIRS</b><br>1021 4TH AVENUE,<br>NEW WESTMINSTER, B.C. | | | |

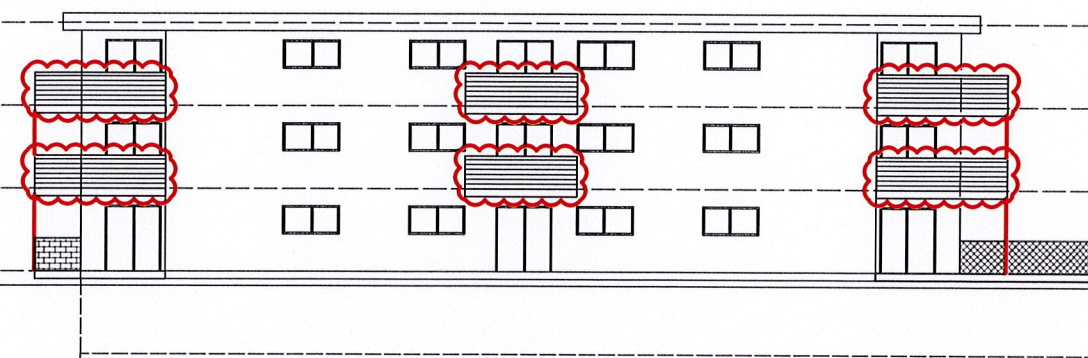
4 EAST ELEVATION  
N.T.S.

BALCONY REPAIRS:

- NEW WATERPROOFING MEMBRANE
- REPLACE EXISTING BALCONY PARAPETS WITH PICKETS GUARDRAILS
- INSTALL NEW 4x4 POST @ CORNER BALCONIES

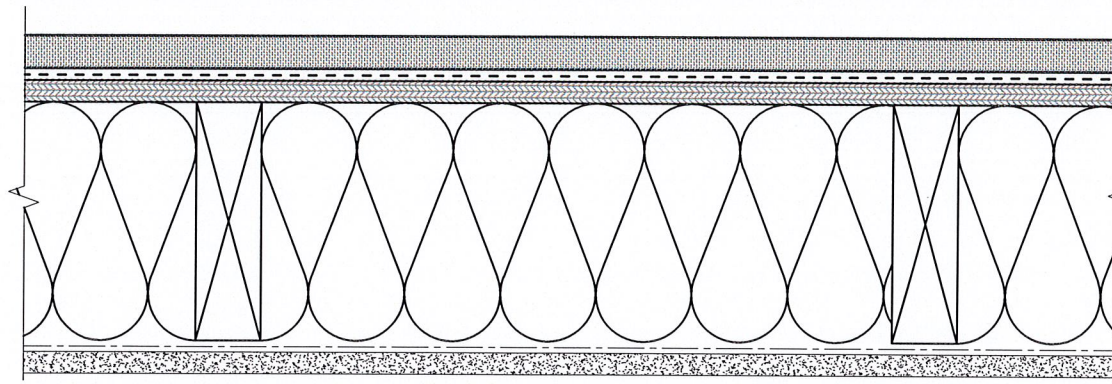
STUCCO CLADDING (EXIST.)  
 TYVEK (EXIST.)  
 1/2" MIN. PLYWOOD SHEATHING (EXIST.)  
 WOOD FRAMING WITH R20 INSULATION AT STUD CAVITY (EXIST.)  
 6MIL POLYETHYLENE (AIR & VAPOUR BARRIER) (EXIST.)  
 G.W.B (EXIST.)

1 WALL TYPE W1 - EXISTING TYPICAL STUCCO CLADDING  
 SECTION - 3" = 1'-0"

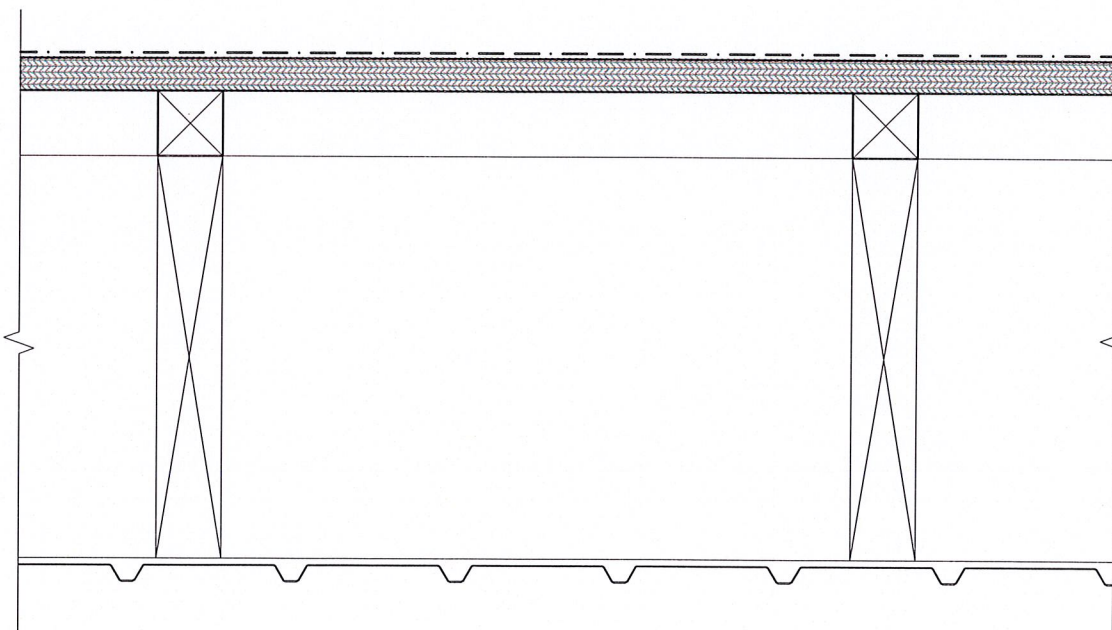
VULKEM 350/351 LIQUID MEMBRANE (NEW)  
 5/8" PLYWOOD DECK SHEATHING T&G (NEW)  
 TAPERED SLEEPERS TO CREATE MIN 2% SLOPE (NEW)  
 JOISTS (EXIST.)  
 ALUMINUM PERFORATED SOFFIT (NEW)

2 FLOOR TYPE F1 - TYPICAL BALCONY DETAIL (OVER NON-LIVING SPACE)  
 SECTION - 3" = 1'-0"

| Item No. | 1021 4 <sup>th</sup> Ave, New Westminster, BC<br>Description | Unit | Estimated Quantity | Unit Price | Amount |
|---|---|---|---|---|---|
| 4. | Remove the existing sheathing board on the top surface of all balcony decks down to the underlying wood framing. Replace sheathing board forming part of balcony decks where directed by the Consultant.<br><br>New sheathing shall be marine grade plywood, no less than 5/8" in thickness. | Square meter | 120 | \$ 300 | \$ 36,000 |

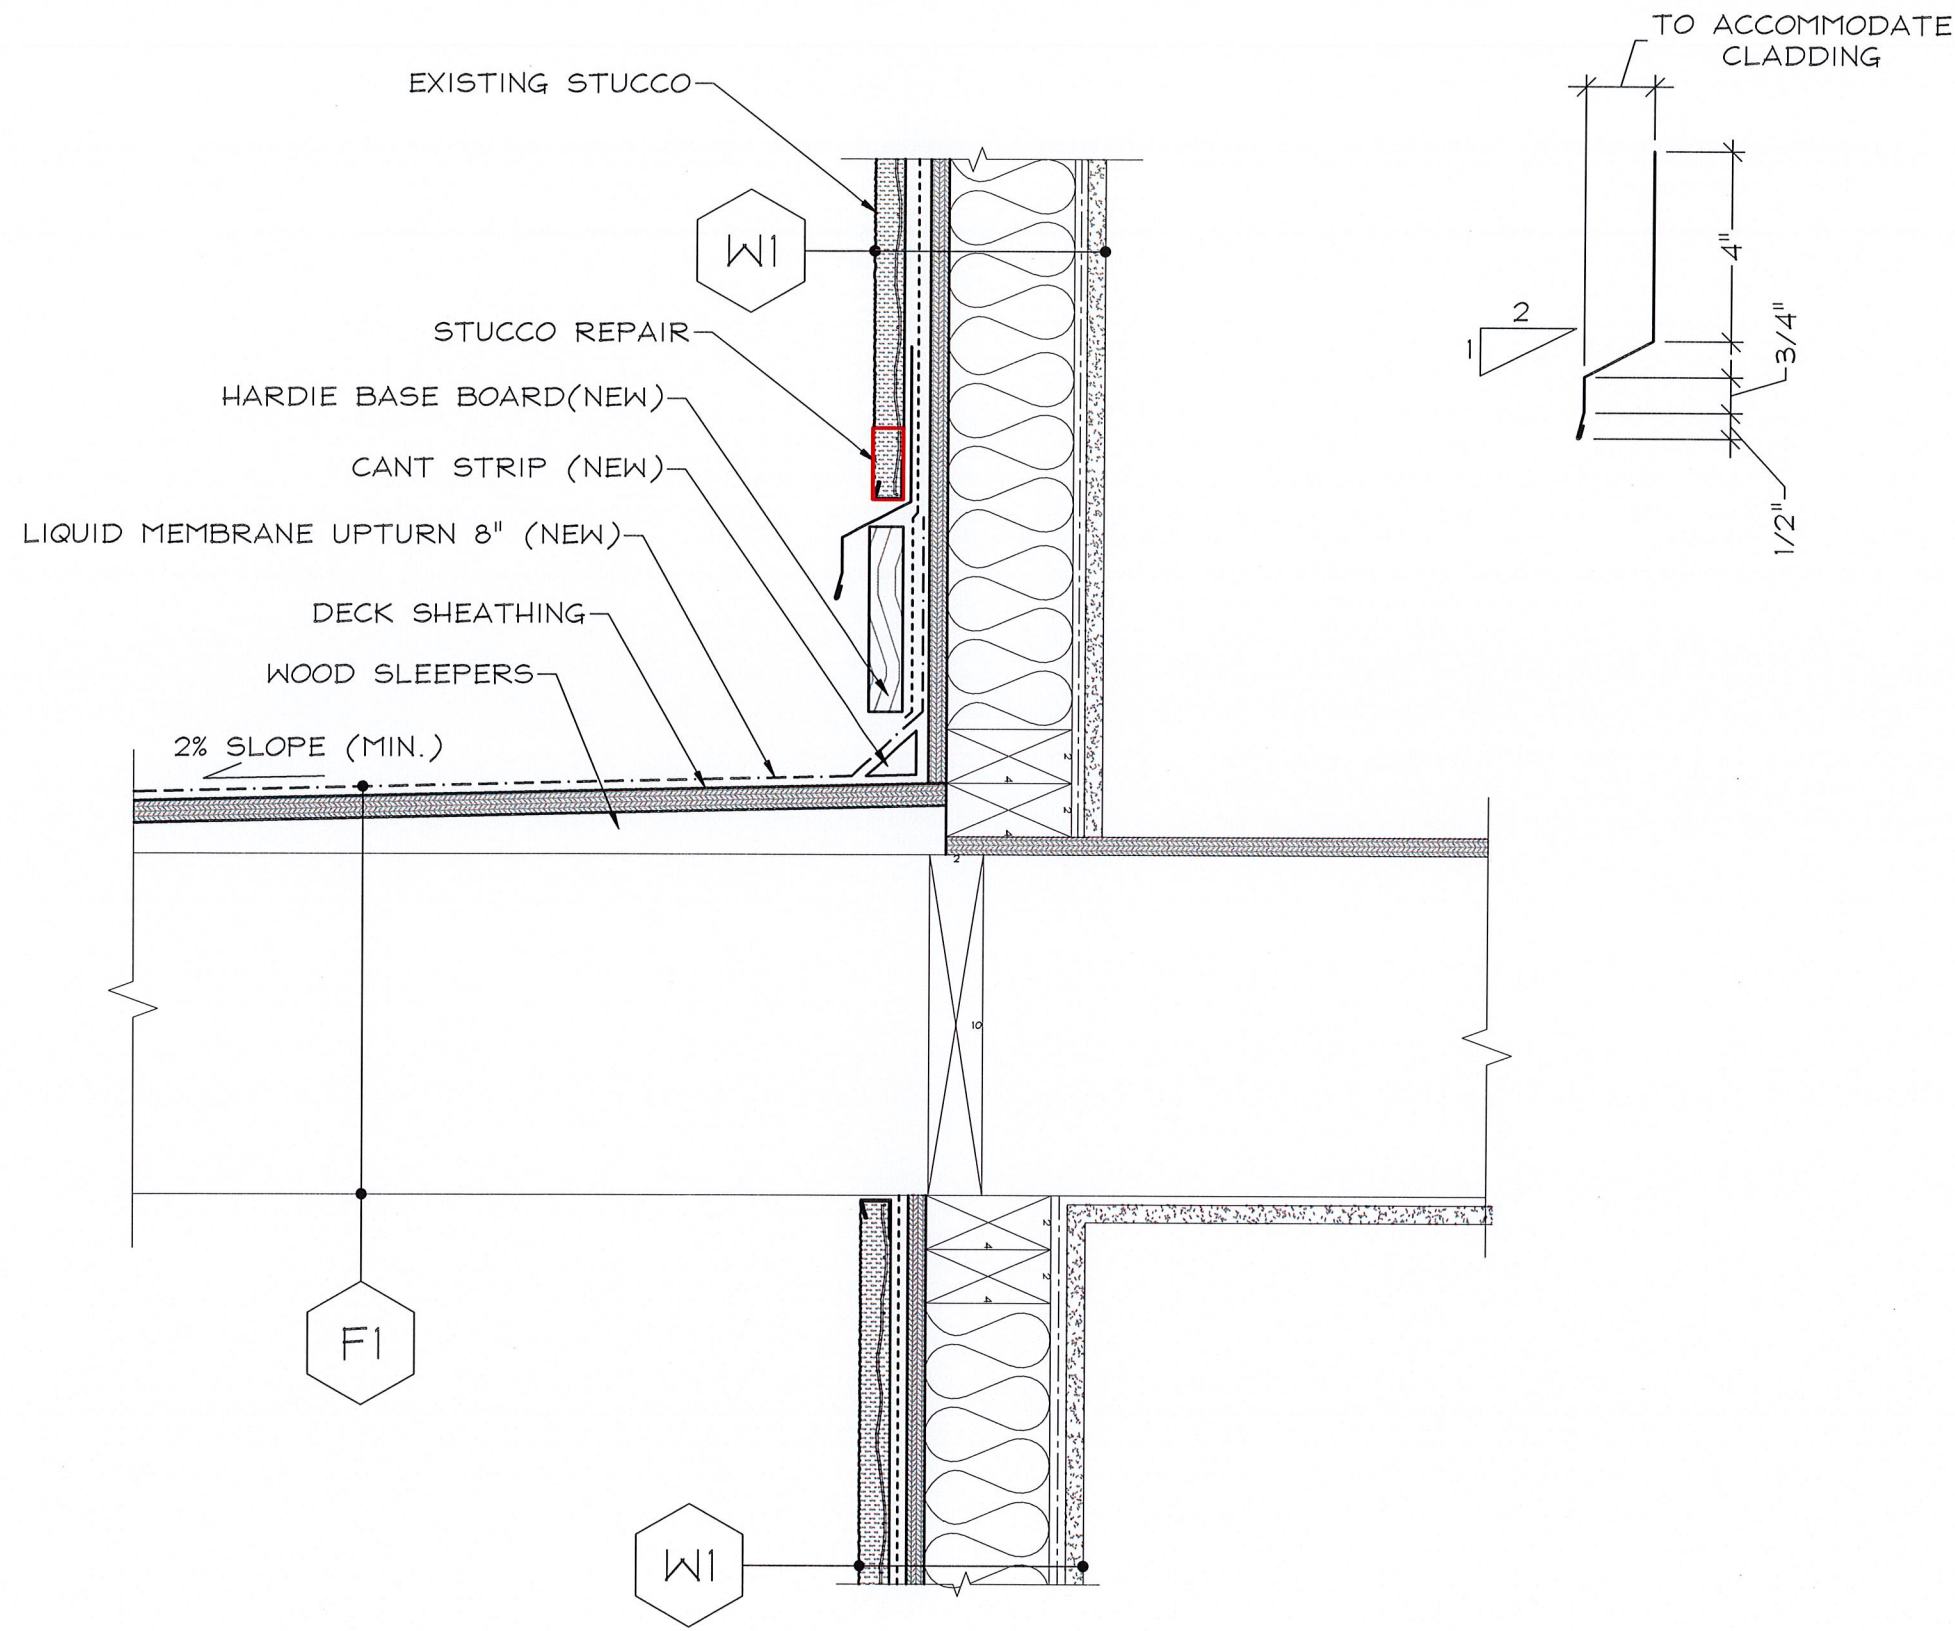
1 BASE OF WALL AT BALCONY  
SECTION - 3" = 1'-0"

- REMOVE 12" OF EXISTING FACE SEALED STUCCO CLADDING @ WALL BASE TO ACCOMMODATE THE MEMBRANE UPTURN.
- INSTALL NEW 24 GA FLASHING & POSITIVELY OVERLAP THE EXISTING BUILDING PAPER.
- INSTALL HARDIE BOARD @ WALL BASE IN LIEU OF STUCCO.

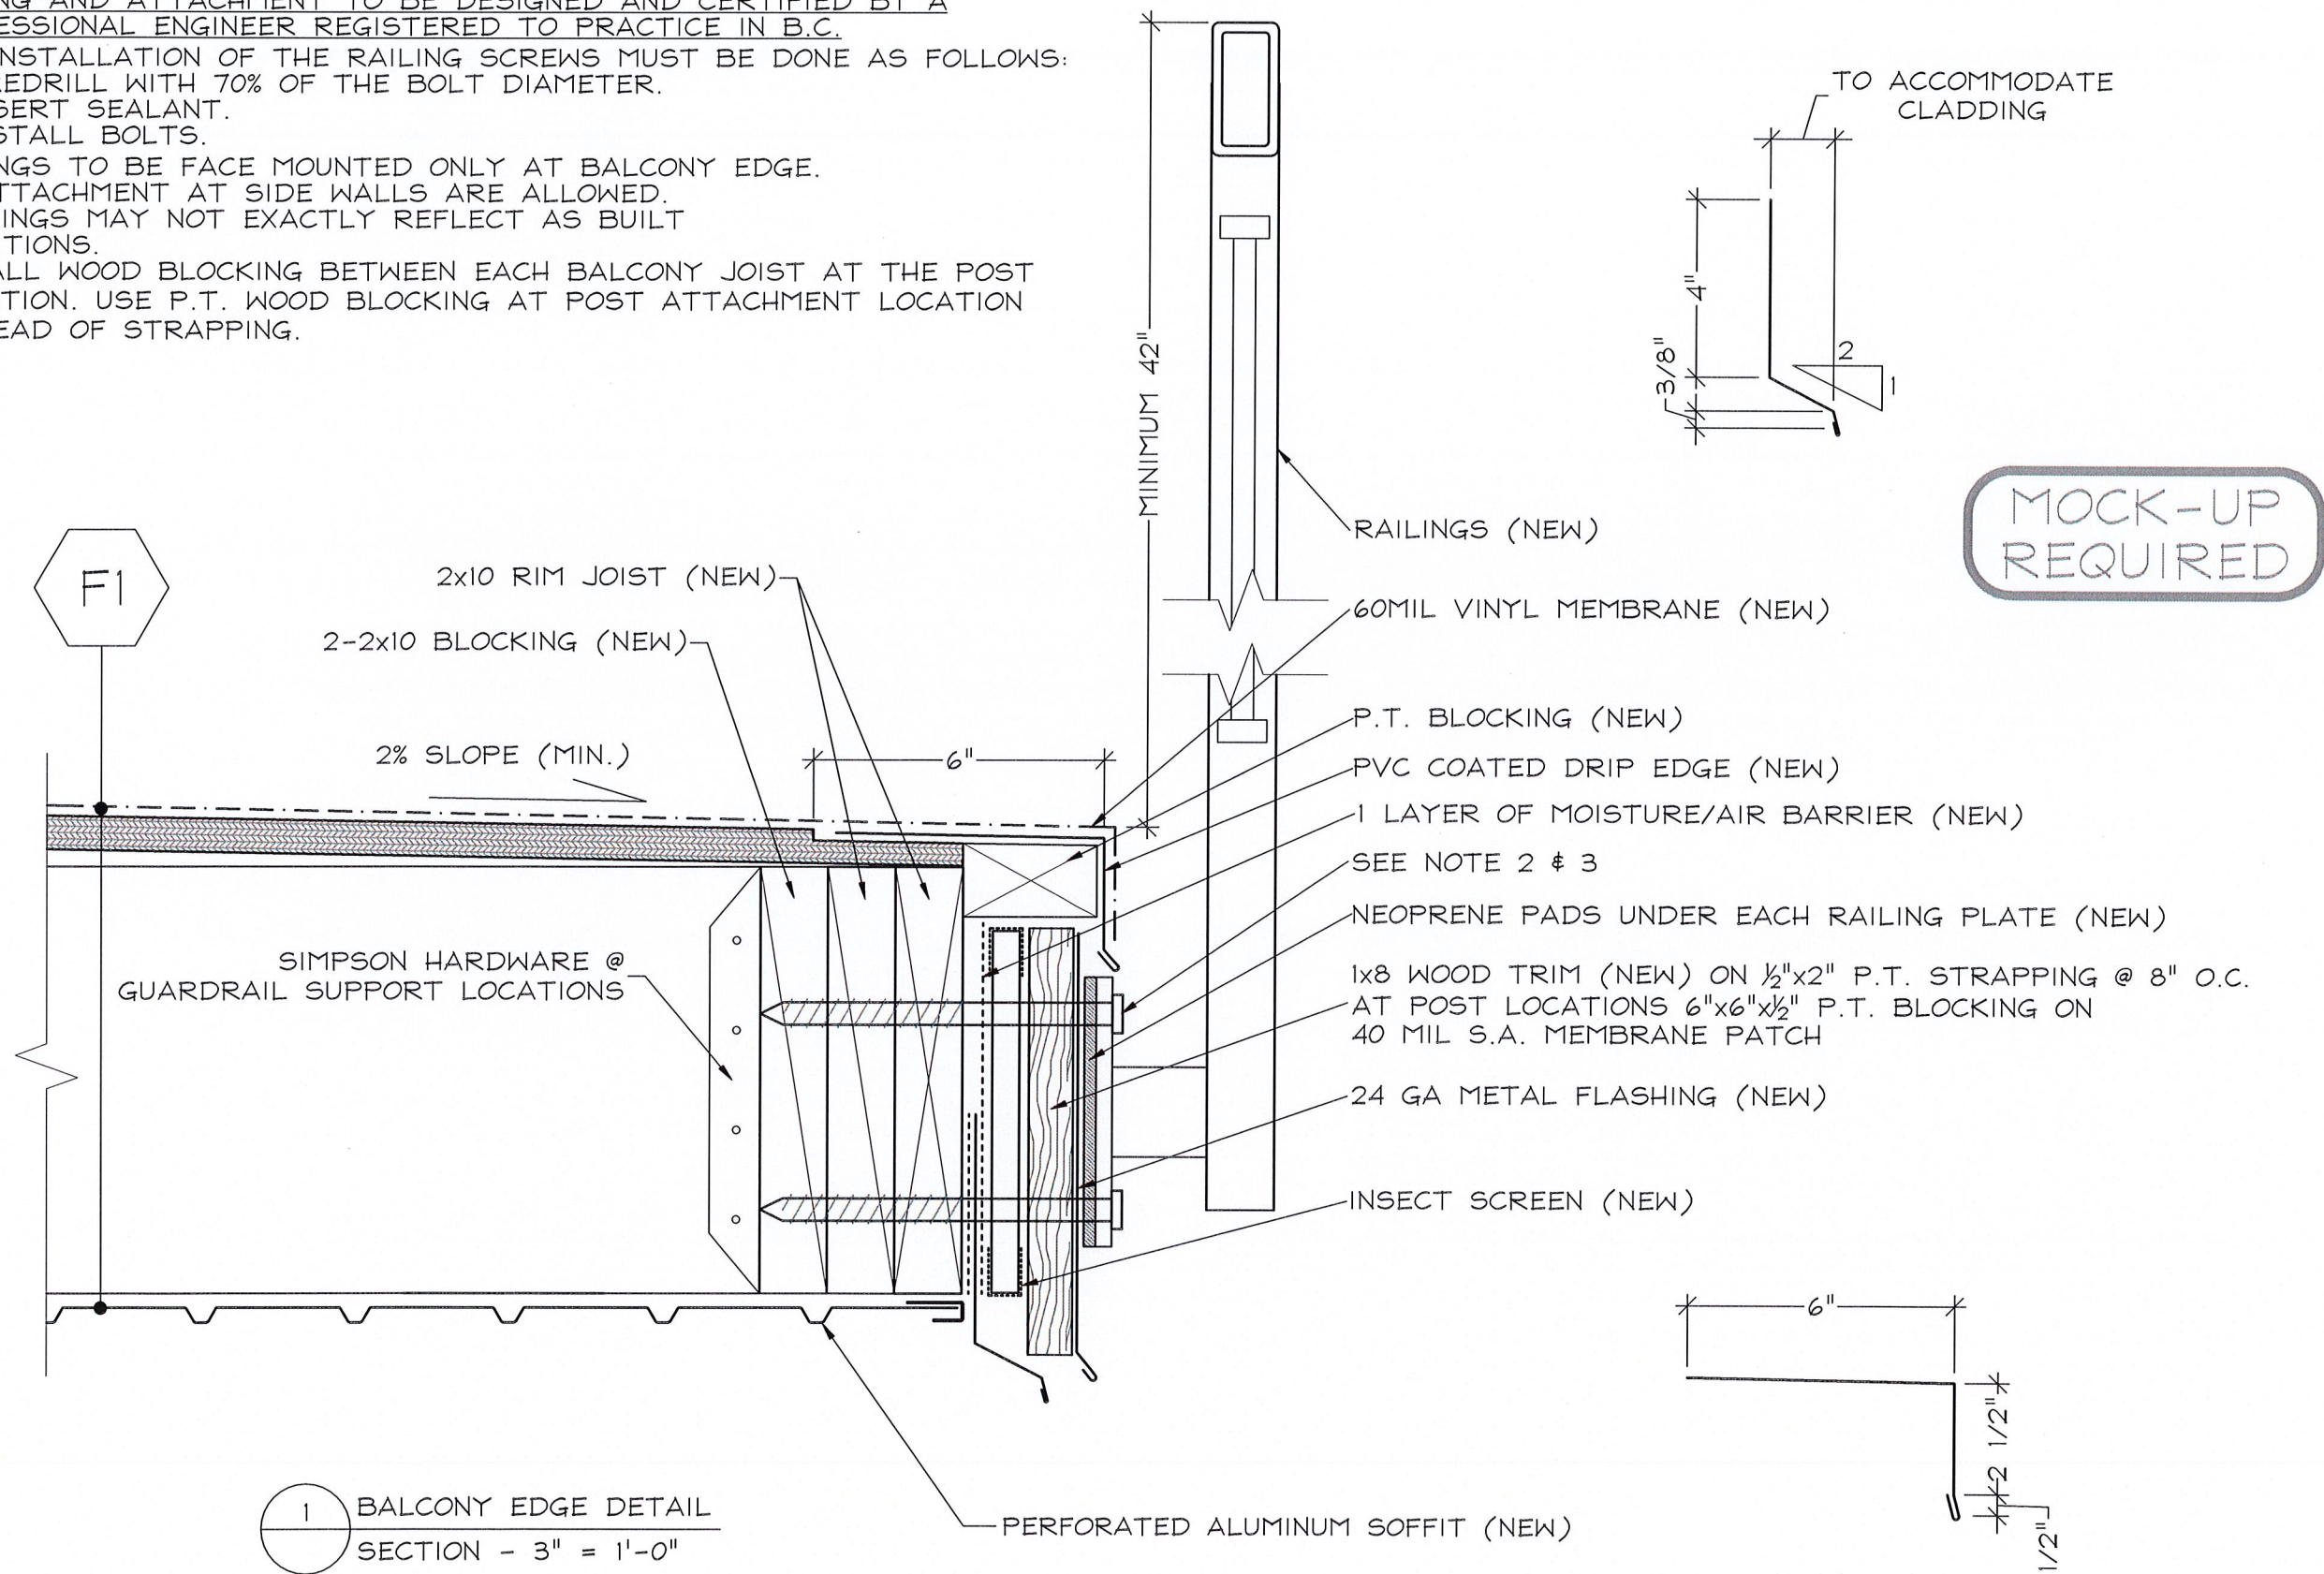
1. RAILING AND ATTACHMENT TO BE DESIGNED AND CERTIFIED BY A PROFESSIONAL ENGINEER REGISTERED TO PRACTICE IN B.C.
2. THE INSTALLATION OF THE RAILING SCREWS MUST BE DONE AS FOLLOWS:
  - A. PREDRILL WITH 70% OF THE BOLT DIAMETER.
  - B. INSERT SEALANT.
  - C. INSTALL BOLTS.
3. RAILINGS TO BE FACE MOUNTED ONLY AT BALCONY EDGE. NO ATTACHMENT AT SIDE WALLS ARE ALLOWED.
4. DRAWINGS MAY NOT EXACTLY REFLECT AS BUILT CONDITIONS.
5. INSTALL WOOD BLOCKING BETWEEN EACH BALCONY JOIST AT THE POST LOCATION. USE P.T. WOOD BLOCKING AT POST ATTACHMENT LOCATION INSTEAD OF STRAPPING.

1 BALCONY EDGE DETAIL  
SECTION - 3" = 1'-0"

| Item No. | 1021 4 <sup>th</sup> Ave, New Westminster, BC<br>Description | Unit | Estimated Quantity | Unit Price | Amount |
|---|---|---|---|---|---|
| 5. | Remove and replace rim joists on the existing balcony assemblies, a dual 2 x 10 rim joist is required, this work shall include the supply and install of a new metal drip flashing over the edge of the balcony and shall include installation of painted fascia.<br><br>This work shall include the cutting of the existing joists as required to facilitate the rim joist installation. | Linear meter | 160 | \$ 300 | \$ 48,000 |

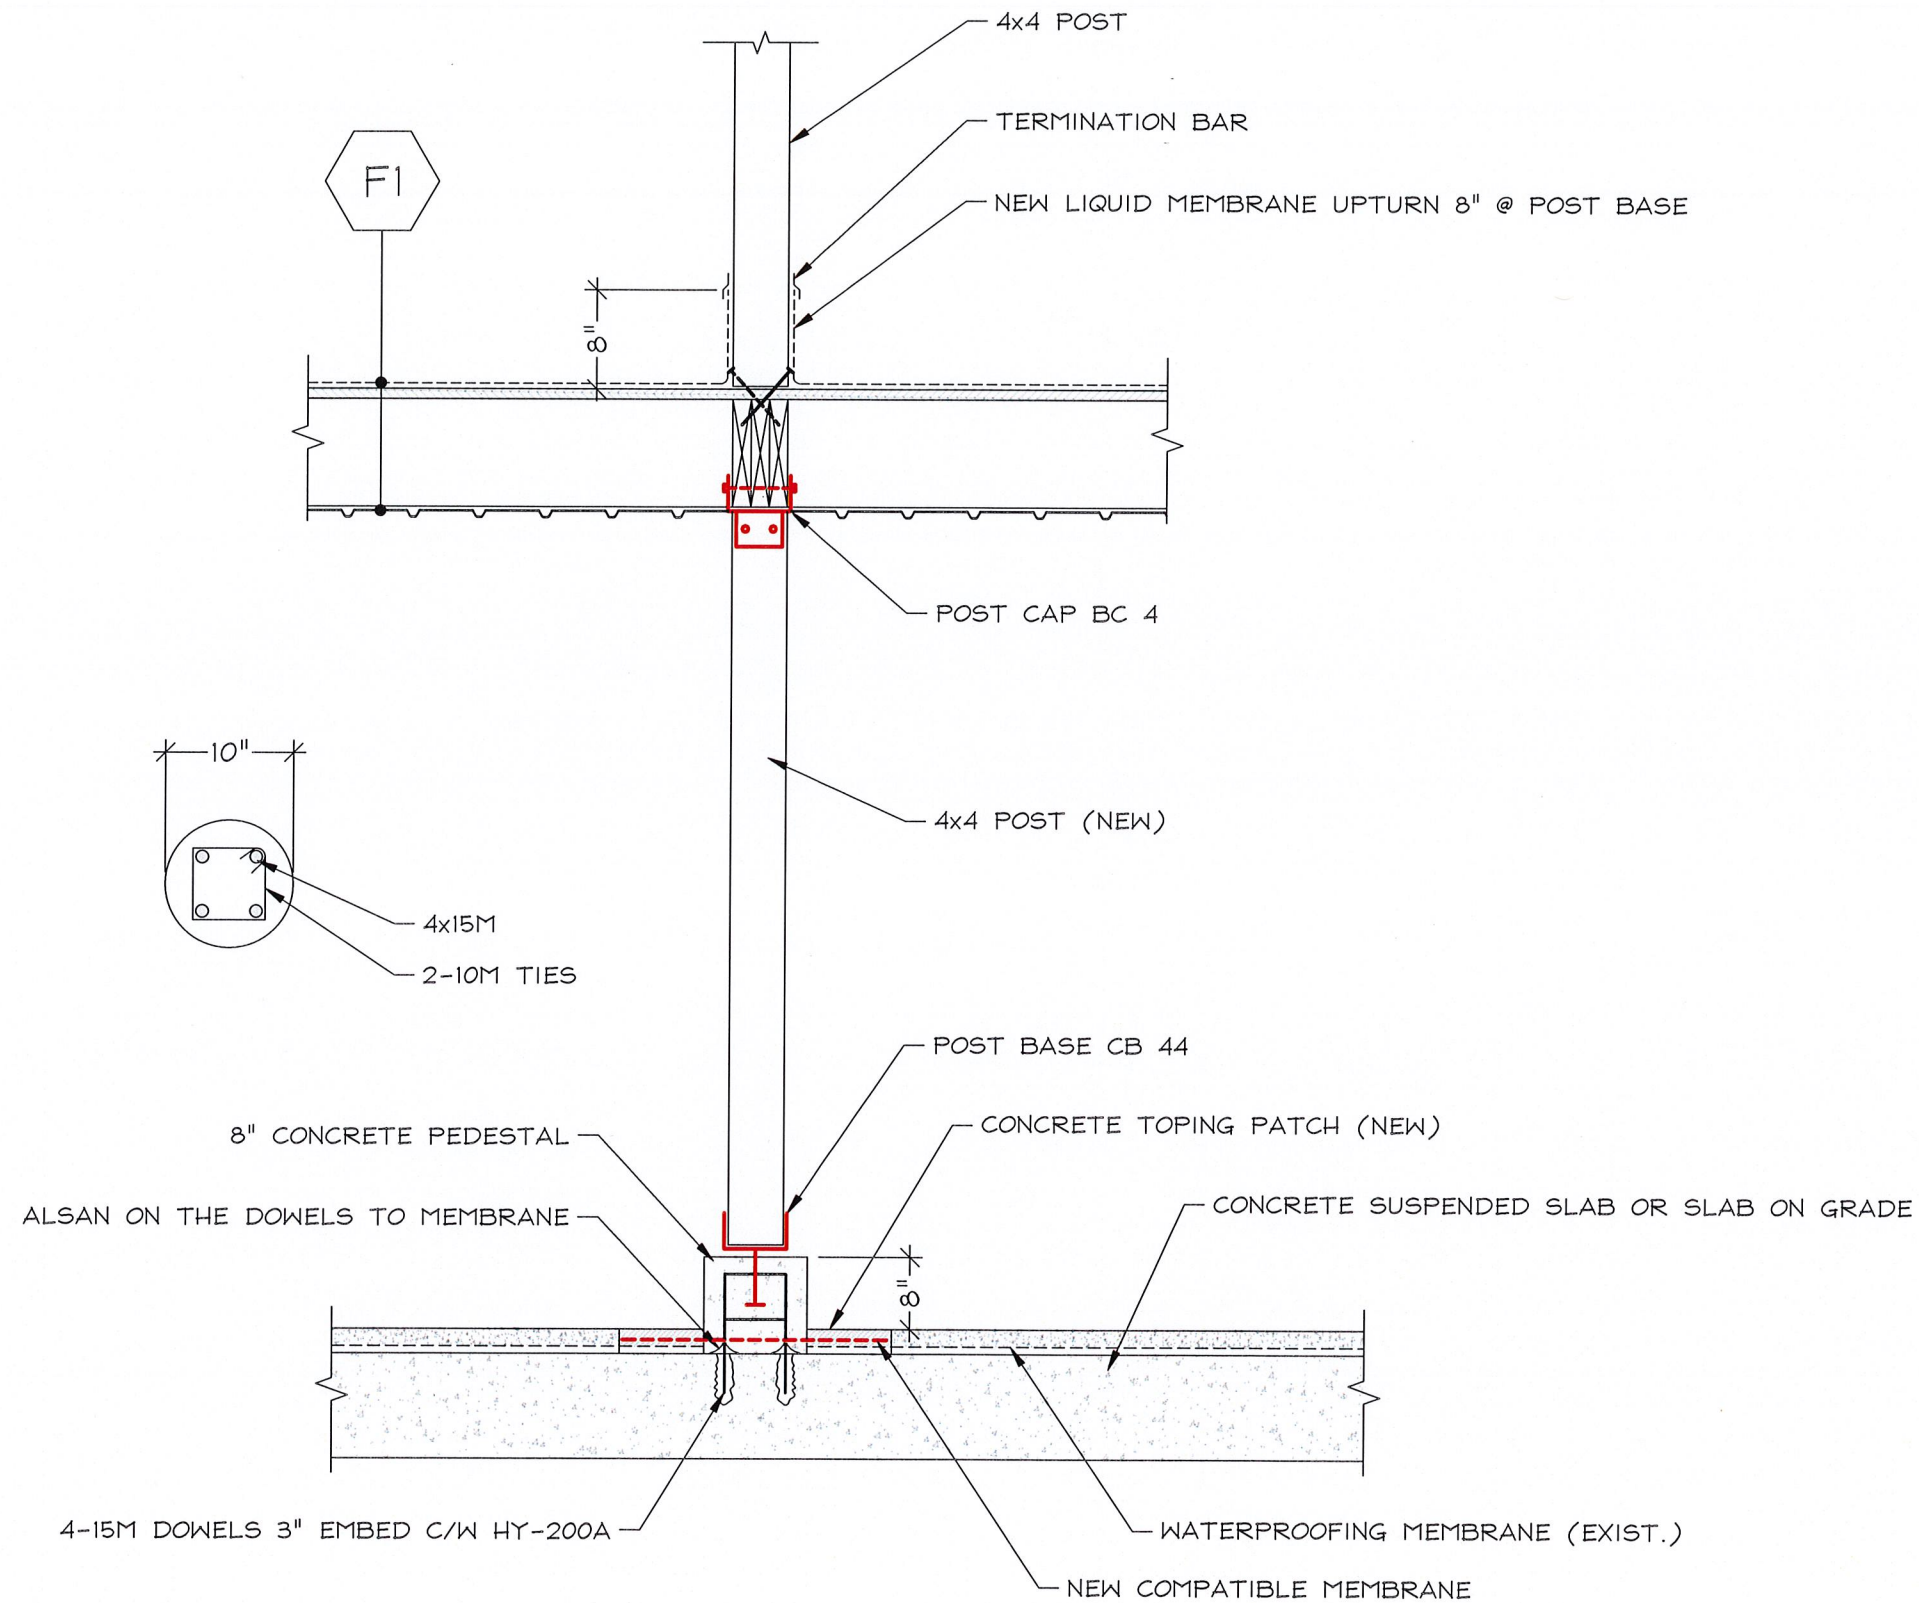
1 POST INSTALLATION - SUSPENDED SLAB  
N.T.S.

| Item No. | 1021 4 <sup>th</sup> Ave, New Westminster, BC<br>Description | Unit | Estimated Quantity | Unit Price | Amount |
|---|---|---|---|---|---|
| 7. | Install a new face-mounted (wood decks) and top-mounted (concrete decks) aluminum post and picket railing assembly across the balcony including all fasteners and through bolt connections, following completion of the deck repairs detailed above, where the existing balcony railing has been removed. | Linear meter | 100 | \$ 600 | \$ 60,000 |
