**RE: Balcony Restoration – Certificate of Completion
Bellevue Tower West
195 21st Street West Vancouver BC**

RJC No. VAN.103256.0016

Certificate of Completion

DEFICIENCY LIST

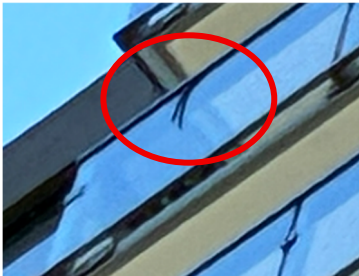
DEFICIENCY LIST					
No.	Deficiency Reported Date MM/DD/YY	Location and Deficiency Description	Required Action	Date Completed MM/DD/YY	Photo
3	10/07/25	Guardrail gasket at unit 1405 has been displaced.	Contractor to restore gasket positions per reviewed shop drawings.	N/A

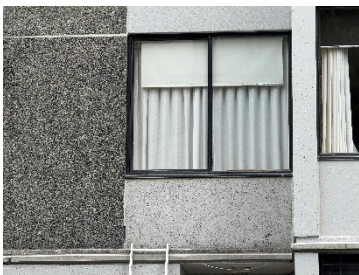
6	10/07/25	Sections of the building on the west and east elevations have not been painted.	Contractor to perform painting per contract documents.	N/A

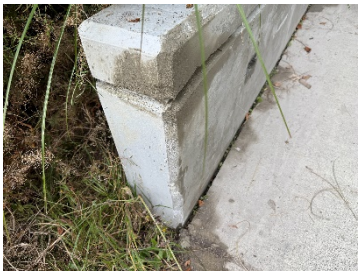
7	10/07/25	Ground floor – damaged concrete and paint at curbs.	Contractor to perform concrete repair and painting to restore damaged curbs to pre-construction condition.	N/A

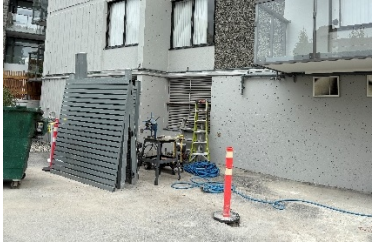
9	10/07/25	Garbage enclosure on the west elevation has not been reinstated.	Contractor to reinstate the garbage enclosure to its pre-construction condition and move the bins from east elevation to the location determined by the Owner.	N/A

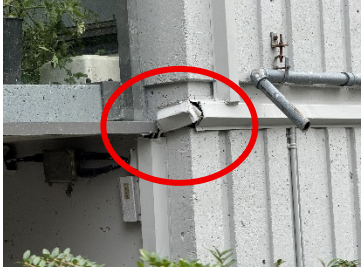
10	10/07/25	Ground floor – bent or damaged flashing.	Contractor to replace bent or damaged flashing.	N/A

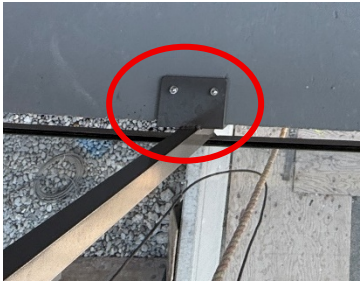
11	10/07/25	Drop 8 – missing bolt caps.	Contractor to install bolt caps to match the locations previously reviewed by RJC.	N/A

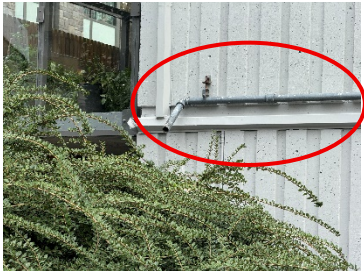
DEFICIENCY LIST					
No.	Deficiency Reported Date MM/DD/YY	Location and Deficiency Description	Required Action	Date Completed MM/DD/YY	Photo
12	10/07/25	Ground floor – unpainted pipes.	Contractor to paint the pipe to match adjacent wall.	N/A

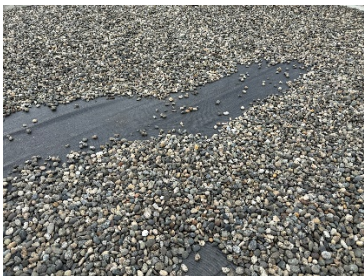
13	10/07/25	Roof – displaced gravel and uncovered filter fabric.	Contractor to re-distribute gravel ballast to provide uniform coverage over the filter fabric.	N/A
